| <b>Rolls-Royce</b> | Rolls-Royce Corporation<br>450 S. Meridian Street<br>Indianapolis, Indiana<br>46225-1103, USA | <b>REPORT NO.</b><br>20FAE-014-PR | <b>REV.</b><br>Initial | <b>PAGES</b><br>1 of 135 |
| <b>TITLE</b><br><br><b>METALLURGICAL INVESTIGATION OF A HELICAL POWER TURBINE PINION GEAR, P/N 6893672, INSTALLED IN AN M250-C47B ENGINE, S/N CAE847031, OPERATED BY PANTHER HELICOPTERS</b> | | <b>PREPARED</b><br><br>Signatures on file | | |

| Engine Model: | M250-C47B |
| Evaluations: | Failure Analysis |

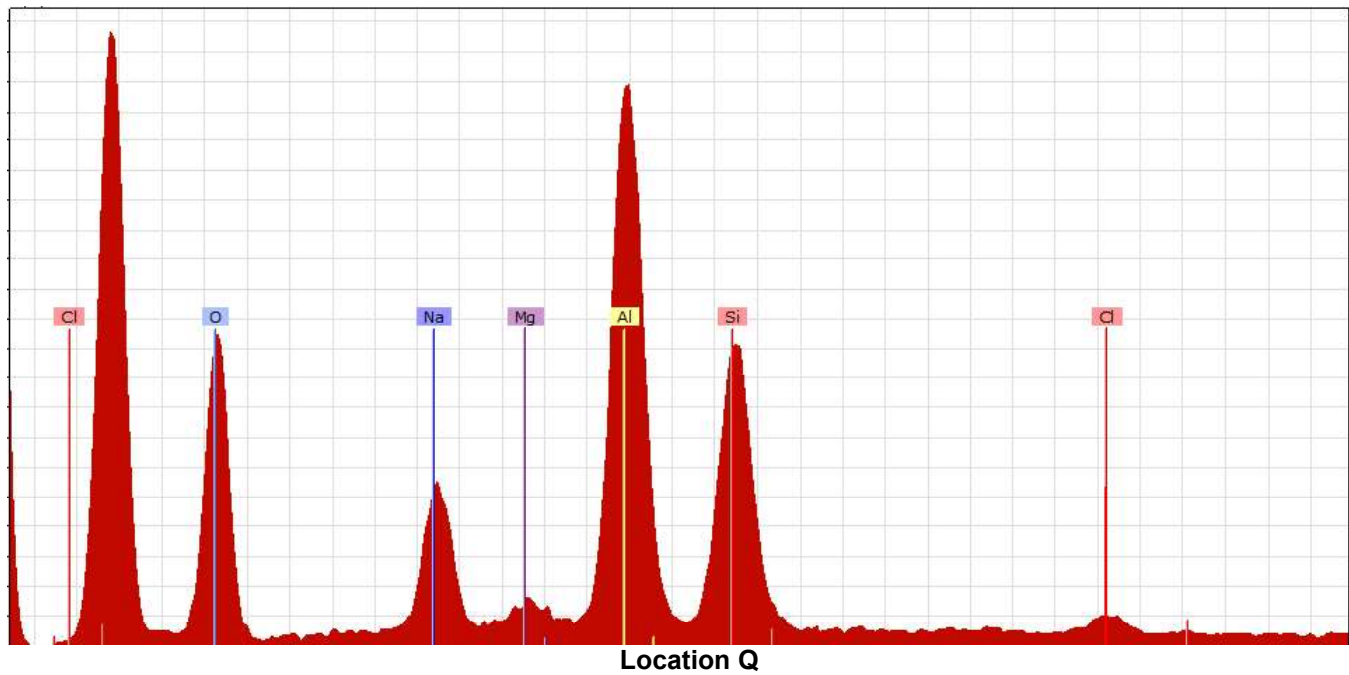
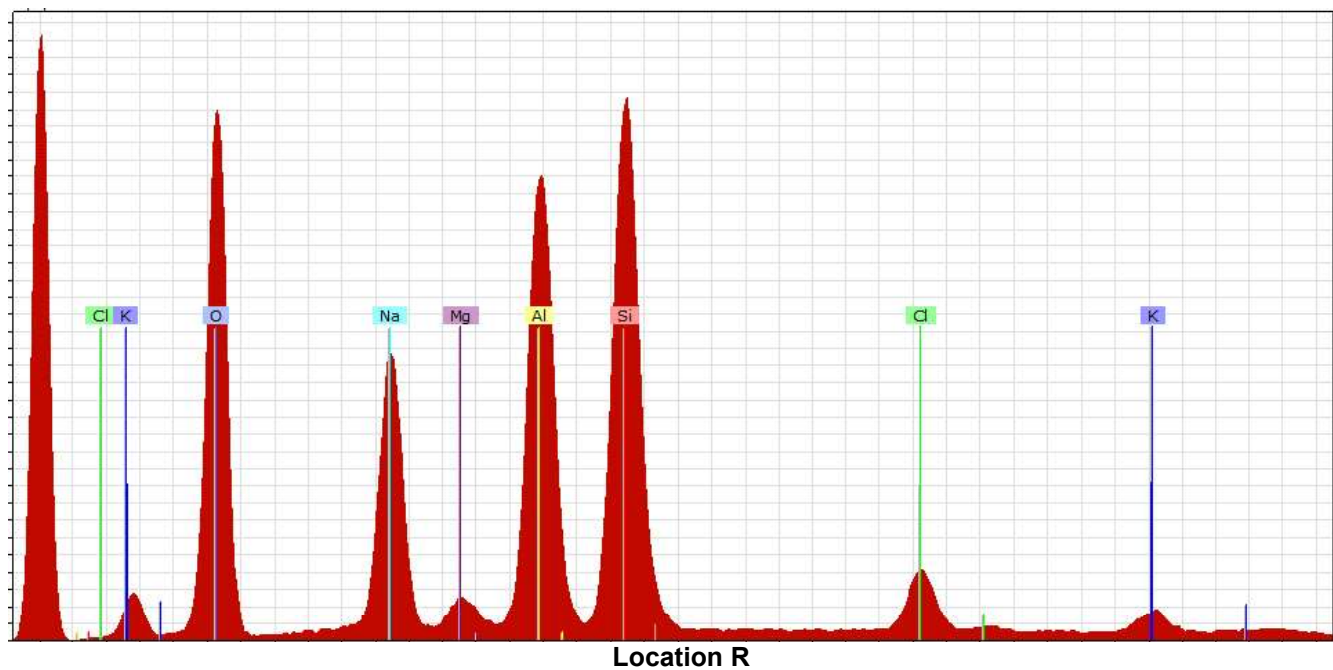
**Figure 87.** Semi-quantitative EDS results for blockage material at locations Q and R in pinion gear oil jet of the oil delivery tube (see Figure 85), which exhibited concentrations of silicon, aluminum, oxygen, sodium, chlorine, and magnesium.

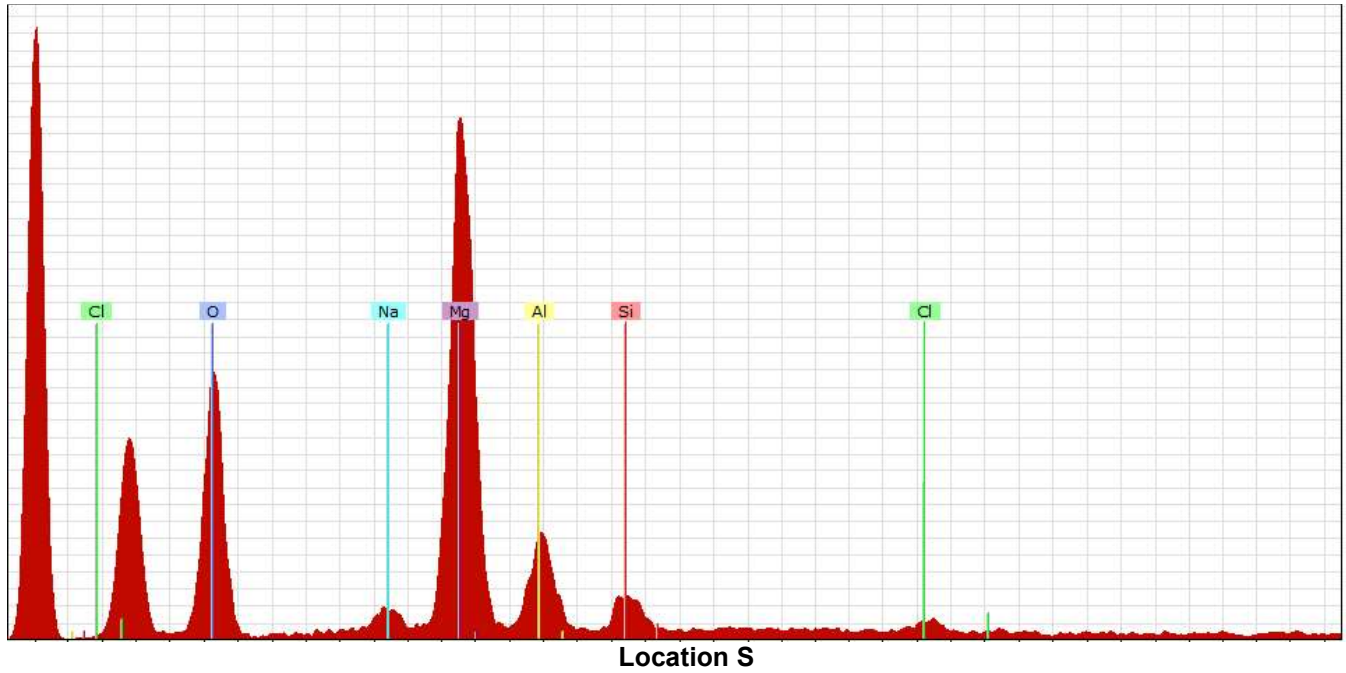
**Figure 88. Semi-quantitative EDS results for blockage material at locations S in pinion gear oil jet of the oil delivery tube (see Figure 85), which exhibited concentrations of magnesium, oxygen, aluminum, silicon, and chlorine.**

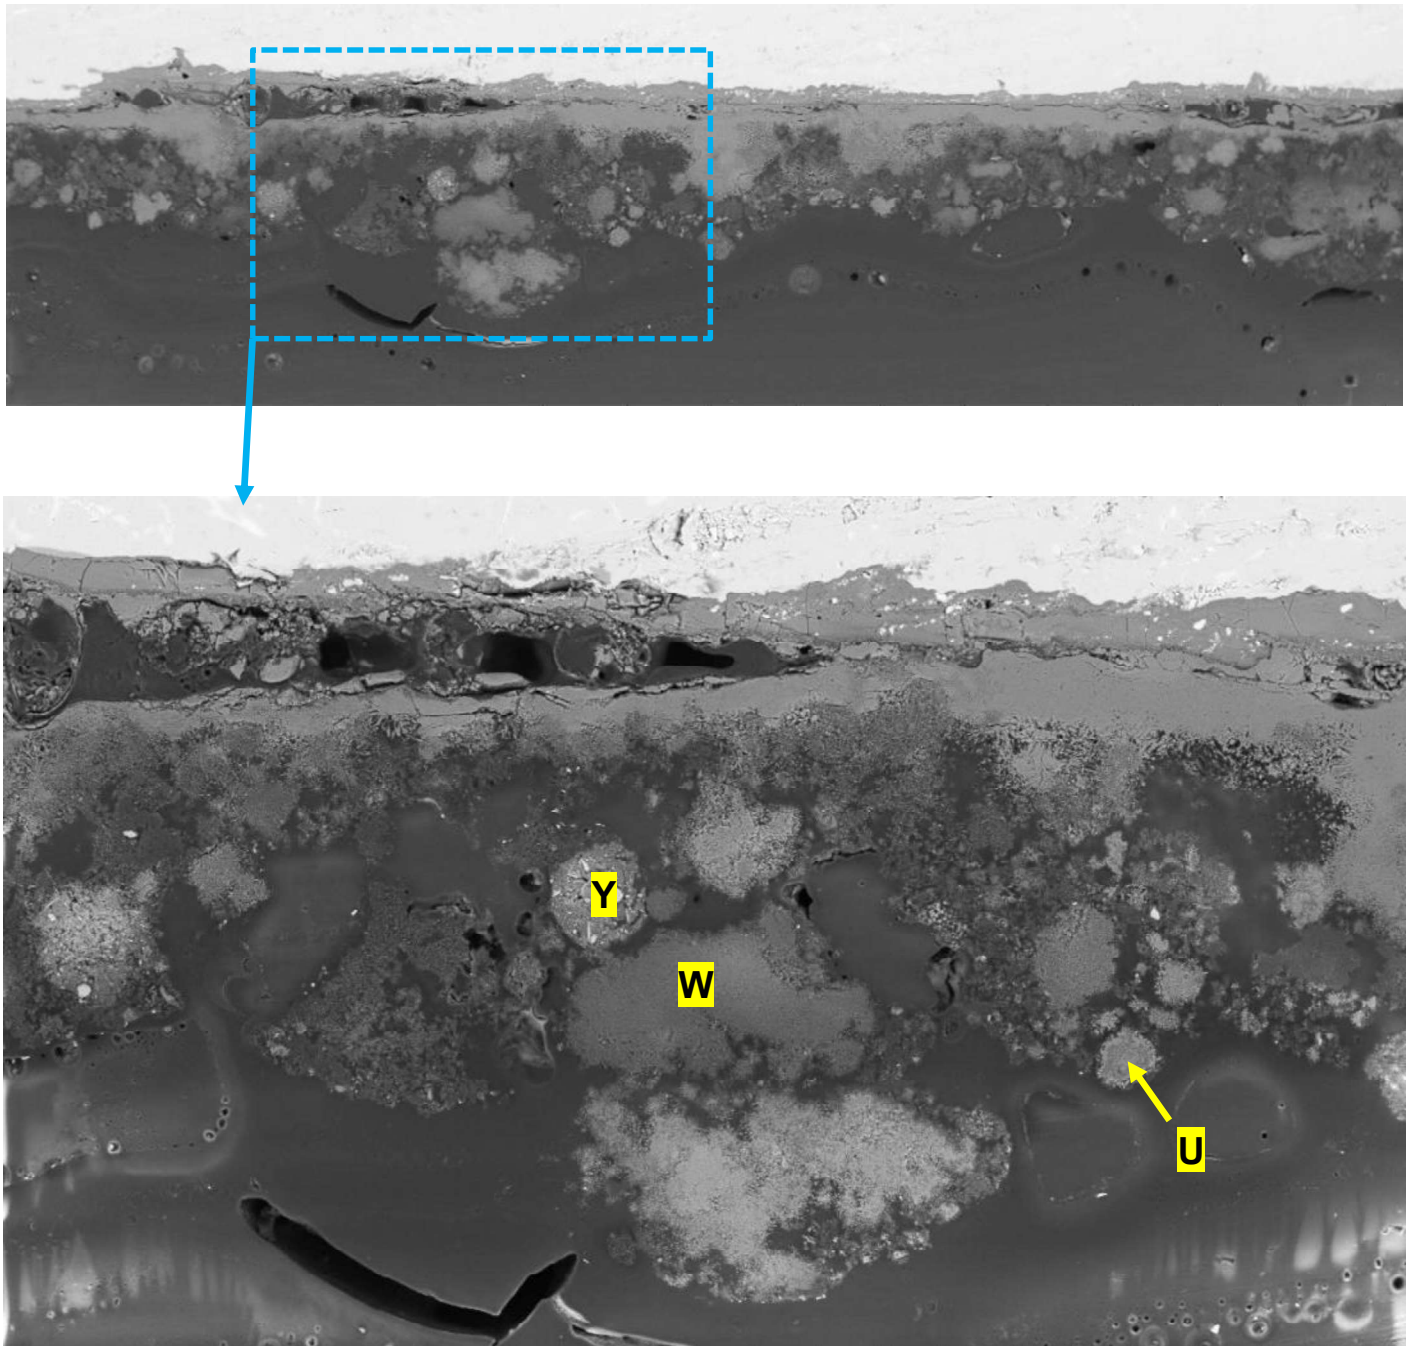
**Figure 89. Backscattered electron SEM images of the metallographic section through the main passageway of the oil delivery tube (see blue boxed area in Figure 62), which exhibited blockage. Semi-quantitative EDS results for blockage material at locations U through Y are shown in more detail in Figure 90 and Figure 91.**

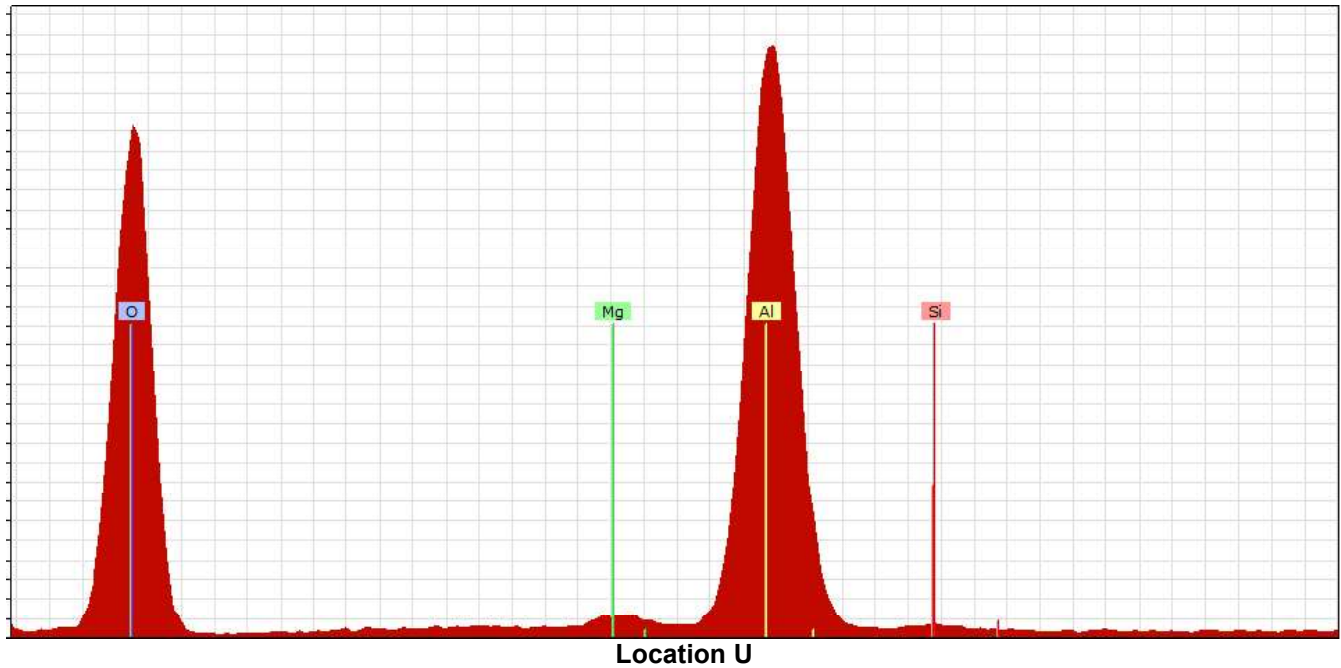
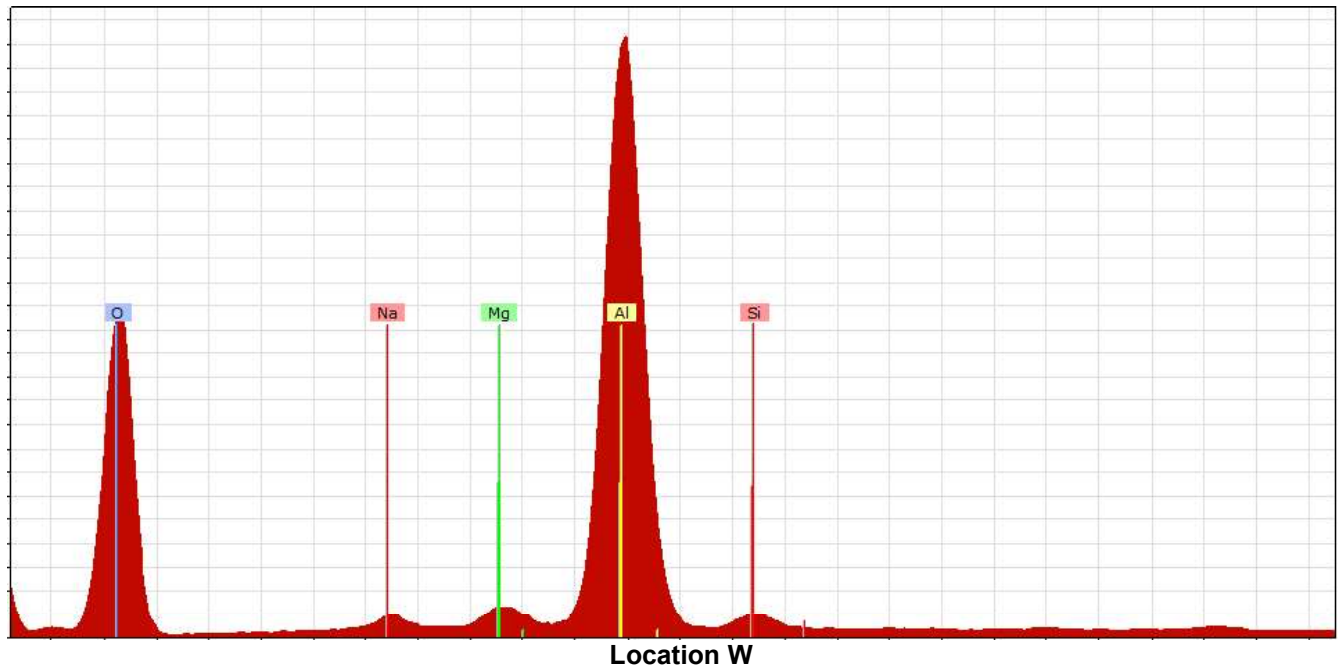
**Figure 90.** Semi-quantitative EDS results for blockage material at locations U and W in the main passageway of the oil delivery tube (see Figure 89). Location U exhibited concentrations of oxygen, aluminum, magnesium, and silicon. Location W exhibited concentrations of aluminum, oxygen, magnesium, silicon, and sodium.

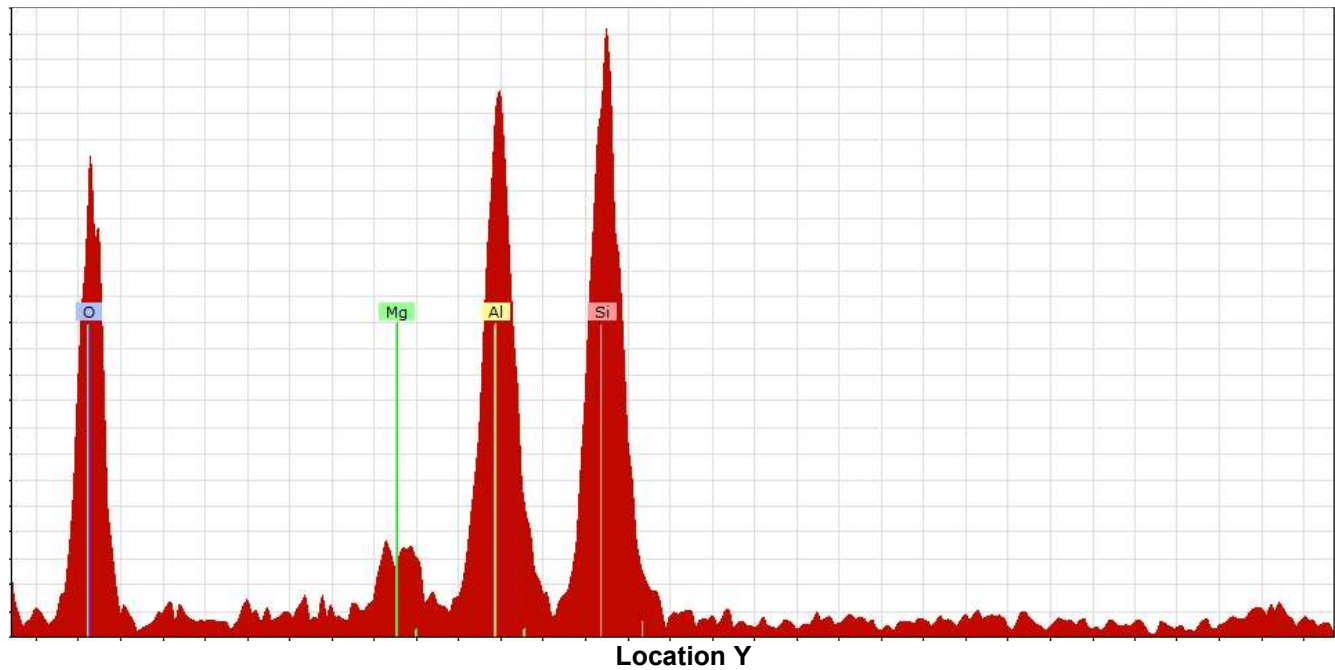
**Figure 91. Semi-quantitative EDS results for blockage material at locations Y in the main passageway of the oil delivery tube (see Figure 89), which exhibited concentrations of oxygen, silicon, aluminum, and magnesium.**

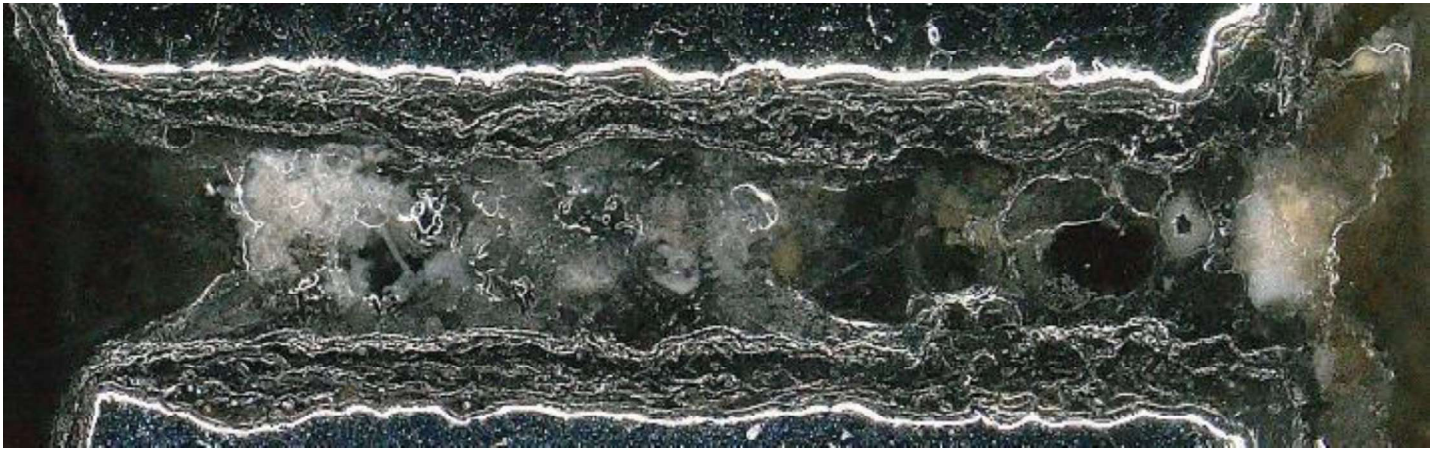
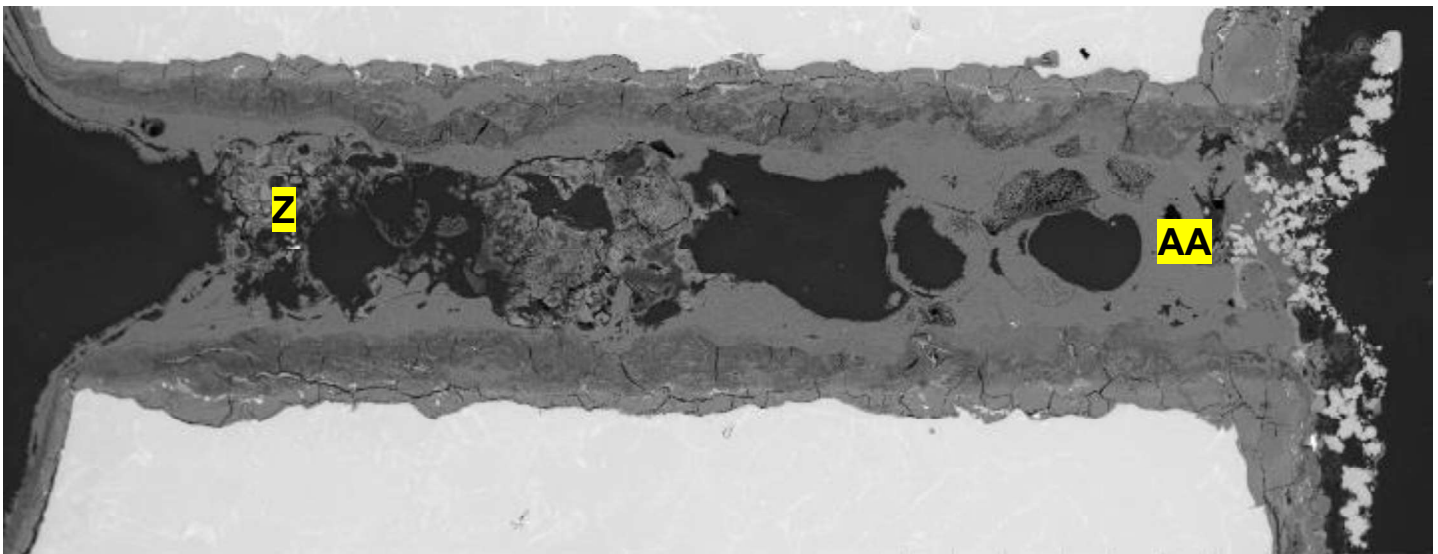
**Figure 92.** Optical (top) and backscattered electron SEM (bottom) images of the metallographic section through No. 3 bearing oil jet A of the oil delivery tube (see orange boxed area in Figure 63), which exhibited blockage. Locations Z and AA are shown in more detail in the following figure.

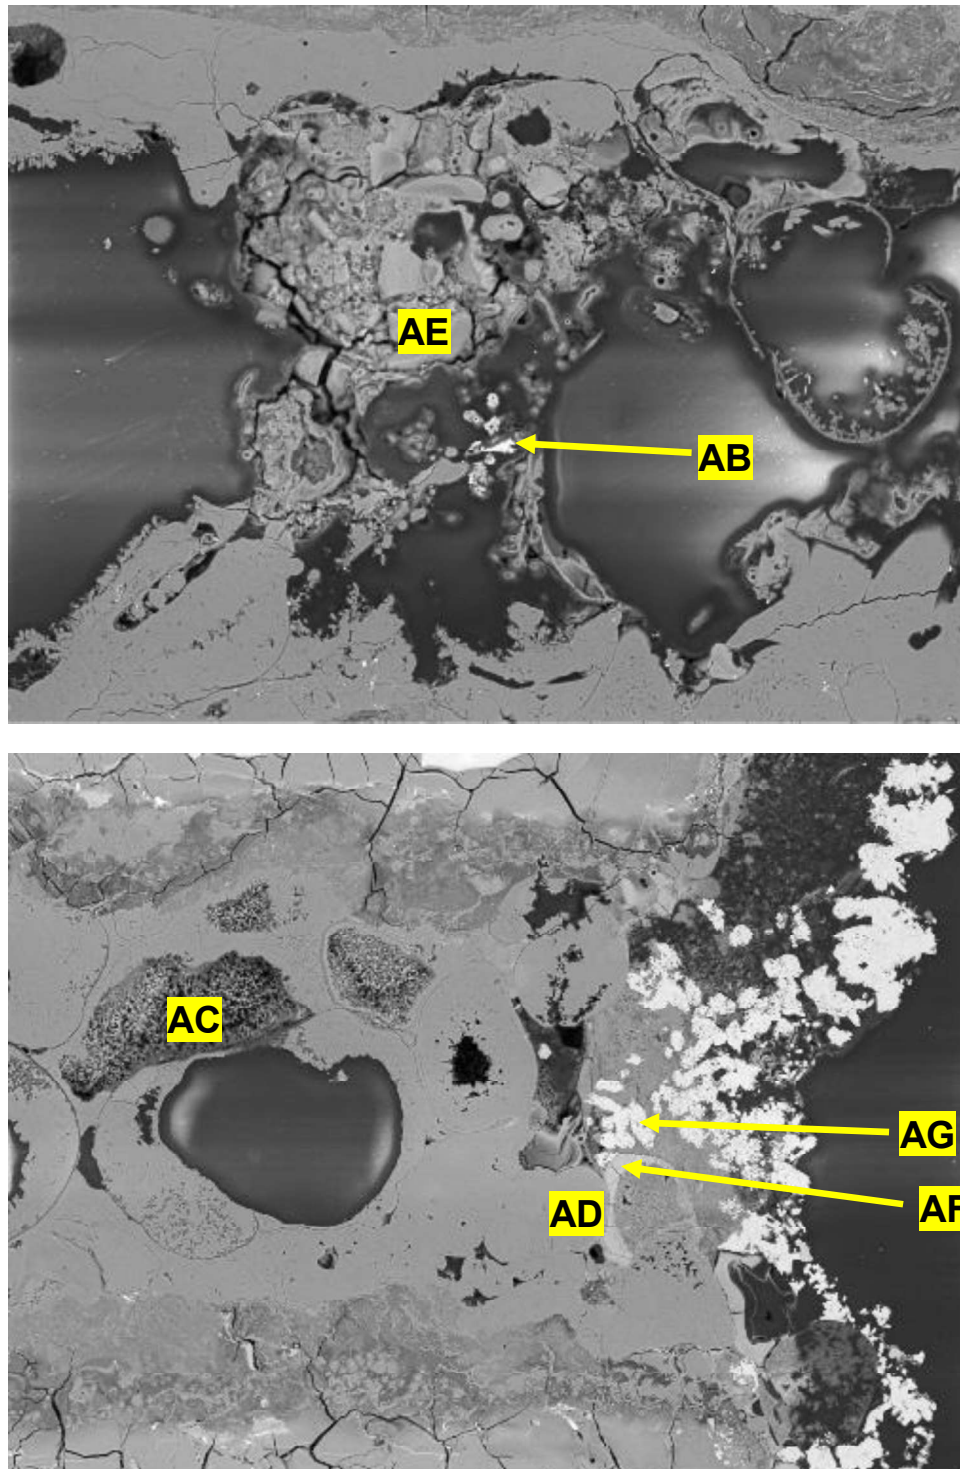
**Figure 93.** Backscattered electron SEM images of the blockage in No. 3 bearing oil jet A of the oil delivery tube. Top and bottom images are detailed views of locations Z and AA in previous figure, respectively. Semi-quantitative EDS results for blockage material at locations AB through AG are shown in more detail in Figure 94 and Figure 96.

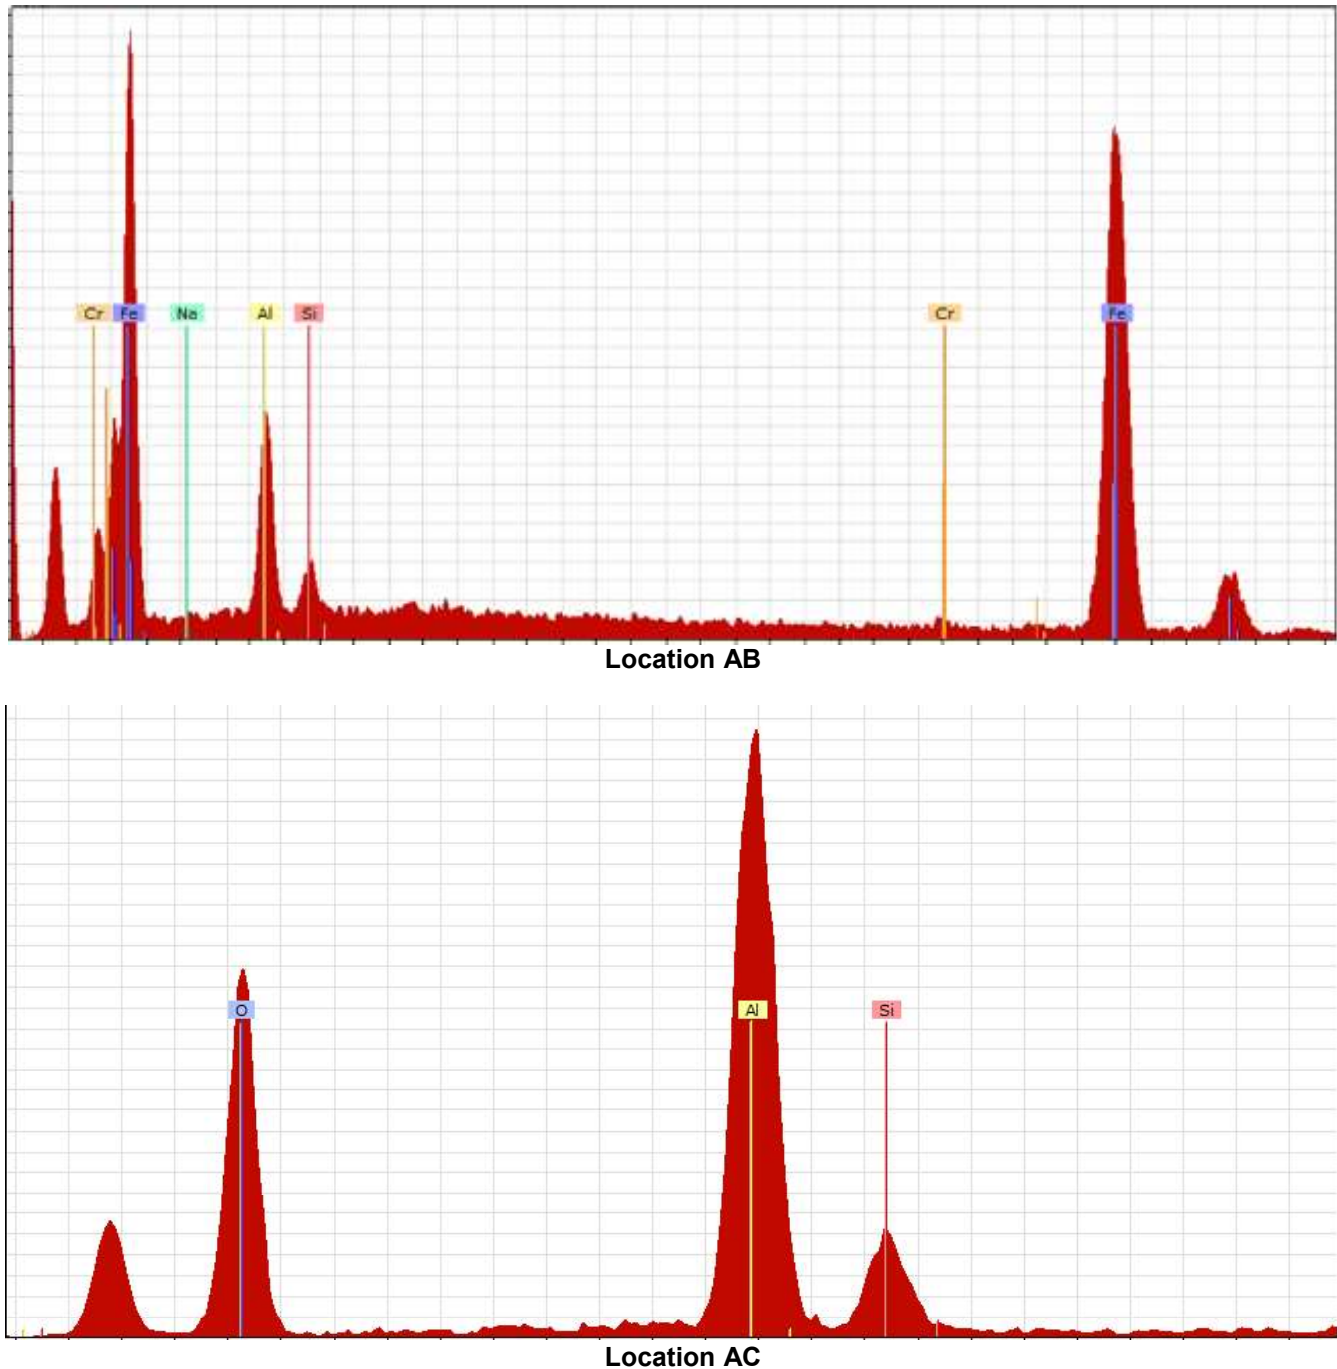
**Figure 94.** Semi-quantitative EDS results for blockage material at locations AB and AC in No. 3 bearing oil jet A of the oil delivery tube (see Figure 93). Location AB exhibited concentrations of iron, aluminum, silicon, chromium, and sodium. Location AC exhibited concentrations of aluminum, oxygen, and silicon.

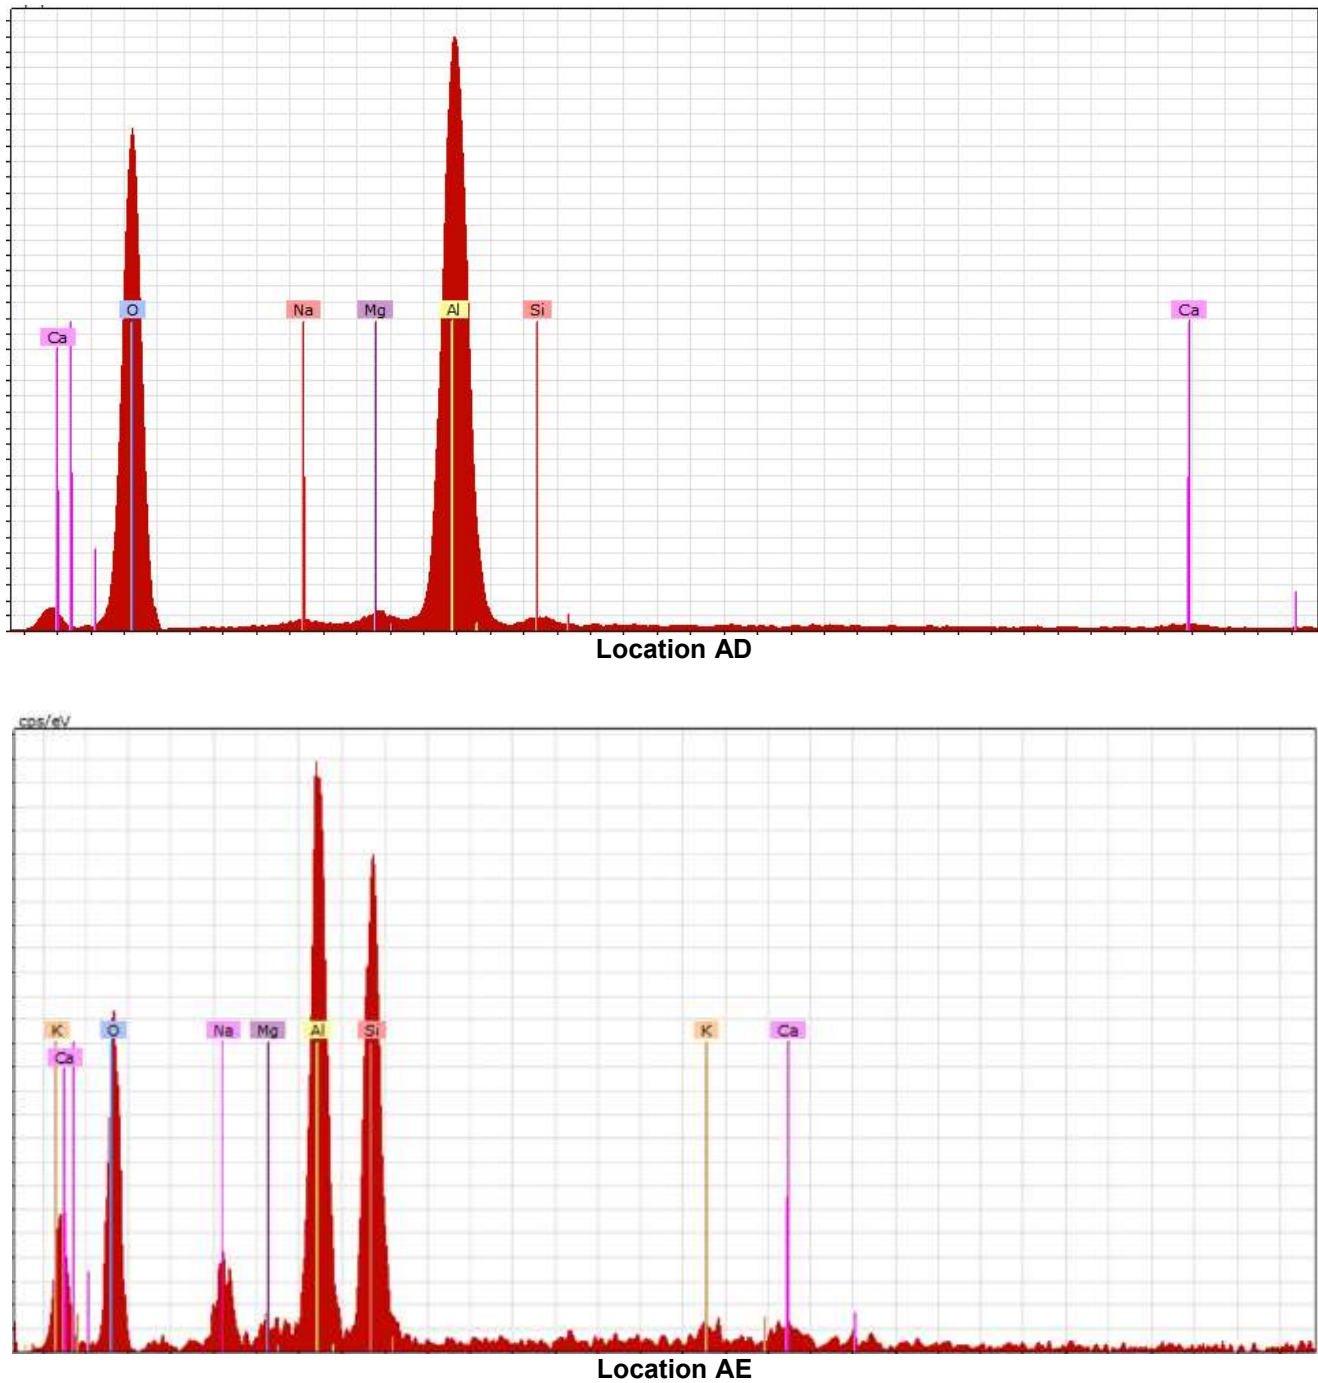
**Figure 95. Semi-quantitative EDS results for blockage material at locations AD and AE in No. 3 bearing oil jet A of the oil delivery tube (see Figure 93). Location AD exhibited concentrations of aluminum, oxygen, and magnesium, calcium, sodium, and silicon. Location AE exhibited concentrations of silicon, aluminum, oxygen, calcium, sodium, magnesium, and potassium.**

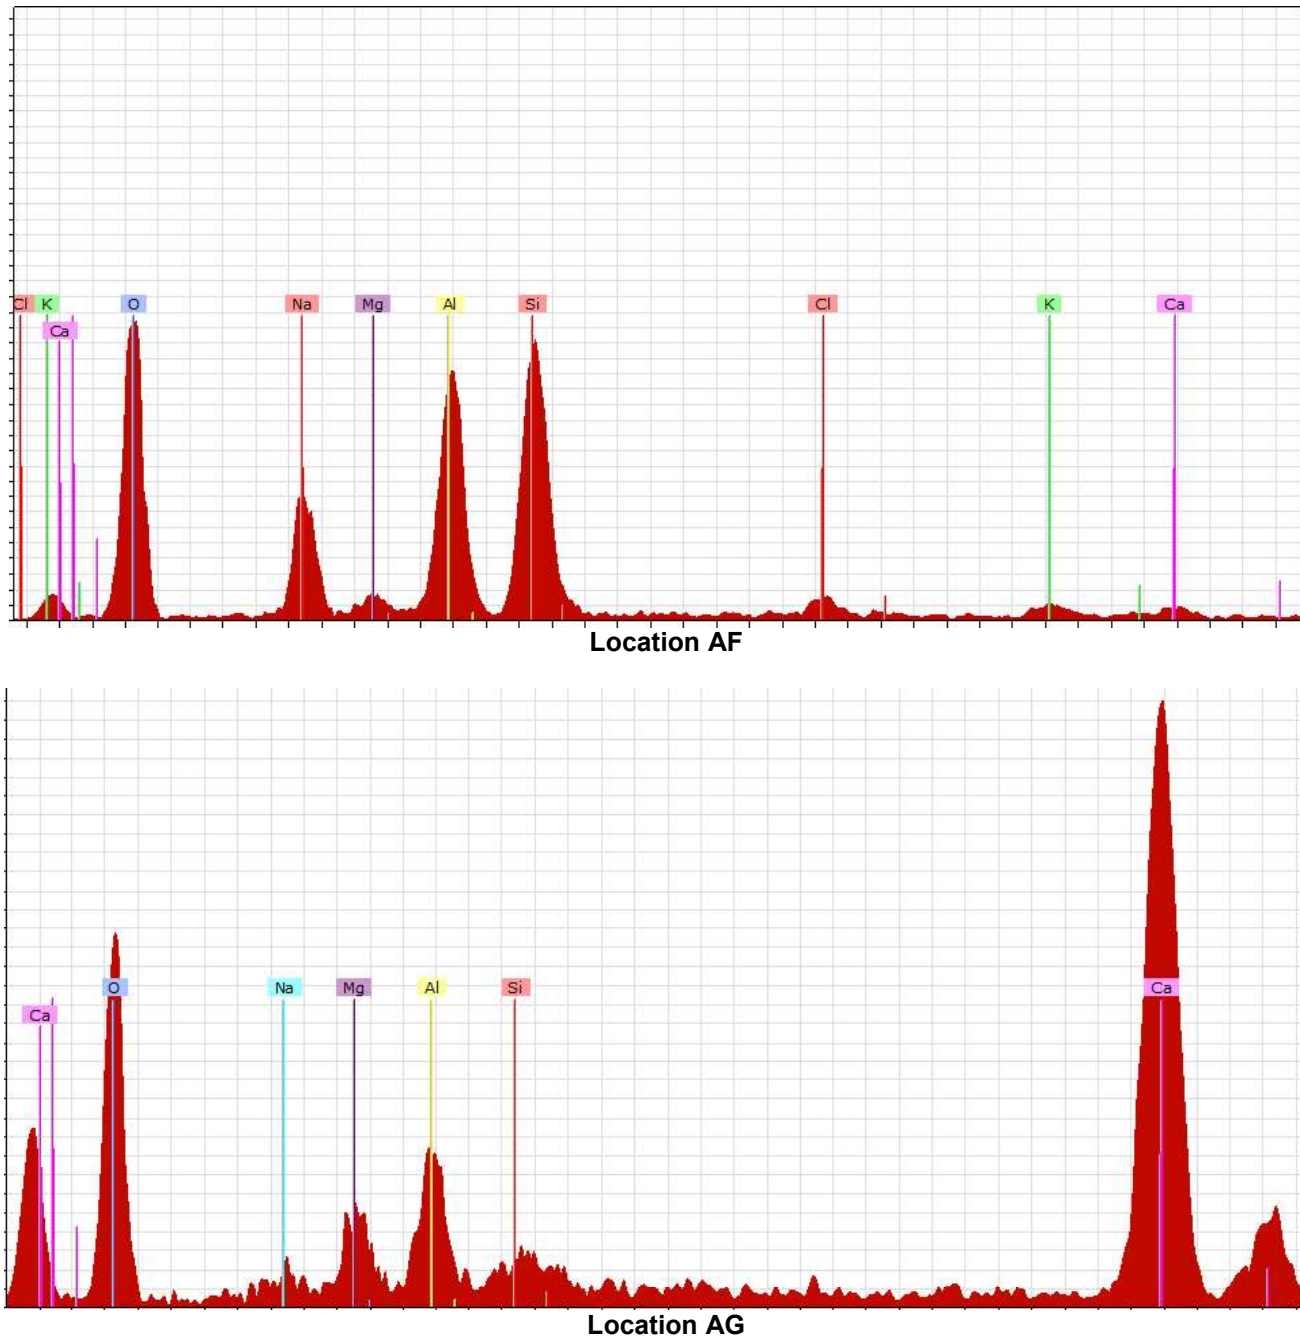
**Figure 96.** Semi-quantitative EDS results for blockage material at locations AF and AG in No. 3 bearing oil jet A of the oil delivery tube (see Figure 93). Location AF exhibited concentrations of silicon, aluminum, oxygen, magnesium, chlorine, potassium, and calcium. Location AG exhibited concentrations of calcium, oxygen, aluminum, magnesium, sodium, and silicon.

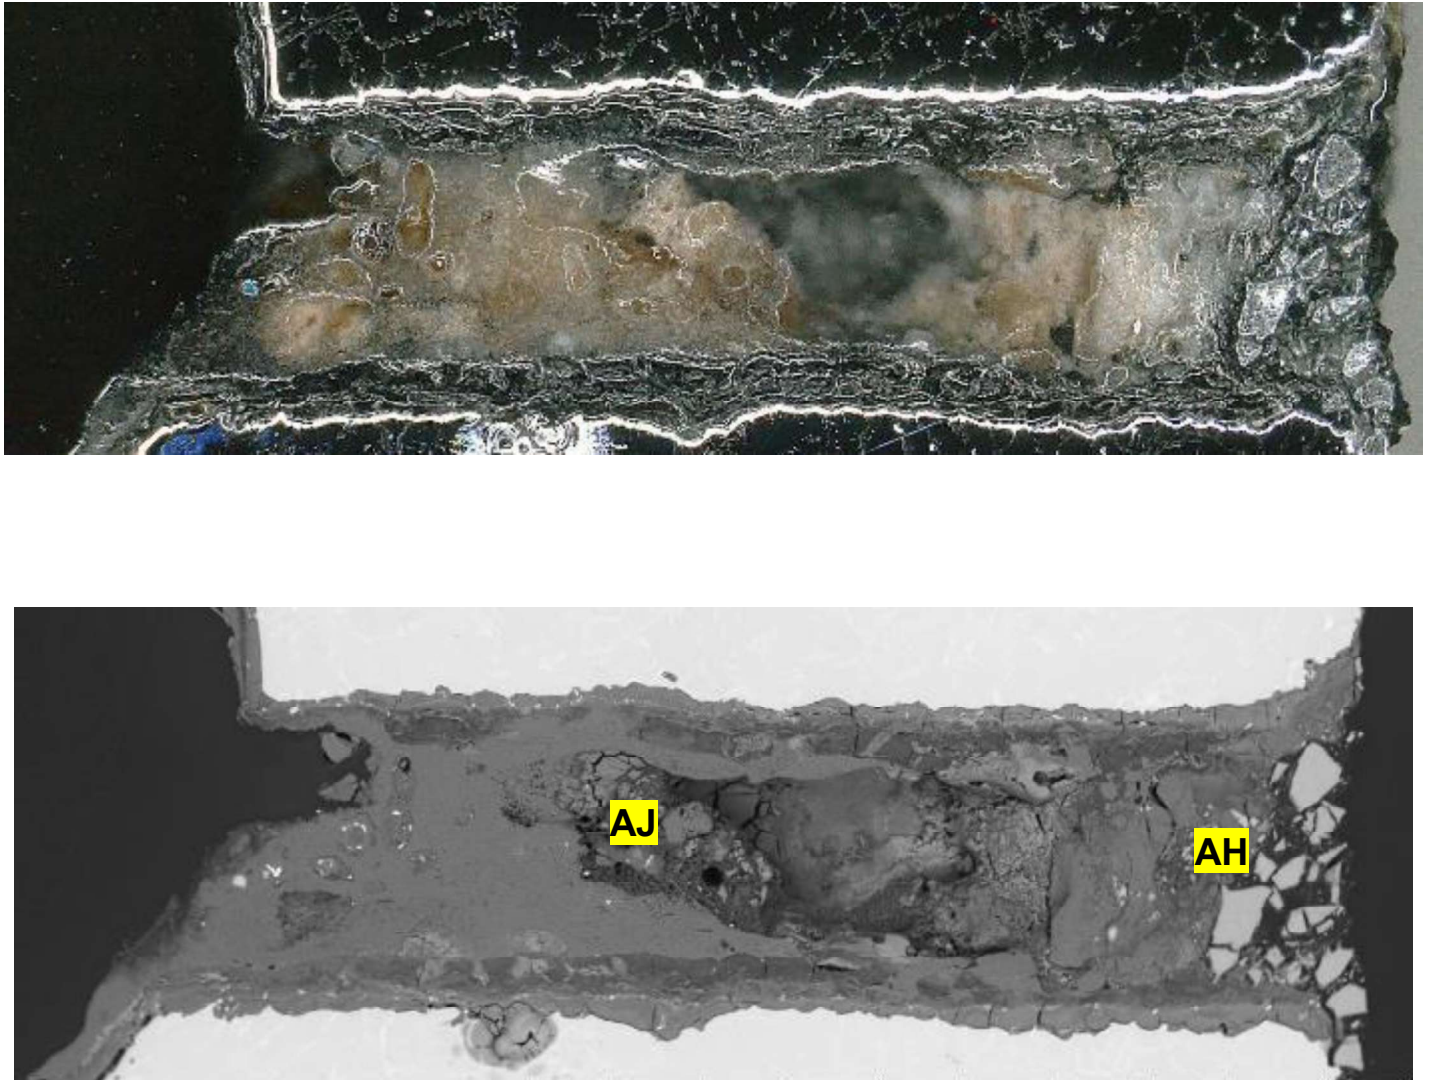
**Figure 97.** Optical (top) and backscattered electron SEM (bottom) images of the metallographic section through No. 3 bearing oil jet B of the oil delivery tube (see orange boxed area in Figure 64), which exhibited blockage. Locations AH and AJ are shown in more detail in the following figure.

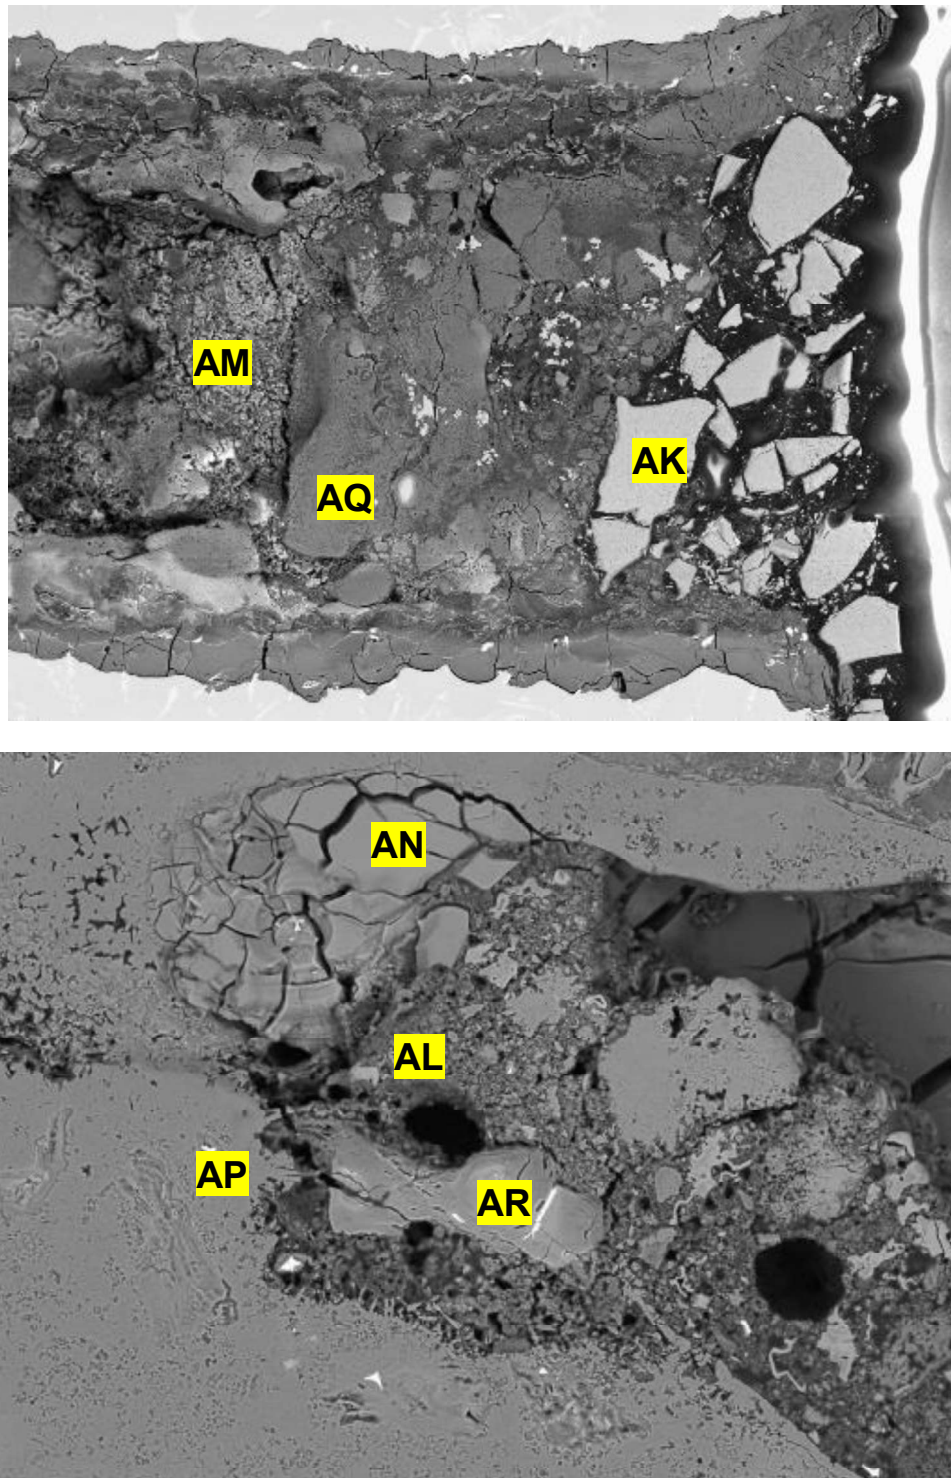
**Figure 98.** Backscattered electron SEM images of the blockage in No. 3 bearing oil jet B of the oil delivery tube. Top and bottom images are detailed views of locations AH and AJ in previous figure, respectively. Semi-quantitative EDS results for blockage material at locations AK through AR are shown in more detail in Figure 99 and Figure 102.

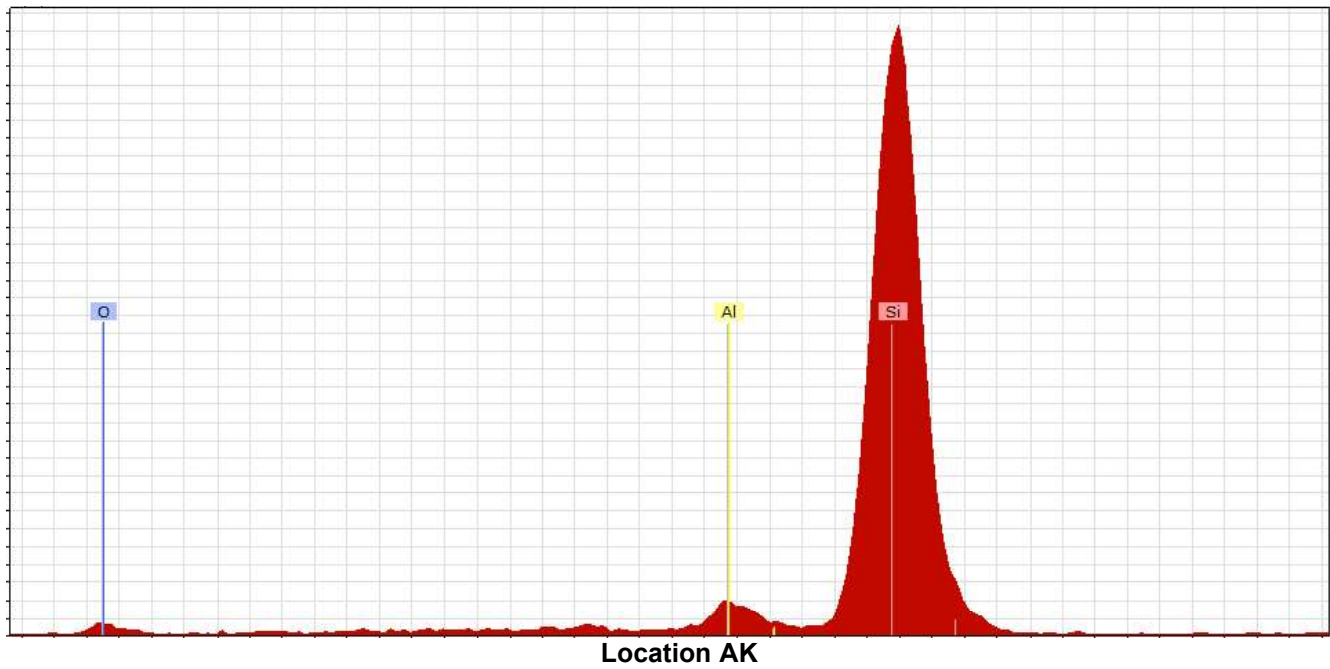
**Figure 99.** Semi-quantitative EDS results for blockage material at location AK in No. 3 bearing oil jet B of the oil delivery tube (see Figure 98), which exhibited concentrations of silicon, oxygen, and aluminum.

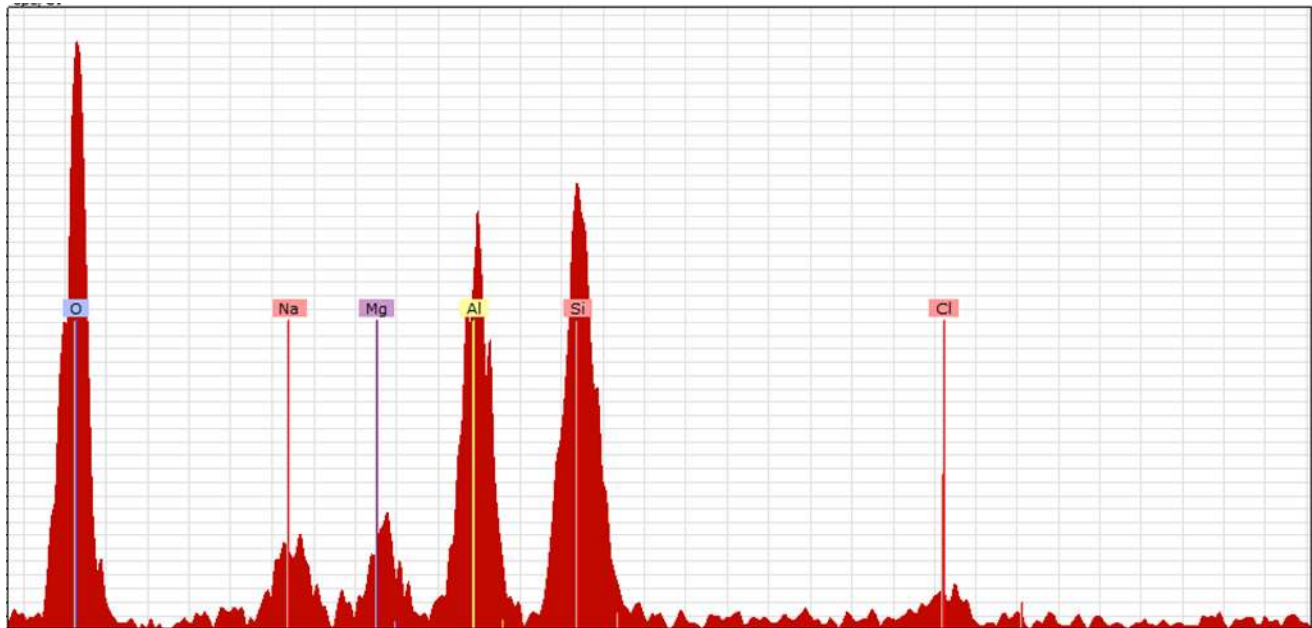
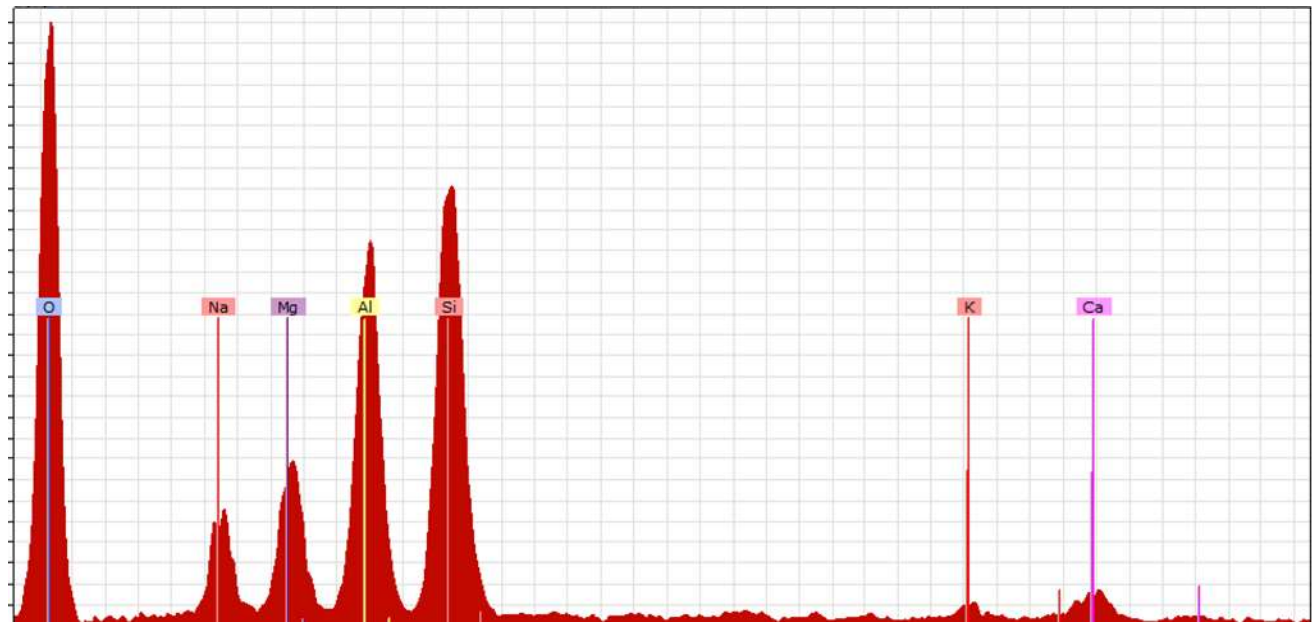
**Figure 100. Semi-quantitative EDS results for blockage material at locations AL and AM in No. 3 bearing oil jet B of the oil delivery tube (see Figure 98), which exhibited concentrations of silicon, aluminum, oxygen, magnesium, and calcium.**
