| <b>Rolls-Royce</b> | Rolls-Royce Corporation<br>450 S. Meridian Street<br>Indianapolis, Indiana<br>46225-1103, USA | <b>REPORT NO.</b><br>20FAE-014-PR | <b>REV.</b><br>Initial | <b>PAGES</b><br>1 of 135 |
| <b>TITLE</b><br><br><b>METALLURGICAL INVESTIGATION OF A HELICAL POWER TURBINE PINION GEAR, P/N 6893672, INSTALLED IN AN M250-C47B ENGINE, S/N CAE847031, OPERATED BY PANTHER HELICOPTERS</b> | | <b>PREPARED</b><br><br>Signatures on file | | |

| Engine Model: | M250-C47B |
| Evaluations: | Failure Analysis |

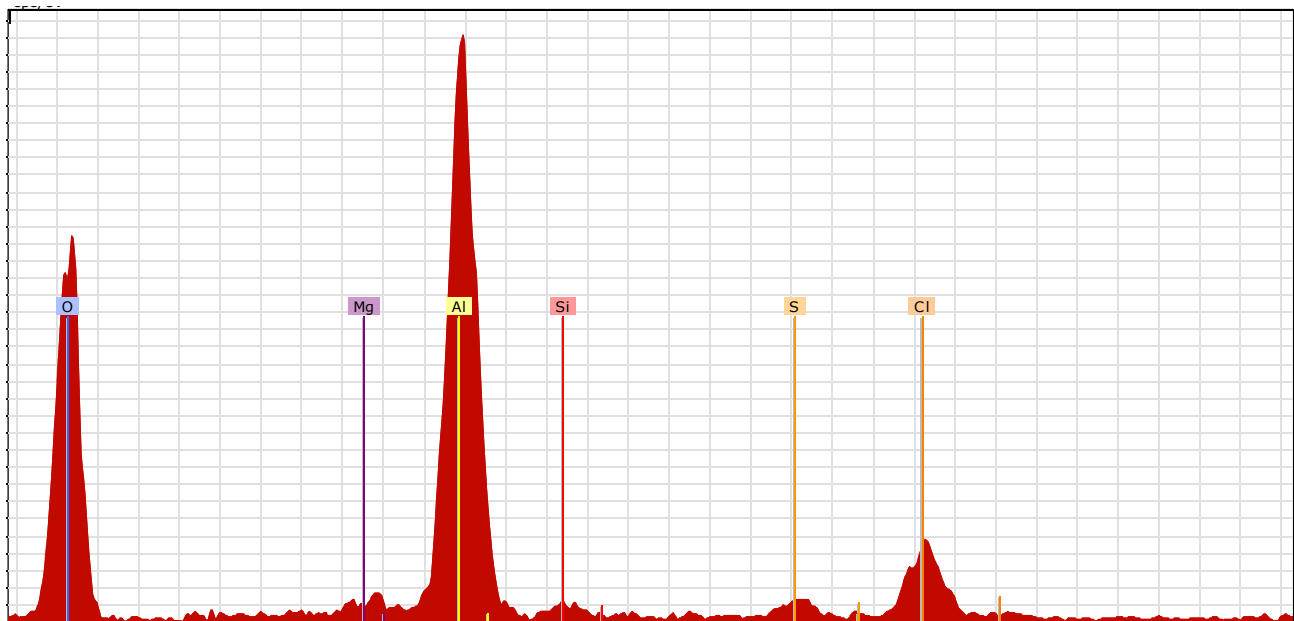
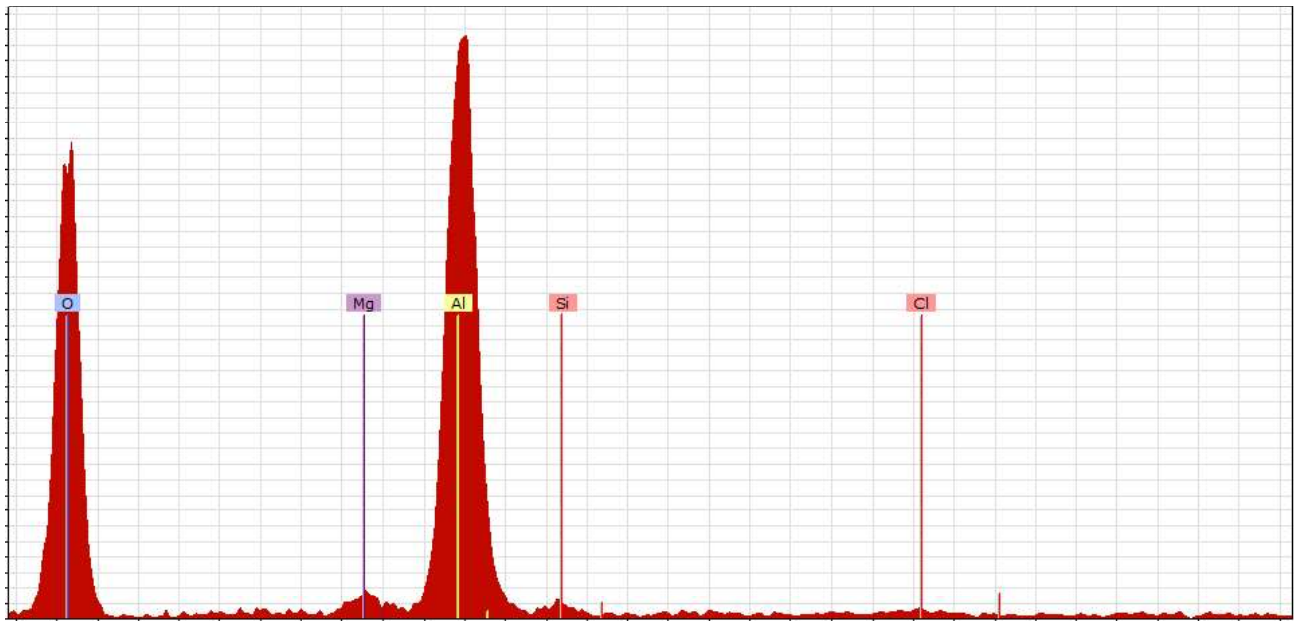
**Figure 101. Semi-quantitative EDS results for blockage material at locations AN and AP in No. 3 bearing oil jet B of the oil delivery tube (see Figure 98), which exhibited concentrations of aluminum, oxygen, silicon, chlorine, and magnesium.**

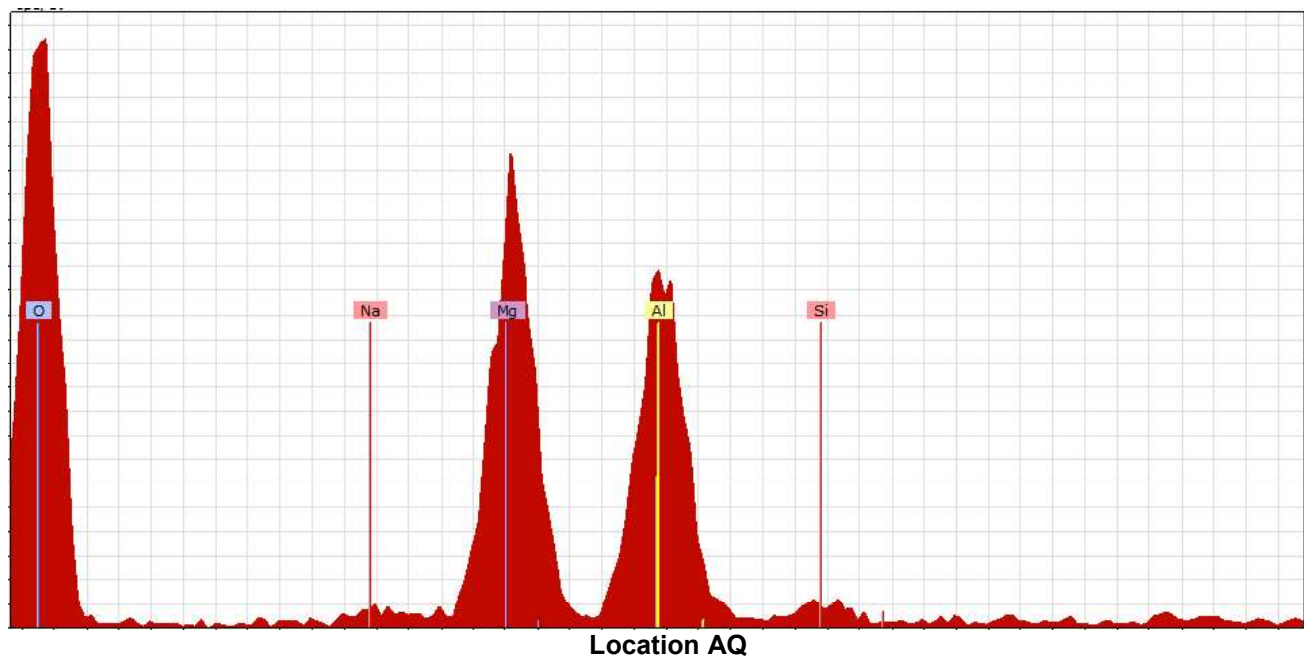
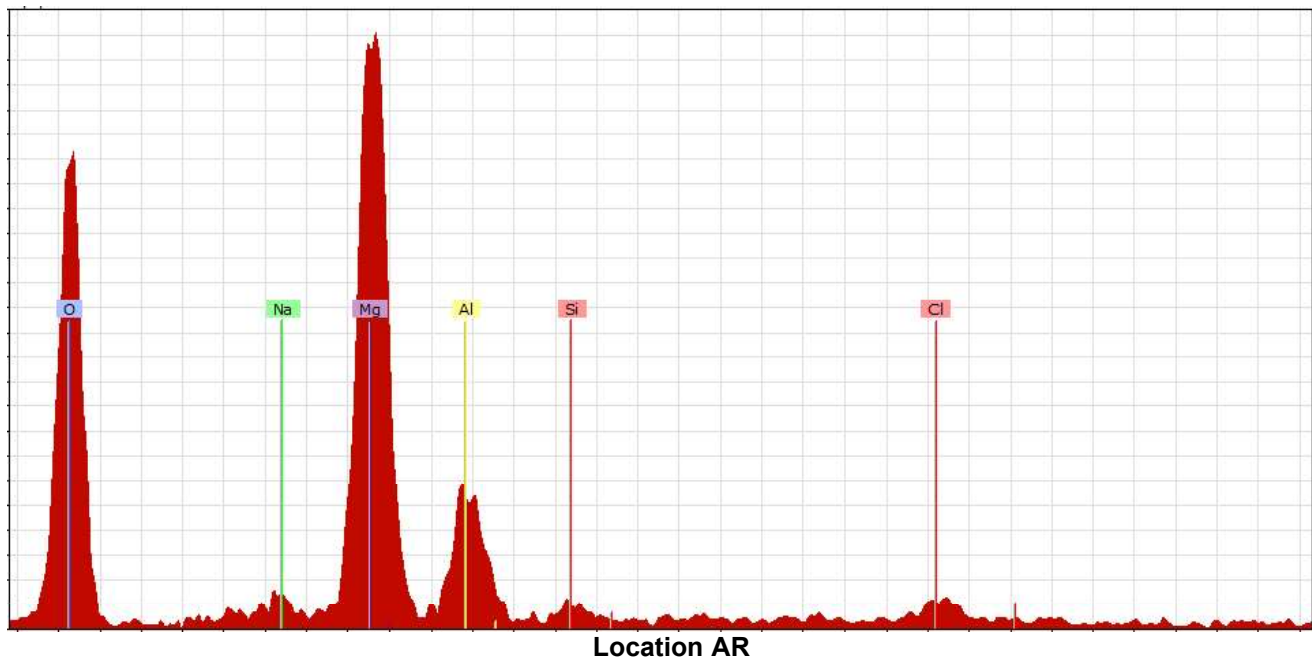
**Figure 102. Semi-quantitative EDS results for blockage material at locations AQ and AR in No. 3 bearing oil jet B of the oil delivery tube (see Figure 98), which exhibited concentrations of magnesium, oxygen, aluminum, silicon, and sodium.**

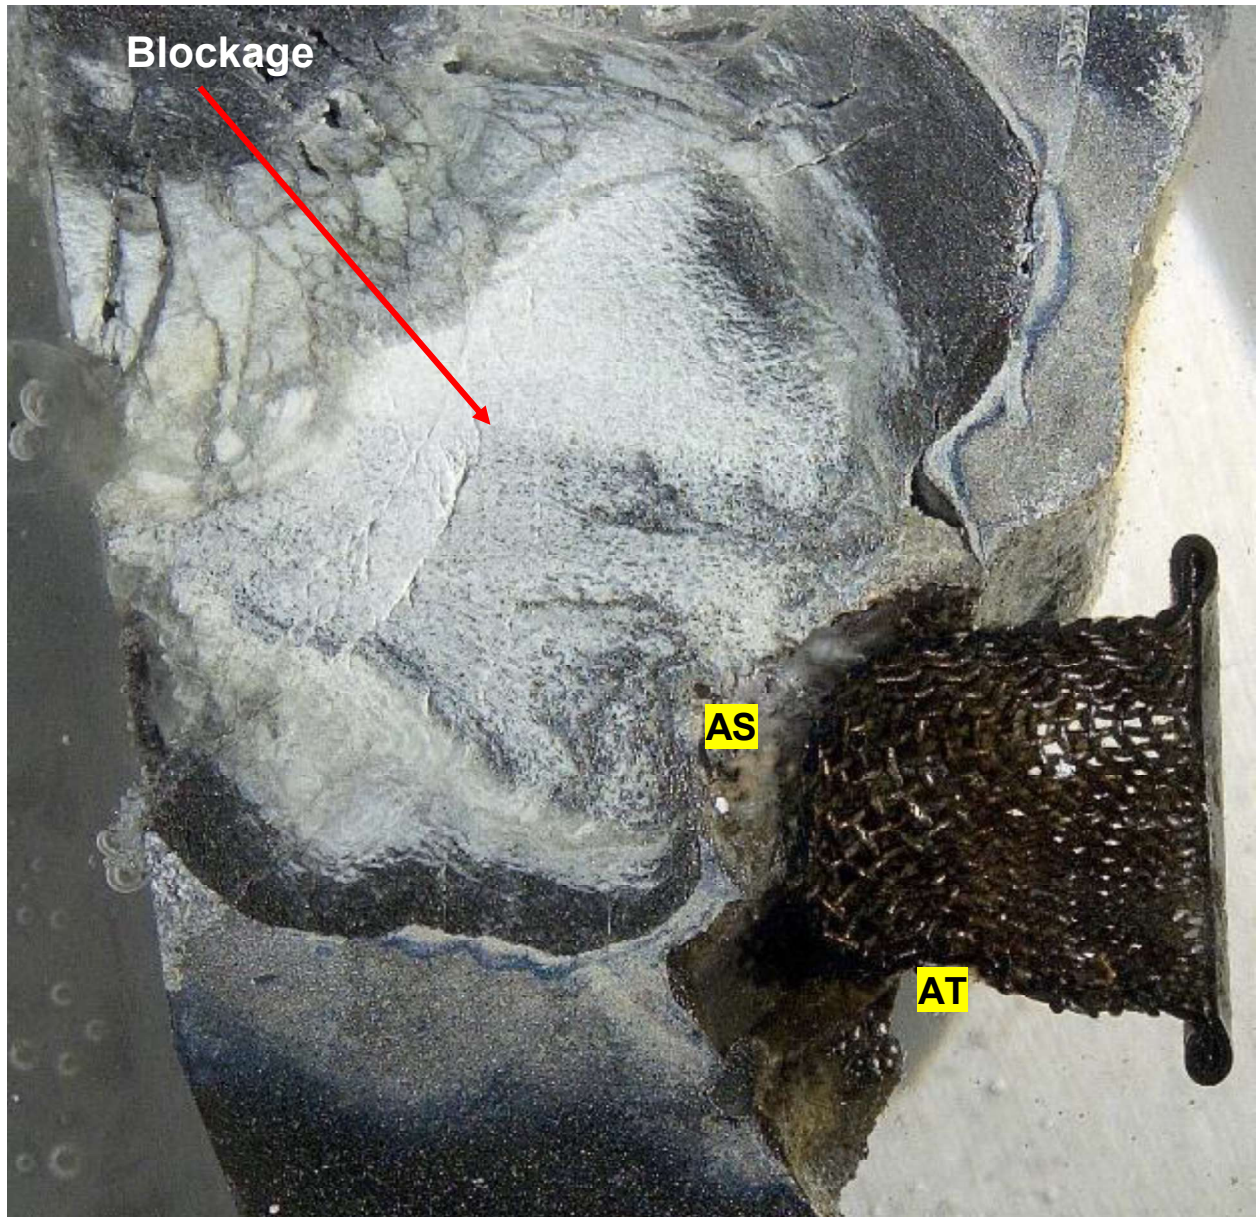
Figure 103. Metallographic section through the gearbox housing and oil screen (see the red dashed line in Figure 58). Locations AS and AT are shown in more detail in the following figure.

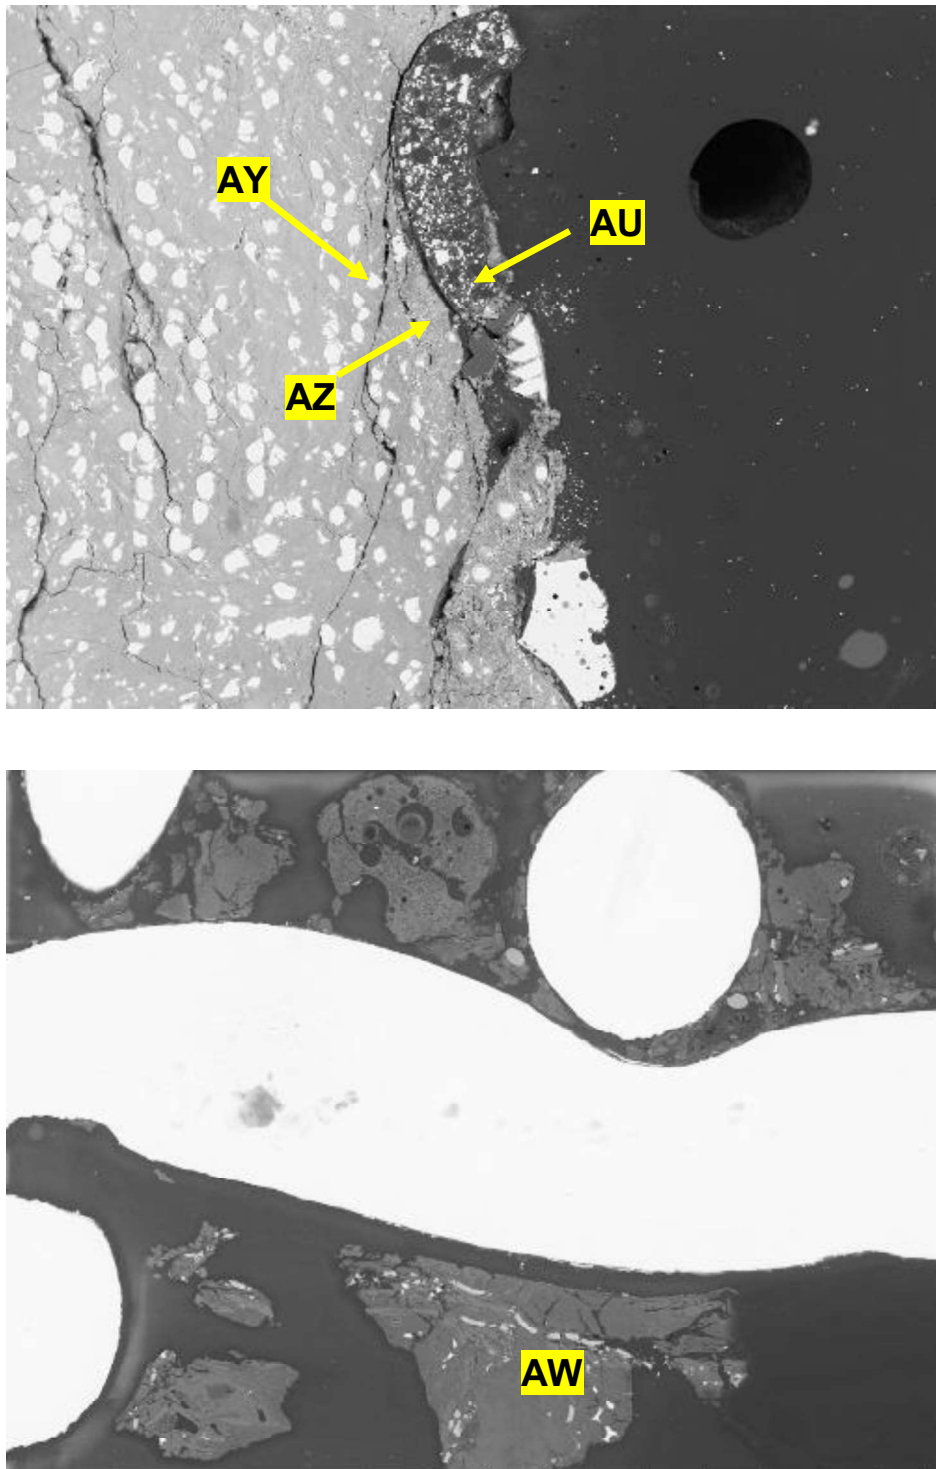
**Figure 104.** Backscattered electron SEM images of the blockage in the gearbox housing (top) and oil screen (bottom). Top and bottom images are detailed views of locations AS and AT in previous figure, respectively. Semi-quantitative EDS results for blockage material at locations AU through AZ are shown in more detail in Figure 105 and Figure 106.

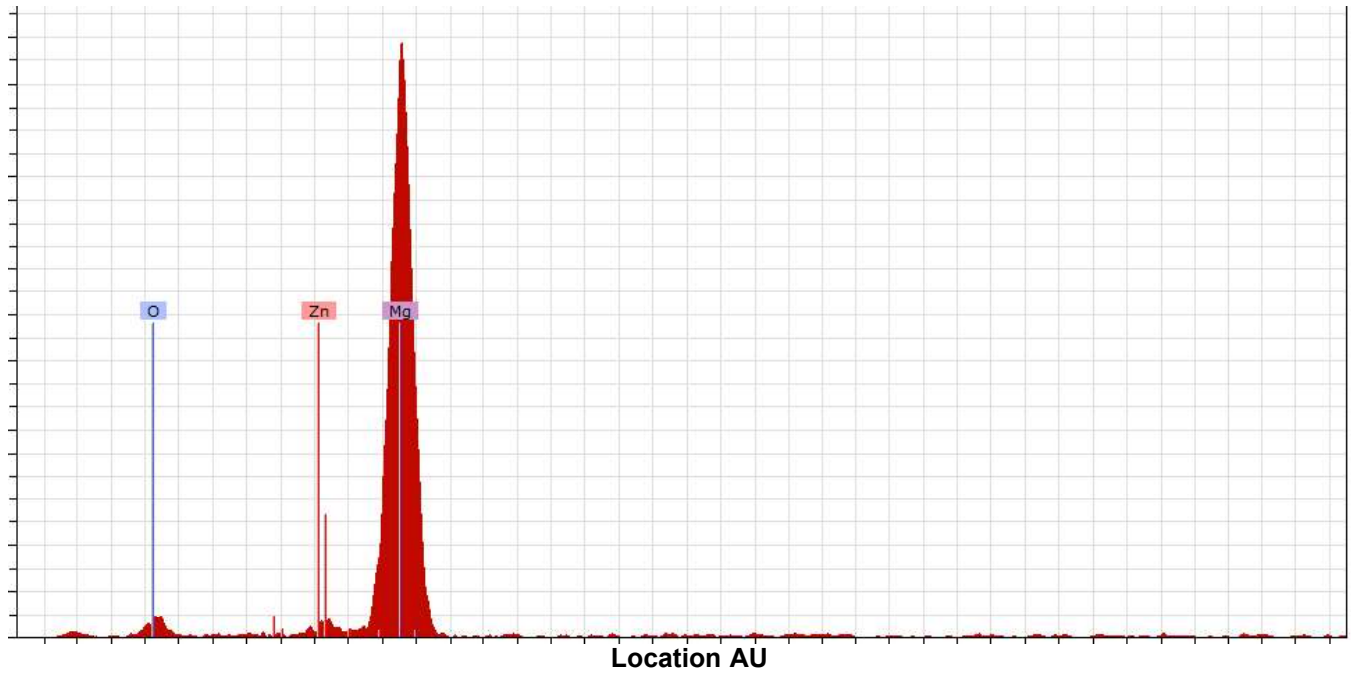
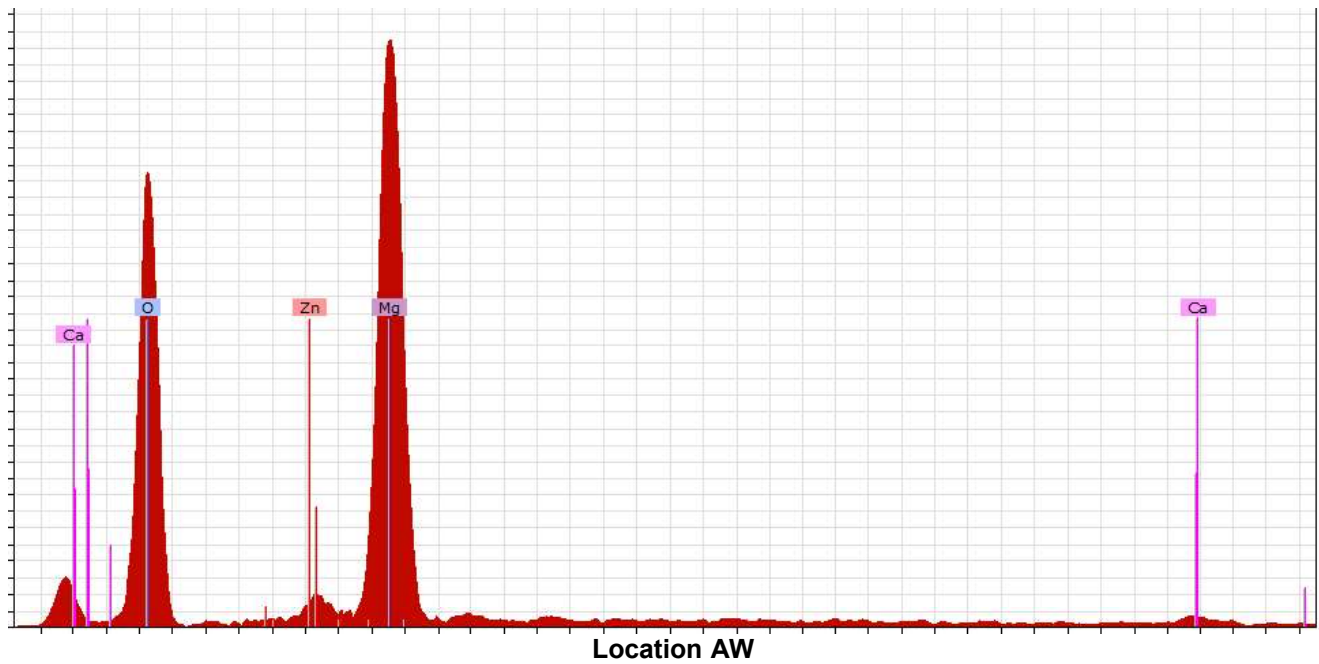
**Figure 105.** Semi-quantitative EDS results for blockage material at locations AU and AW in the gearbox housing (see Figure 104), which exhibited concentrations of magnesium, oxygen, and zinc.

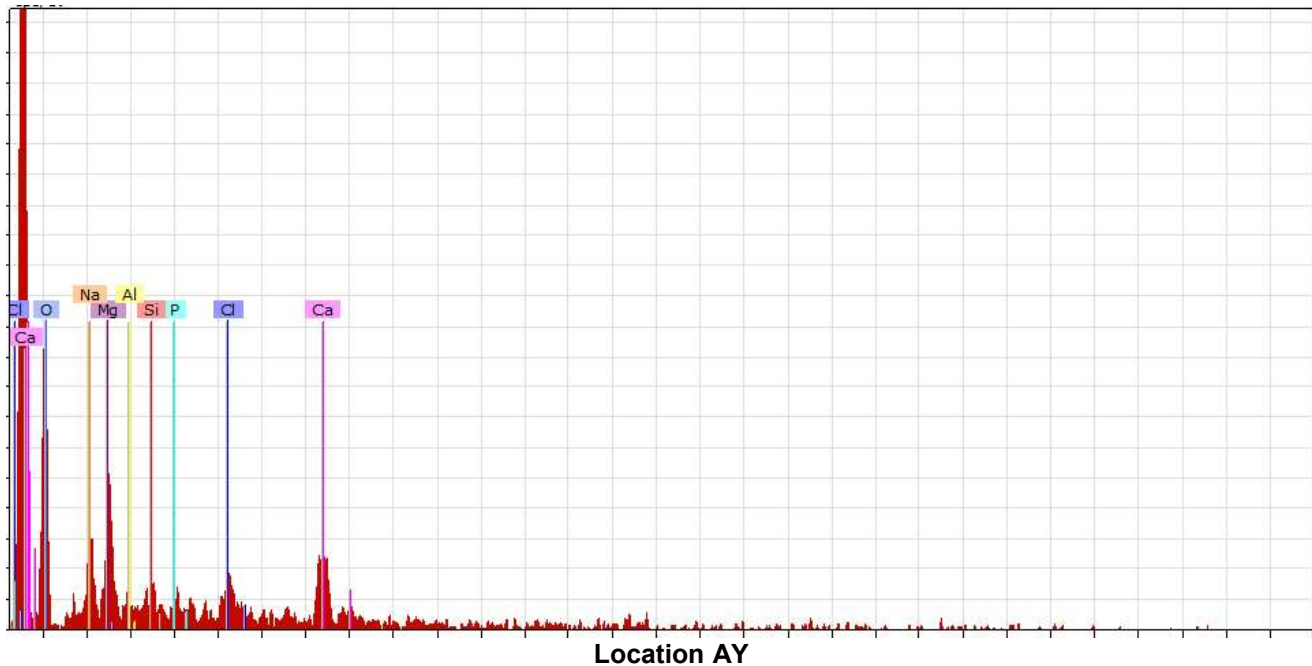
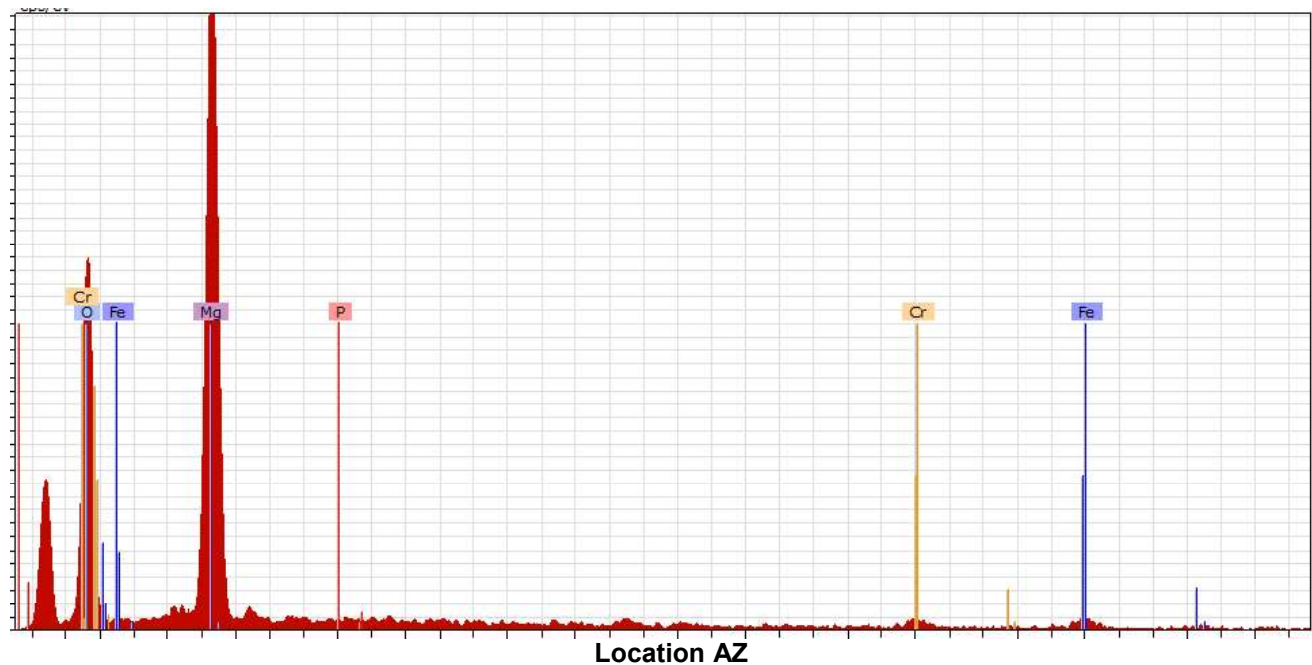
**Figure 106.** Semi-quantitative EDS results for blockage material at locations AY and AZ in the gearbox housing and oil screen (see Figure 104). Location AY exhibited concentrations of magnesium, oxygen, calcium, silicon, sodium, and aluminum. Location AZ exhibited concentrations of magnesium, oxygen, iron, and chromium.

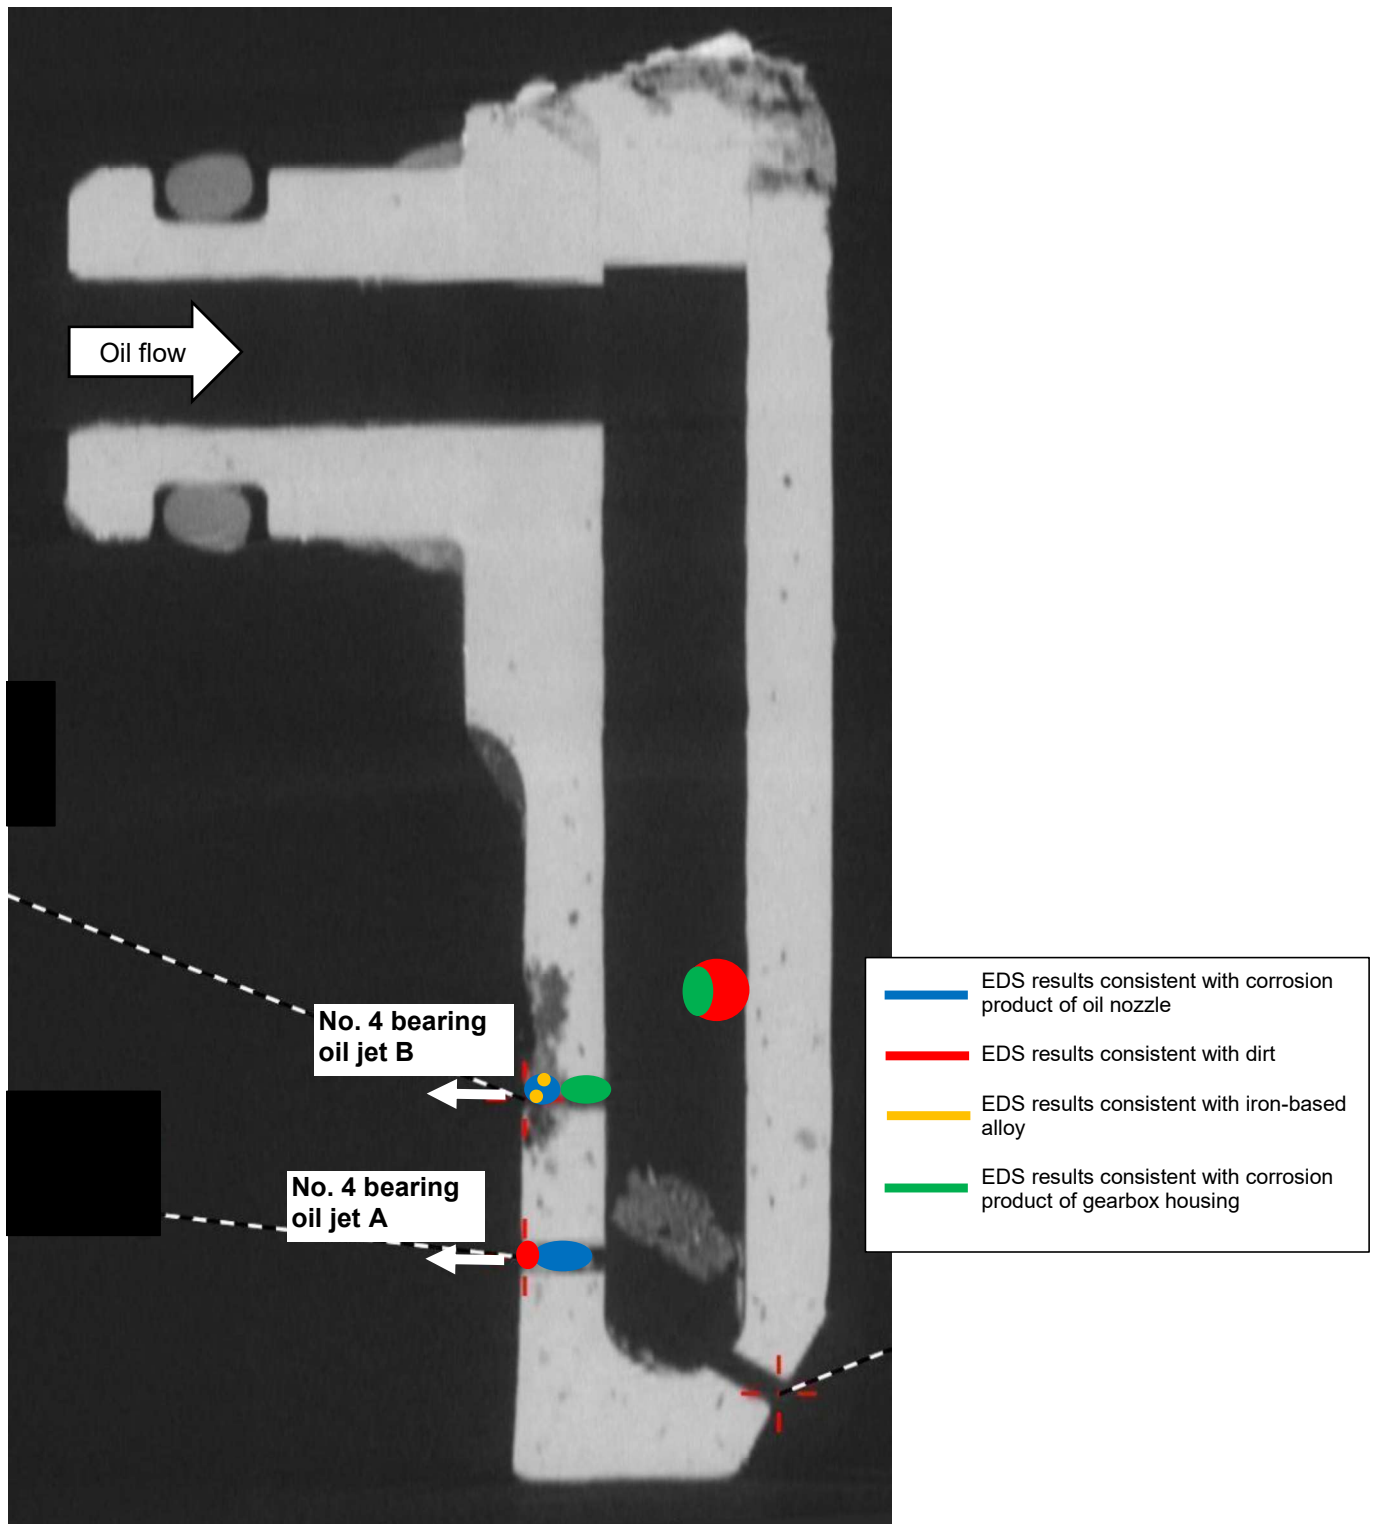
**Figure 107.** Color map of the EDS results for the blockage material in the oil jets and main passageway of the pinion bearing oil nozzle.

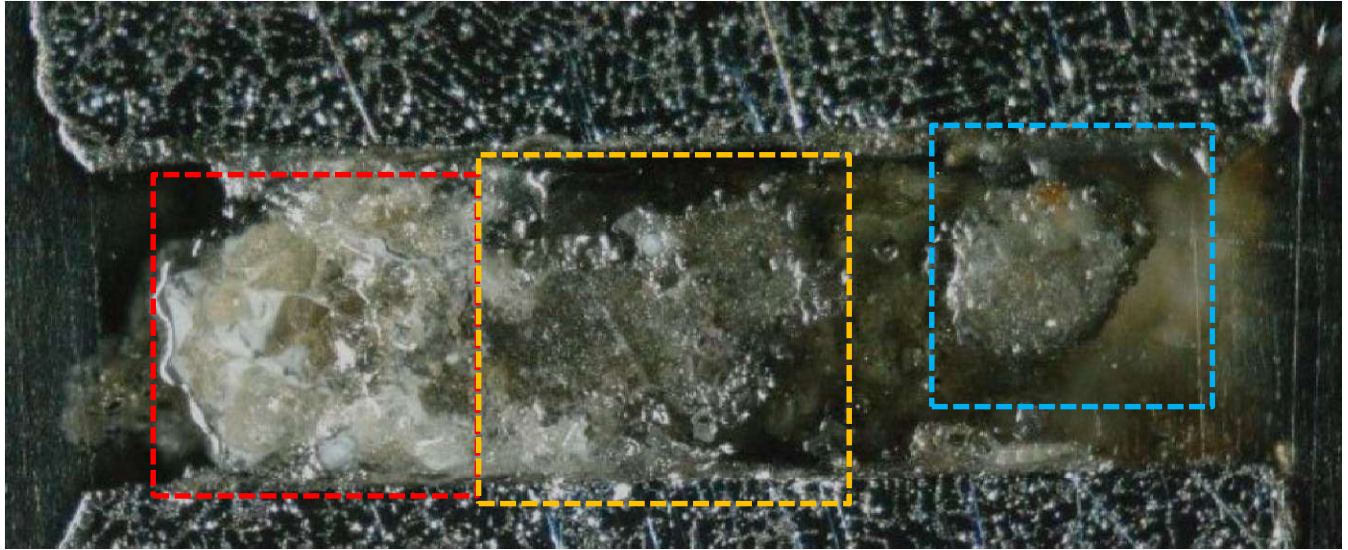
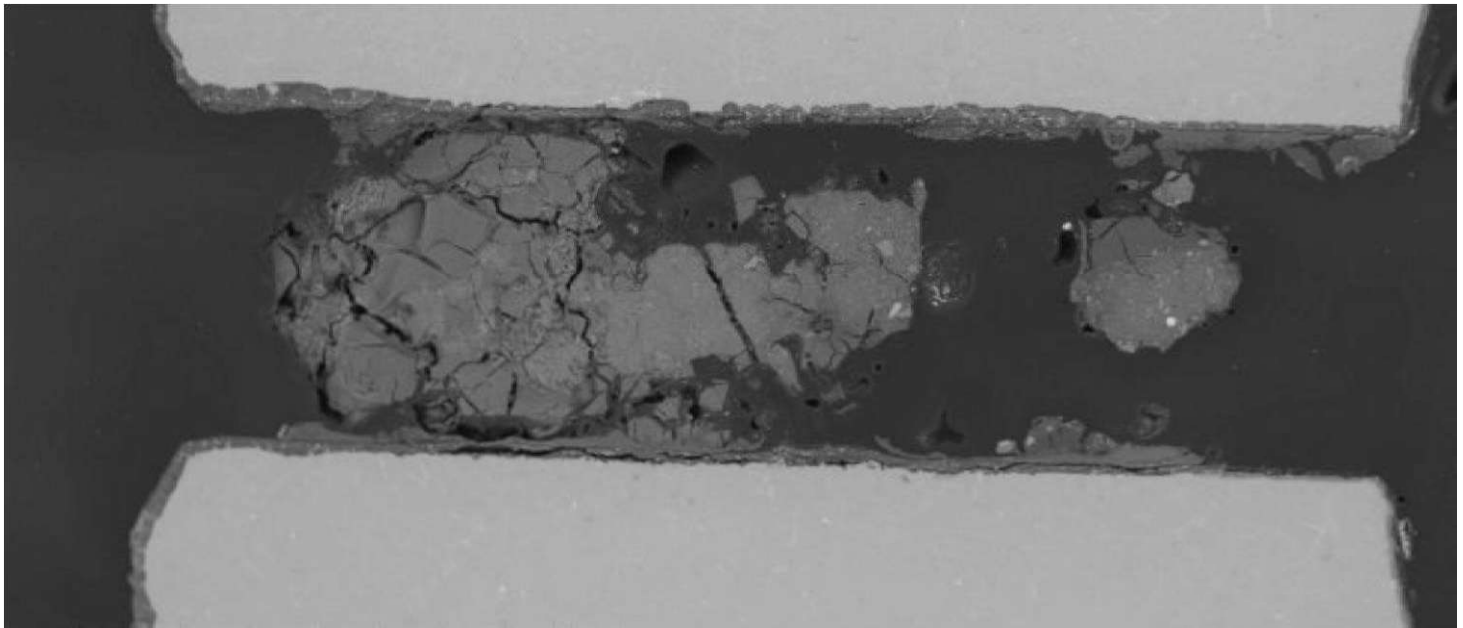
Figure 108 through Figure 110 show optical and backscattered electron SEM images of metallographic section through No.4 bearing oil jet A of the oil delivery tube (see Figure 70), which exhibited blockage material. Figure

**Figure 108. Optical (top) and backscattered scanning electron microscope (bottom) images of the metallographic section through No. 4 bearing oil jet A of the oil nozzle (see orange boxed area in Figure 71), which exhibited blockage. The red, orange, and blue boxed areas are shown in more detail in Figure 109 and Figure 110.**

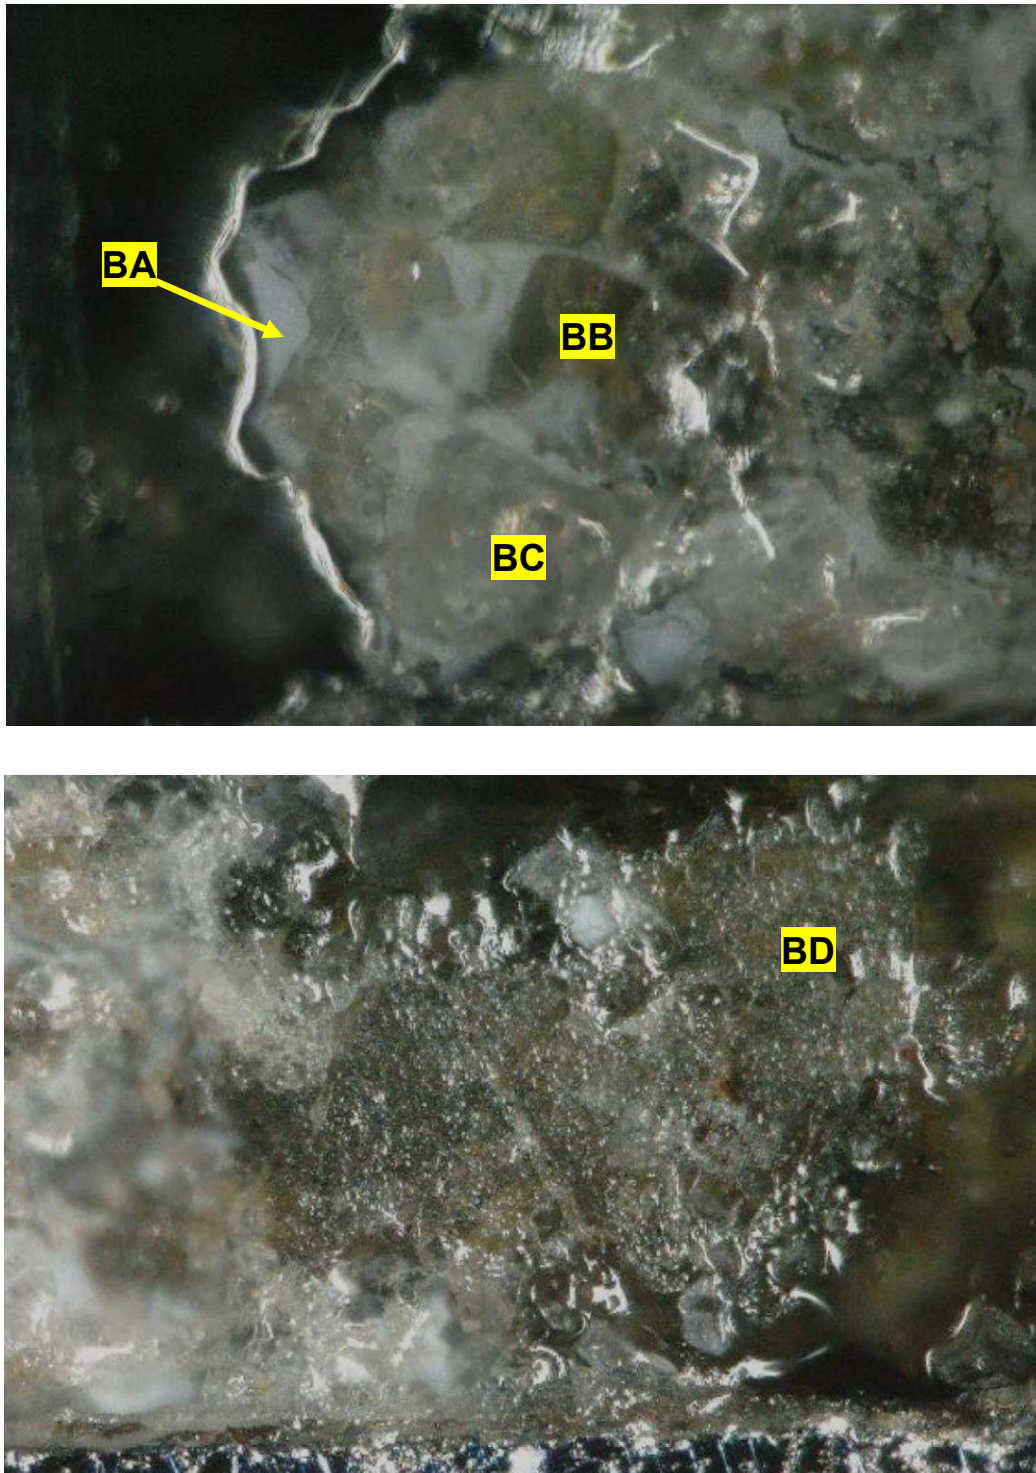
111 through Figure 113 show the EDS results for the blockage material. Blockage material at location BA in Figure 109 exhibited higher concentrations of oxygen, silicon, and aluminum (listed in order of concentration), which is consistent with terrestrial material (dirt). Blockage material at locations BA through BF in Figure 109 and Figure 110 exhibited higher concentrations of oxygen, aluminum, silicon, and chlorine (listed in order of concentration), which is consistent with corrosion product of the oil nozzle.

**Figure 109.** Detailed views of the blockage in No. 4 bearing oil jet A of the oil nozzle. Top and bottom images are detailed views of the red and yellow boxed areas in previous figure, respectively. Semi-quantitative EDS results for blockage material at locations BA through BD are shown in more detail in Figure 111 and Figure 112.

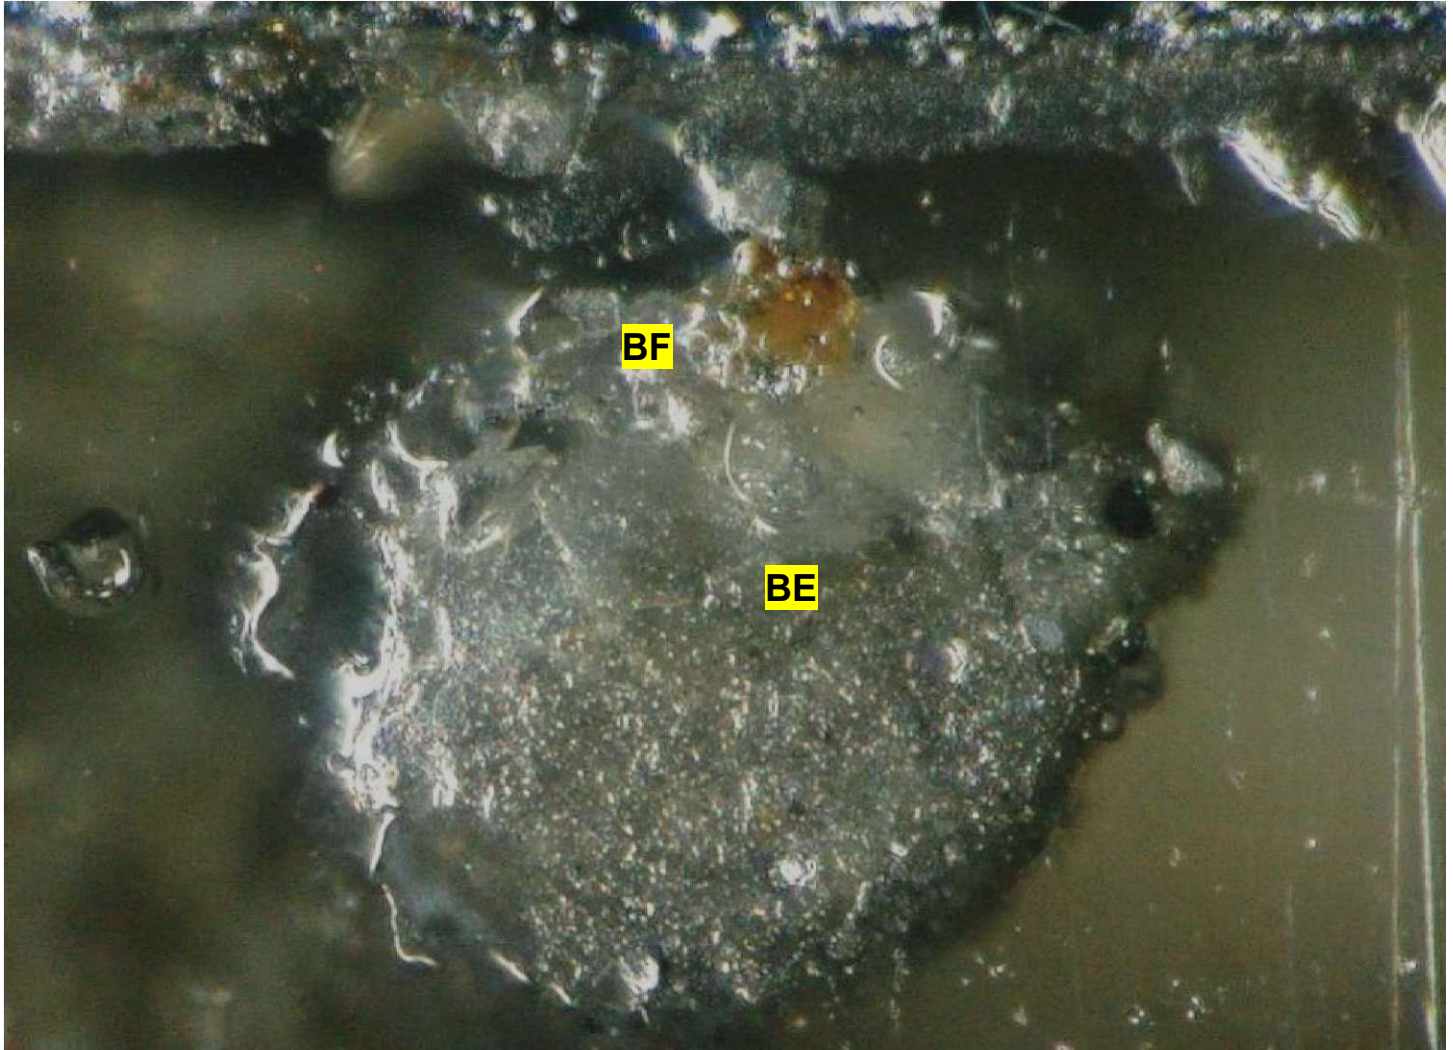
**Figure 110.** Detailed view of the blockage in No. 4 bearing oil jet A of the oil nozzle (blue boxed area in Figure 108). Semi-quantitative EDS results for blockage material at locations BE and BF are shown in more detail in Figure 113.

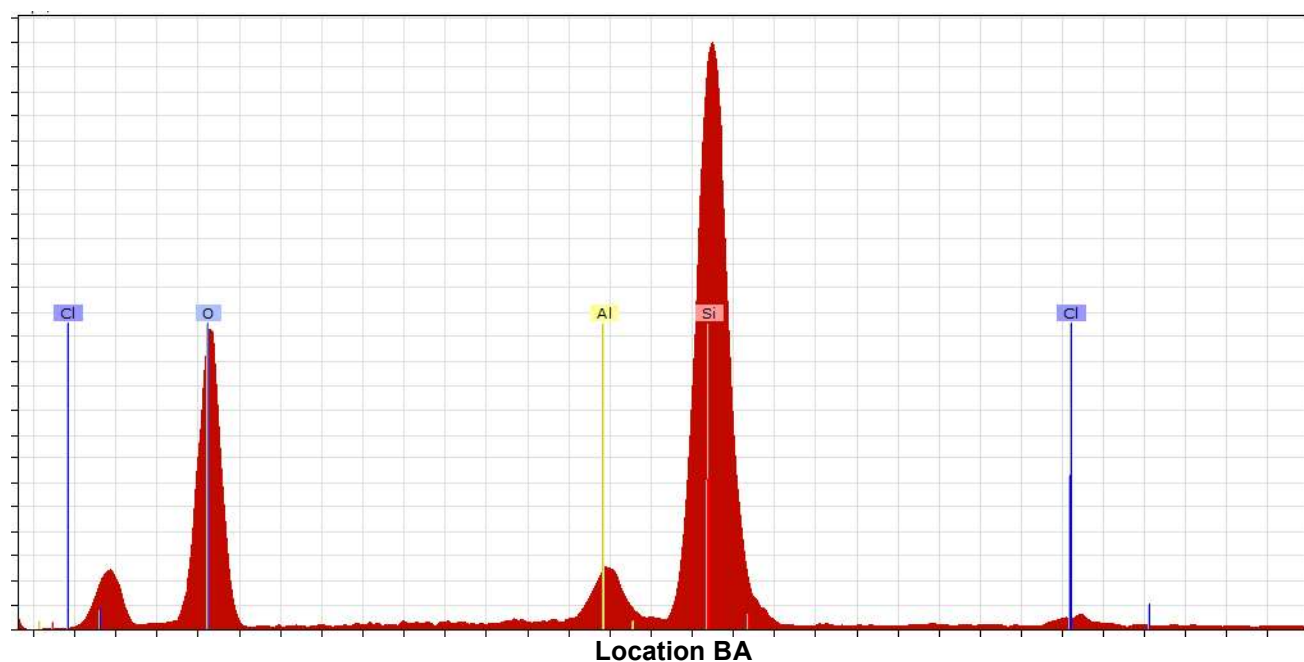
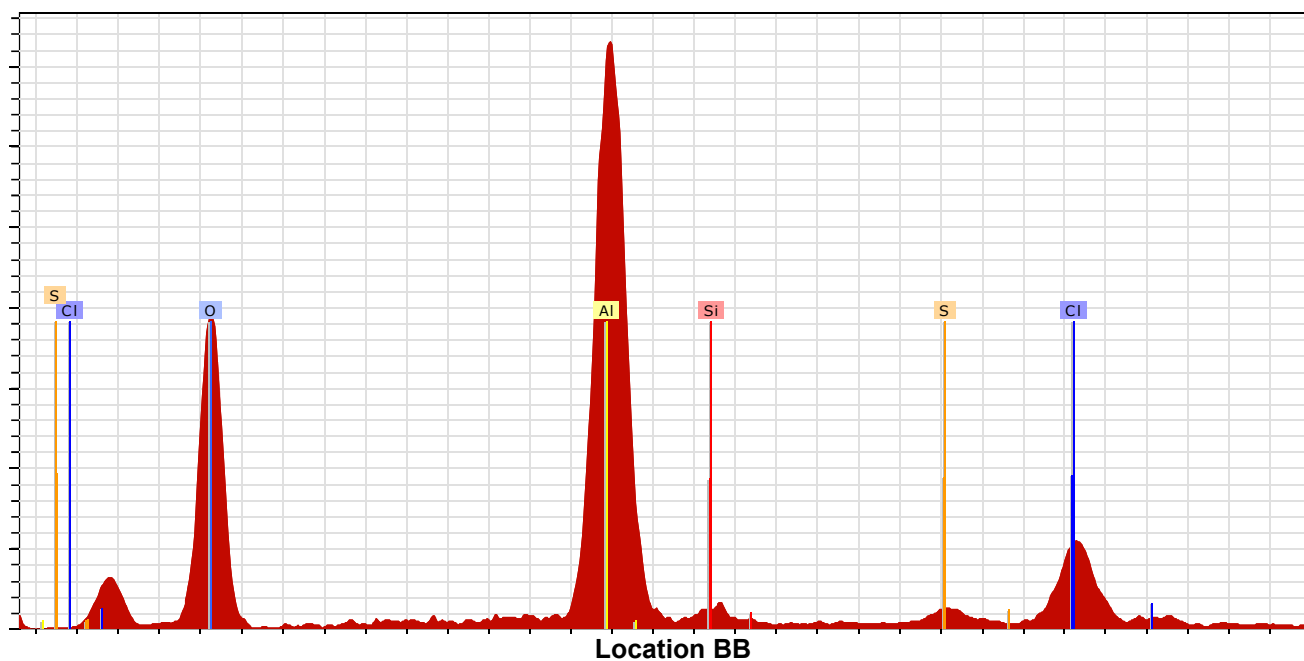
**Figure 111. Semi-quantitative EDS results for blockage material at locations BA and BB in No. 4 bearing oil jet A of the oil nozzle (see Figure 109). Location AU exhibited concentrations of silicon, aluminum, and chlorine. Location AW exhibited concentrations of aluminum, silicon, oxygen, sulphur, and chlorine.**

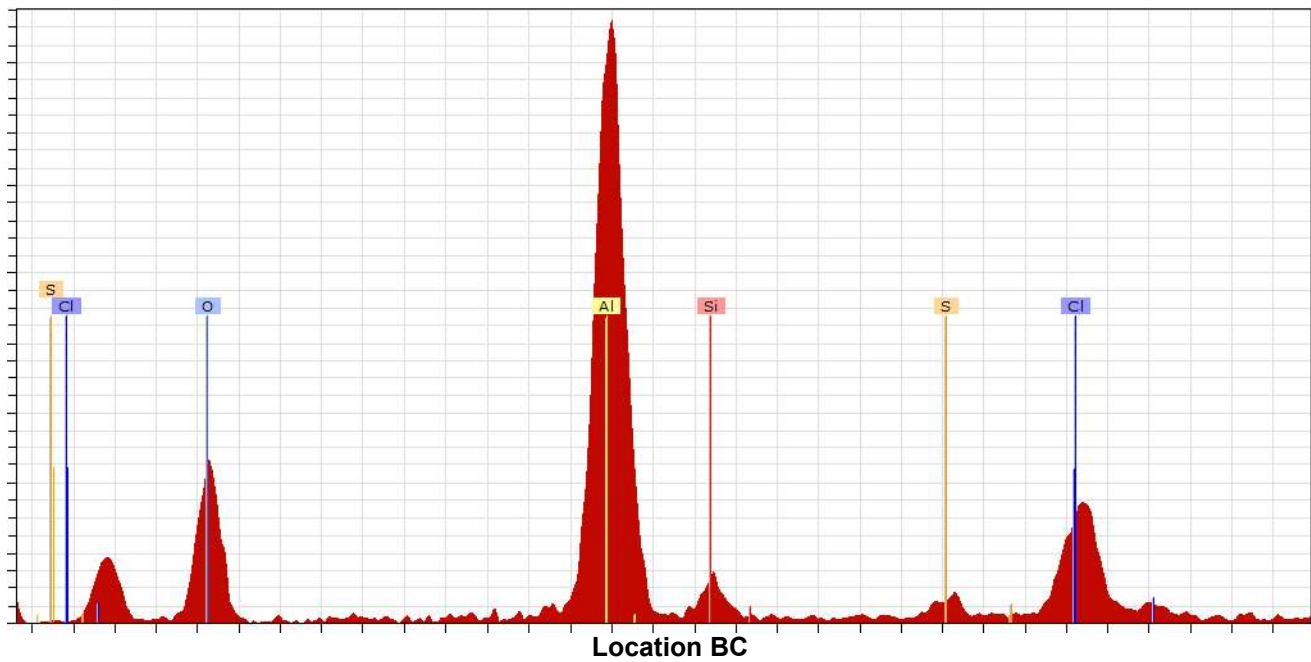
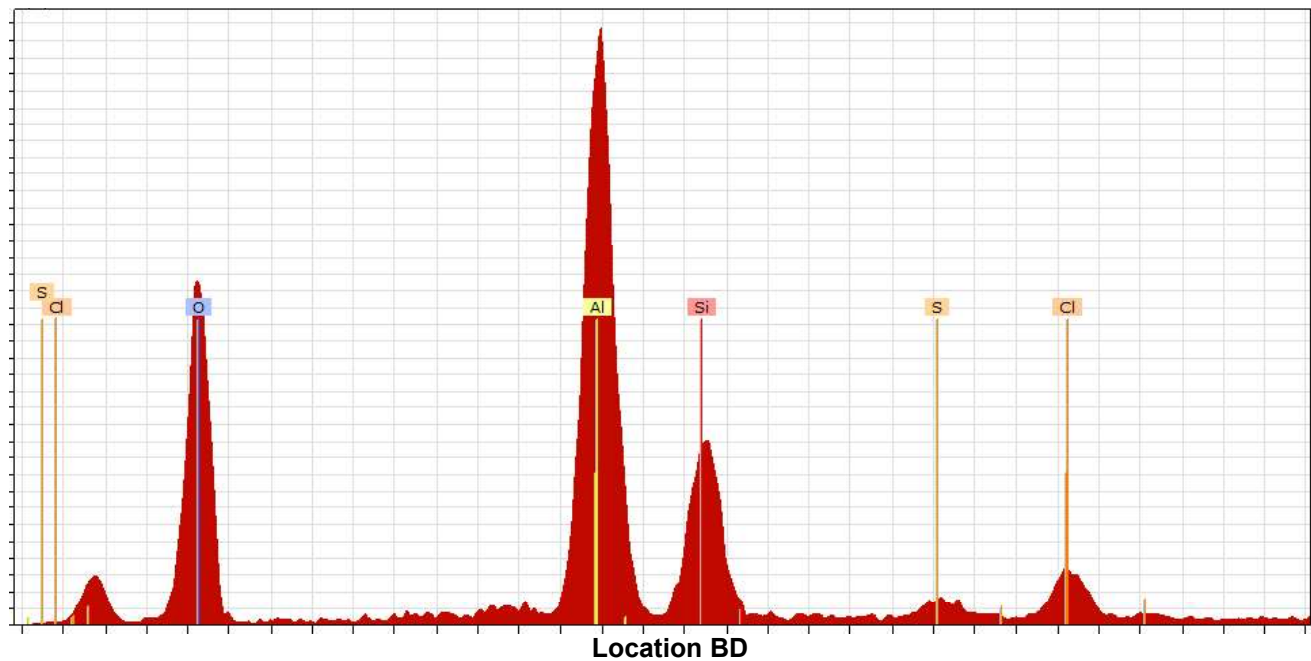
**Figure 112.** Semi-quantitative EDS results for blockage material at locations BC and BD in No. 4 bearing oil jet A of the oil nozzle (see Figure 109), which exhibited concentrations of aluminum, silicon, oxygen, sulphur, and chlorine.

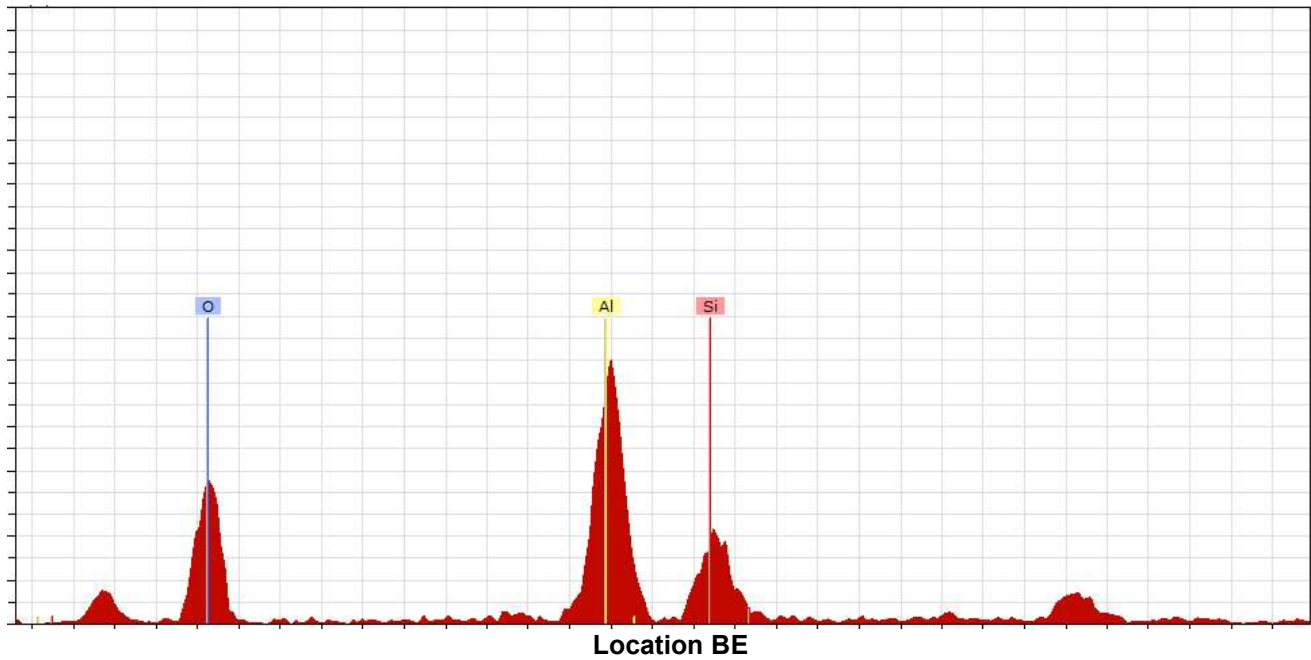
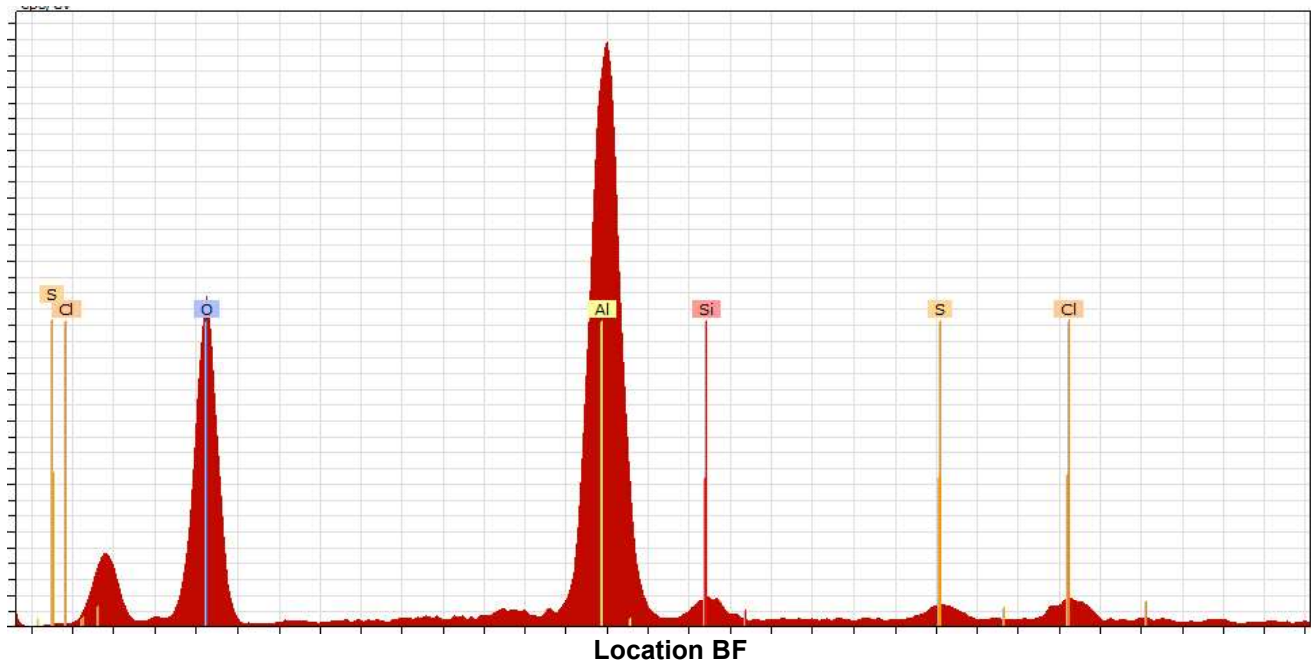
**Figure 113. Semi-quantitative EDS results for blockage material at locations BE and BF in No. 4 bearing oil jet A of the oil nozzle (see Figure 110), which exhibited concentrations of aluminum, silicon, and oxygen.**
