| <b>Rolls-Royce</b> | Rolls-Royce Corporation<br>450 S. Meridian Street<br>Indianapolis, Indiana<br>46225-1103, USA | <b>REPORT NO.</b><br>20FAE-014-PR | <b>REV.</b><br>Initial | <b>PAGES</b><br>1 of 135 |
| <b>TITLE</b><br><br><b>METALLURGICAL INVESTIGATION OF A HELICAL POWER TURBINE PINION GEAR, P/N 6893672, INSTALLED IN AN M250-C47B ENGINE, S/N CAE847031, OPERATED BY PANTHER HELICOPTERS</b> | | <b>PREPARED</b><br><br>Signatures on file | | |

| Engine Model: | M250-C47B |
| Evaluations: | Failure Analysis |

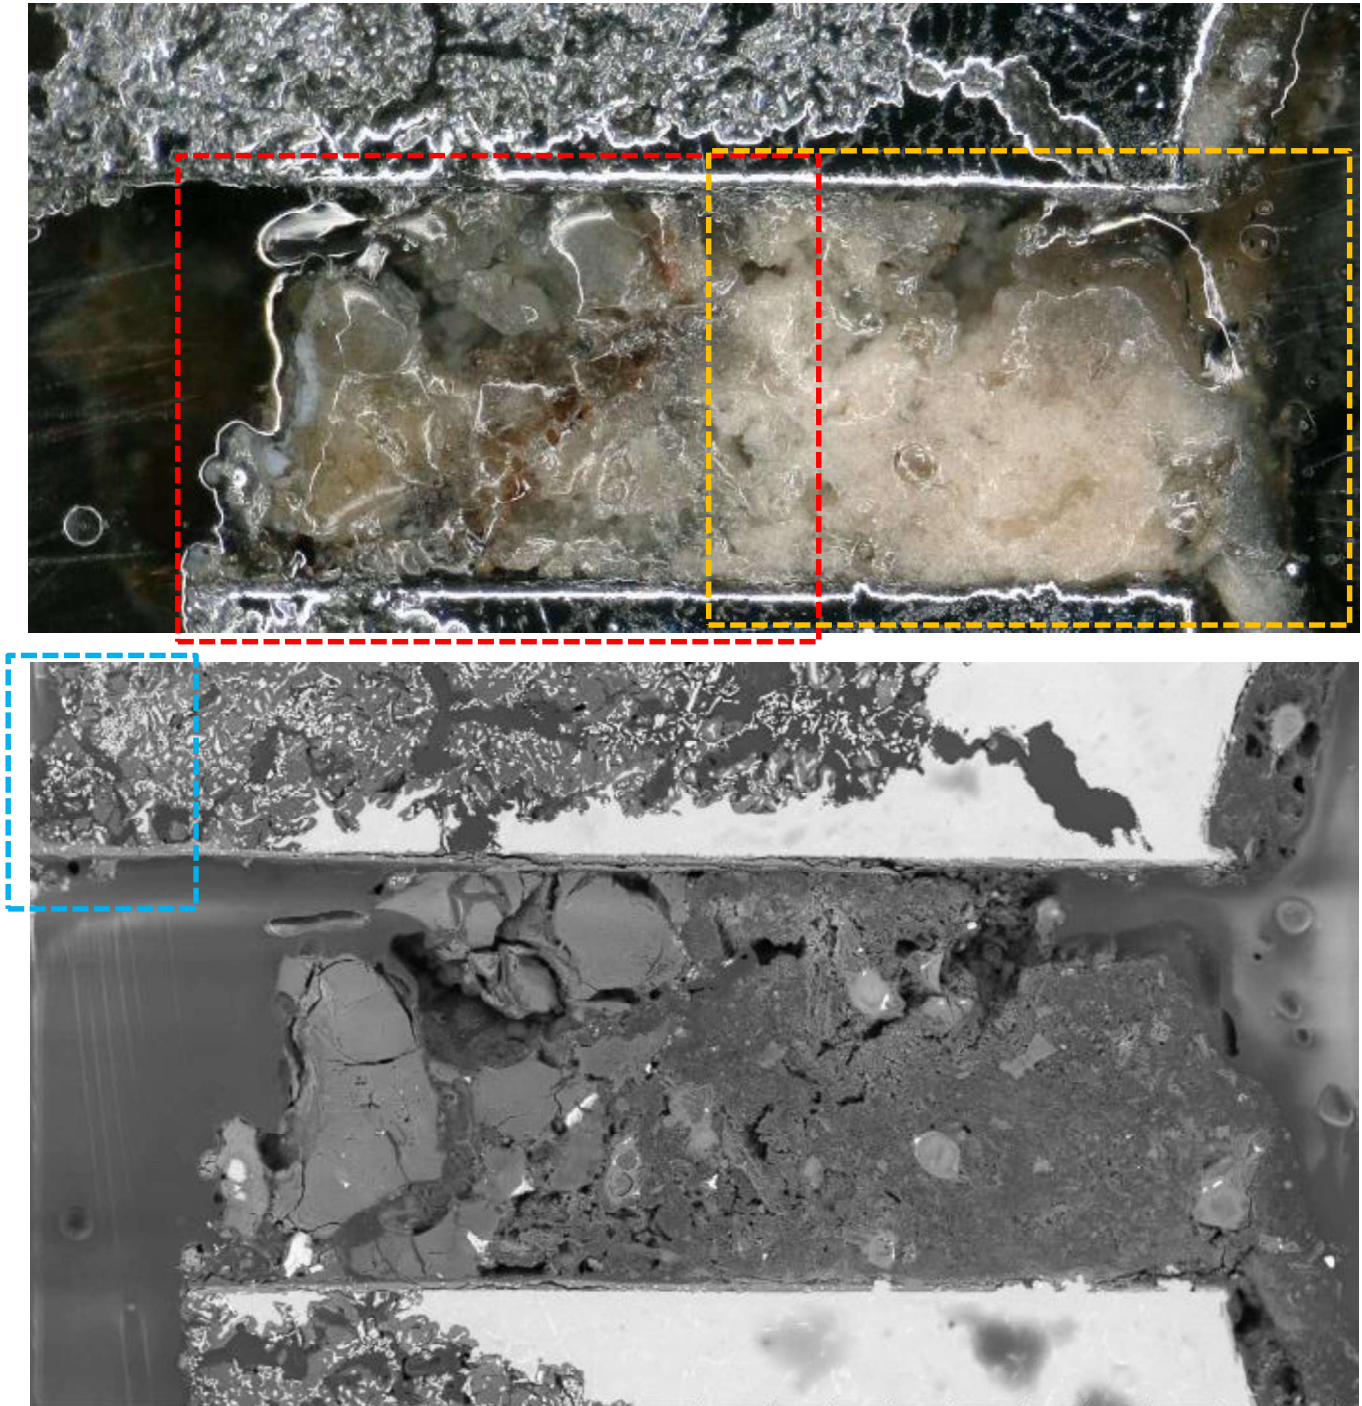
Figure 114 through Figure 116 show optical and backscattered electron SEM images of metallographic sections through No.4 bearing oil jet B of the oil delivery tube (see Figure 70), which exhibited blockage material. Figure 117 through Figure 119 show the EDS results for the blockage material. Blockage material at location BG in Figure 115 exhibited higher concentrations of oxygen, aluminum, chlorine, sodium, and silicon (listed in order of concentration), which is consistent with corrosion product of the oil nozzle. Finer metallic blockage particles on the outer end of the hole (see location BH in Figure 115) exhibited higher concentrations of iron. The specific iron-based alloy could not be identified. The amorphous aggregate and courser particles at the inner end of the hole (see location BJ and BK in Figure 116) exhibited higher concentrations of oxygen, magnesium, aluminum, and silicon (listed in order of concentration). Finer, brighter (i.e., higher average atomic weight) particles at the inner end of the hole (see location BL in Figure 116) exhibited higher concentrations of magnesium, zinc, and rare earth metals, which is consistent with the material type required by the component definition of the gearbox housing material. Corroded base material adjacent to hole at location BM in Figure 116 exhibited higher concentrations of oxygen, aluminum, chlorine, silicon, and sodium (listed in order of concentration).

**Figure 114.** Optical (top) and backscattered scanning electron microscope (bottom) images of the metallographic section through No. 4 bearing oil jet B of the oil nozzle (see orange boxed area in Figure 72), which exhibited blockage. The red, orange, and blue boxed areas are shown in more detail in Figure 115 and Figure 116.

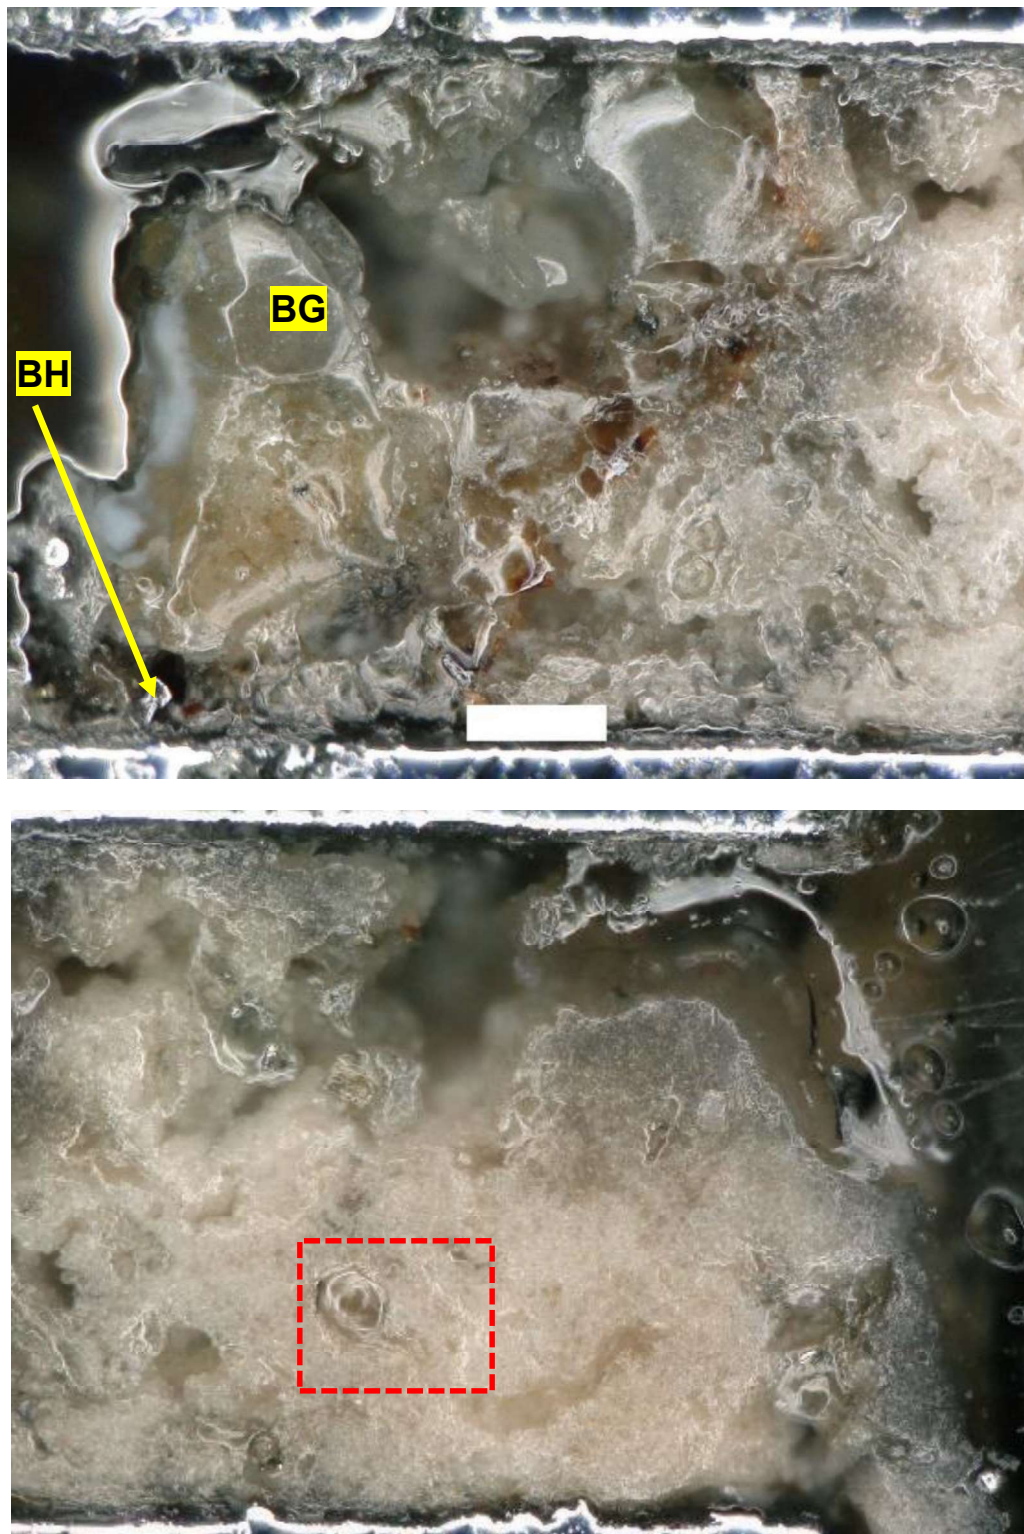
**Figure 115.** Detailed views of the blockage in No. 4 bearing oil jet B of the oil nozzle. Top and bottom images are detailed views of the red and orange boxed areas in previous figure, respectively. Semi-quantitative EDS results for blockage material at locations BG and BH are shown in more detail in Figure 117. The red boxed area is shown in more detail in the following figure.

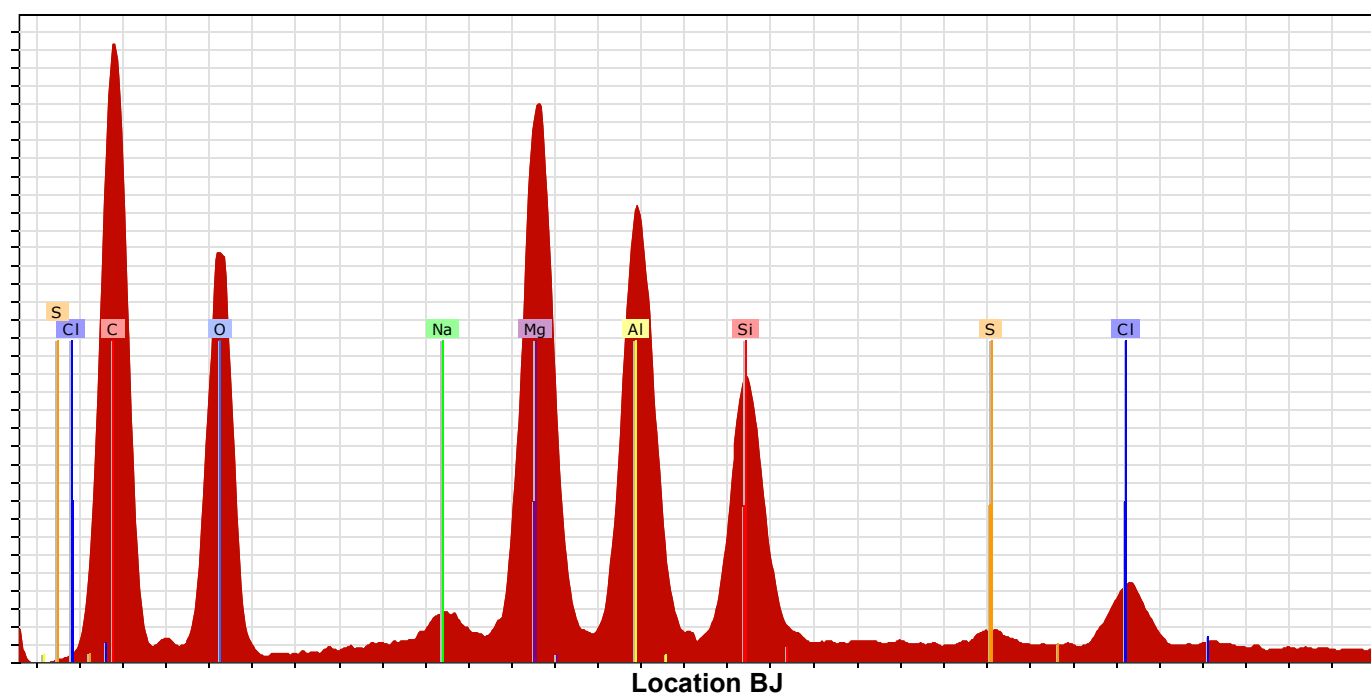
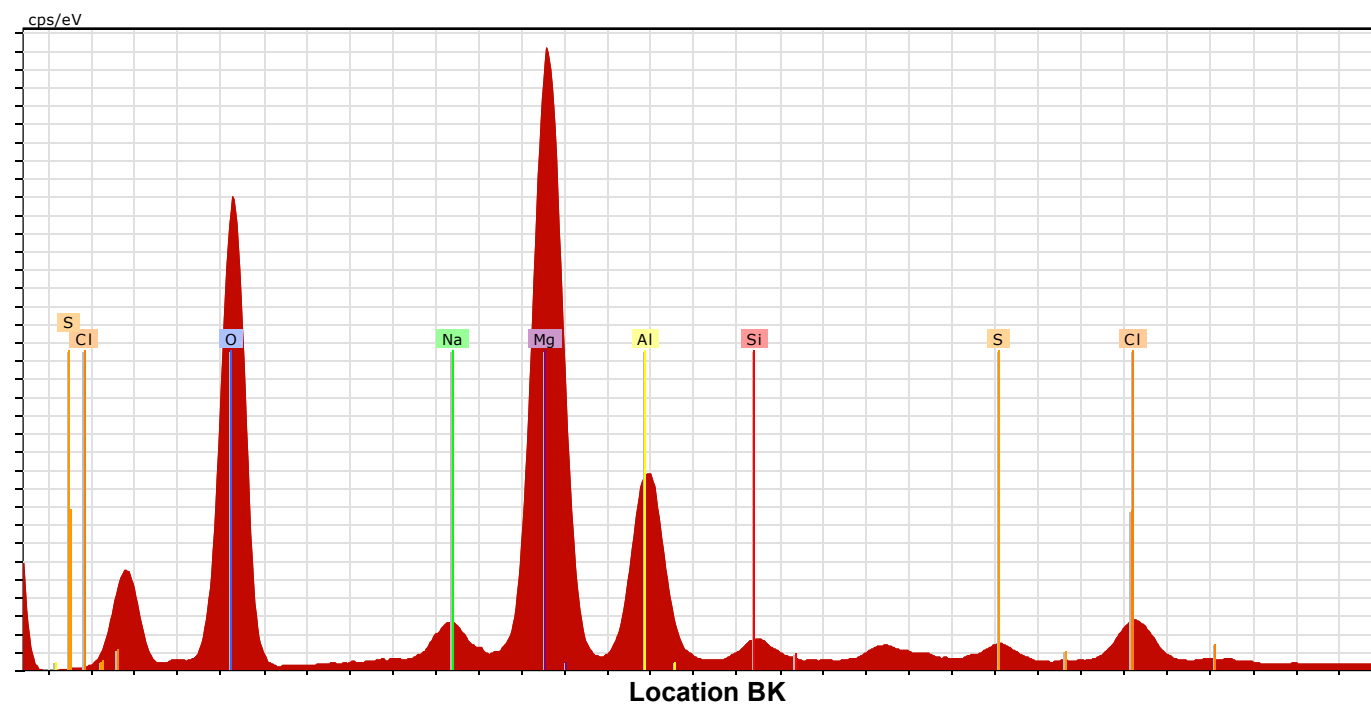
**Figure 118. Semi-quantitative EDS results for blockage material at locations BJ and BK in No. 4 bearing oil jet B of the oil nozzle (see Figure 116), which exhibited concentrations of magnesium, oxygen, aluminum, sulphur, chlorine, and silicon.**

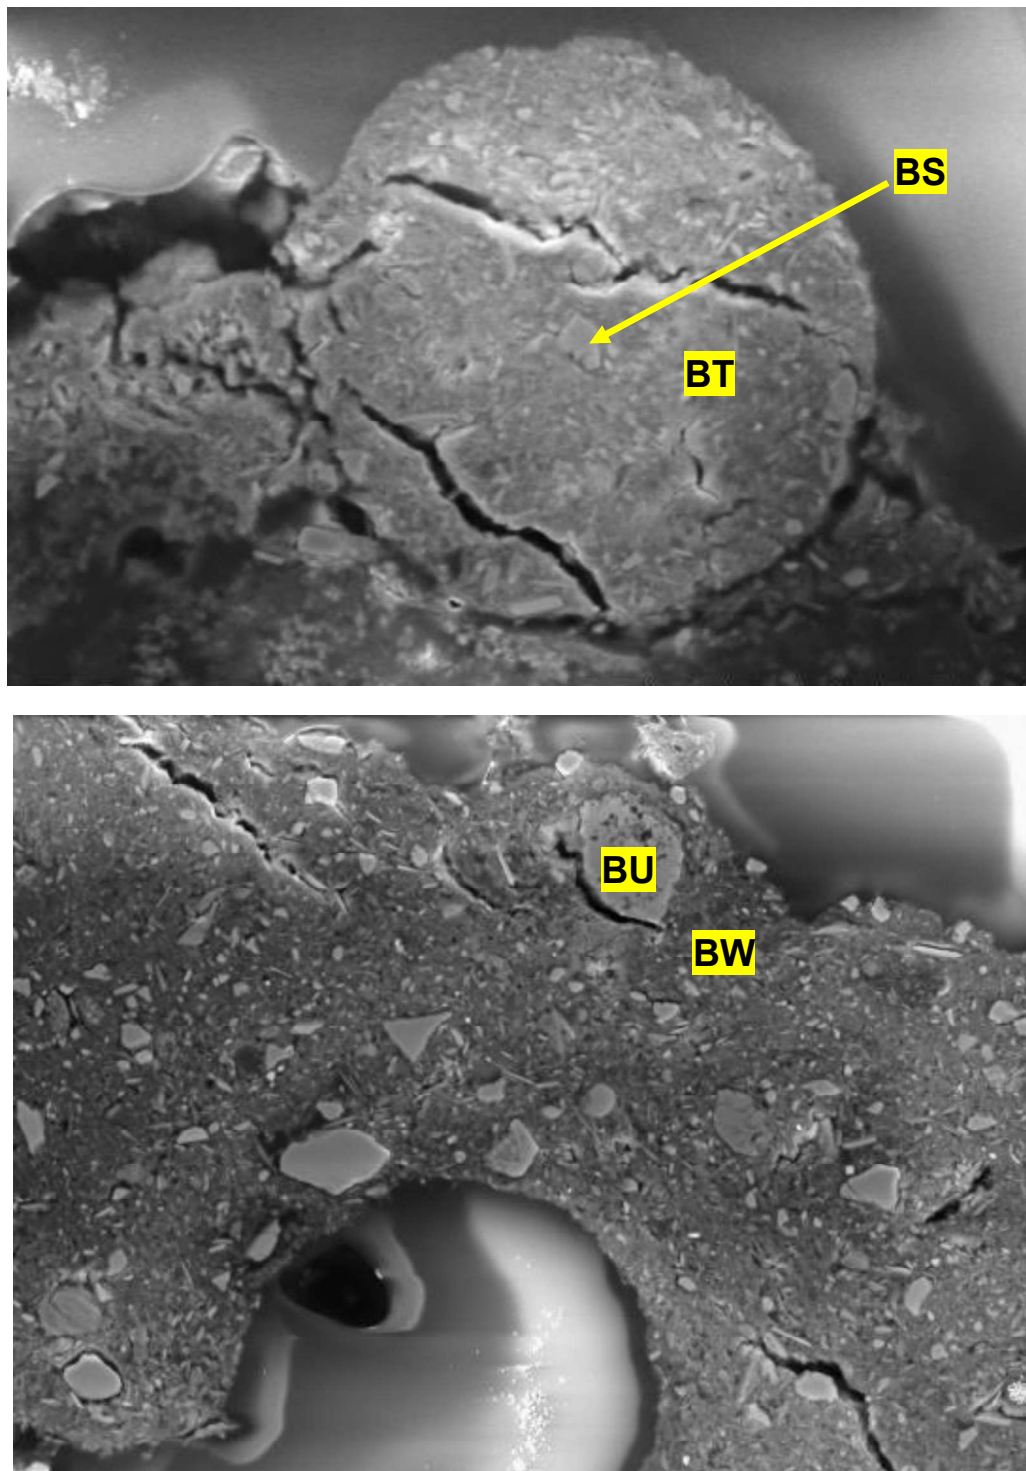
**Figure 121. Backscattered electron SEM images of debris in the oil nozzle main passage. Top and bottom images are detailed views of locations BN and BP in previous figure, respectively. Semi-quantitative EDS results for debris material at locations BS through BW are shown in more detail in Figure 124 and Figure 125.**

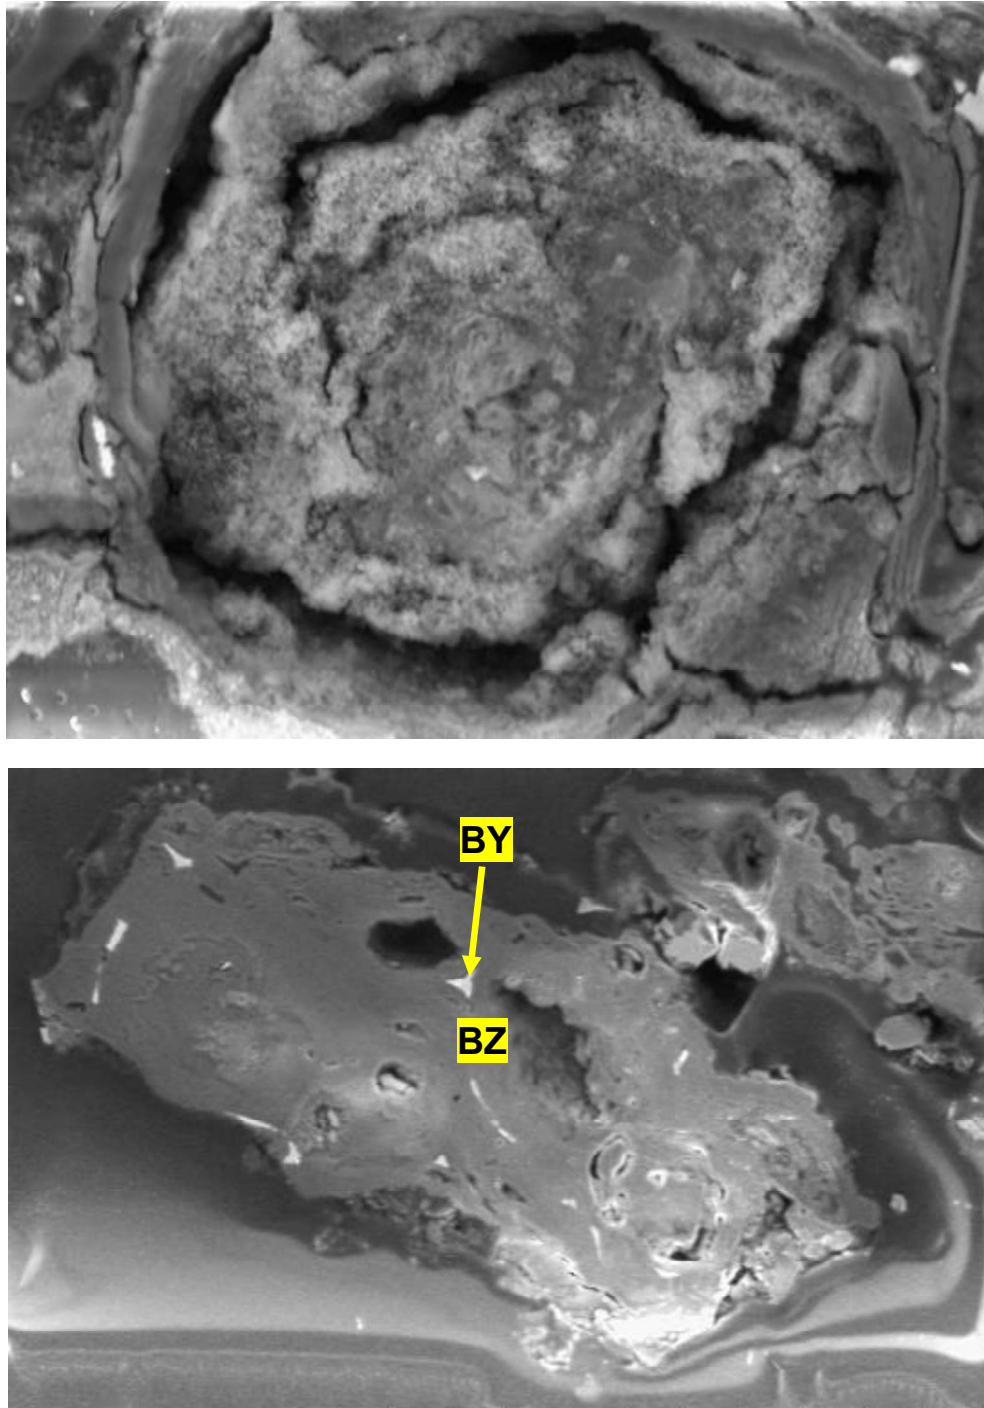
**Figure 122.** Backscattered electron SEM images of debris in the oil nozzle main passage. Top and bottom images are detailed views of locations BQ and BR in Figure 120, respectively. Semi-quantitative EDS results for debris material at locations BQ, BY, and BZ are shown in more detail in Figure 123 and Figure 126.

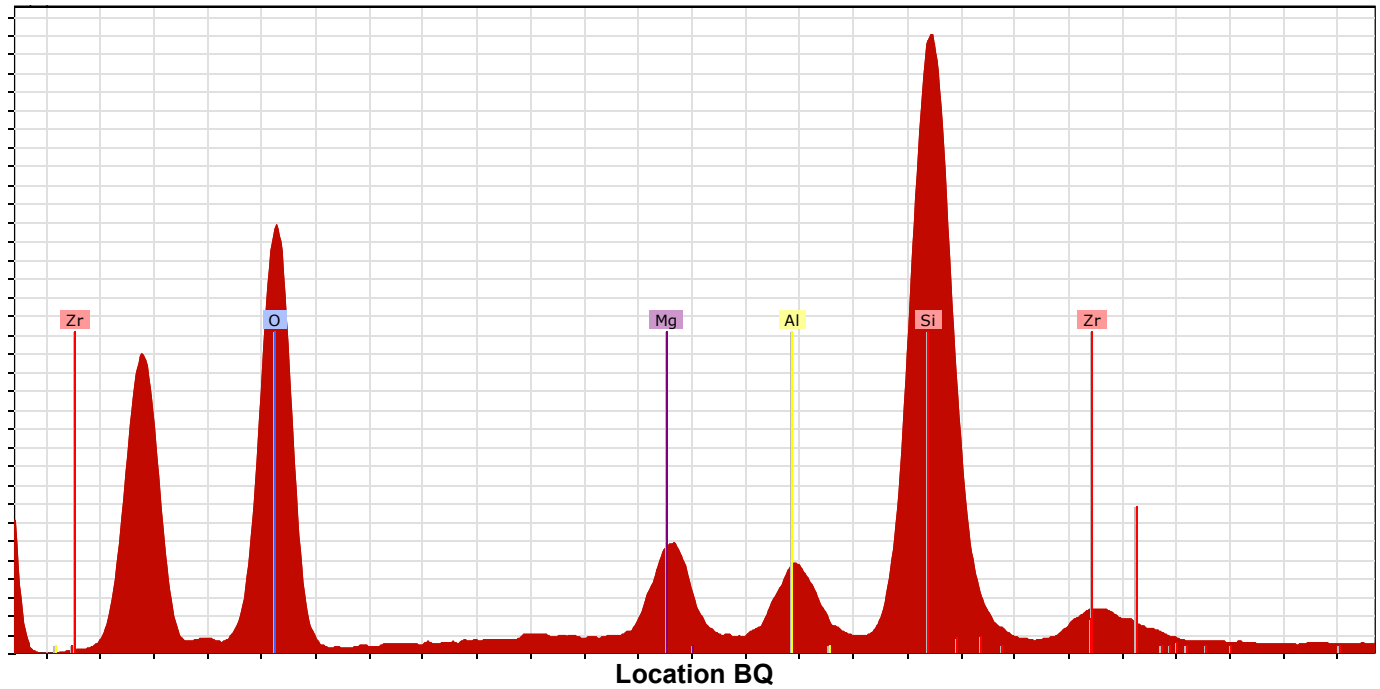
**Figure 123. Semi-quantitative EDS results for debris at location BQ in the main passageway of the oil nozzle (see Figure 122), which exhibited higher concentrations of silicon, magnesium, aluminum, zirconium, and oxygen.**

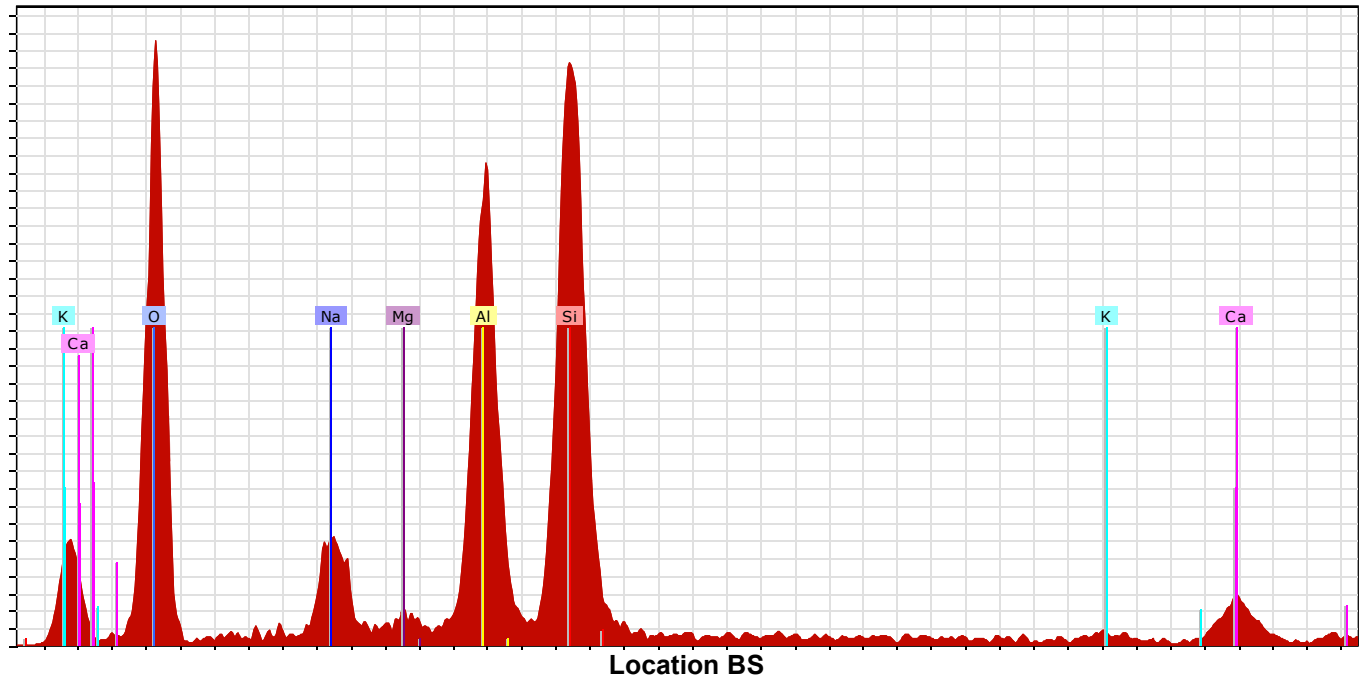
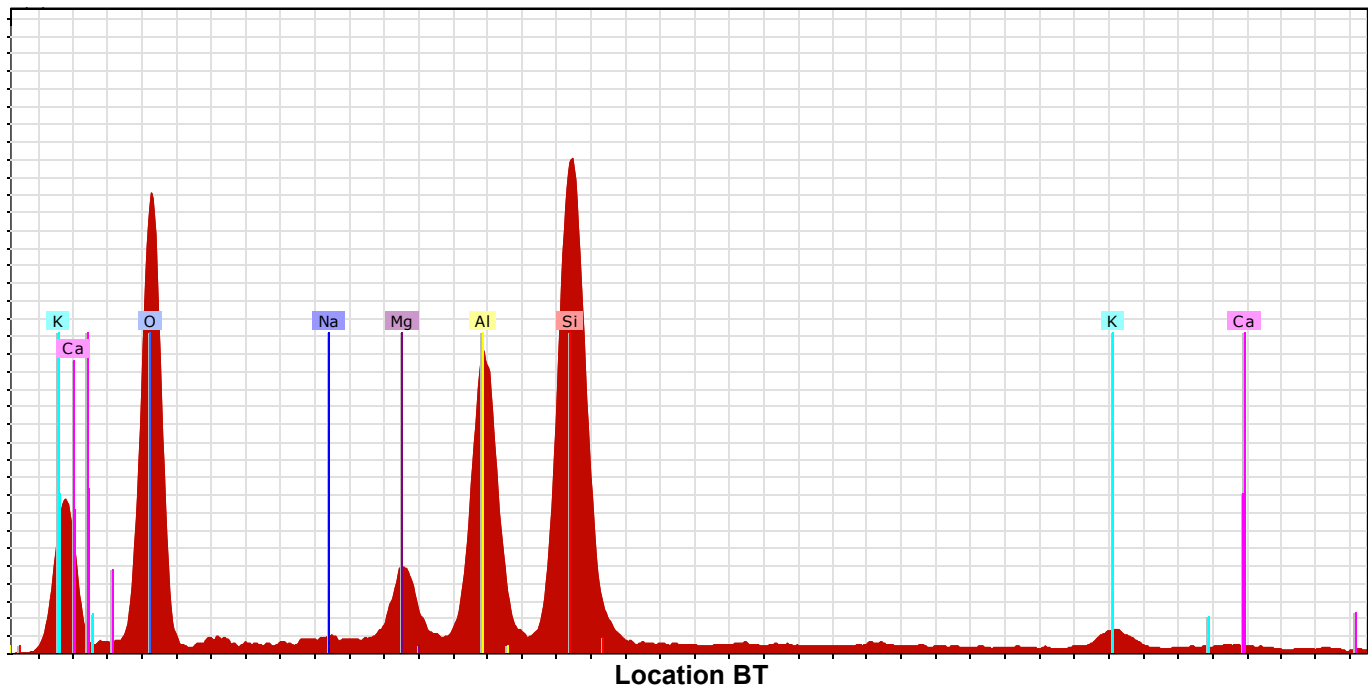
**Figure 124.** Semi-quantitative EDS results for debris at locations BS and BT in the main passageway of the oil nozzle (see Figure 121). Location BS exhibited higher concentrations of silicon, aluminum, calcium, magnesium, sodium, potassium, and oxygen. Location BT exhibited higher concentrations of silicon, aluminum, magnesium, sodium, potassium, and oxygen.

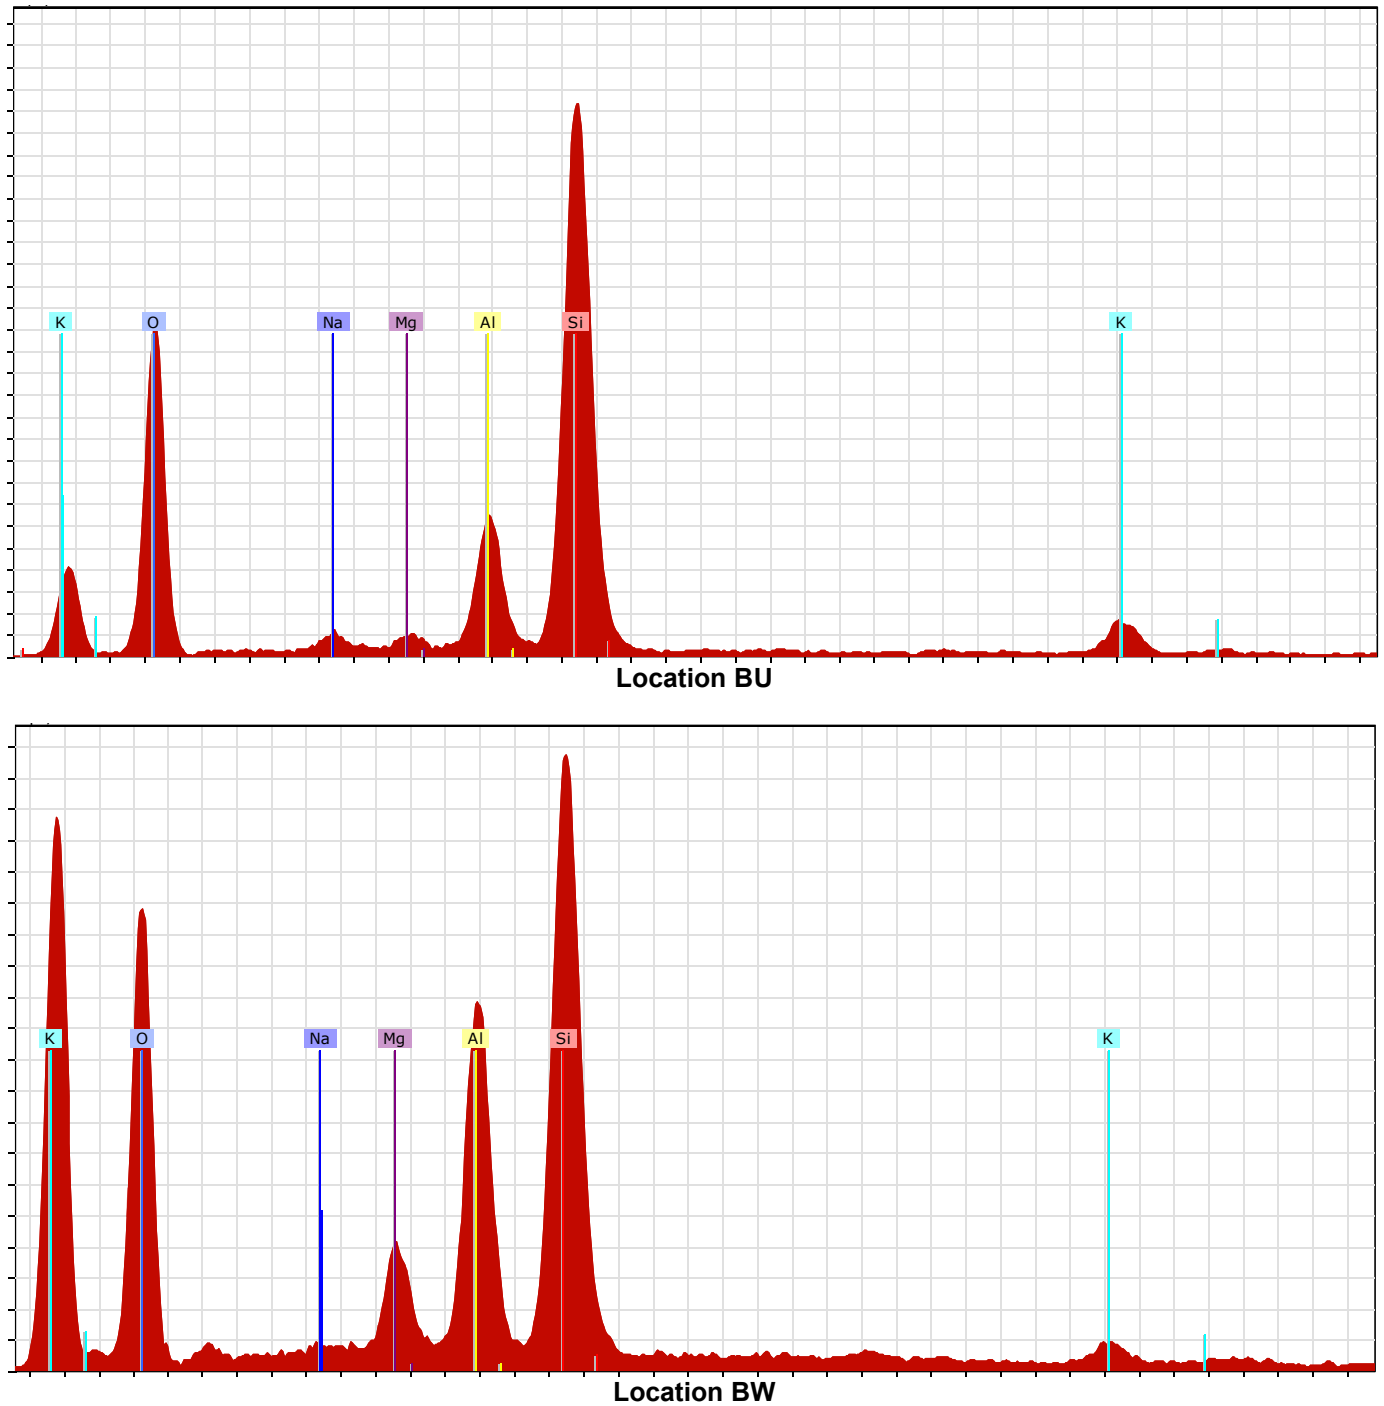
**Figure 125.** Semi-quantitative EDS results for debris at locations BU and BW in the main passageway of the oil nozzle (see Figure 121), which exhibited higher concentrations of silicon, aluminum, magnesium, sodium, potassium, and oxygen.

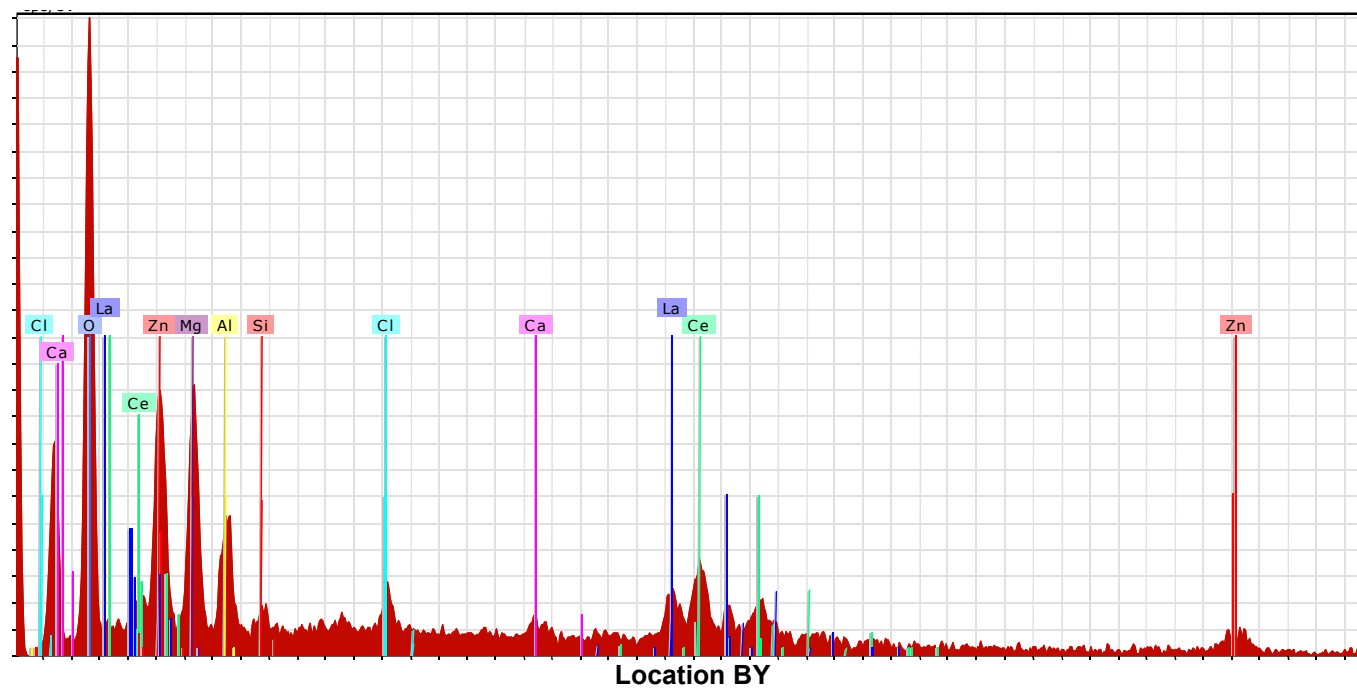
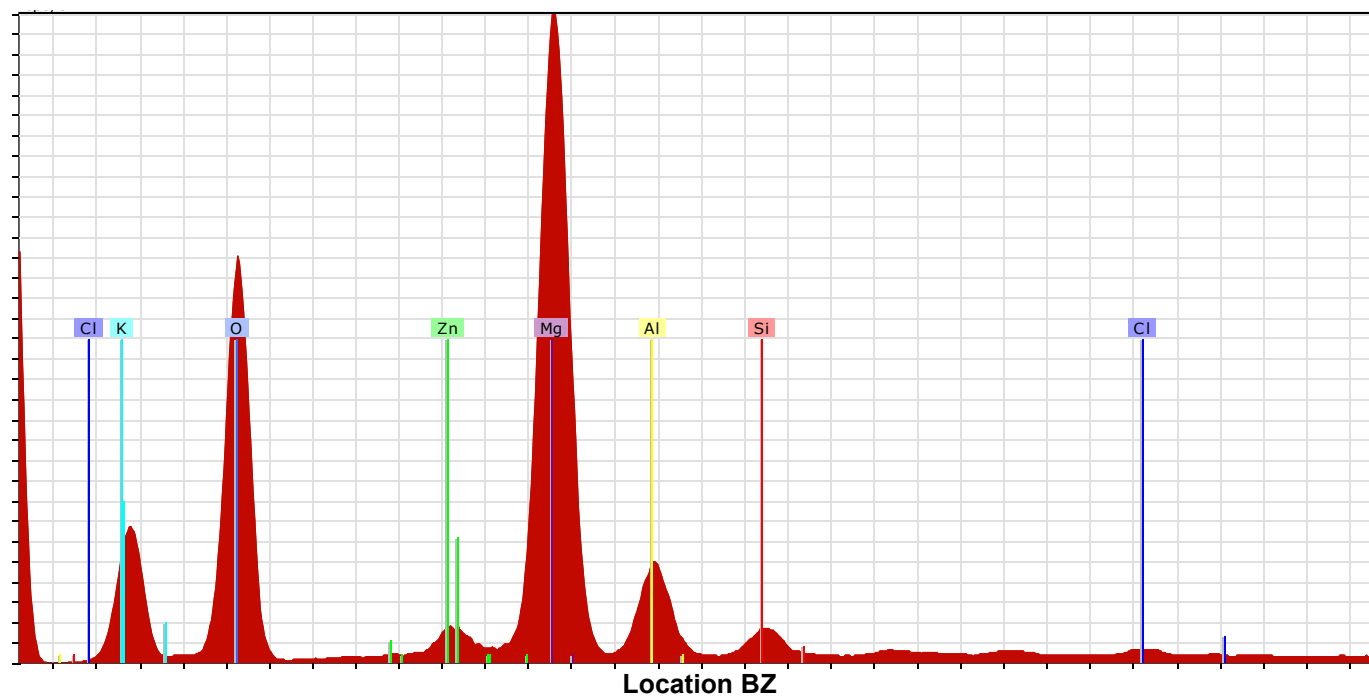
**Figure 126.** Semi-quantitative EDS results for debris at locations BY and BZ in the main passageway of the oil nozzle (see Figure 122). Location BY exhibited higher concentrations of magnesium, zinc, rare earth metals, aluminum, and oxygen. Location BZ exhibited higher concentrations of magnesium, aluminum, zinc, silicon, chlorine, and oxygen.
