# National Transportation Safety Board

CEN20FA070

## **WRECKAGE EXAMINATION SUMMARY**

Location: Springfield, Illinois  
Date: January 28, 2020  
Time: 1503 central standard time  
Airplane: Piper PA-60-601P, Registration No. N6071R

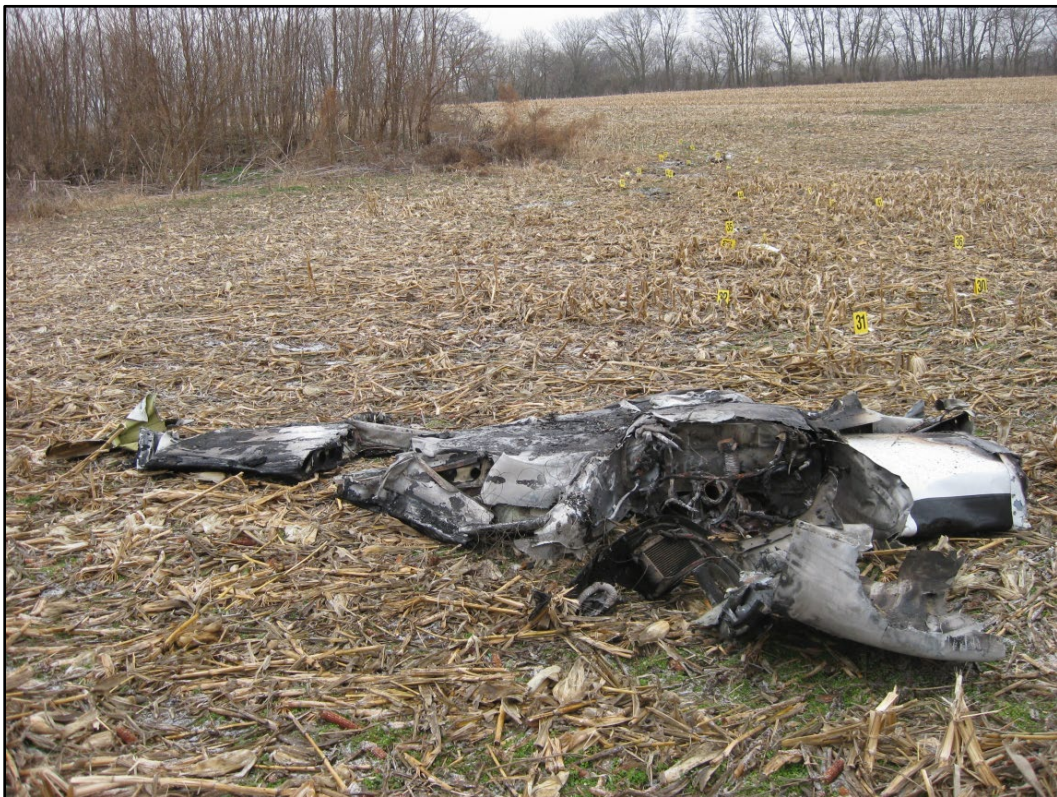
**Figure 8** - Right Wing Layout

Both wing spars were fractured at their wing roots and each wing remained partially attached to the fuselage by engine control cables. Flight control continuity could not be verified because the control push/pull tubes for the ailerons, elevators, and rudder exhibited extensive impact and fire damage. Both ailerons and flaps exhibited impact and fire damage. The hydraulic flap actuators were found extended about 1.5"

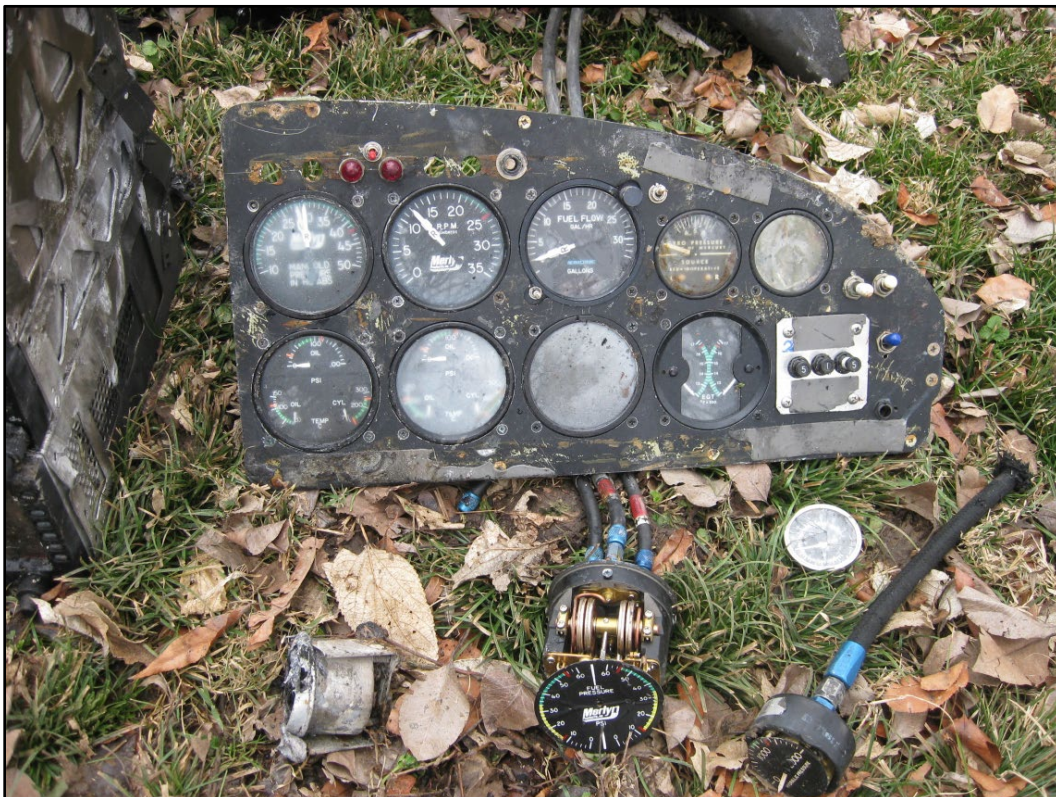
**Figure 10** - Instrument Panel (Right Side)

The instrument panel sustained significant thermal damage during the postaccident fire. The airspeed indicator and altimeter were destroyed by fire. The attitude indicator and horizontal situation indicator (HSI) were extensively damaged by fire and could not be tested. The internal gyros of the attitude indicator and HSI did not exhibit any evidence of rotational scoring. The turn indicator gyro was found separated from its instrument case that was not located during the investigation. The turn indicator gyro did not exhibit any evidence of rotational scoring. The backup course deviation indicator was destroyed by fire. The electronic engine trend monitor was destroyed by fire. The engine tachometer indicated 1,200 rpm for both engines. The manifold pressure gauge indicated 28 and 30 inches of mercury for the left and right engines, respectively.
