Aircraft Accident/Incident report No.: 200128

**NTSB File No.:** CEN20FA070

**Aircraft:** Aerostar PA-60-601P (Modified to the "Samurai 350" configuration by Merlyn Products Inc. STC SA4156NM and SE4157NM)

## PROPELLER EXAMINATION REPORT

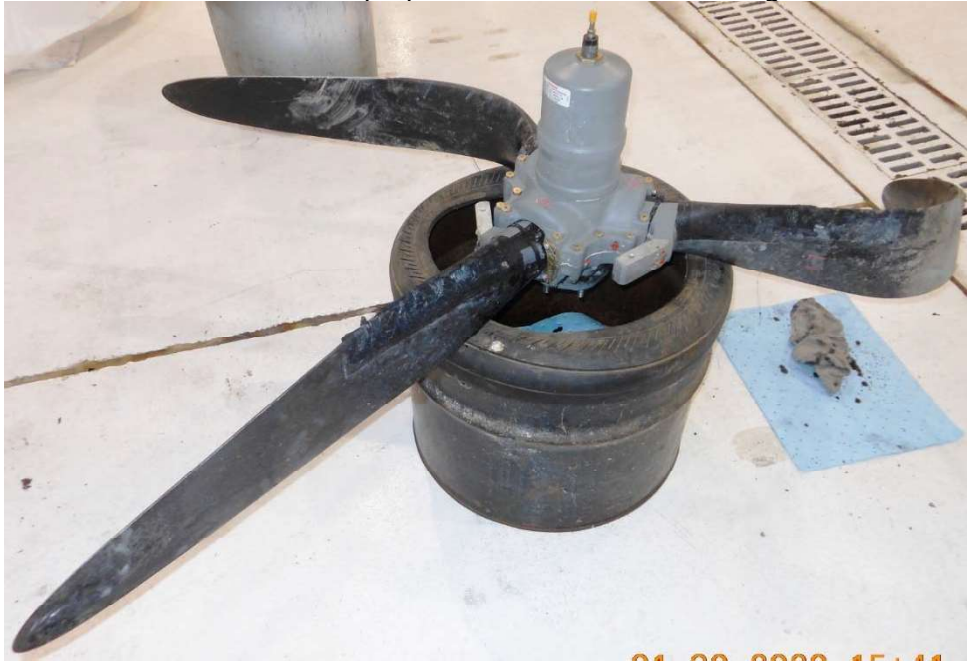
Photo #9 – Left propeller after removal from engine

**Cylinder/Hydraulic Unit:** The cylinder/hydraulic unit appeared intact, undamaged and securely attached to the hub as shown in Photo #9. The air valve remained intact and an aircharge of 20 psig was measured before disassembly. Photo #12 shows the hydraulic unit components.

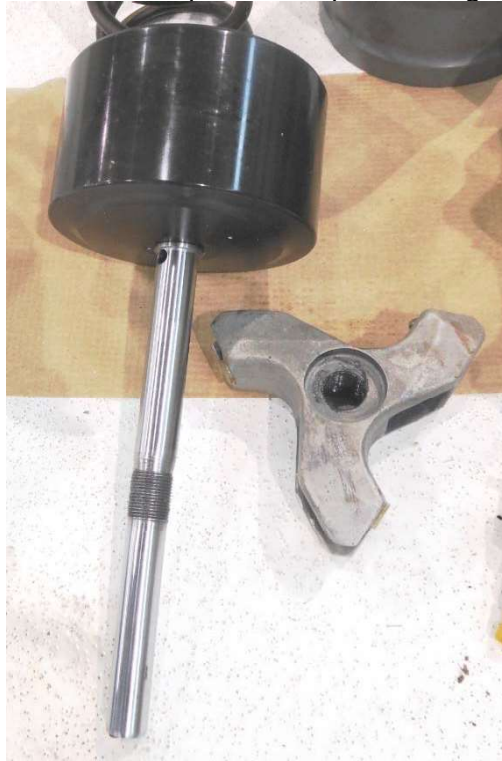
**Piston:** The piston appeared intact and undamaged (Photo #11).

**Fork:** The fork appeared intact and undamaged (Photo #11). The anti-rotation bumpers appeared intact and not smashed.

Photo #11 – Left piston and pitch change rod

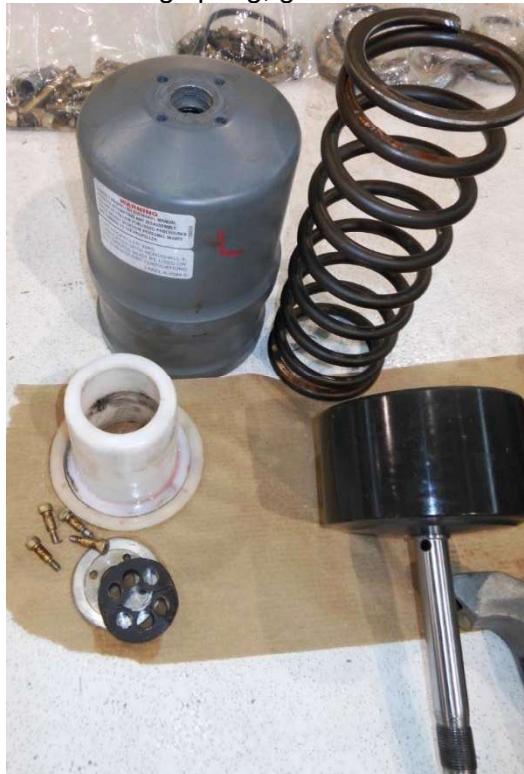
**Spring/Spring Guides:** The feathering spring, spring retaining cup and spring seat appeared intact and undamaged (Photo #12).

Photo #12 – Left feathering spring, guides and start lock components

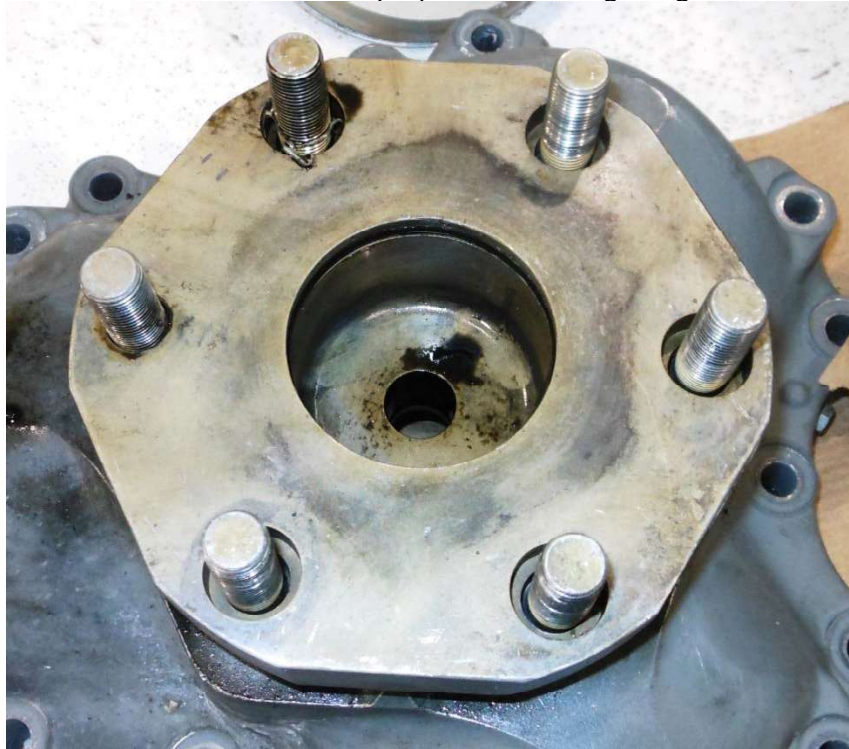
Photo #13 – Left propeller mounting flange

**Engine/Propeller Mounting:** The propeller remained attached to the engine crankshaft flange with no apparent damage to the mounting area (Photo #13). All mounting hardware was present and lock-wired.

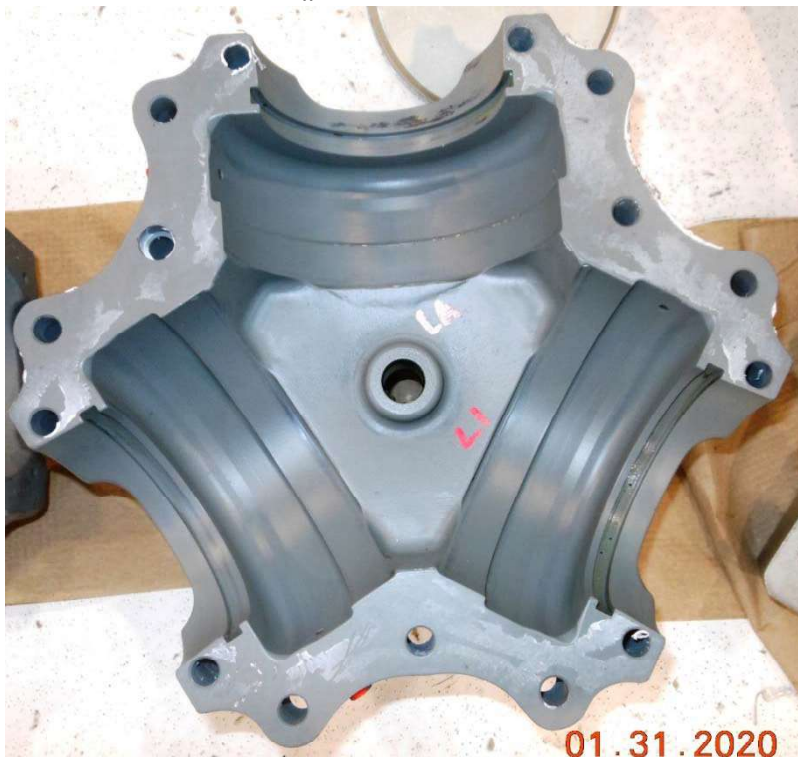
Photo #14 – Left aft hub half

**Hub Assembly:** See Photos #14 and #15. Upon opening the hub, it appeared to have been recently overhauled; all components appeared clean with little wear. The bearing grease was clean and the amount suggested it had not been serviced since assembly. There were no visibly obvious cracks or fractures in the blade retention system, with all through bolts present and secure. There was damage to the preload plate shelf and blade retention pocket of L3 in the face/trailing edge quadrant. There was also an impact mark on the aft hub from the blade seal rub strip in the L3 blade aperture, in the aft direction.

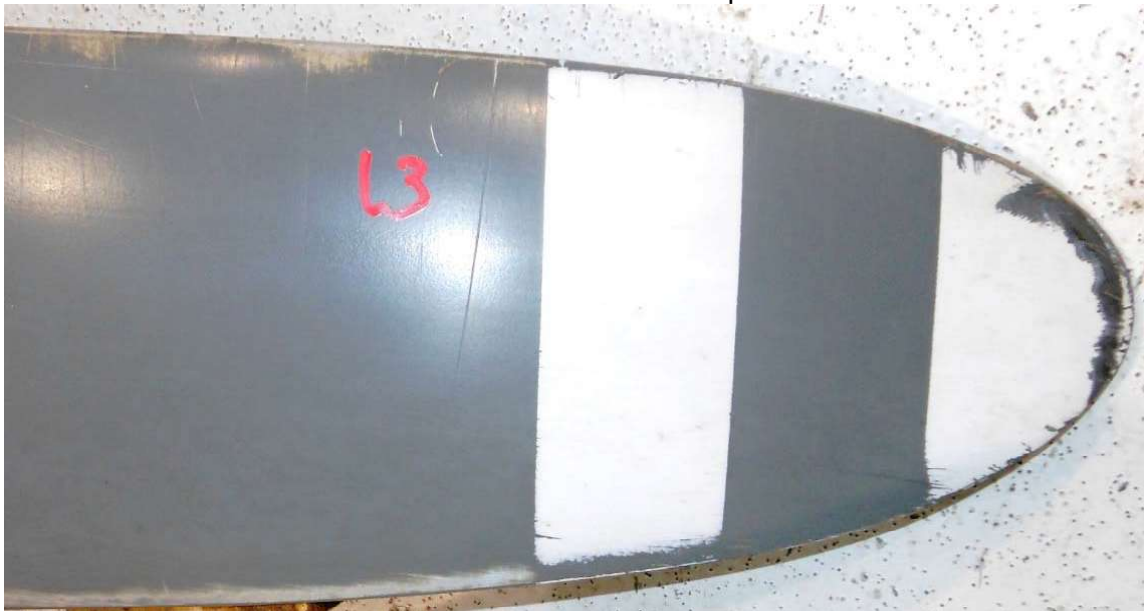
Photo #22 – L3 camber side tip area

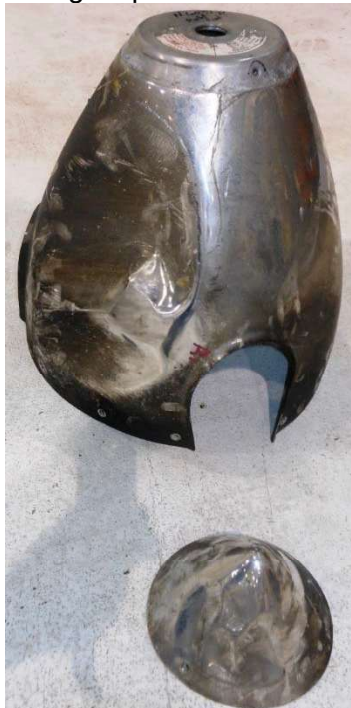
Photo #24 – Right spinner dome and dome cap

**Spinner Dome:** The spinner dome was dented with counterweight impressions at blade aperture R1 with angles of 38 and 55 degrees which equate to a blade angle of approximately 25 and 42 degrees respectively. The spinner dome and cap are shown in Photos #23 and #24. The measurement of the counterweight impression is shown in Photo #25.

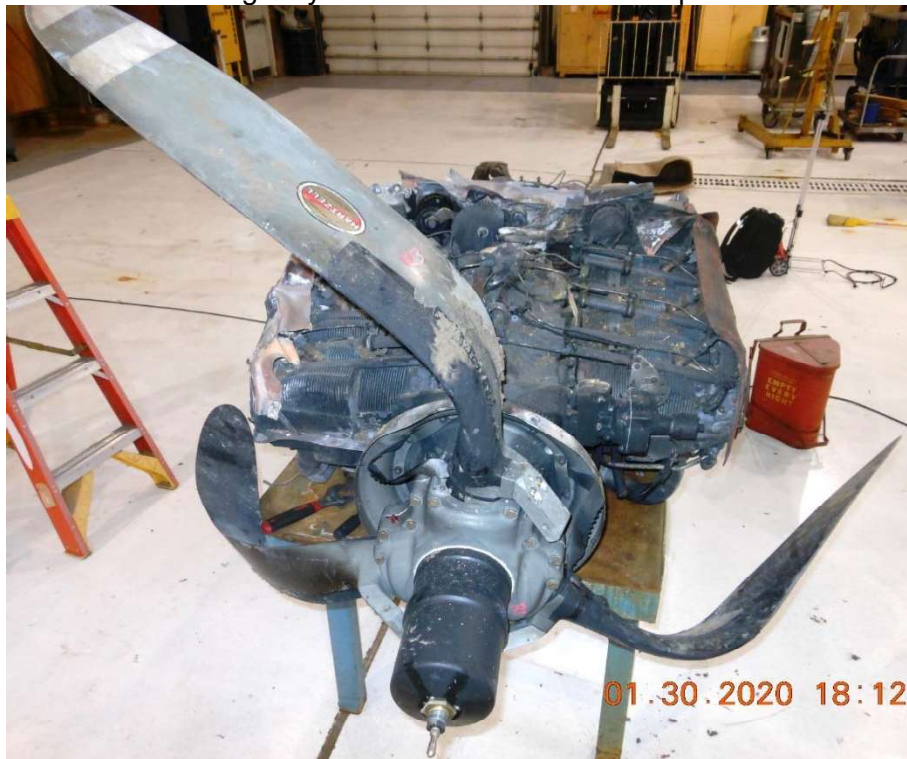
**Cylinder/Hydraulic Unit:** The cylinder/hydraulic unit appeared intact, undamaged and securely attached to the hub as shown in Photo #26. The air valve remained intact and an aircharge of 38 psig was measured before disassembly.

Photo #26 – Right hydraulic unit condition after spinner removal

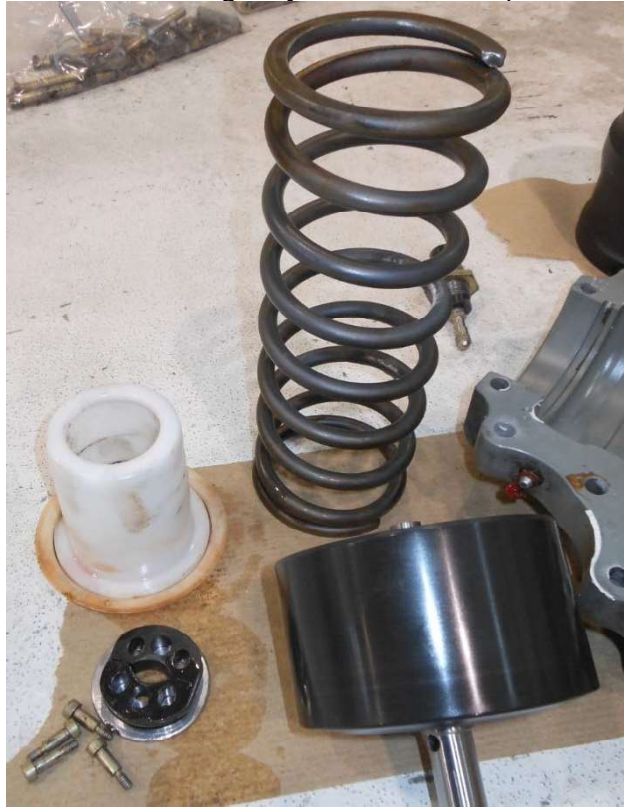
**Piston:** The piston appeared intact and undamaged (Photo #27).

**Spring/Spring Guides:** The feathering spring, spring retaining cup and spring seat appeared intact and undamaged (Photo #27).

Photo #27 – Right hydraulic unit components

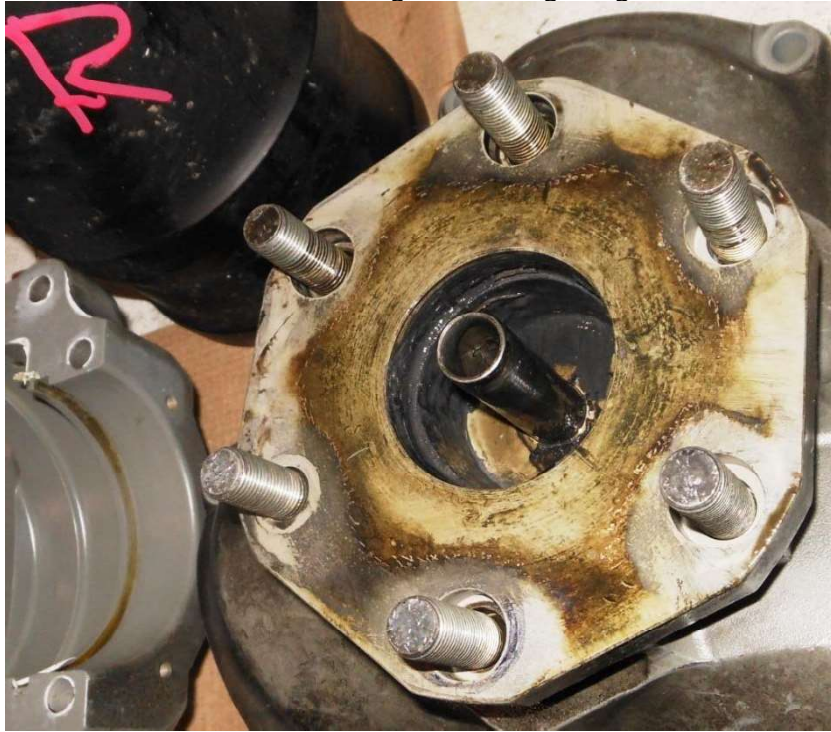
Photo #31 – Right mounting flange

**Engine/Propeller Mounting:** The propeller mounting flange and hardware appeared intact and undamaged as shown in Photo #31. All six mounting studs were present, secure and lock-wired.

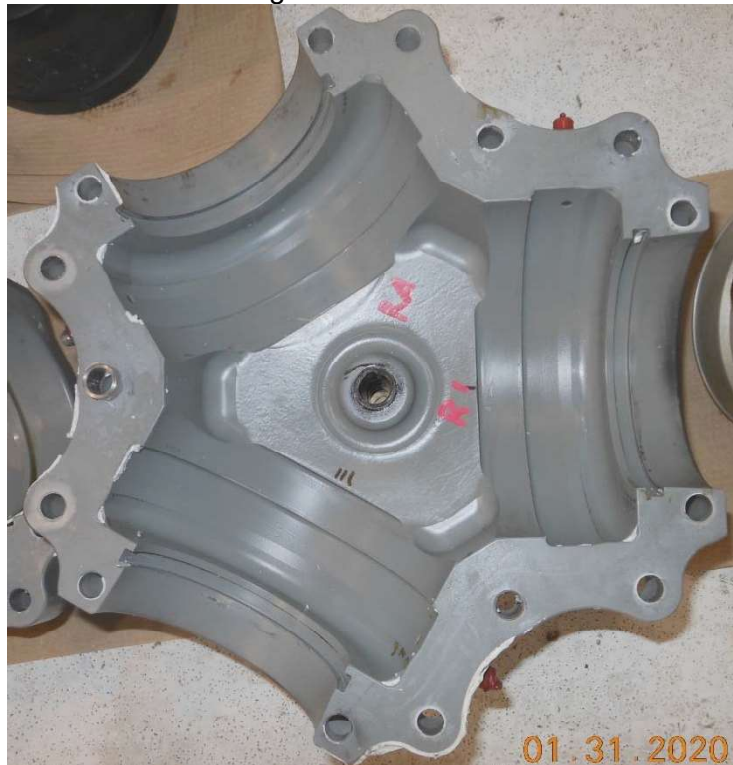
Photo #32 – Right aft hub half internal surface

**Hub Assembly:** See Photos #32 and #33. There were no visibly obvious cracks or fractures in the blade retention system, with all through bolts present and secure. There was varying degree of damage to the preload plate shelf/web in all three blade retention pockets. The aft hub web in retention pocket R3 was visibly displaced indicating impact forces in the aft direction. There was an impact mark on the aft hub aperture from the blade R2 shank/rub strip in the aft direction. The cylinder mounting boss appeared intact and undamaged. The aft pitch change rod segment remained in the aft hub bore. There were fork contact marks on the forward hub half between the R1 and R2 blade retention pockets.

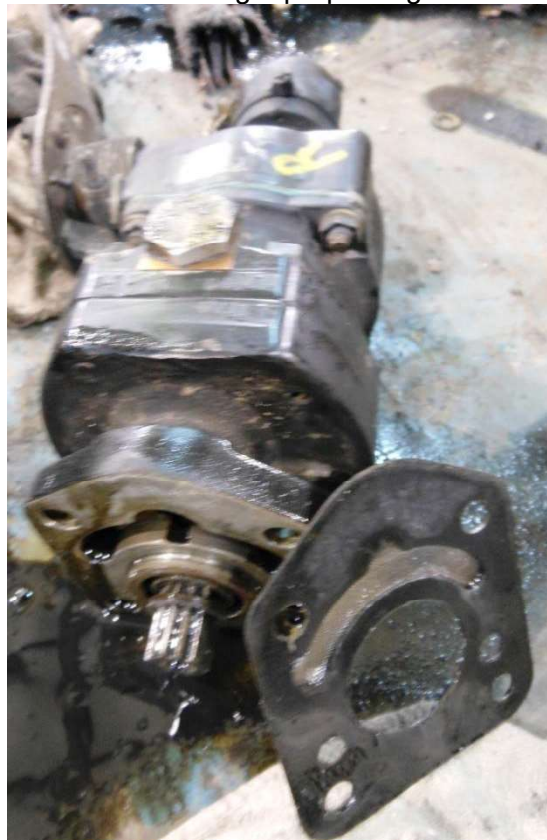
Photo #38 – Right propeller governor

Both left and right governor gasket/screens were clear. Both governor pump shafts rotated freely and smoothly by finger force and “gurgled” indicating pumping action. The control arm also rotated freely and smoothly by hand force. There were no external discrepancies noted that would preclude normal operation.
