**NATIONAL TRANSPORTATION SAFETY BOARD**  
**Office of Aviation Safety**  
**Washington, D.C. 20594**

**Powerplants Group Chairman's Factual Report**  
**NTSB No.: CEN20LA159**

Location: Mesquite, Texas

Aircraft: Boutique Air, Pilatus PC-12, N477SS

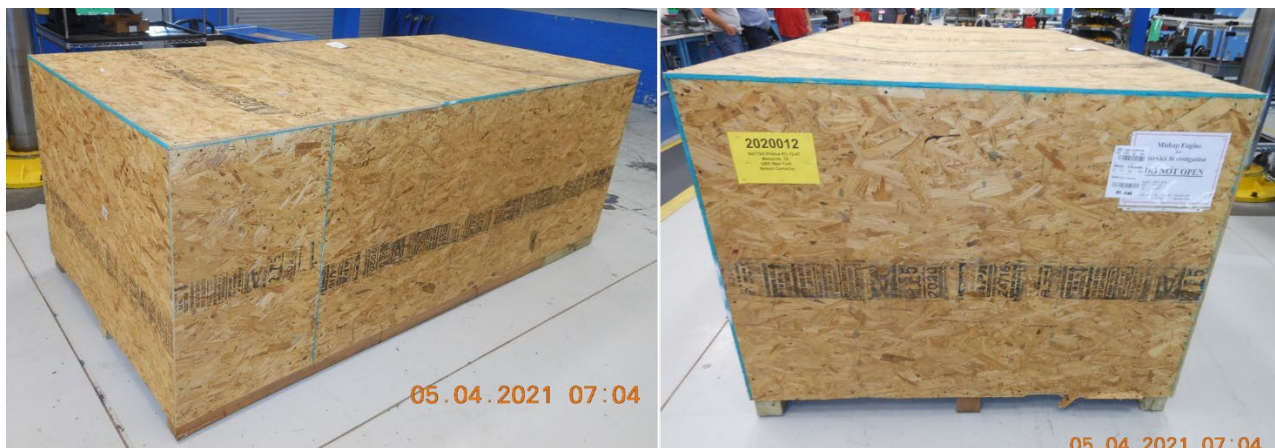
The propeller and engine were shipped as an assembly in a large particle board crate to the Pratt & Whitney Canada, Bridgeport, West Virginia facility. The crate was secured in the PWC PT6 shop when the investigation team arrived (**Photo 2**). All four propeller blade tips were separated during the impact sequence and were not included in the shipping container. The propeller blades were numbered with a paint marker in the counterclockwise direction (ALF) (**Photos 3 and 4**). Blade radius measurements were taken off the hub flat (**Table 1**). The spinner dome was separated during impact, and small remnants of the dome and the attaching screws remained fastened to the spinner bulkhead flange. The pitch change rod was in the full aft position, on the mechanical feather stop. The counterweights were missing from propeller blades 1, 2, and 3 and the blade pitch could be rotated by hand. There were shiny impact marks on the spinner bulkhead coincident with the position of the missing counterweights (**Photo 5**). The shanks on blades 1, 2, and 3 had impact witness marks from contact with the hub blade aperture and/or static balance weights in a location consistent with the blades being in the feather position at impact.

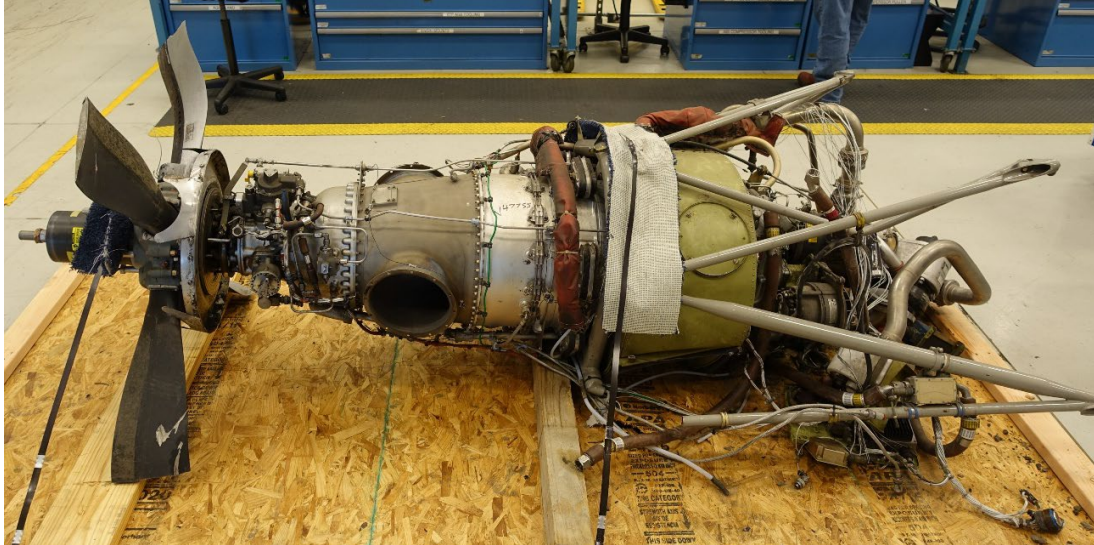
**Photo 9- Left Side of Engine, as Received**

The engine was intact and did not exhibit indications of undercowl fire or uncontainment (**Photos 9, 10, and 11**). The engine was shipped with multiple airframe components installed including: the plenum, sections of the mount structure, starter, air conditioning (A/C) compressor, and multiple ducts and wiring harnesses. Prior to airframe component removal, the reversing cable-to-beta valve rigging was checked in accordance with the Pilatus aircraft maintenance manual (AMM) procedure 12-A-76-10-00-00A-903A-A, Section 3.4- Adjustment of the Beta Control Cable and Pratt and Whitney engine maintenance manual (EMM) Section 76-10-00, Prop Reverse Linkage- Maintenance Procedures. The beta valve plunger was extended beyond the face of the propeller governor (**Photo 12**)<sup>4</sup>. A wire could be inserted through both the forward and aft clevis inspection holes that act as check points for proper thread engagement (**Photos 13 and 14**). The forward clevis adjustment nut was rotated full aft. The wire rope, swaging ball end<sup>5</sup> on the forward end of the reversing cable was not properly secured between the clevis rod end and the push-pull control terminal and was free to rotate within the linkage assembly (**Photo 16**). The reversing cable was removed and was measured for indications of stretch. According to the PWC drawing, the cable has a maximum tolerance of 55.5425-inches. An informal measurement of the cable determined the cable was at approximately the maximum allowable length.

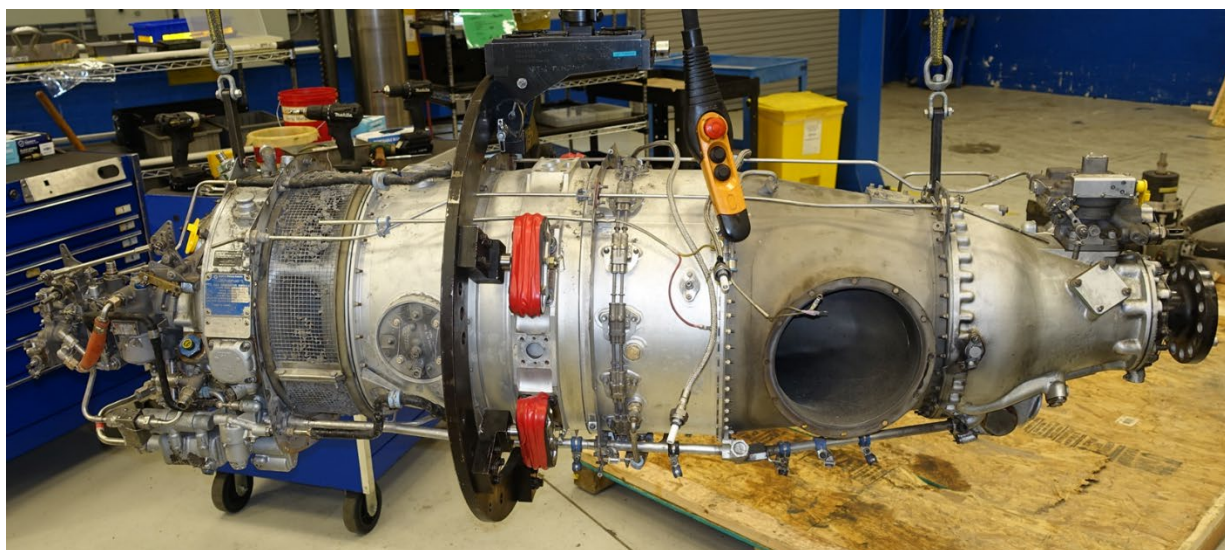
**Photo 17- Right Side of Engine**

The airframe components were removed, and the engine external surfaces were visually examined (**Photo 16 and 17**). Mud/earthen debris was adhered to the engine inlet screen 360 degrees around the engine. The No. 2 bearing scavenge line and a fuel supply line located at the 6 o'clock position exhibited bending deformation (**Photo 18**). The Ng and Nf spools<sup>6</sup> both spun smoothly with no indication of internal rub. The magnetic chip detector (MCD) was removed from the reduction gearbox (RGB) and there was no debris accumulation. One of the two MCD prongs was damaged during removal (**Photo 19**). The fuel, oil, and P3<sup>7</sup> filters were in good condition and free of debris.

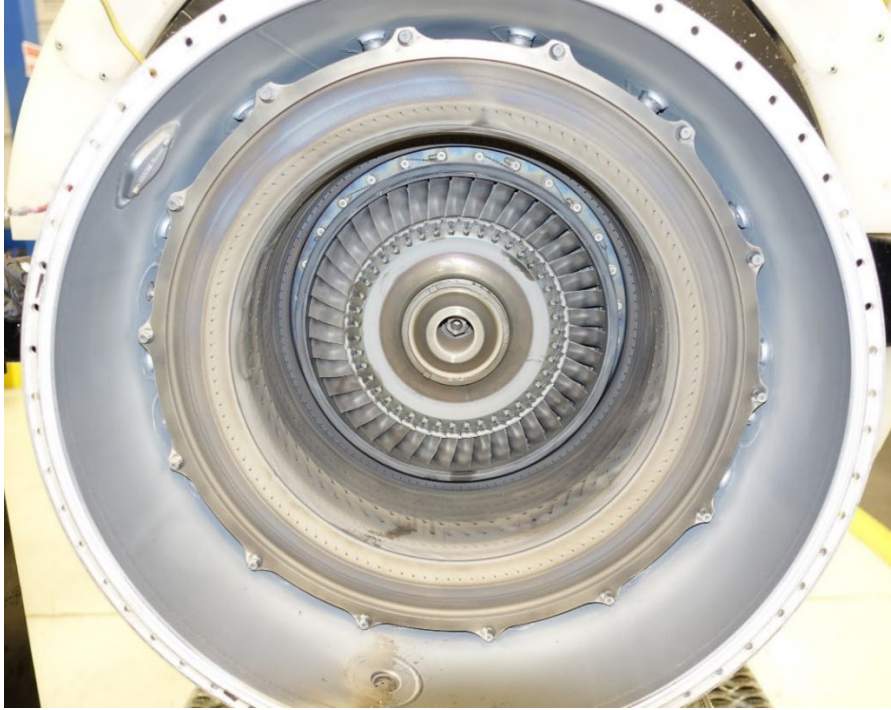
**Photo 21- Compressor Turbine and Combustion Liner**

The PT module was separated from the engine. The trailing edge of all CT blades were in good condition. The combustion liner was intact and there was no evidence of burn through and fuel nozzle streaking (**Photo 22**). The leading edge of the 1<sup>st</sup> stage PT blades and trailing edge of the 2<sup>nd</sup> stage PT blades visible through the exhaust were unremarkable (**Photo 23**). The team decided not to further disassemble the engine modules due to a lack of evidence of internal damage.
