## **NATIONAL TRANSPORTATION SAFETY BOARD**

# **STRUCTURES**

**CEN20LA175**

**Report Title:** Examination of a damaged MLG Drag Leg Assembly p/n 114-810023-1 on Beechcraft 1900C, S/N UB-12, N31704

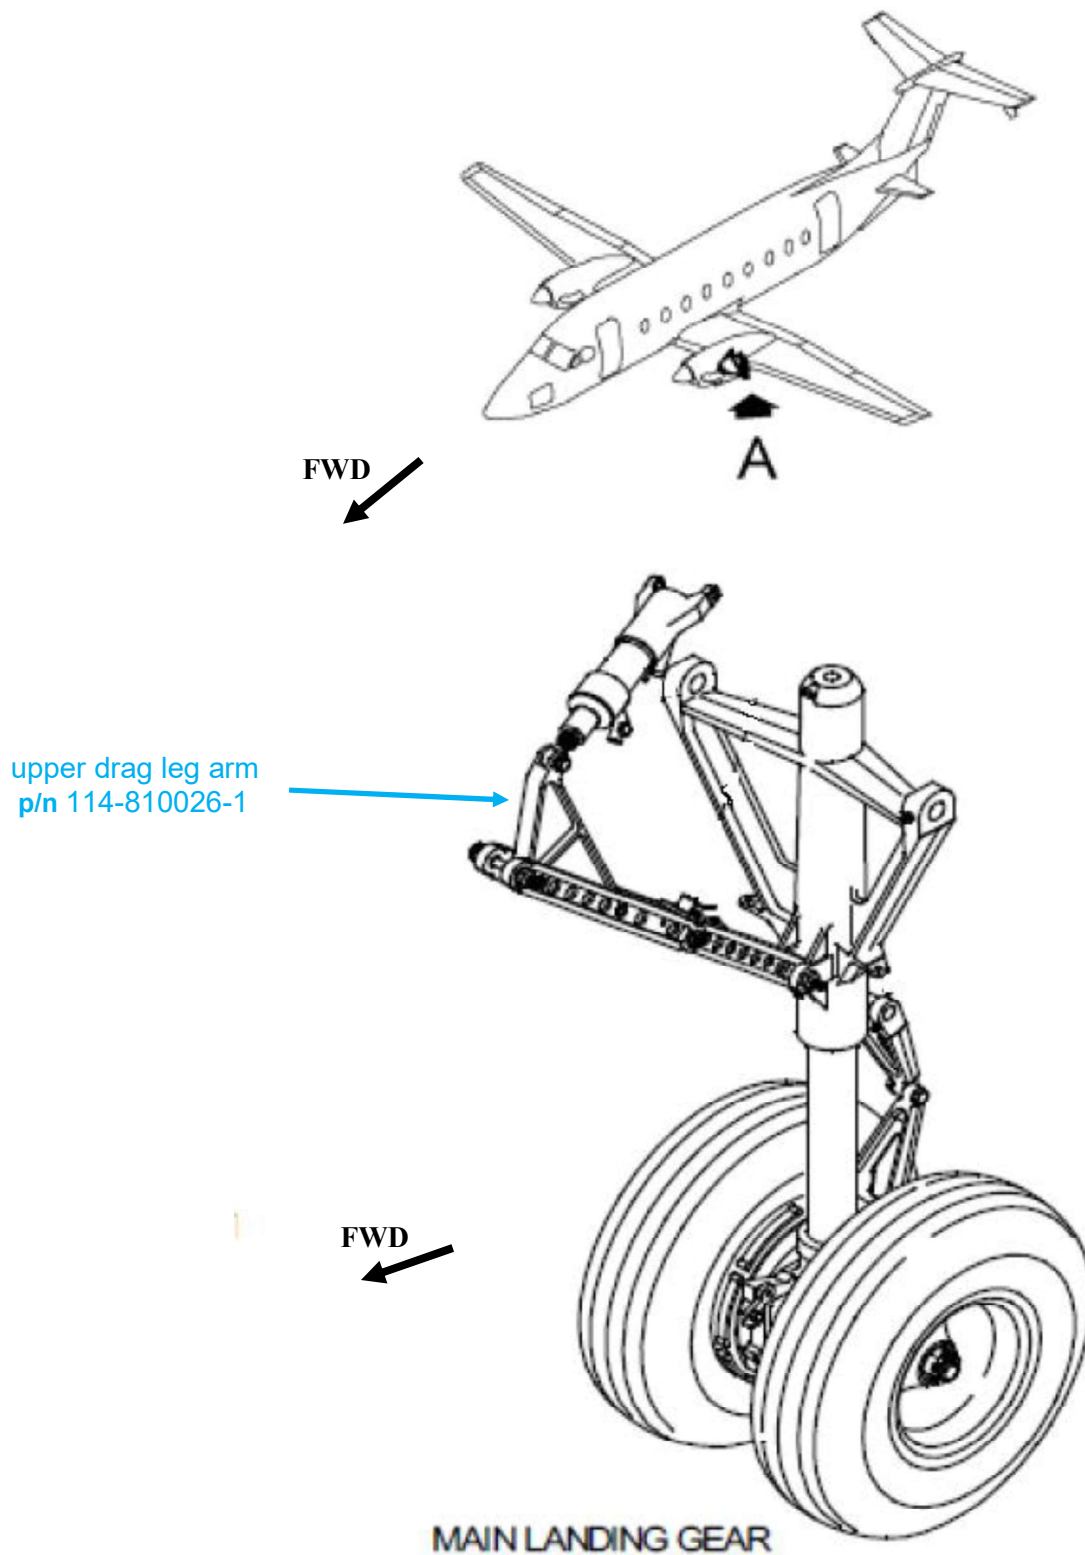
During a landing mishap on May 8, 2020 the drag leg assembly p/n 114-810023-1 on the left hand MLG of M1900C-UB-12 sustained damage, with the upper drag leg arm p/n 114-810026-1 being broken into two pieces. Figure 1 shows the location of the drag leg assembly on a model 1900C aircraft. Beechcraft engineering drawing specifies 1.500" thick 7075-T6 aluminum alloy plate per QQ-A-250/12 for the fabrication of the broken upper drag leg arm p/n 114-810026-1. The outside surface of the upper drag arm to receive chemical film plus one coat of polyamide epoxy primer per finish code P01C01.

Figure 1 View from the Illustrated Parts Catalog showing location of the upper drag leg arm p/n 114-810026-1 on the left MLG of Model 1900C aircraft. The as-received parts are shown in Figure 2.

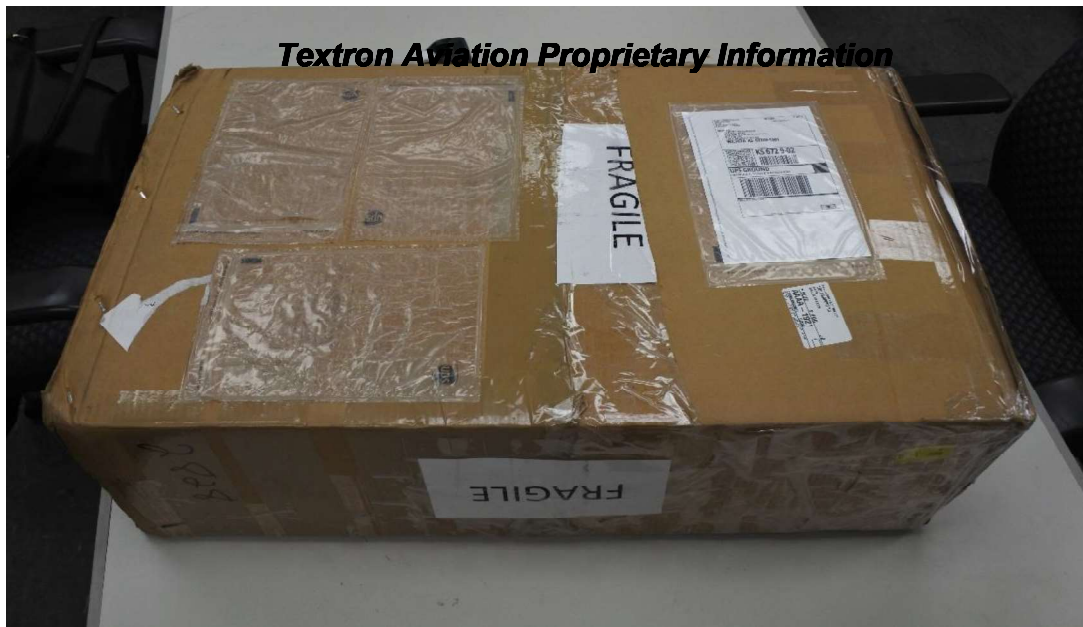
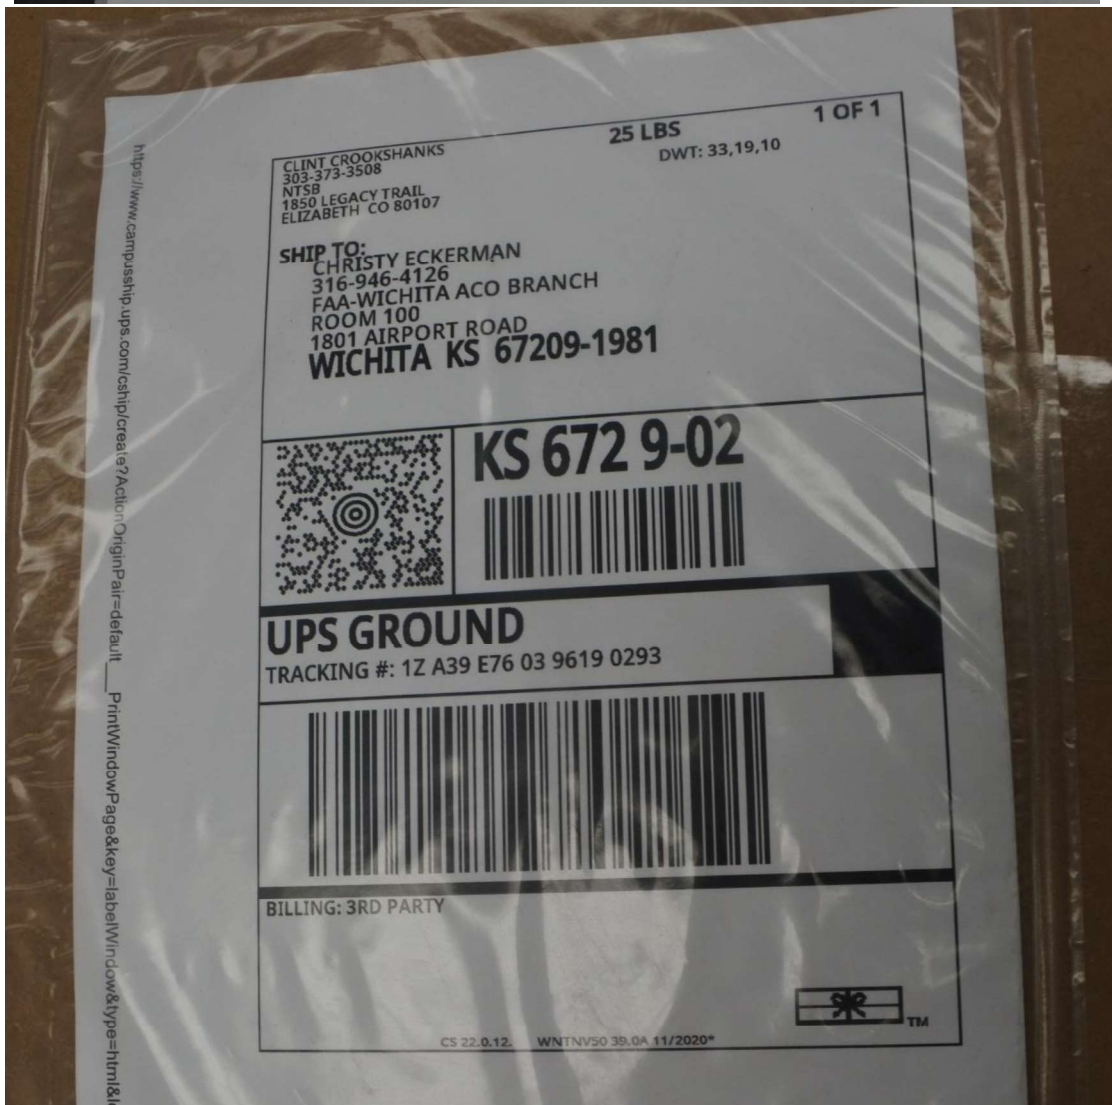
On March 4, 2021 a meeting was held at Textron Aviation M&P lab and a box containing the damaged parts from M1900C-UB-12 was opened at presence of FAA, Air safety and M&P personnel with other FAA and NTSB personnel participating virtually; reference Figures [2-3].

Figure 2 A box containing the damaged parts was brought to the M&P lab for examination.
