# National Transportation Safety Board

CEN20LA197

## **WRECKAGE EXAMINATION SUMMARY**

Location: Cambridge, Ohio  
Date: May 27, 2020  
Time: 1458 eastern daylight time  
Airplane: Beech 35-A33, Registration No. N123JB

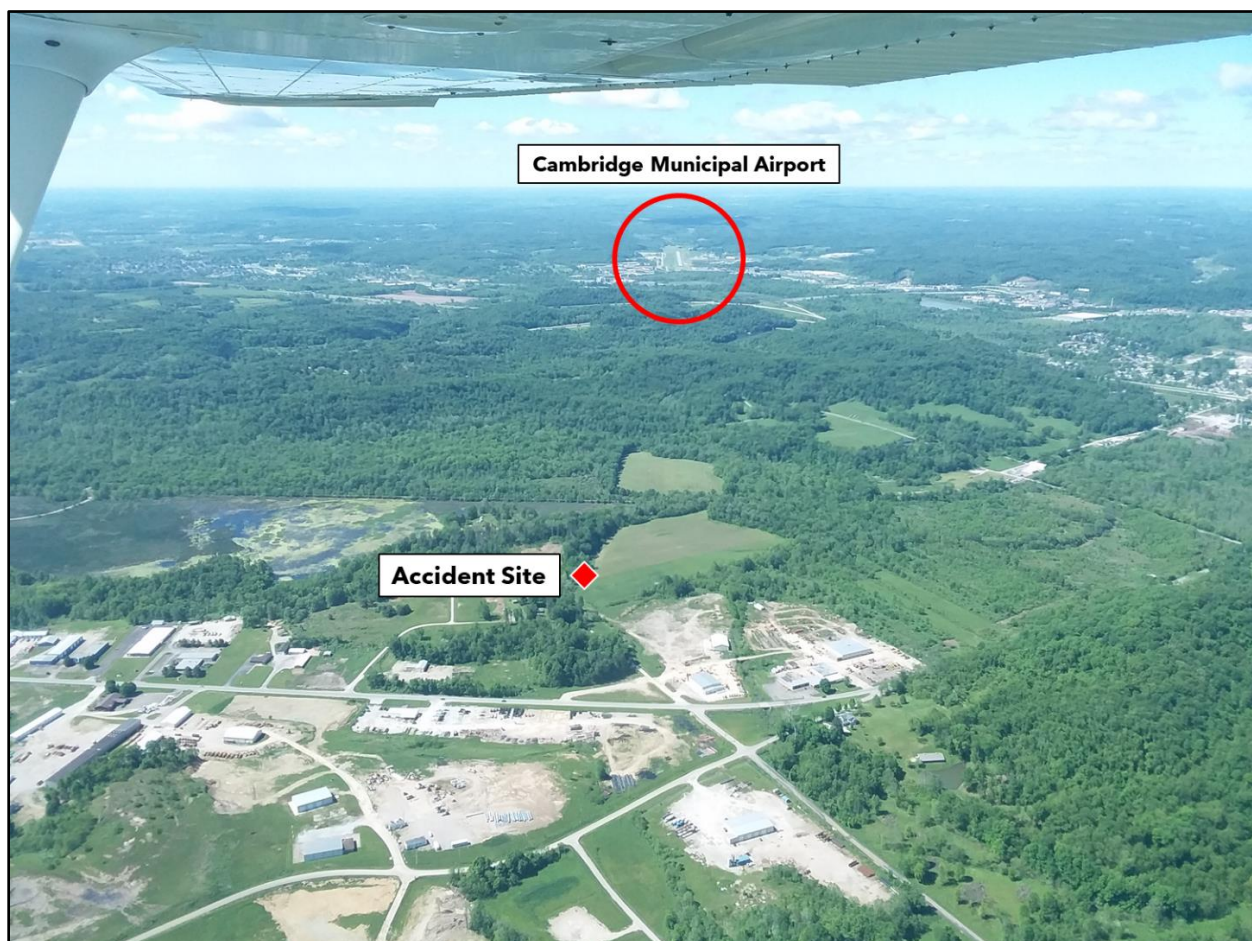
**Figure 1** - Aerial Photograph Showing Accident Site Location (FAA Photo)

According to the FAA inspectors who responded to the accident site, the airplane wreckage was at the edge of a field located about 3 nautical mile northeast of Cambridge Municipal Airport (CDI), Cambridge, Ohio, as shown in figures 1 and 2. There was no evidence that the airplane's wheels contacted the ground before the airplane flew into the trees at the eastern edge of the field on an east heading. Based on the damage to the trees and the airplane, the airplane impacted the trees a few feet above ground level in a level pitch attitude, as shown in figure 3.
