**NATIONAL TRANSPORTATION SAFETY BOARD**  
**Office of Aviation Safety**  
**Washington, D.C. 20594**

**POWERPLANTS GROUP CHAIRMAN'S FACTUAL REPORT**

**NTSB No: CEN20LA215**

Aircraft: Mitsubishi MU2B, N44MX, McNeely Charter Service, Inc.

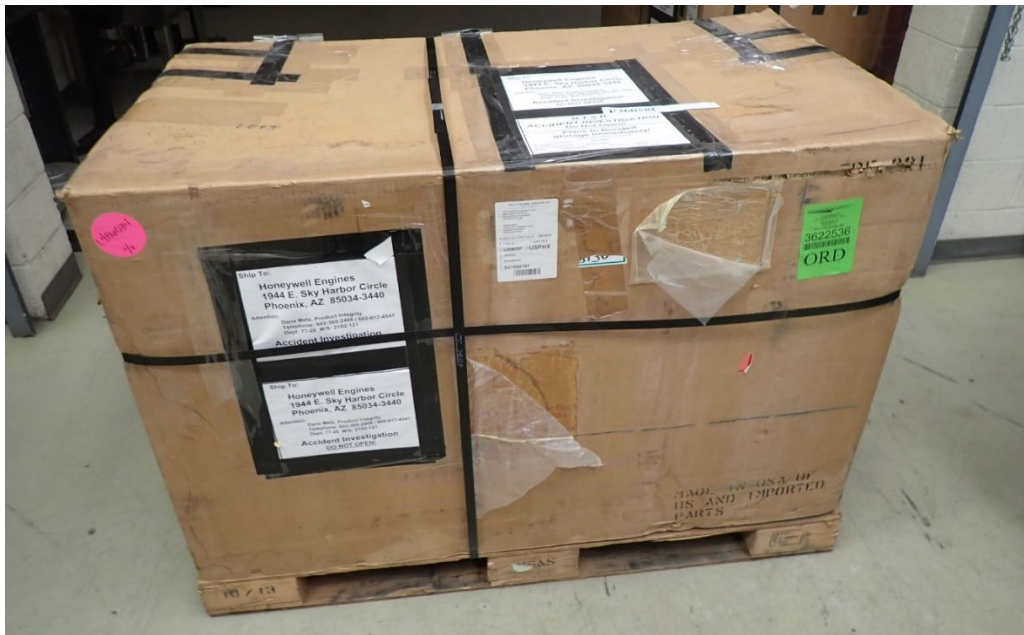
**Photo 1- Engine Shipping Container, as Received at Honeywell**

The engine was secured in a cardboard box in the Honeywell Product Integrity cage when the investigation group arrived (**Photo 1**). The engine was shipped with multiple airframe components

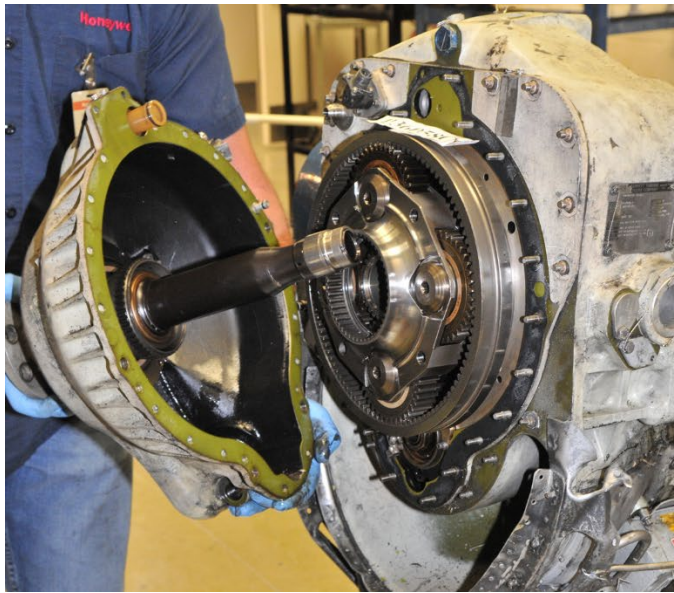
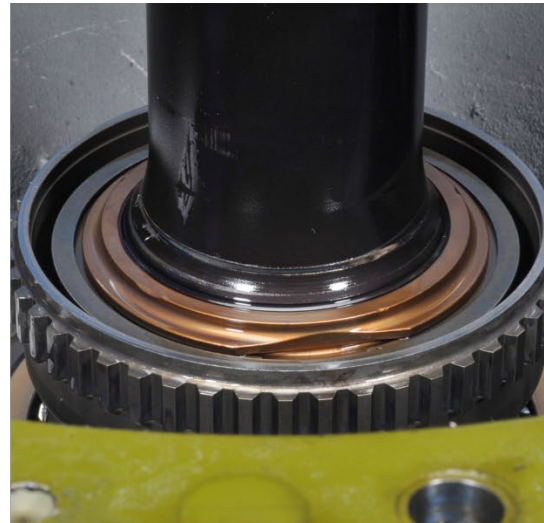
The mechanic notified the group that AGB nose cone attaching bolts were not torqued as expected. Breakaway torque was checked on a random sample of bolts and each had less than 5 inch-pounds (in-lbs.) of torque.<sup>3</sup> When the nose cone was removed, the propeller thrust bearing, propeller shaft, and propeller coupling were complete. The propeller thrust bearings were oil wetted and rotated smoothly. The nose cone had white slimy residue in the lower recess and five nuts, and three fractured bolts were recovered from 6 o'clock position. The propeller shaft had a 360 degree circumferential rub at the forward radius, light localized rubs 1 inch and 1.5 inches aft of the shaft base, and non-uniform circumferential rub and gouging 5.75 inches from the shaft base that resulted in raised metal (**Photo 11**). The ring gear, sun gear and planetary gears were intact (**Photo 12**). Impact marks and rub were noted on the aft gear tooth surface of all four planet gears and there was concurrent impact and rub marks on the forward face of the ring gear support (**Photo 13**). One planetary gear bearing outer race was cracked at two locations and rotated with some resistance. The other three planetary gears rotated smoothly. Metal shavings were observed on the planetary gear carrier. The forward side of the sun gear inner diameter had 360 degree circumferential rub and raised metal slivers (**Photo 14**).

<sup>3</sup> According to the engine maintenance manual, the nose cone bolt torque is 80 in-lbs. and the two larger bolts located at the 12 o'clock position are supposed to be torqued to 100 in-lbs.

**Photo 11- (L) Nose Cone Following Removal, (R) Propeller Shaft Circumferential Rub at Lower Radius**

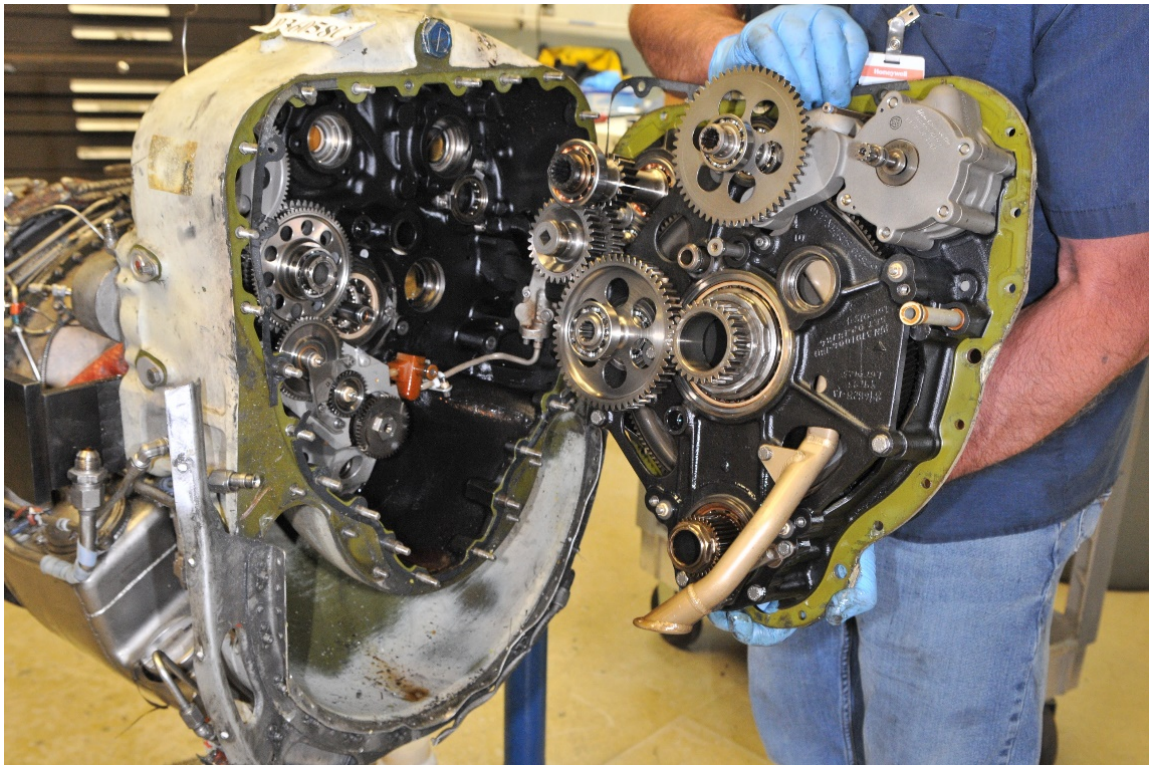
**Photo 16- Diaphragm Assembly**

The AGB diaphragm was intact and in good condition. The torque coupling shaft was removed, and the aft spline was separated. The broken spline was later recovered from the torsion shaft (**Photos 15**). The aft diaphragm gearset and mating accessory gears were intact (**Photo 16**). The torque sensor was intact, and the gear teeth were in good condition. The high speed pinion was manually rotated and the geartrain rotated smoothly. After removal of the torque sensor housing, the main shaft gear was manually rotated and there was concurrent rotation of the turbine as viewed through the exhaust. Impact marks were observed on the AGB case feather valve bore and the torque sensor housing (**Photo 17**). According to Honeywell Product Integrity, impacts in these locations are common during propeller strike events on airplanes equipped with TPE331 engines.

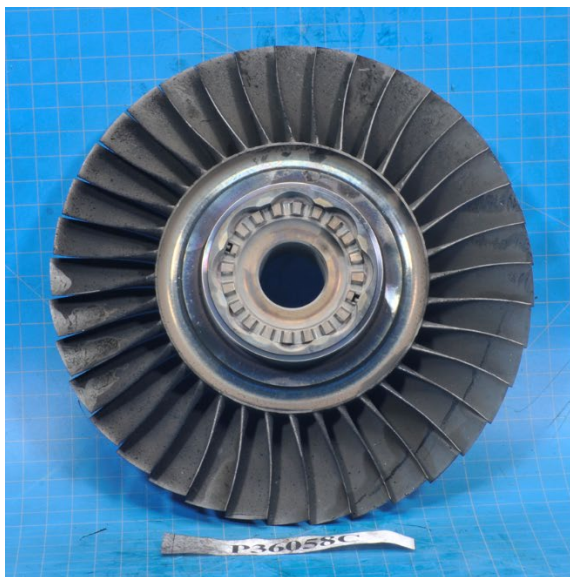
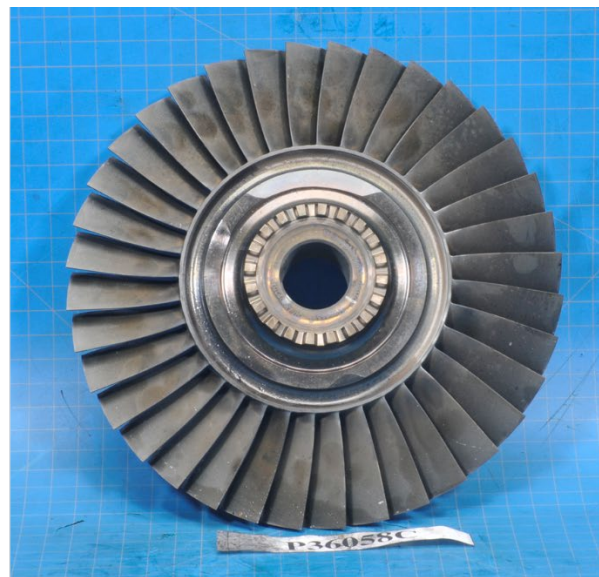
**Photo 18- 3<sup>rd</sup> Stage Turbine Rotor, (L) Leading Edge, (R) Trailing Edge**

The turbine rear frame was intact, and the rear turbine bearing was oil wetted and rotated with light resistance. All three stages of turbine rotors and stator vanes were complete (**Photos 18-23**). Metal spray and black spatter/streaking were observed on the blades and vanes of each stage. The turbine rotor shrouds were intact. There was rub/scoring on the 1<sup>st</sup> and 2<sup>nd</sup> stage turbine rotor shrouds. The 1<sup>st</sup> stage turbines vanes exhibited thermal damage and material loss on the leading edge blade tips. The curvic couplings between each stage were undamaged and properly mated. The interstage air seals were in good condition.

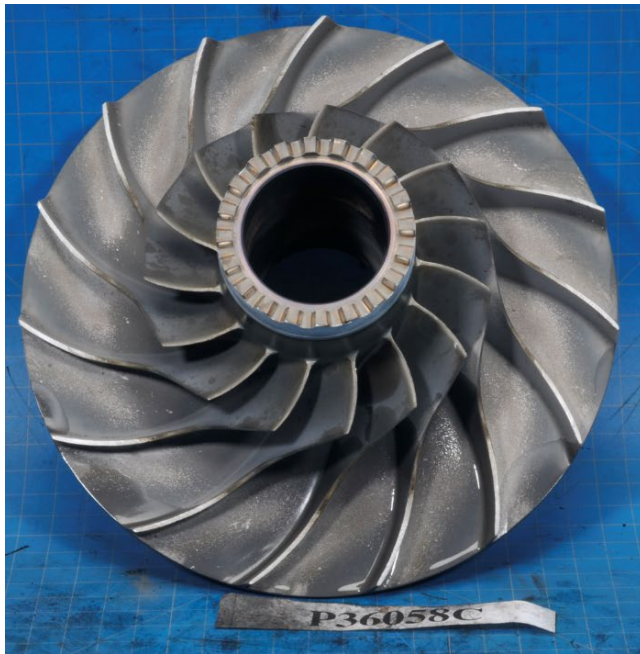
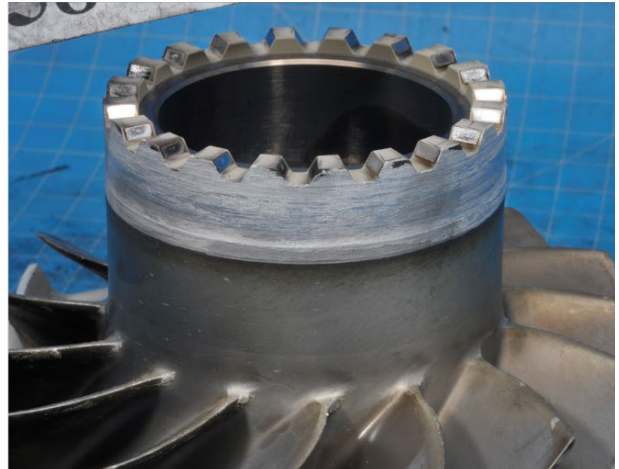
The 2<sup>nd</sup> stage compressor impeller was intact. The impeller vanes had light tip rub along the length of all blades and localized impact damage was observed on the leading edge of one blade. There was 360 degree rotational scoring aft of the forward 2<sup>nd</sup> stage impeller curvic coupling (**Photo 25**). The 2<sup>nd</sup> stage impeller shroud<sup>4</sup> inducer had 360 degree rotational scoring, more severe from the 6 to 12 o'clock positions. The impeller shroud knee had rotational scoring from 6 to 12 o'clock positions. The impeller shroud exducer had rotational scoring from the 7 to 5 o'clock positions, more severe from the 12 to 5 o'clock positions (**Photo 26**). The 2<sup>nd</sup> stage compressor diffuser had debris between the vanes (**Photo 27**).

**Photo 25- (L) 2<sup>nd</sup> Stage Compressor Impeller Vane Scoring, (R) Impeller Curvic Coupling Outer Diameter Scoring**

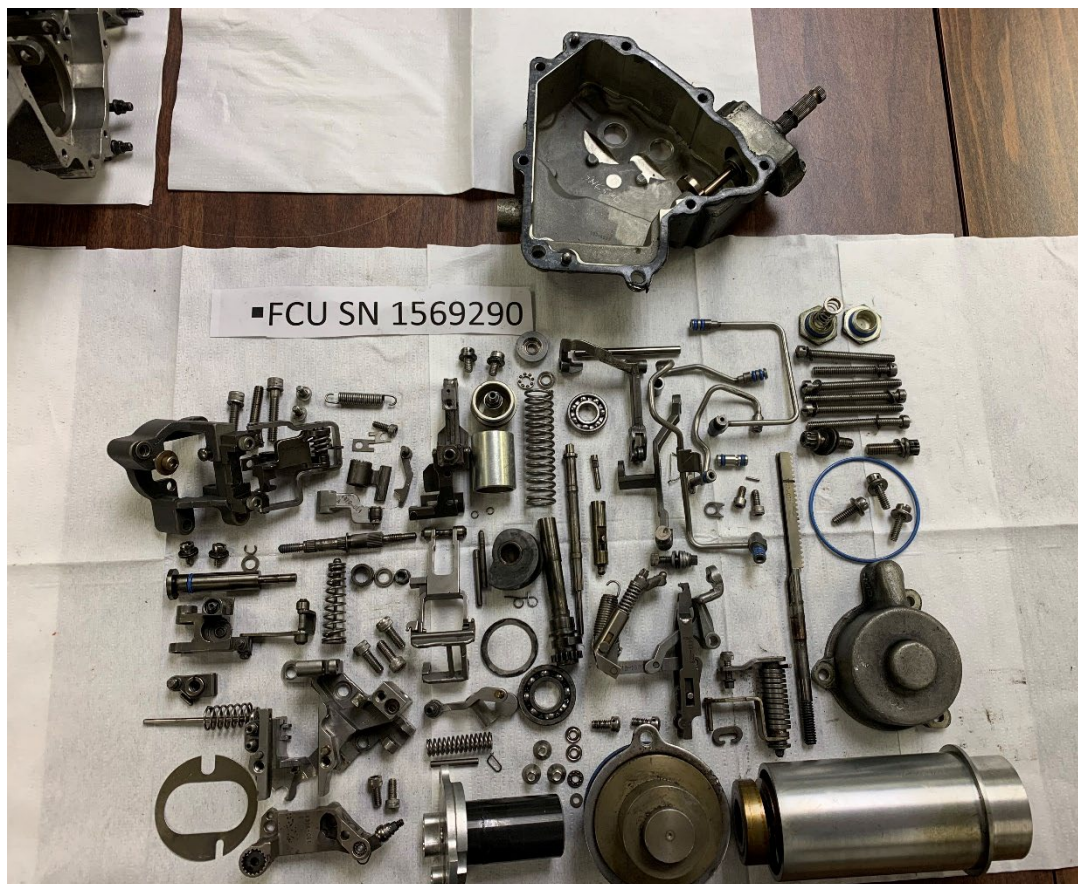
**Photo 33- No. 1 Engine FCU Disassembled**

A visual examination of the FCU, part number (P/N) 807426, serial number (S/N) 1569290, removed from the No. 1 engine revealed that the input drive shaft was bent, and the input mounting flange exhibited impact damage and was missing material (**Photo 32**). The FCU could not be safely installed on a test bench due to the damage, so the FCU was fully disassembled (**Photo 33**). There was no evidence of preimpact part failure or other internal anomalies.

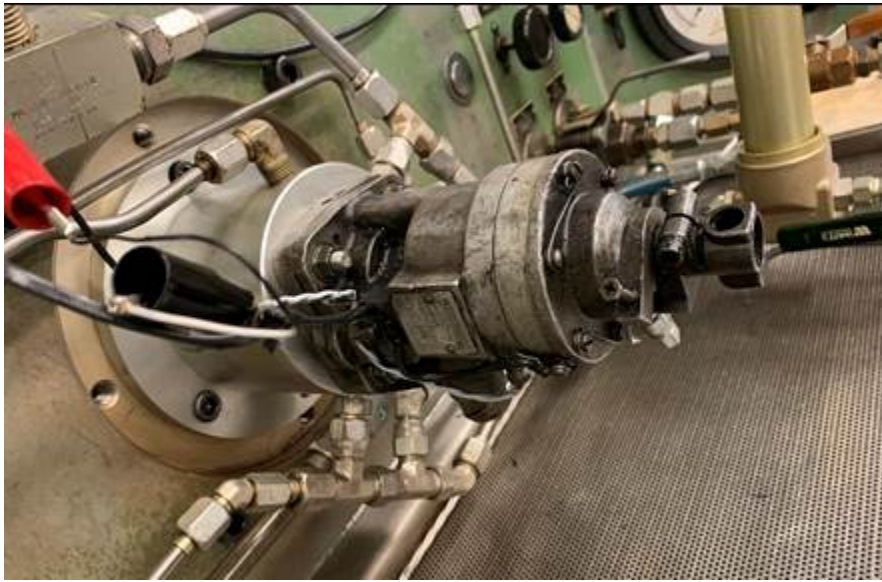
**Photo 34- No. 1 Engine Propeller Governor Installed on Test Bench**

The propeller governor, P/N 8210-263, S/N 247721, was installed on a test bench and an acceptance test procedure (ATP) was performed in accordance with Woodward TSP-1674 Revision AD (**Photo 34**). During the examination and testing, there were no indications of internal binding. Multiple test points were recorded outside of ATP tolerance, but according to Woodward Engineering, the values were consistent with customer adjustments to the propeller governor min/max screws and were not outside of expected ranges for a typical service run component. The propeller governor test run sheet is available in the docket as Powerplants- Attachment 1- No. 1 Engine (P36058C) Propeller Governor Test Report.

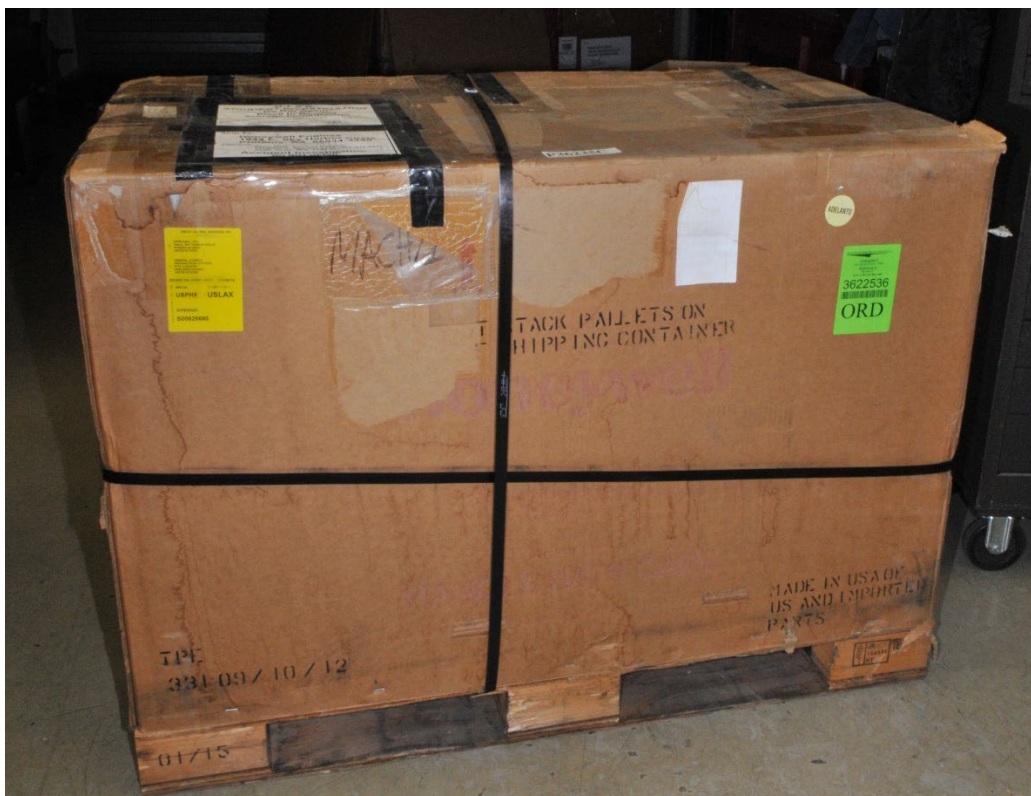
**Photo 38- Engine Shipping Container, as Received at Honeywell**

The engine was secured in a cardboard box in the Honeywell Product Integrity cage when the investigation group arrived (**Photo 38**). The engine was shipped with multiple airframe components installed including: the engine mount horseshoe, starter generator, fire detection loops, wiring harnesses, and part of the aft firewall (**Photos 39, 40, and 41**). Oil samples collected at Wentworth Salvage during the wreckage layout were included in the shipping box.

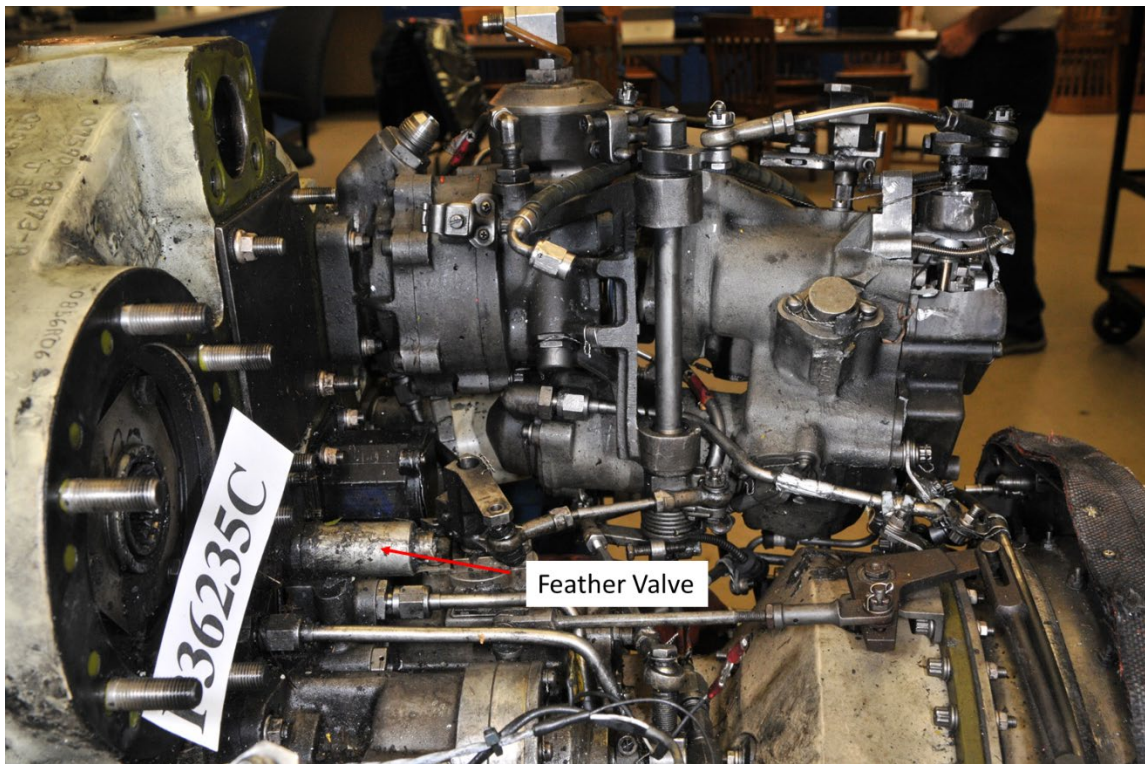
**Photo 44- Feather Valve**

from the AGB mount. The FCU was pulled apart from the fuel pump at the interface flange (**Photo 43**). The FCU housing was fractured at the three fuel pump attachment studs and the attaching bolt was broken. The FCU drive spline appeared to have rust surface discoloration. The propeller feather valve plunger was separated and attached to the linkage arm (**Photo 44**). The propeller governor was intact and when removed it was verified that the check valve orifice was free of obstructions. The starter spline was separated, and the broken spline was recovered from the AGB case. The oil tank exhibited crushing damage and after removal, a small impact penetration and an indent were observed on the aft bottom side of the tank. The FSOV cover was torn open around the input shaft exposing the internal mechanism. The shaft indicator was aligned with the 3 o'clock position, consistent with the manual off position (**Photo 45**).

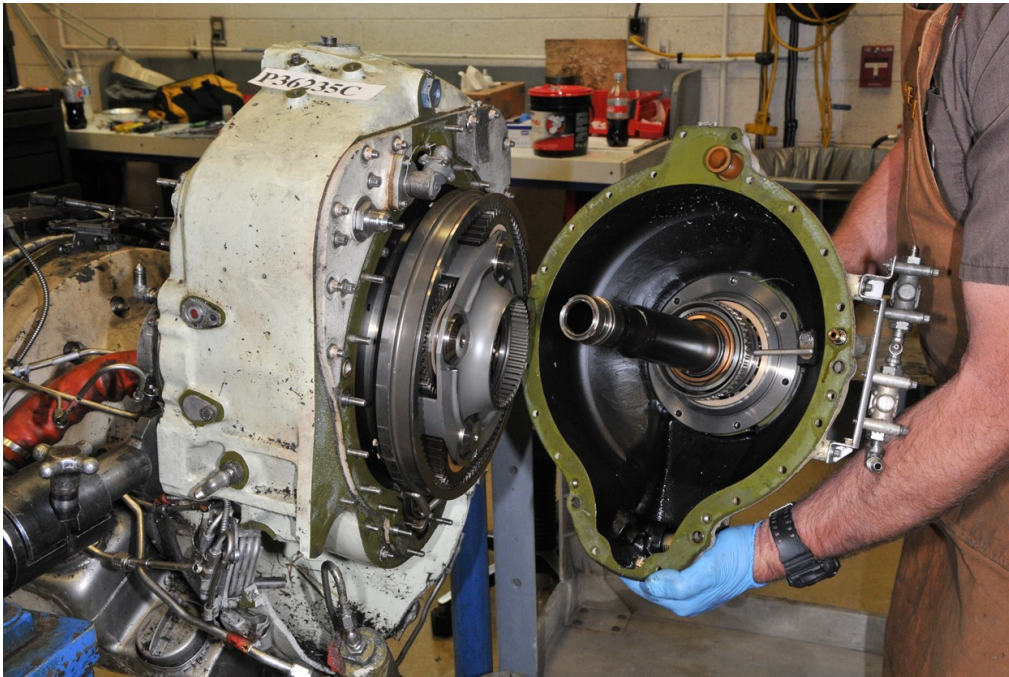
**Photo 47- Nose Cone and Propeller Shaft**

The mechanic notified the group that AGB nose cone attaching bolts felt under torqued. Breakaway torque was checked on a random sample of bolts and all bolts were torqued to less than 10 in-lbs. When the nose cone was removed, the forward propeller thrust bearing, propeller shaft, and propeller coupling were complete (**Photo 47**). The propeller thrust bearing was oil wetted and rotated smoothly. Seven nuts were recovered from the 6 o'clock position of the nose cone. The propeller shaft had 360 degree circumferential scoring at the forward radius and a non-uniform circumferential scoring 5.75 inches from the shaft base that resulted in raised metal (**Photo 48**). The ring gear, sun gear and planetary gears were intact (**Photo 49**). Impact marks and scoring were noted on the aft gear tooth surface of all four planet gears and there were coincident impact marks and scoring on the forward face of the ring gear support (**Photo 50**). Three of the four planetary gears had bearing outer race cracks. One of the four planetary gears rotated with some resistance, the other three rotated smoothly. The sun gear forward inner diameter had 360 degree circumferential scoring (**Photo 51**). The aft propeller thrust bearing was pushed in the aft direction and the snap ring was no longer engaged in the aft side of AGB case (**Photo 52**).

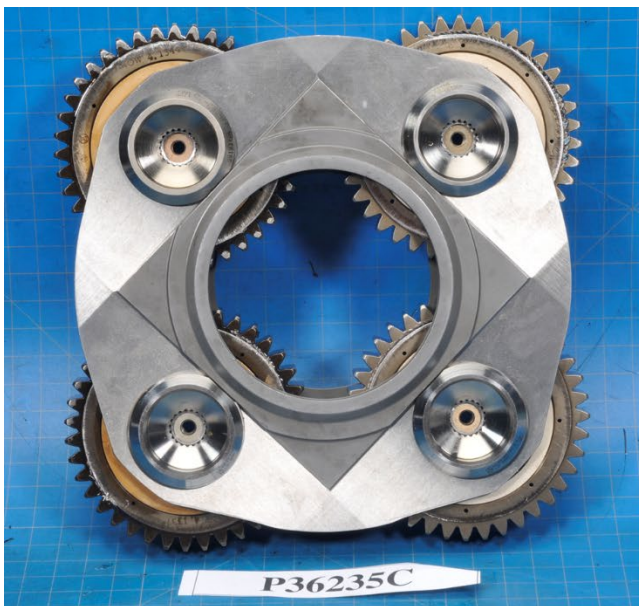
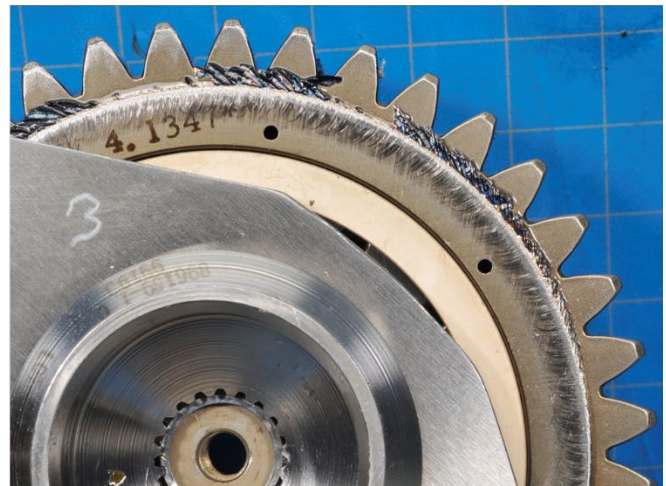
**Photo 50- Planetary Gear Teeth, Aft Face Circumferential Scoring**

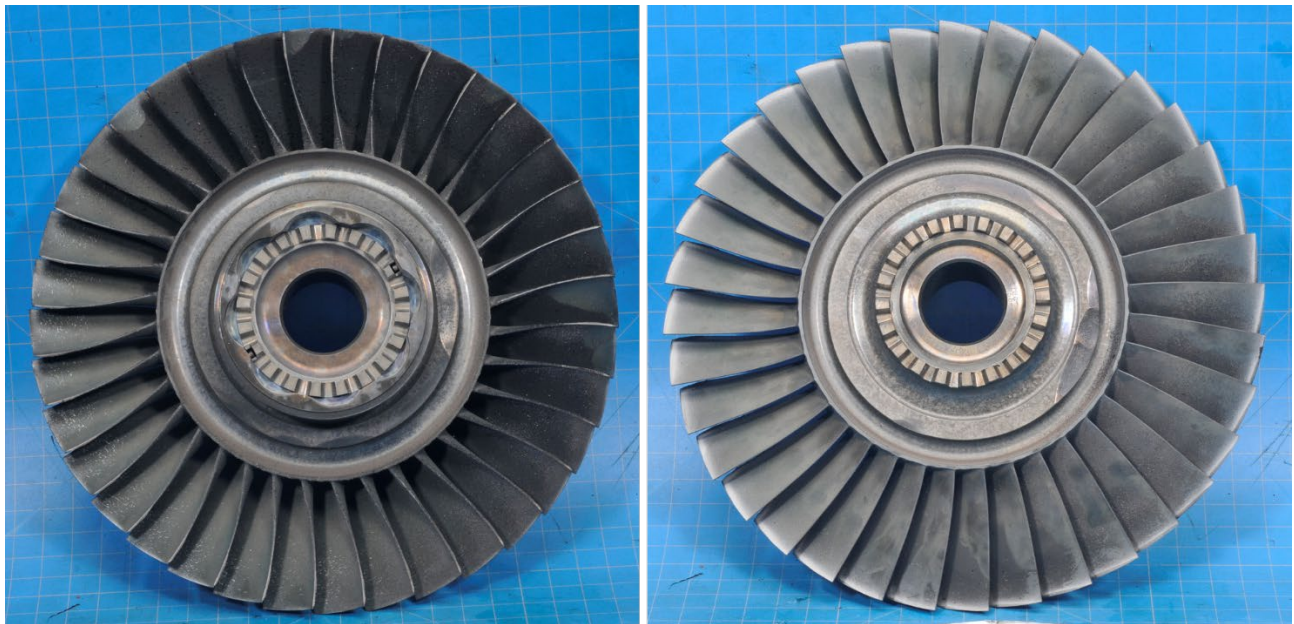
**Photo 56- 3<sup>rd</sup> Stage Turbine Rotor, (L) Leading Edge, (R) Trailing Edge**

The turbine rear frame was intact, and the rear turbine bearing was oil wetted and rotated smoothly. All three stages of turbine rotors and stator vanes were complete (**Photos 56-61**). The blades and vanes in all three stages had light metal spray, black spatter/streaking, and earthen debris adhered to pressure and suction surfaces of all blades. The most significant metal spray and debris coating was noted on the leading edge and pressure side of the 1<sup>st</sup> stage turbine rotor blades. The 1<sup>st</sup> stage shroud had light rub from the 11 to 12 o'clock positions. The curvic couplings between each stage were undamaged and properly mated. The interstage air seals were in good condition.

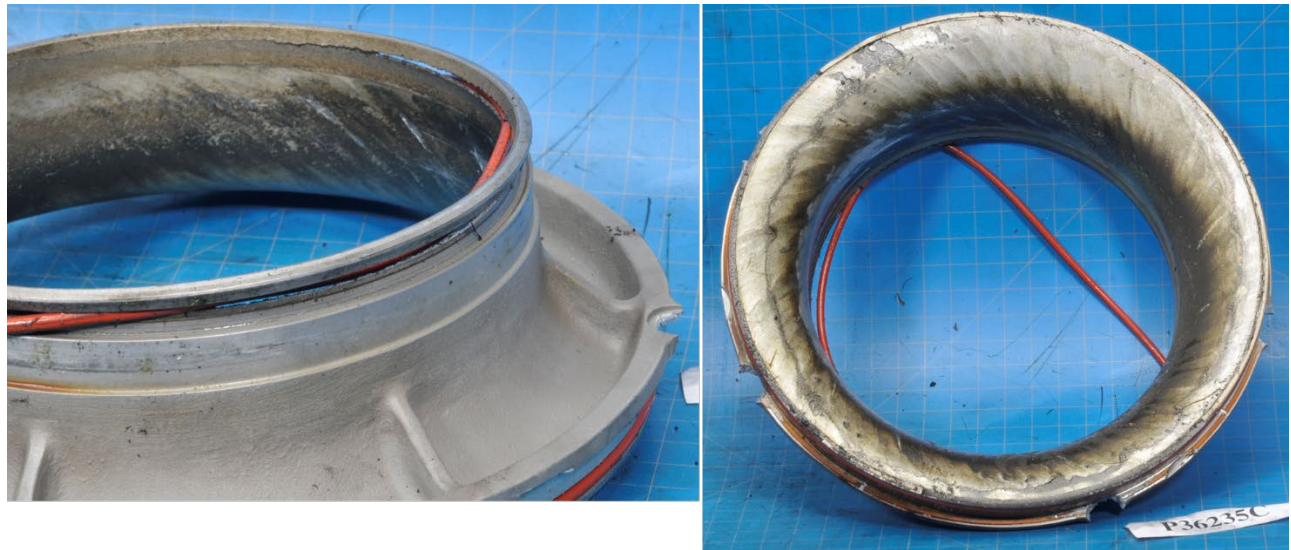
**Photo 66- 1<sup>st</sup> Stage Impeller Shroud**

The 1<sup>st</sup> stage compressor impeller had blade tip rub along the span of all blades (**Photo 65**). The impeller forward hub had 360 degree rotational scoring and the aft hub had light 360 rotational scoring. The 1<sup>st</sup> stage shroud had a crack from the 3 to 12 o'clock positions at the o-ring groove\*. The six impeller shroud mount flange holes were torn, and the flange was separated\*. The 1<sup>st</sup> stage impeller shroud had light 360 rotational scoring at the inducer, 360 degree rotational scoring at the knee, more severe from the 7 to 11 o'clock positions, and 360 degree scoring at the exducer, more severe from the 12 to 5 o'clock positions (**Photo 66**). The crossover duct was in a good condition. There was earthen debris between the 1<sup>st</sup> stage diffuser vanes (**Photo 67**).

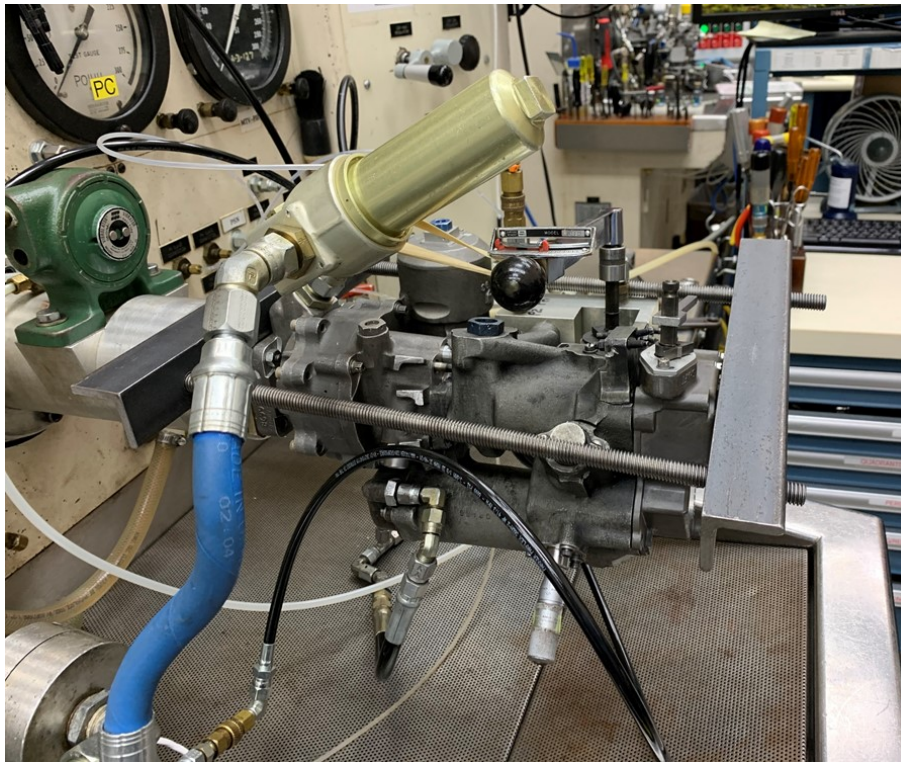
**Photo 71- No. 2 Engine Fuel Control Secured to Test Bench**

The No. 2 engine FCU, P/N 807426, S/N 1706938, and propeller governor, P/N 8210-262, S/N 1806734, were shipped to Woodward in Loves Park, Illinois for examination. A visual examination of the FCU was performed to determine if it was safe to install on a test bench. The FCU air section cover<sup>7</sup> was fractured and missing material. The input mounting flange exhibited impact damage and was missing three of the four flange attaching lugs (ears) (**Photo 70**). The air section cover was replaced with a spare and the FCU was secured/clamped to the test bench with angled metal bar stock and all thread rod (**Photo 71**). The input drive speed on the test bench was slowly increased and there were no audible indications of internal damage. A steady drip leak was observed that appeared to originate from the mounting flange interface. According to Woodward engineering, the leak would not impact the test schedules. The FCU was tested in accordance with Woodward TSP-8963 Revision D. There were no anomalies noted during testing that would have precluded normal FCU operation. Multiple test points were outside of ATP limits but according to Woodward engineering were within the expected range of customer adjustments for a service run unit. The FCU test run sheet is available in the docket as Powerplants- Attachment 4- No. 2 Engine (P36235C) Fuel Control Test Report.

<sup>7</sup> The FCU air section cover must be airtight to perform at altitude. The altitude fuel schedules could not be tested during the component exam, but other fuel schedules were not affected.

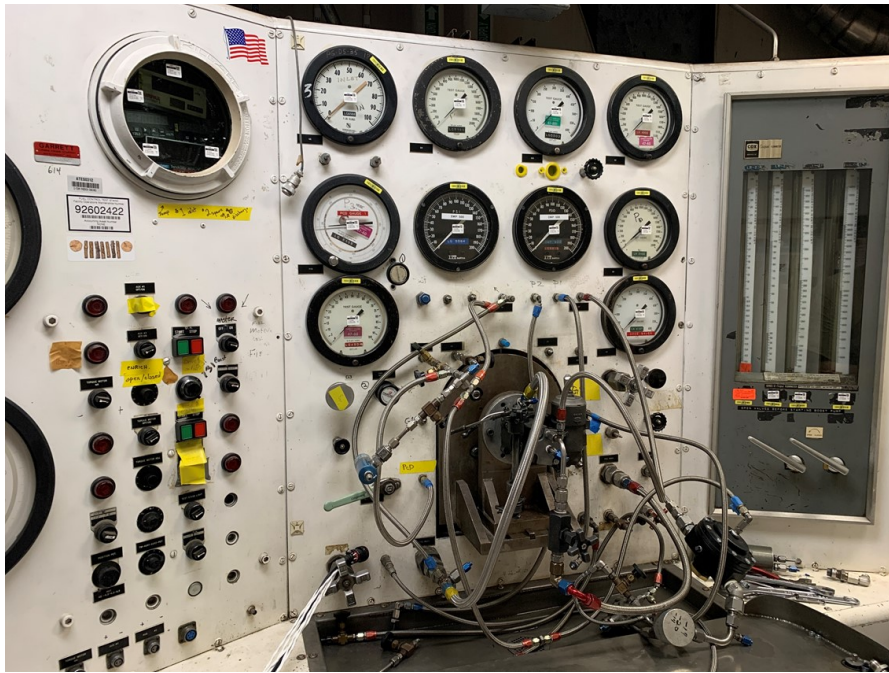
**Photo 72- No. 2 Engine Fuel Pump Installed on Test Bench**

The No. 2 engine fuel pump was hand carried to the Honeywell Engineering Laboratory in Phoenix, Arizona for bench testing. The fuel pump was tested in accordance with the fuel pump ATP procedure, DS-869151-1W (**Photo 72**). All test points met specification. The fuel pump test run sheet is available in the investigation docket as Powerplants- Attachment 6- No. 2 Engine (P36235C) Fuel Pump Test Report.
