**NATIONAL TRANSPORTATION SAFETY BOARD**  
Office of Aviation Safety

**AIRCRAFT EXAMINATION SUMMARY**

**A. ACCIDENT**      **CEN20LA219**

Location:      Beecher, IL  
Date:      June 8, 2020  
Time:      0946 Central Daylight Time (CDT)  
Operator:      Private  
Aircraft:      Flight Design GMBH CTLS  
Registration:      N257V

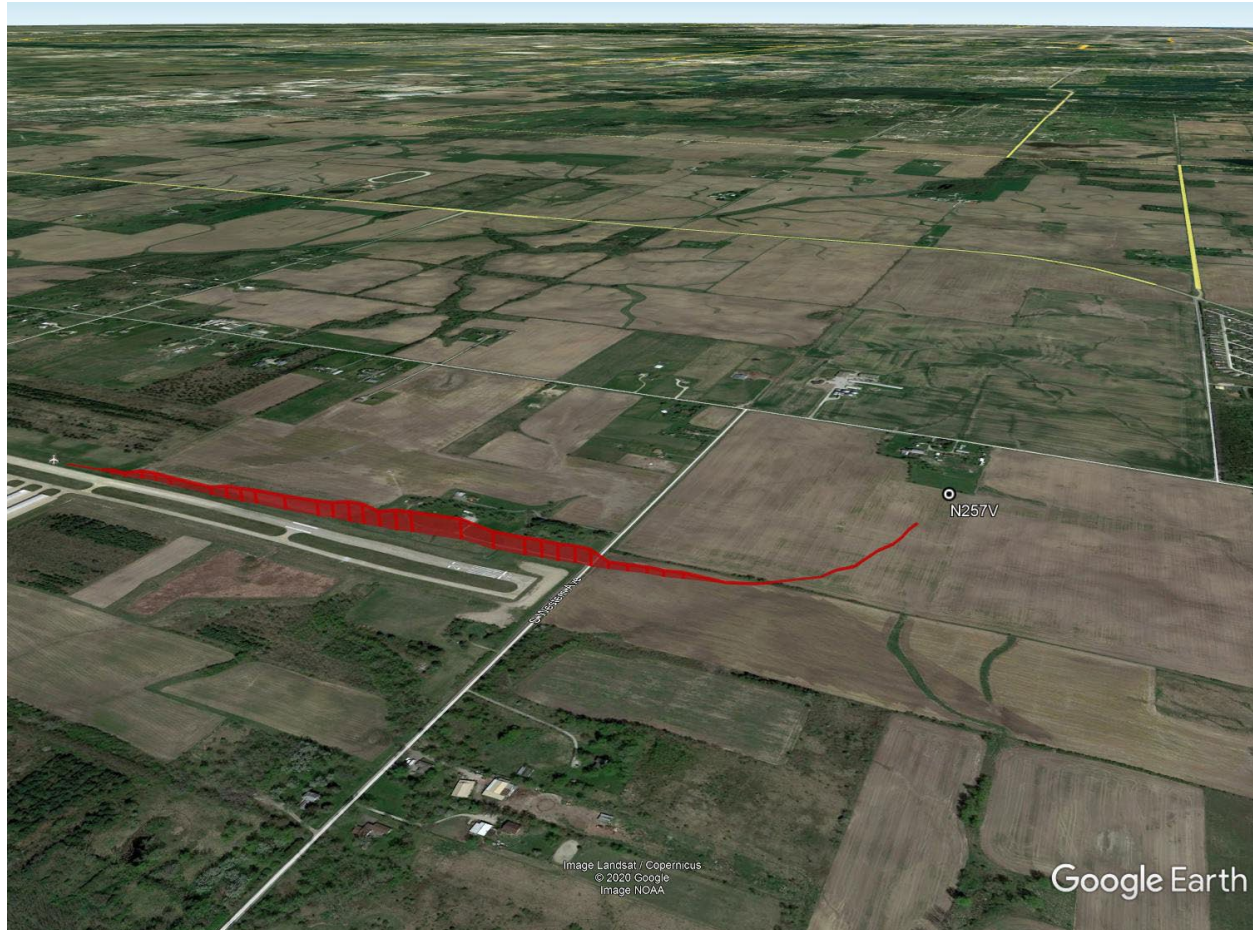
Figure 1 – ADS-B Track

On June 8, 2020, at 0946 central daylight time, a Flight Design GMBH CTLS airplane, N257V was destroyed when it impacted terrain during an apparent forced landing after takeoff from runway 09 at the Bult Field airport (C56), near Beecher, IL. The pilot was fatally injured. The airplane was operated as a Title 14 Code of Federal Regulations Part 91 personal flight.
