**NATIONAL TRANSPORTATION SAFETY BOARD  
Office of Aviation Safety  
Washington, DC 20594**

**SUMMARY OF AIRFRAME AND ENGINE EXAMINATION**

**CEN20LA278**

Aircraft: [Schweizer Grumman G-164B (S/N 522B) N6917K]

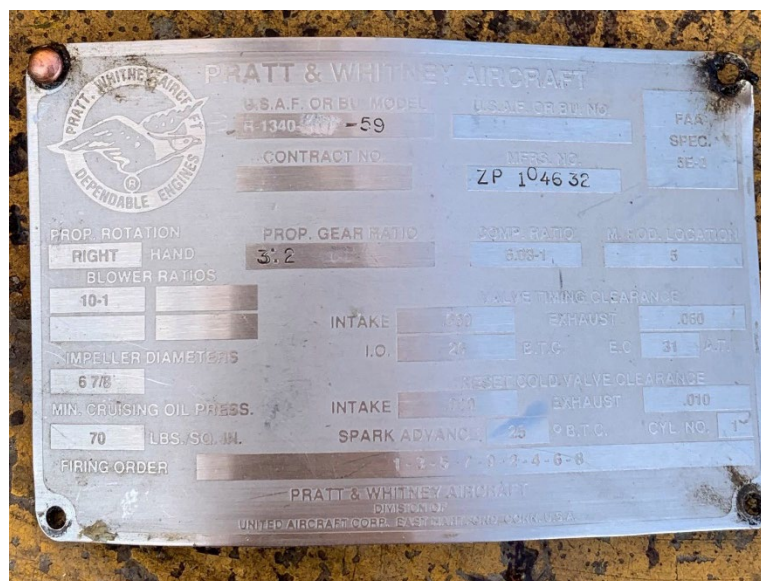
Figure 14, Engine Data Plate

The engine was separated from the airframe at the mounts. It was lifted by forklift and the exterior was photographed. Half of the reduction gear housing was broken out. One fourth of the reduction drive gear was broken out and several of the gear teeth, opposite the gear fracture were mashed and broken. Several of the push rods in the area where the reduction gear housing was broken out, were broken out, and the three cylinders in that area, Cylinders number 4, 5, and 6, and the sump between cylinders 5 and 6, showed impact and fire damage. An attempt to rotate the reduction drive gear was made with no success. The engine data plate was located on the reduction gear housing by the bottom fracture.
