**NATIONAL TRANSPORTATION SAFETY BOARD  
OFFICE OF AVIATION SAFETY  
WASHINGTON, D.C. 20594**

**POWERPLANTS GROUP CHAIR'S FACTUAL REPORT  
NTSB ID: CEN20LA352**

Location: Rockford, Illinois  
Date: August 20, 2020  
Time: 1543 Central Daylight Time  
Aircraft: Raytheon Aircraft Company Super King Air B200, Reg. N198DM

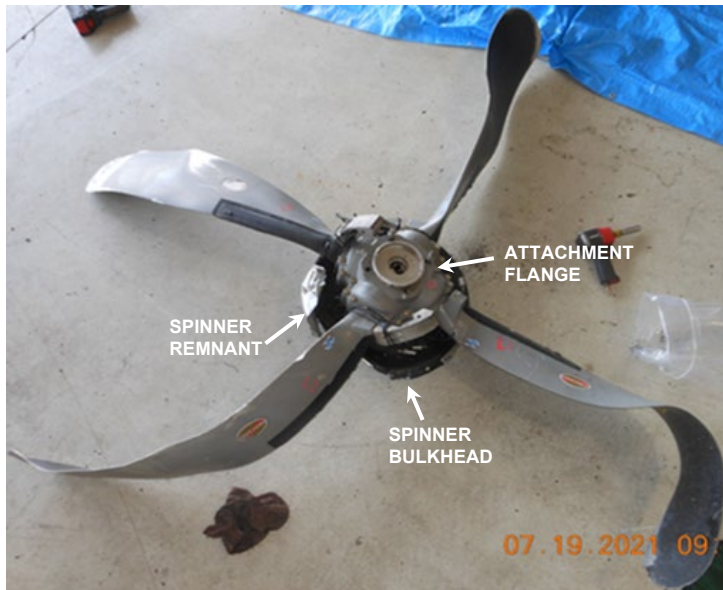
**Figure 1.** Front view of left propeller

The hydraulic unit was separated from the propeller. The blades were all bent aft to varying degrees and all displayed chordwise rotational scoring, predominantly on the camber side. All propeller blades could be partially rotated by hand force. The L1 counterweight was liberated. See Figure 1.

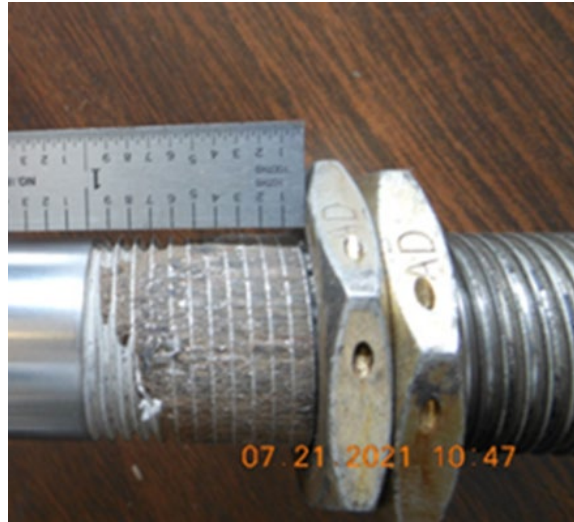
**Figure 4.** Feather stop

The feather stop nuts were positioned 1.63 inches from the pitch change rod end. They were tight and undamaged. Dirt was packed into approximately one inch of threads aft of the feather stop. See Figure 4.

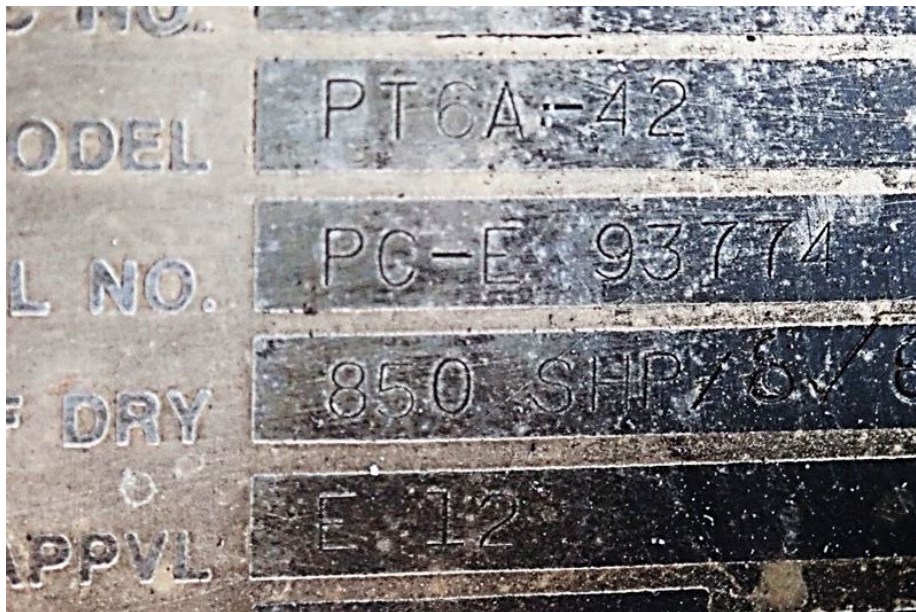
**Figure 12.** ESN 93774 data plate

The engine dataplate identified the engine as ESN 93774. See Figure 12.

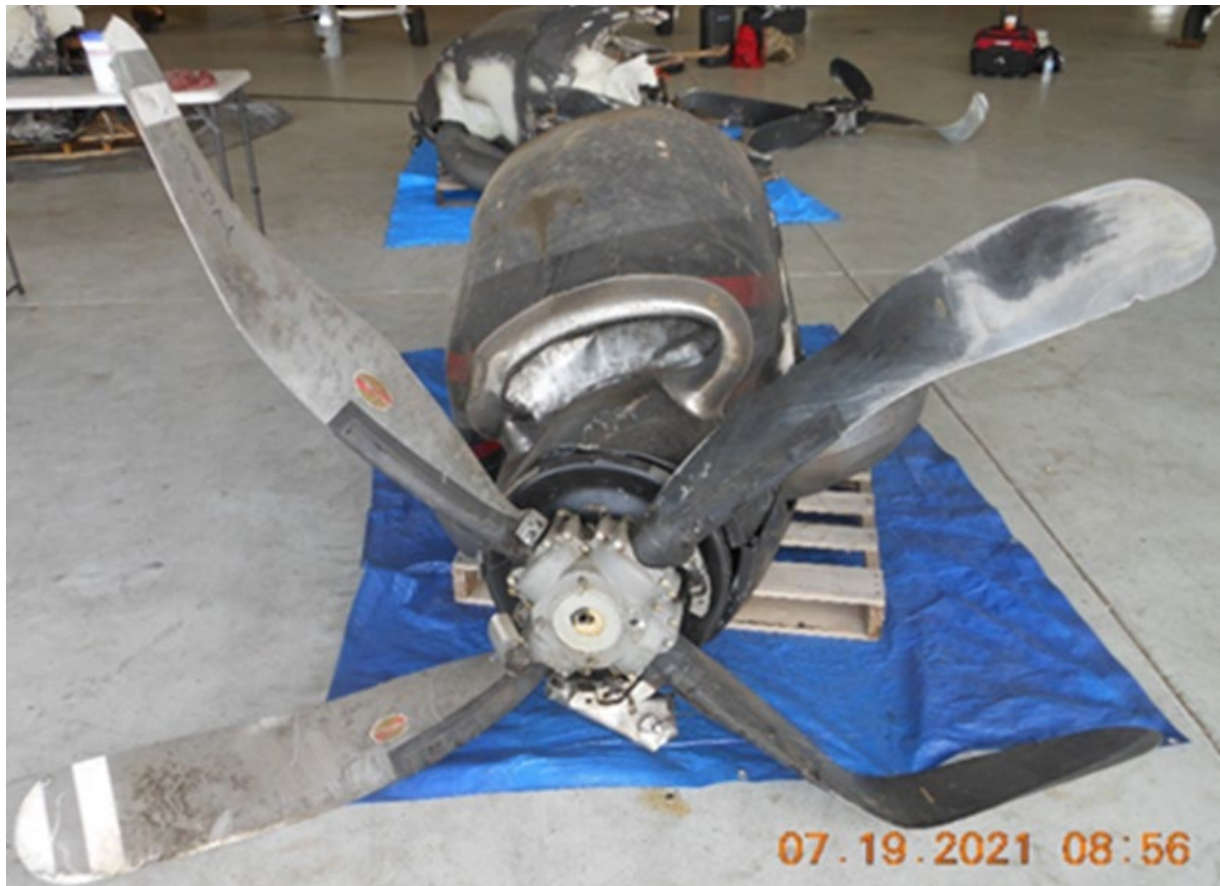
**Figure 24.** Right powerplant

Propeller S/N FY3747 was received attached to the right engine. The propeller attachment hardware was secure and lockwired. The propeller governor and beta linkage was properly attached. See Figures 24 and 25.

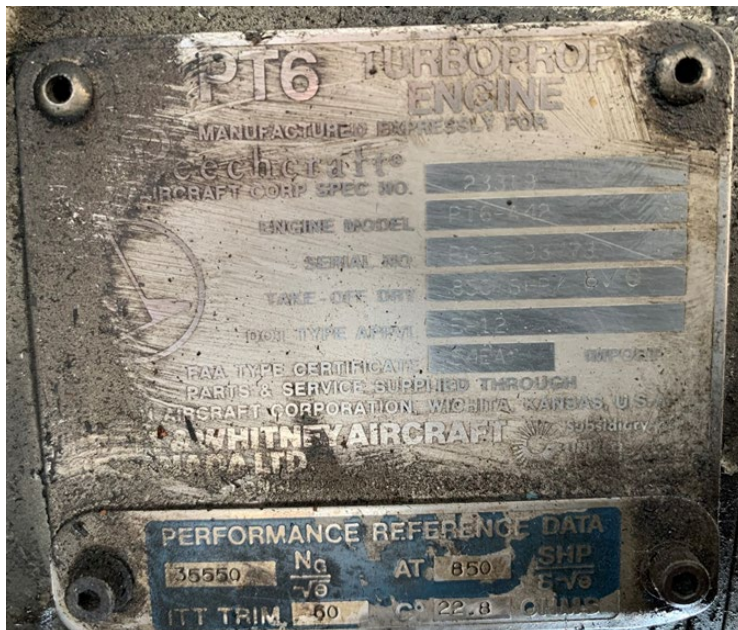
**Figure 33.** ESN 93773 engine data plate

The engine dataplate identified the engine as ESN 93773. See Figure 32.

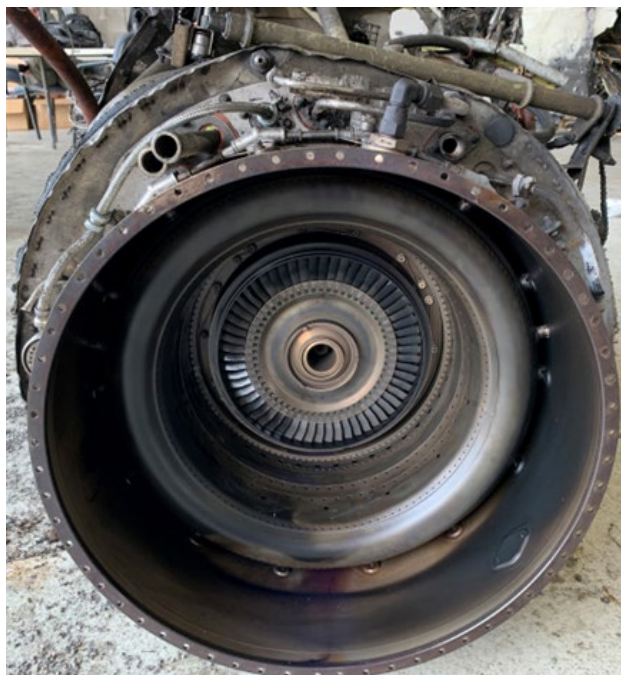
The engine was separated at the C flange. No anomalies were noted to viewable portions of the combustion chamber liner. The small exit duct was not accessed. See Figures 36 and 37.

**Figure 36.** Left engine hot section showing combustor and CT disk assembly downstream face

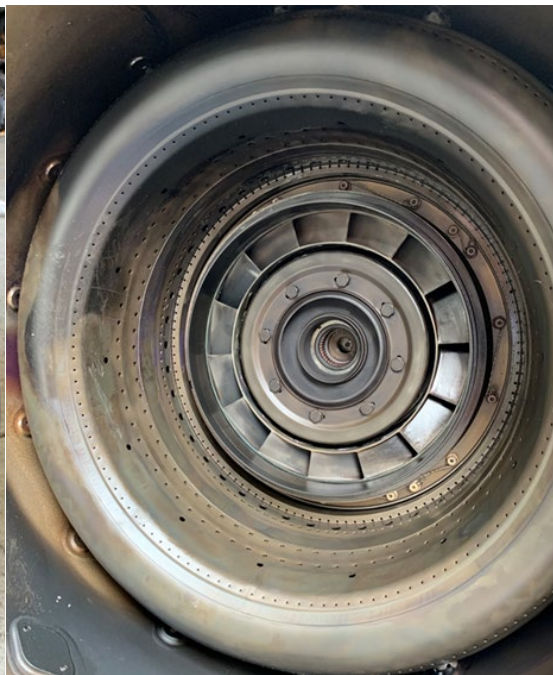
**Figure 37.** CT disk removed, exposing CT vane assembly downstream side

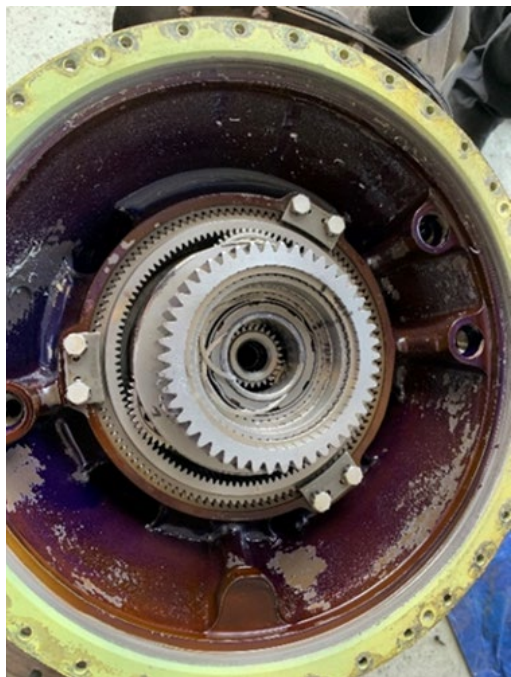
The RGB housings were split to investigate the drive disconnect. The S1 planetary gear assembly turned smoothly when rotated, with no drive train anomalies noted. See Figure 44.

**Figure 44.** S1 planetary gearing showing S1 and S2 sun gears
