**NATIONAL TRANSPORTATION SAFETY BOARD**  
**Office of Aviation Safety**  
**Washington, D.C. 20594**

**POWERPLANT GROUP CHAIRMAN'S FACTUAL REPORT**

**NTSB No: CEN20LA402**

Aircraft: Piper PA-46-310P, N236KM

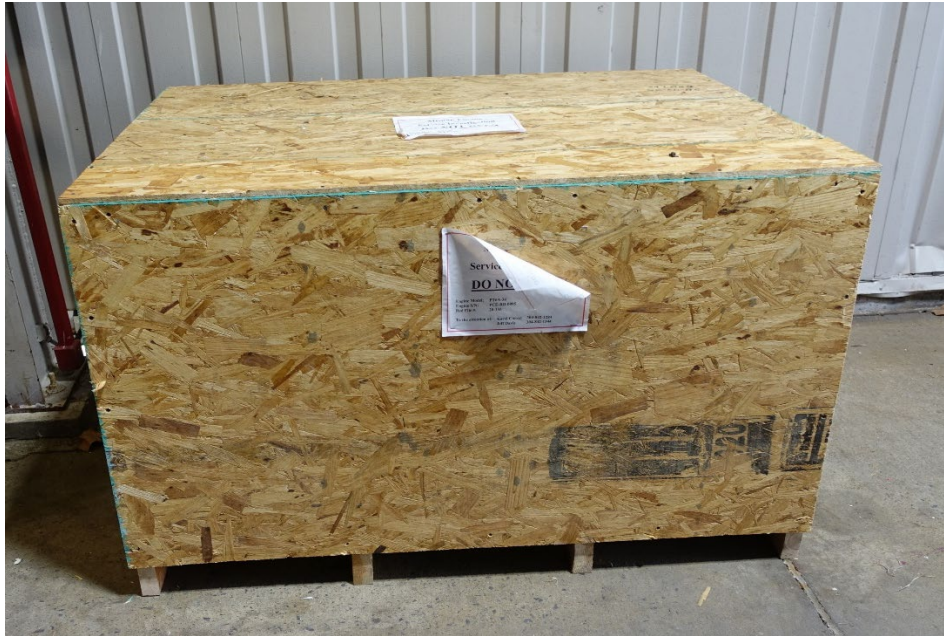
**Photo 1- Engine Shipping Container, as Received at PWC-Bridgeport, WV**

The engine was secured in a shipping container when the team arrived at PWC- Bridgeport (**Photo 1**). Due to the condition of the engine, the teardown was completed on an outdoor concrete pad (**Photos 2, 3, and 4**). The center firewall was deformed around the engine and multiple airframe components including: the starter, alternator, air conditioning compressor, wiring, and parts of the mount structure remained attached to the engine. A cutting wheel and saw were used to remove some of the airframe components so the external engine condition could be documented (**Photo 5**).

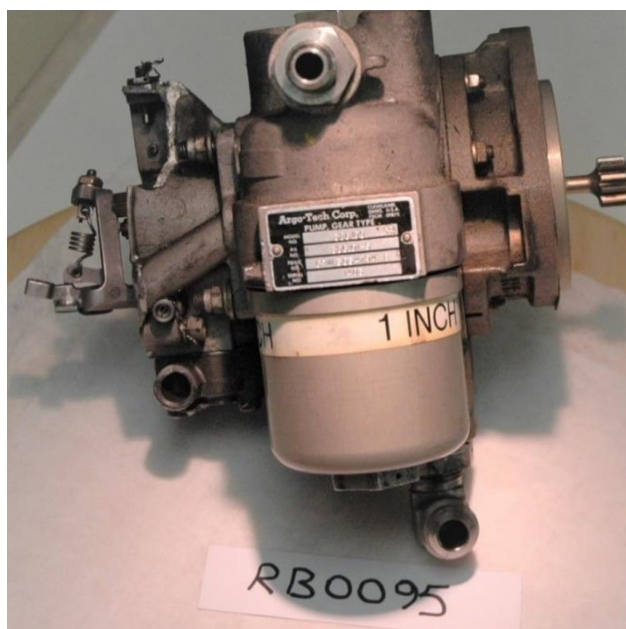
The fuel pump, P/N 3034794, S/N 1403, input driveshaft rotated smoothly after the pump was separated from the FCU. There was no significant debris present in the pump inlet screen. The fuel pump was bench tested in accordance with Eaton component maintenance manual (CMM) 73-10-10 Revision 4 and met test procedure requirements.

**Photo 21- Fuel Pump, as Received at PWC (Photo Courtesy of PWC)**
