Rotech Flight Safety Ltd. 6235 Okanagan Landing Road  
Vernon, BC V1H 1M5 Canada

## **INVESTIGATION REPORT**

| <b>Date of accident:</b> | September 24 2020 | <b>NTSB file number:</b> | CEN20LA417 |

| <b>Aircraft Make:</b> | Quick Silver | <b>Aircraft registration:</b> | N9045Z |

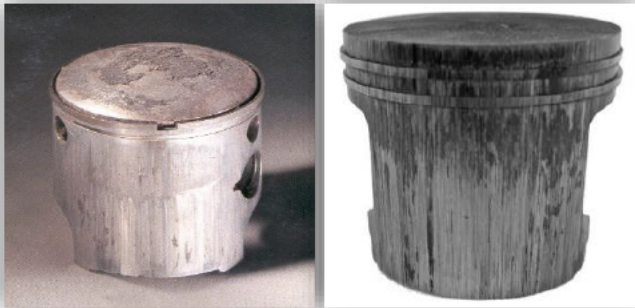
| Description | Example | |
|---|---|--|
| <p><b>Poor fuel-oil ratio:</b> insufficient quantity of oil cause deep scores on the piston and cylinder wall. The piston and cylinder wall will also be dry, dull in colour and absent of an oil film.</p> | | |

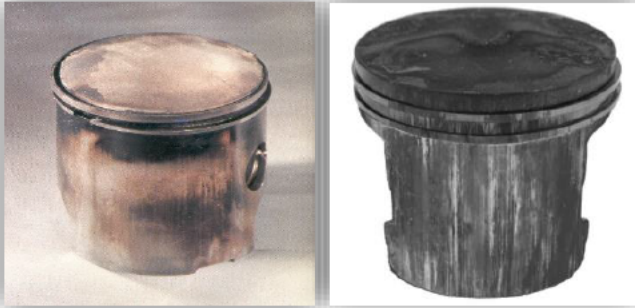
| Description | Example | |
|---|---|--|
| <p><b>Incorrect Oil:</b> Poor oil quality or incorrect oil type does not properly lubricate and causes excessive carbon deposit build up. The piston rings can stick because of oil carbon, allowing gasses to pass the piston and cause exhaust side seizures. The carbon deposit damages the surfaces, reducing proper lubrication.</p> | | |

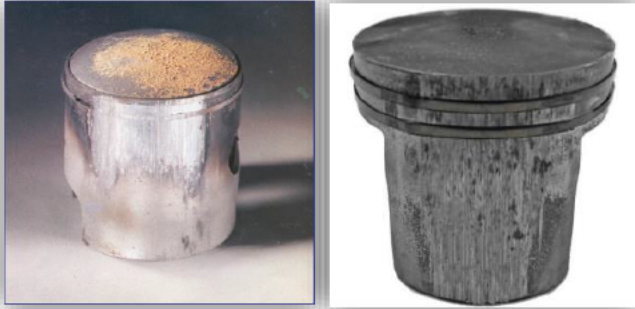
| Description | Example | |
|---|---|--|
| <p><b>Heat Seizure:</b> Incorrect air/fuel ratio can cause insufficient lubrication normally associated with overheating. This can be caused by either lean jetting, incorrect propeller loading, intake or main seal leak. Major piston damage and metal transfer will be observed.</p> | | |

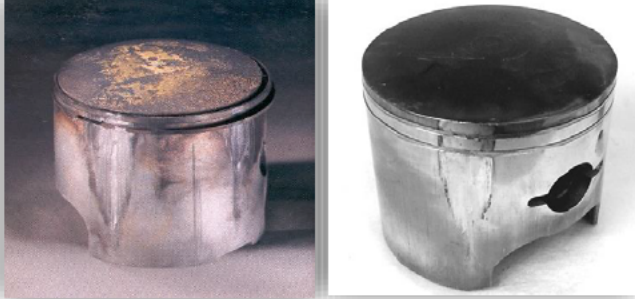
| Description | Example | |
|---|---|--|
| <p><b>Cold Seizure:</b> Thermo-imbalance of pistons and cylinder due to improper warm-up of engine and excessive temperature differences of the intake and exhaust of engine. The result is the piston expands faster than the cylinder wall. This type of damaged can be identified by the scoring and metal transfer on the corners of the piston and intake side of the cylinder wall.</p> | | |
