# National Transportation Safety Board

CEN21FA209

Aircraft Performance Study

Location: Hattiesburg, Mississippi  
Date: May 4, 2021  
Time: 23:05 Central daylight time (CDT)  
04:05 UTC, May 5, 2021  
Airplane: Mitsubishi MU-2B, N322TA

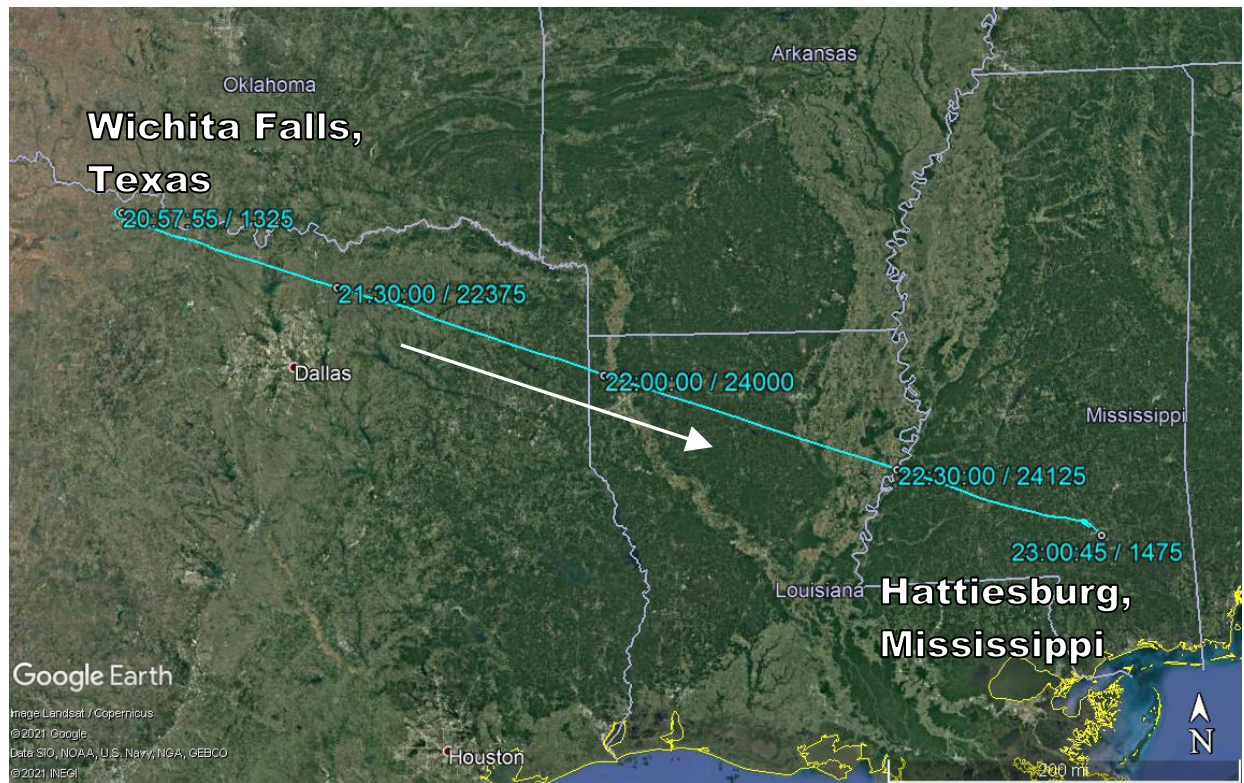
The aircraft took off from Wichita Falls Municipal Airport in Wichita Falls, Texas at about 20:58 CDT (Figure 1). The airplane climbed to about 24,000 ft above mean sea level (msl) (Figure 2). The pilot checked in with Houston Air Route Traffic Control Center (ARTCC) Picayune sector (ZHU27) and requested to descend [1] into Hattiesburg. The airplane was cleared to 2,400 ft and shortly after 22:35, the airplane began its descent. During the descent, the pilot discussed the current weather and

**Figure 1.** Accident flight in blue with select times and altitudes (msl) annotated in blue.

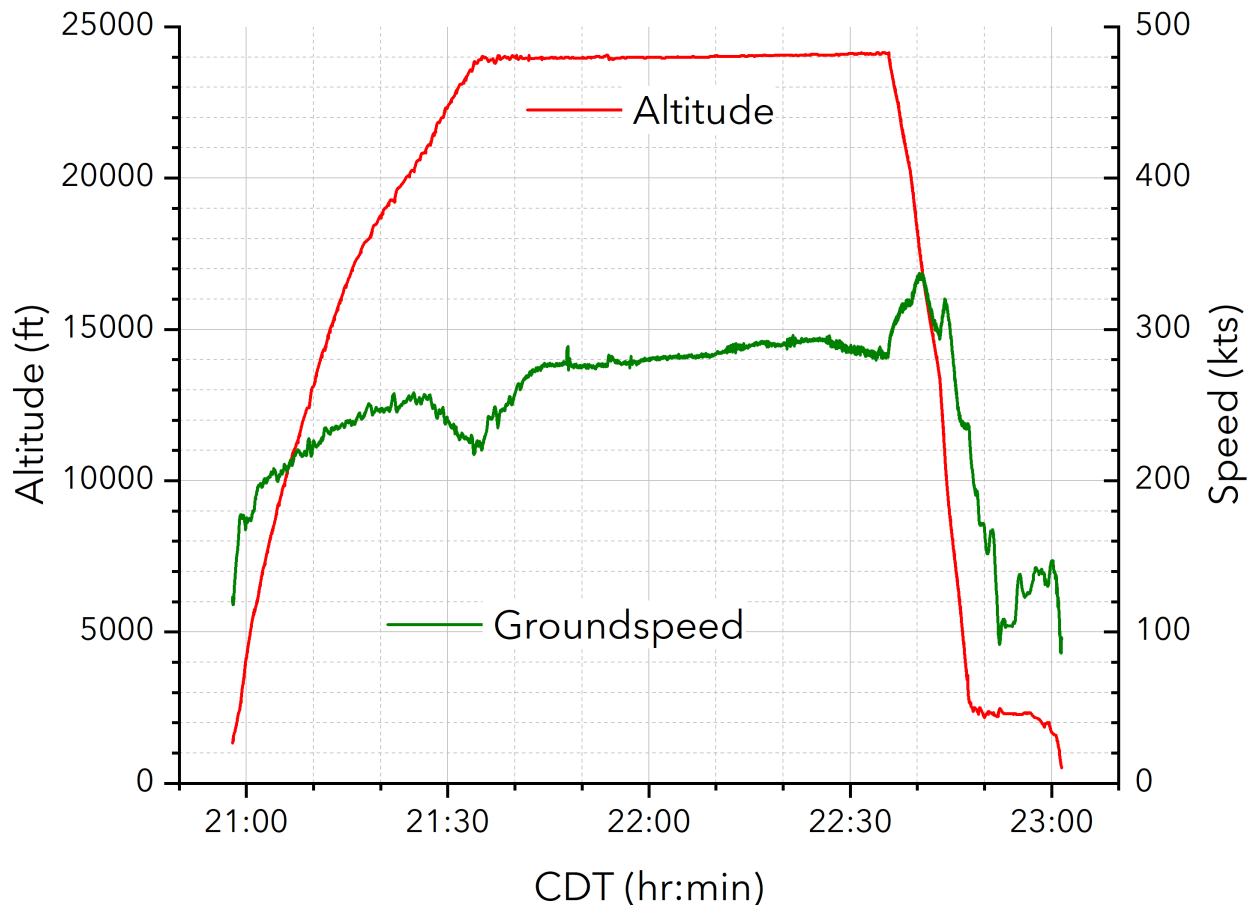
**Figure 2.** Altitude (msl) and calculated groundspeed.
