# National Transportation Safety Board

CEN21FA220

## **WRECKAGE EXAMINATION SUMMARY**

Location: St. Louis, Michigan  
Date: May 17, 2021  
Time: 1308 eastern daylight time  
Airplane: Cessna 182H, Registration No. N2430X

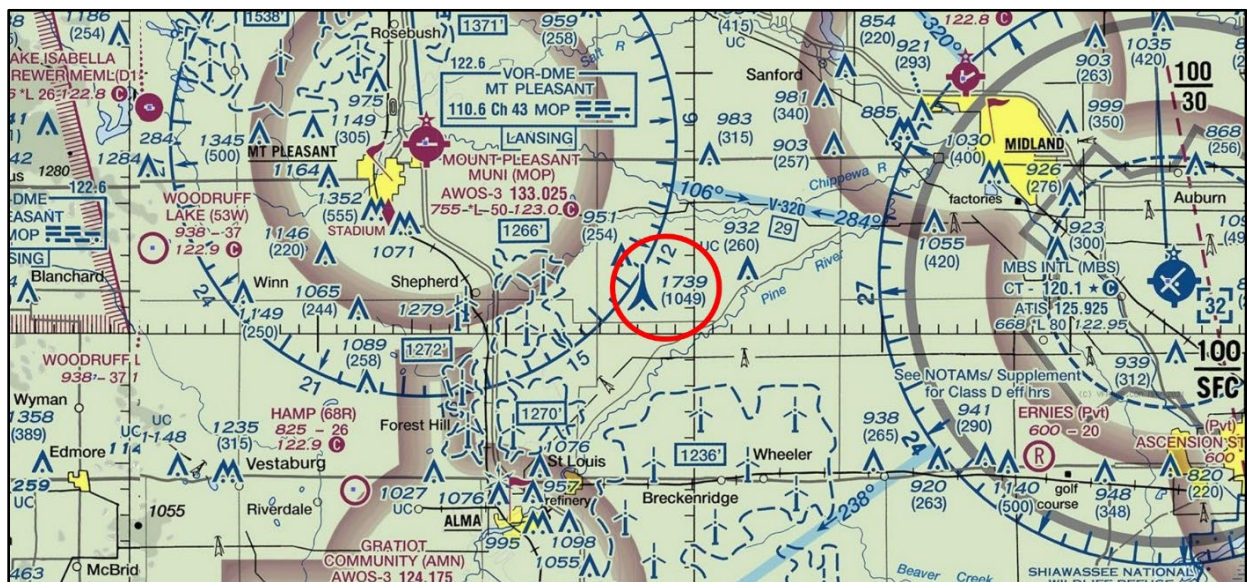
**Figure 2 - Location of Tower on VFR Sectional Chart**

The wreckage debris path began in the vicinity of a 1,049-foot-tall tower, as depicted in figure 1. The tower was identified as Federal Communications Commission (FCC) Tower Registration No. 1007986. The location of the tower is depicted on a visual flight rules (VFR) sectional chart, as shown in figure 2. According to the VFR Sectional Chart, the top of the tower is at 1,739 ft mean sea level (msl). The tower base is at 690 ft msl. The tower design is depicted in figure 3. Photos of the tower are shown in figures 4-5.
