## **NATIONAL TRANSPORTATION SAFETY BOARD**

### **ON SCENE OBSERVATIONS**

**CEN21FA300**

Location: Roff, Oklahoma  
Date: July 2, 2021  
Aircraft: Beech 35-33, Registration N302Z  
NTSB IIC: Samantha Link

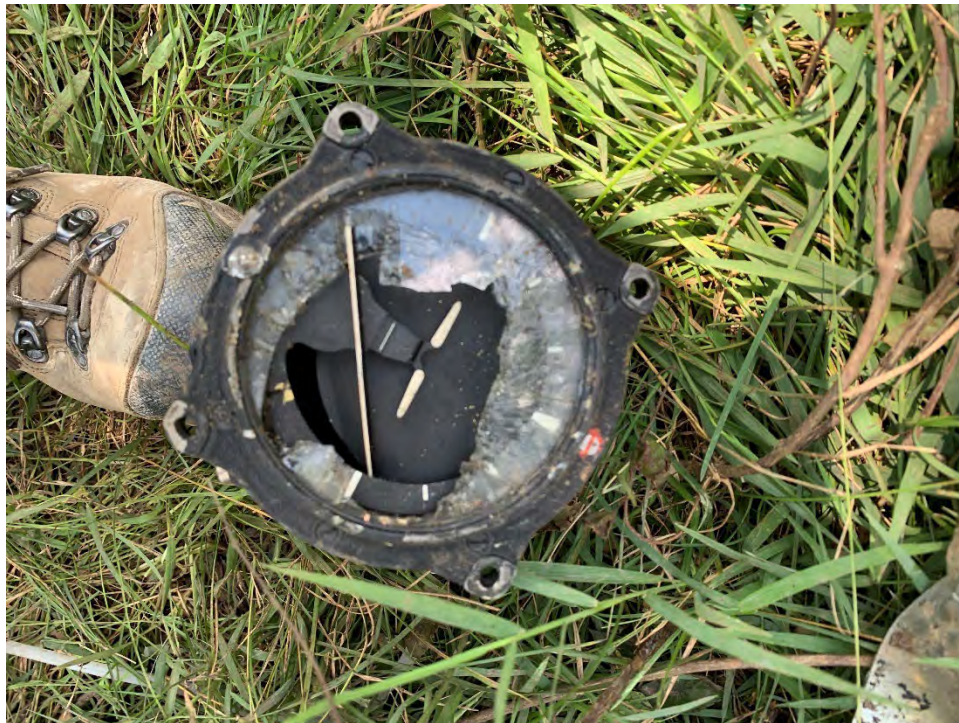
- The instrument panel was heavily fragmented. The recovered instruments and radios exhibited crush damage and were unremarkable.
  - The fuel selector was positioned on the right-wing fuel tank.

Figure 19: Attitude Indicator

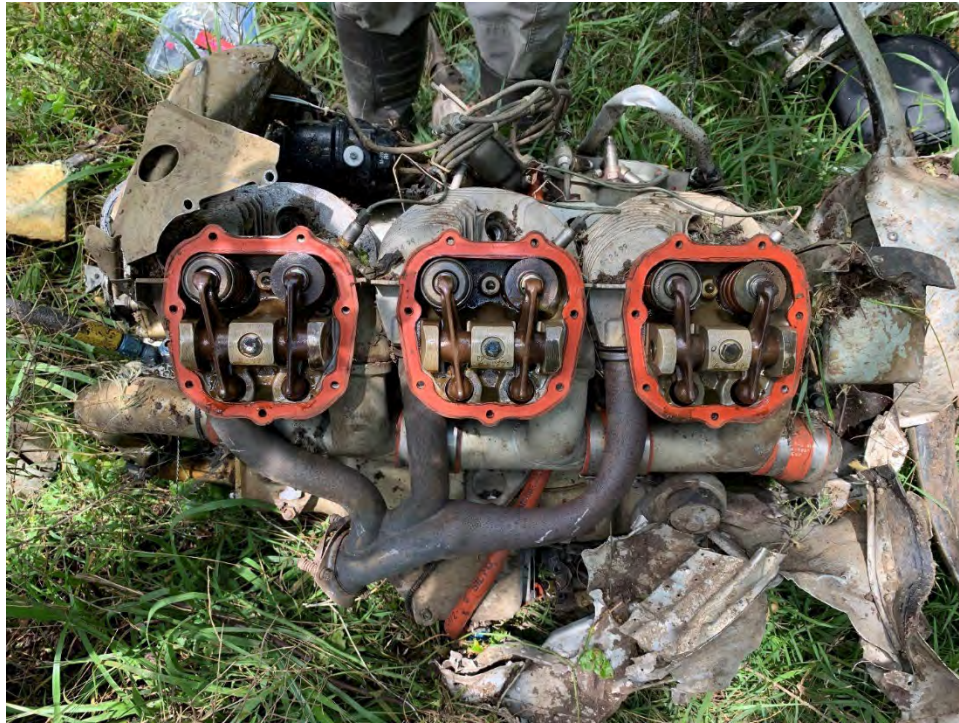
Figure 22: Right Side of Engine
