# National Transportation Safety Board

CEN21FA304

## **MATERIALS LABORATORY**

Factual Report 22-079

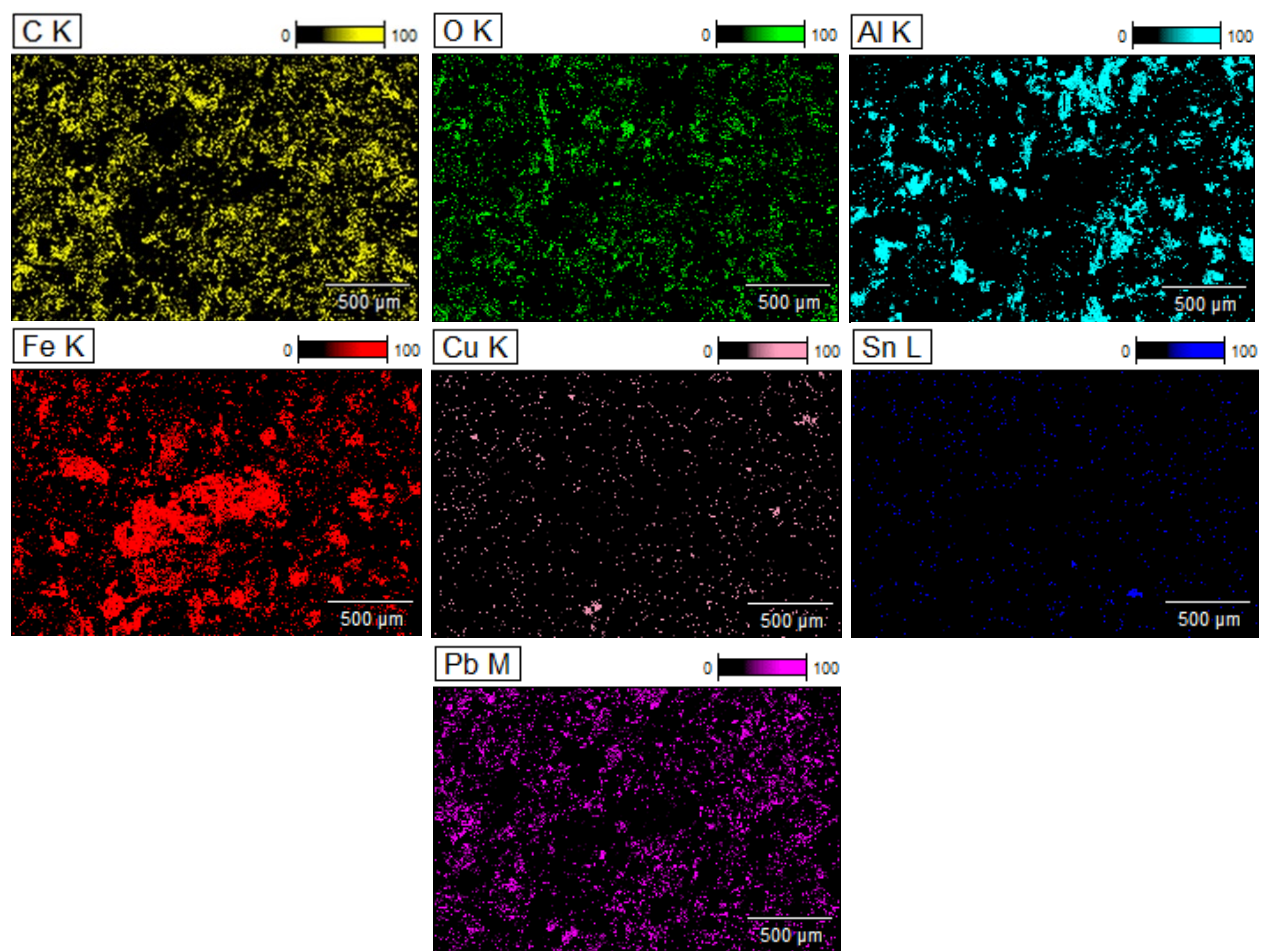
the false colors is shown in Figure 6. Overall, the EDS analysis revealed the following primary elements: C, O, Al, Fe, Cu, and Pb.

**Figure 6.** Images of the micrograph in Figure 5 showing the elements represented by the colors.

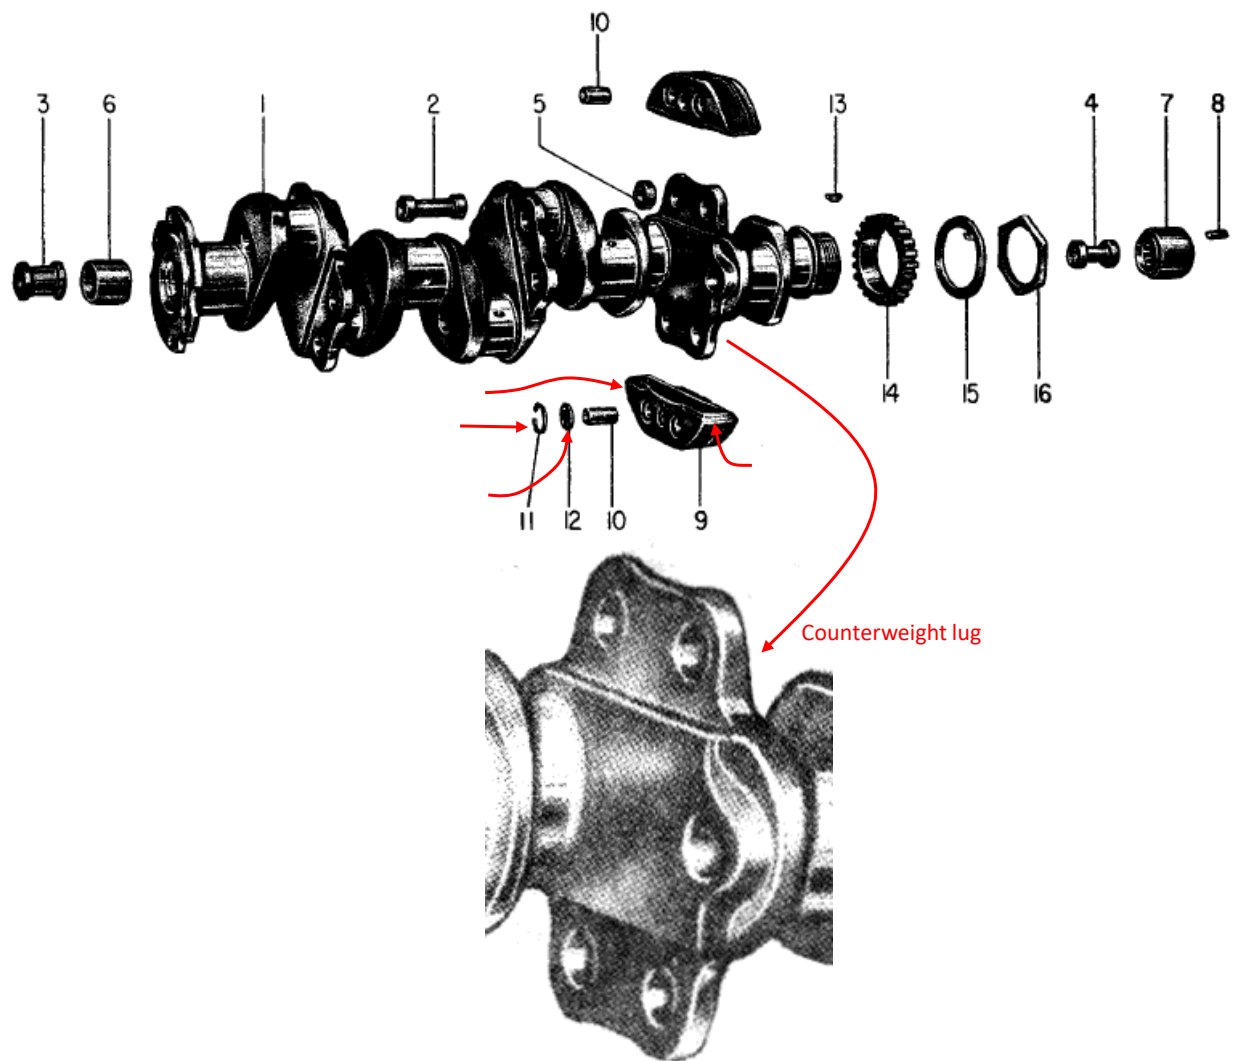
The pieces recovered from inside the crankcase are shown in Figure 12. Descriptions of the pieces and corresponding examination observations are listed in Table 1. Three pieces, shown in Figures 13, 16, and 19 exhibited curved surfaces and case cracking. The composition of the pieces was evaluated using a hand-held x-ray fluorescence spectrometer. All three pieces exhibited minor concentrations of nickel, chromium and molybdenum and major iron concentration (consistent with type 4340 steel alloy used for crankshafts). The case cracking is consistent with nitrided steel (crankshafts are fabricated from nitrided type 4340 steel). The curved surfaces are consistent with the geometrical features of a counterweight lug on the crankshaft (see Figure 22)

| Item | Description | Observations |
|---|---|---|
| 11a,b | Pieces from a crankshaft counterweight lug (Figure 22) | Pieces exhibited deformation and batter. The ends exhibited partial fracture features. 11a exhibited overstress fracture features on both ends and evidence of nitride case cracking on the machined surfaces. 11b exhibited progressive fracture features on both ends and evidence of nitride case cracking on the machined surfaces. Composition consistent with type 4340 steel (via handheld x-ray fluorescence spectrometer). |
| 12 | Piece consistent with a crankshaft counterweight lug (Figure 22) | Piece exhibited deformation and batter. Progressive fracture features are present on both ends and evidence of nitride case cracking on the machined surfaces. Composition consistent with type 4340 steel (via handheld x-ray fluorescence spectrometer). |
| 13 | Unknown, consistent with the web between the two halves of the counterweight (Figure 22) | Pieces exhibited deformation and batter. Composition consistent with type 4140 steel (via handheld x-ray fluorescence spectrometer). |

**Figure 22.** Images from the Lycoming Aircraft Engines Parts Catalog for GSO-480 and IGSO-480 Series Aircraft Engines with key components indicated.
