# National Transportation Safety Board

CEN21FA304

## **WRECKAGE EXAMINATION SUMMARY**

Location: Killeen, Texas  
Date: July 4, 2021  
Time: 1722 central daylight time (2222 UTC)  
Airplane: Focke-Wulf FWP-149D, Registration No. N9145

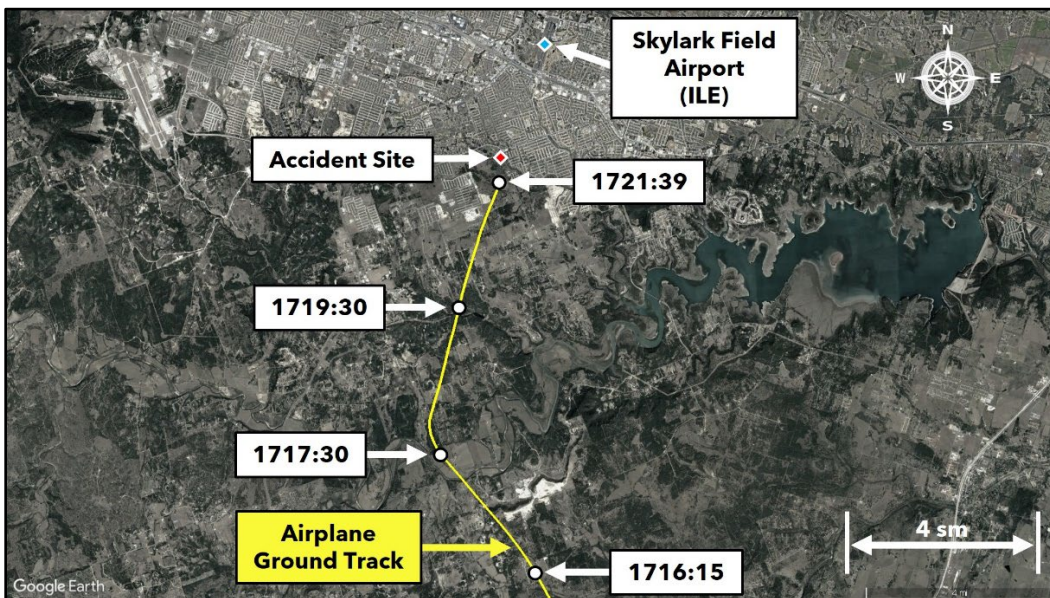
**Figure 3** - Airplane's ground track, intended destination, and accident location

The main wreckage was located about 2.2 miles south-southwest of the runway 1 displaced threshold at Skylark Field Airport (ILE), Killeen, Texas, as shown in figure 3, and about 0.5 mile north of the final ADS-B track point, as shown in figure 4.
