# NATIONAL TRANSPORTATION SAFETY BOARD

## MATERIALS LABORATORY FACTUAL REPORT

Report No. 21-054

Place : Seiling, Oklahoma  
Date : 07/12/2021  
Vehicle : WSK PZL Mielec M-18A Dromader (N9310R)  
NTSB No. : CEN21FA314  
Investigator : Tim Sorenson

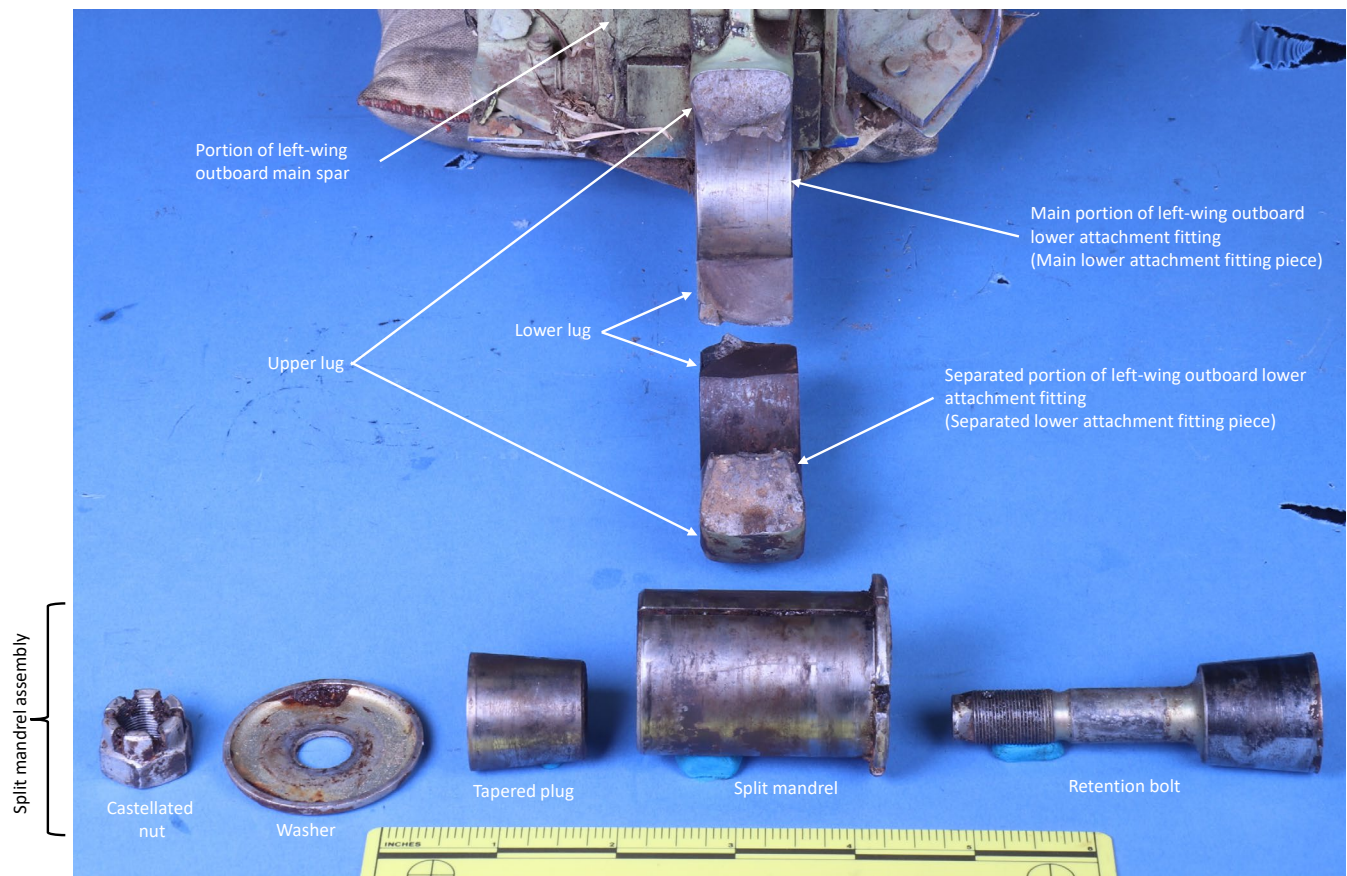
Figure 1 Close view of the as-received evidence with the name of key components annotated in the image.

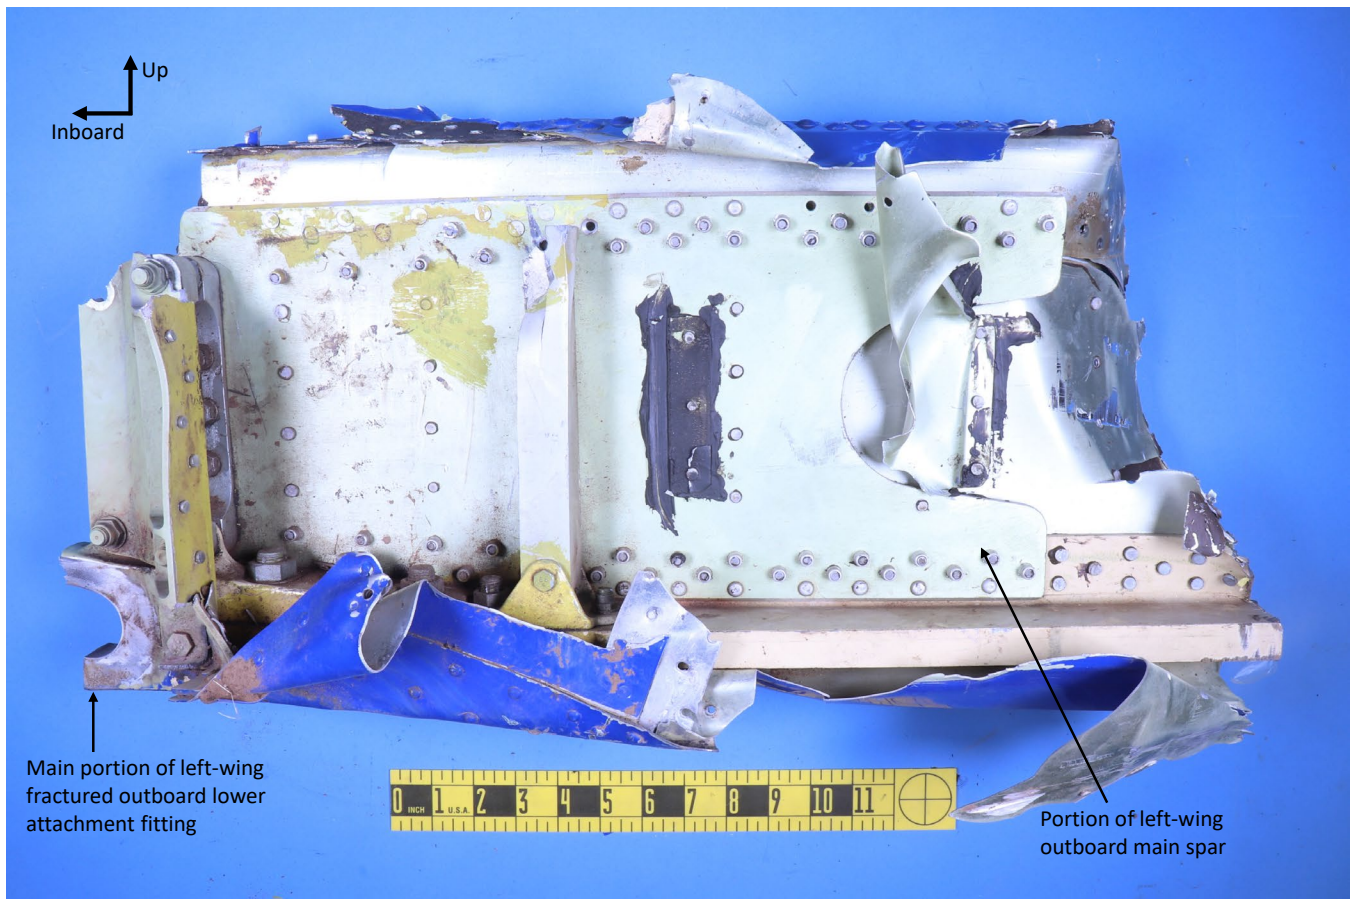
Figure 2 View of the forward-facing side of the as-received outboard left-wing main spar piece with fractured main lower attachment fitting piece.

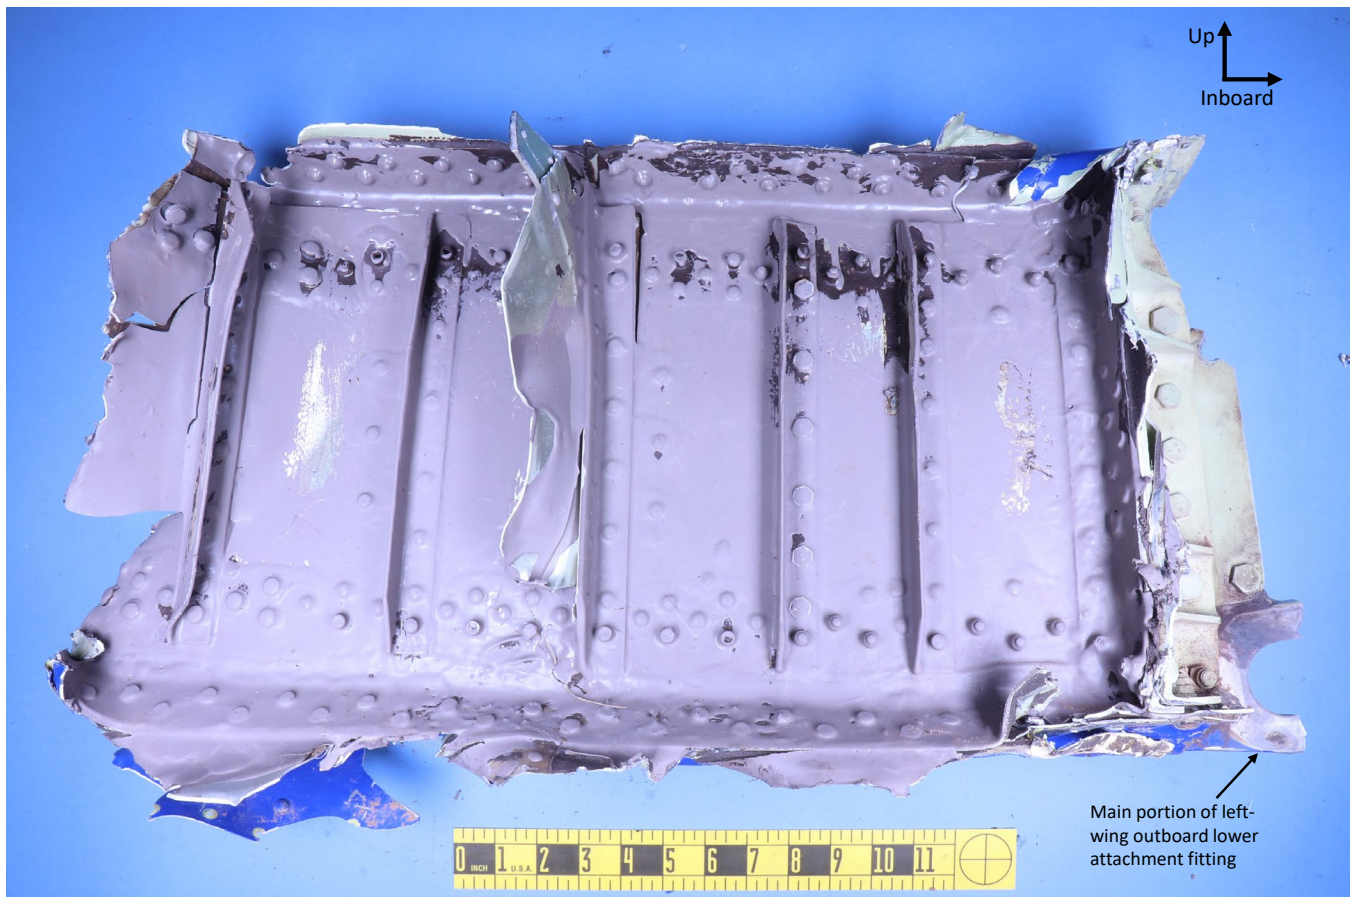
Figure 3 View of the aft-facing side of the as-received outboard left-wing main spar piece with fractured main lower attachment fitting piece.

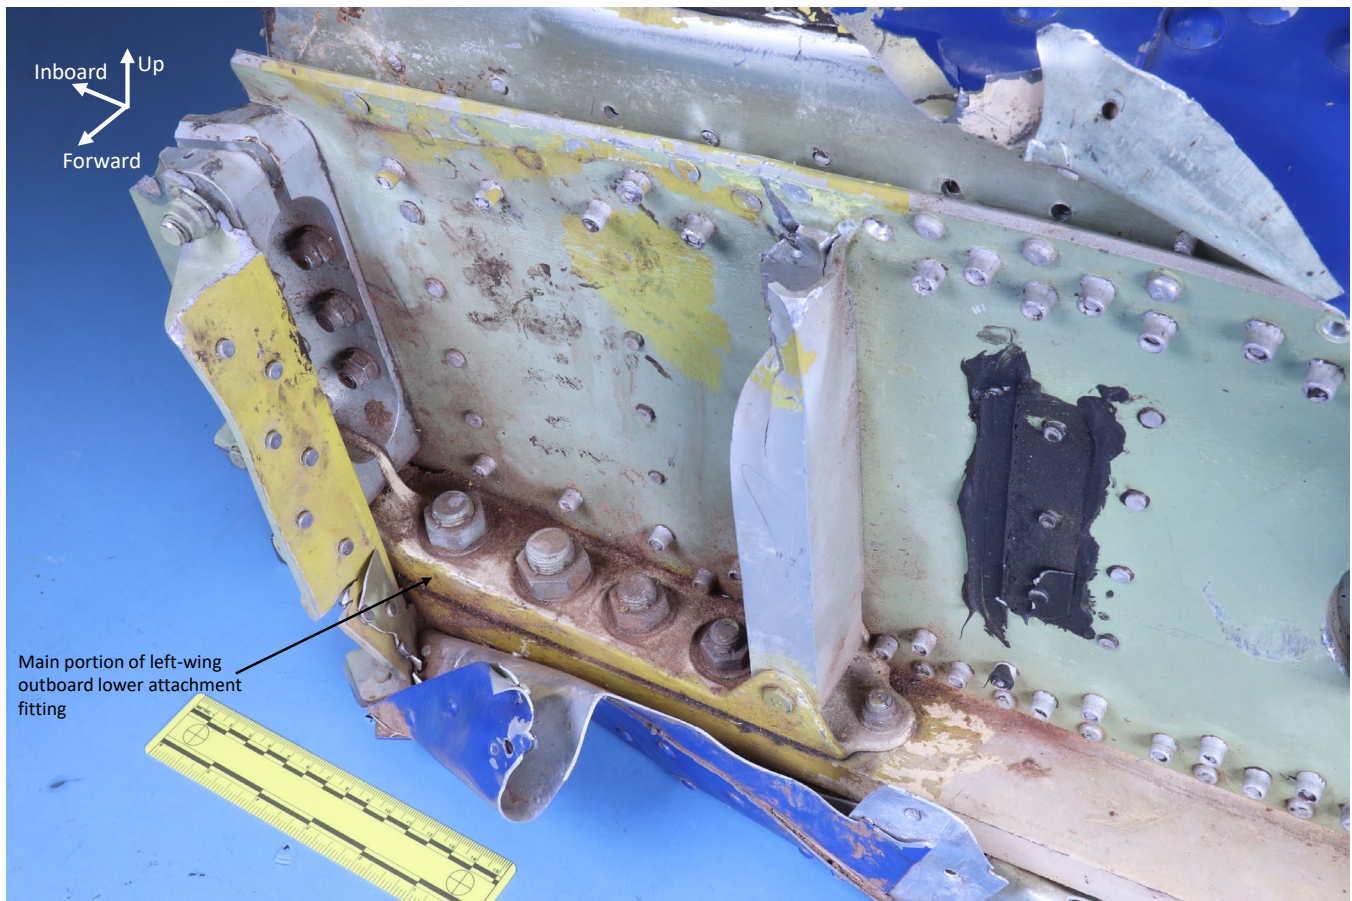
Figure 6 Oblique view of the as-received left-wing spar piece with the outboard main lower attachment fitting piece as installed.

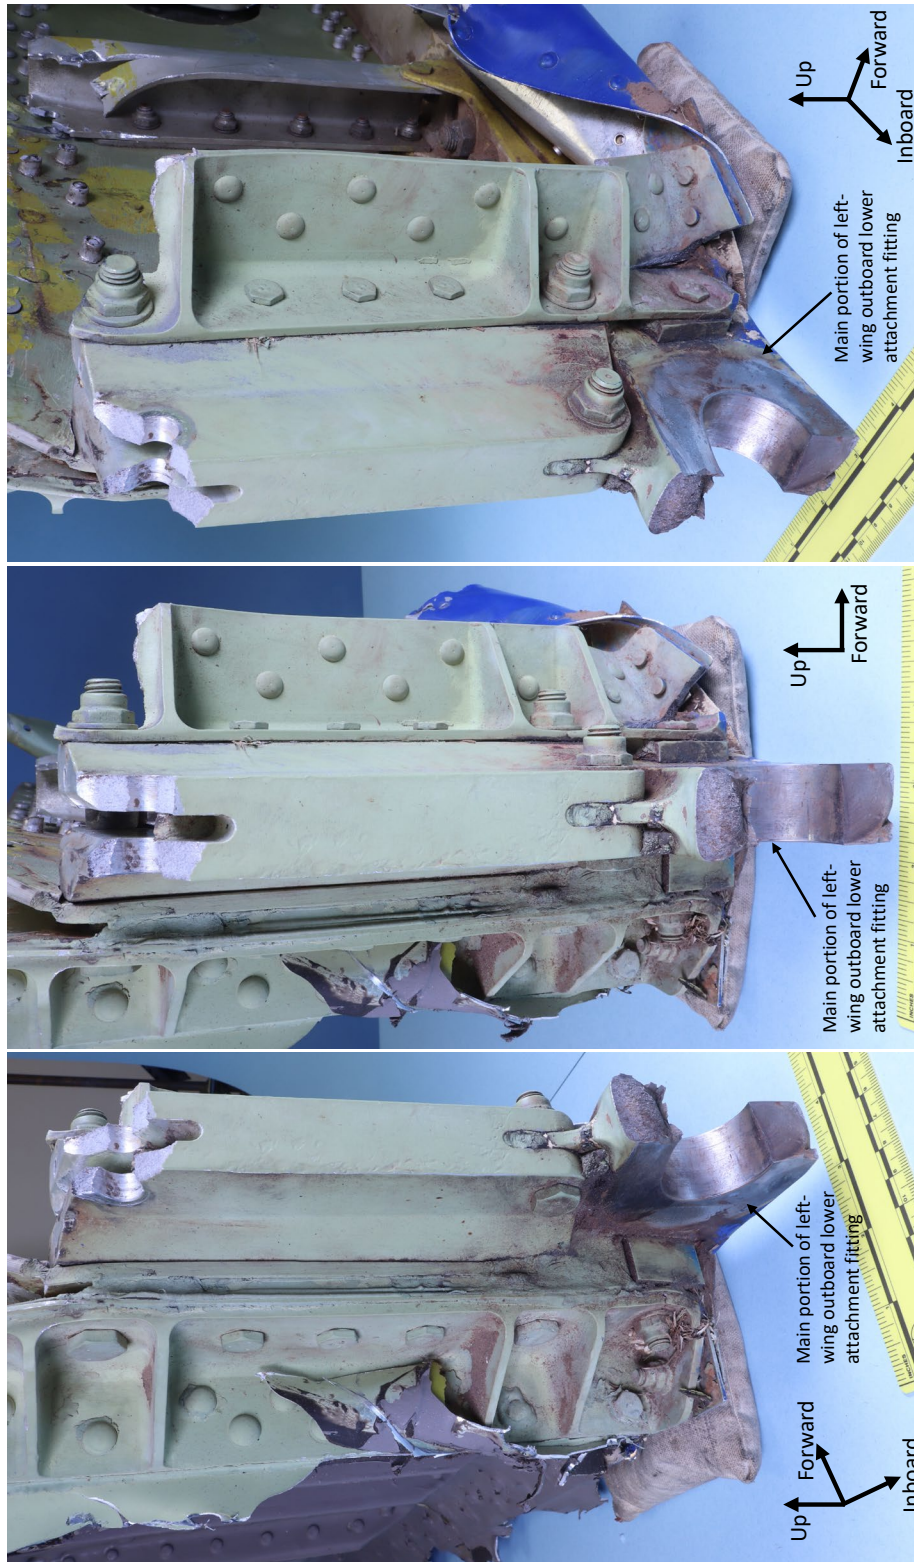
Figure 7 Images of inboard face of the as-received spar piece with the fractured end of the main lower attachment fitting piece.

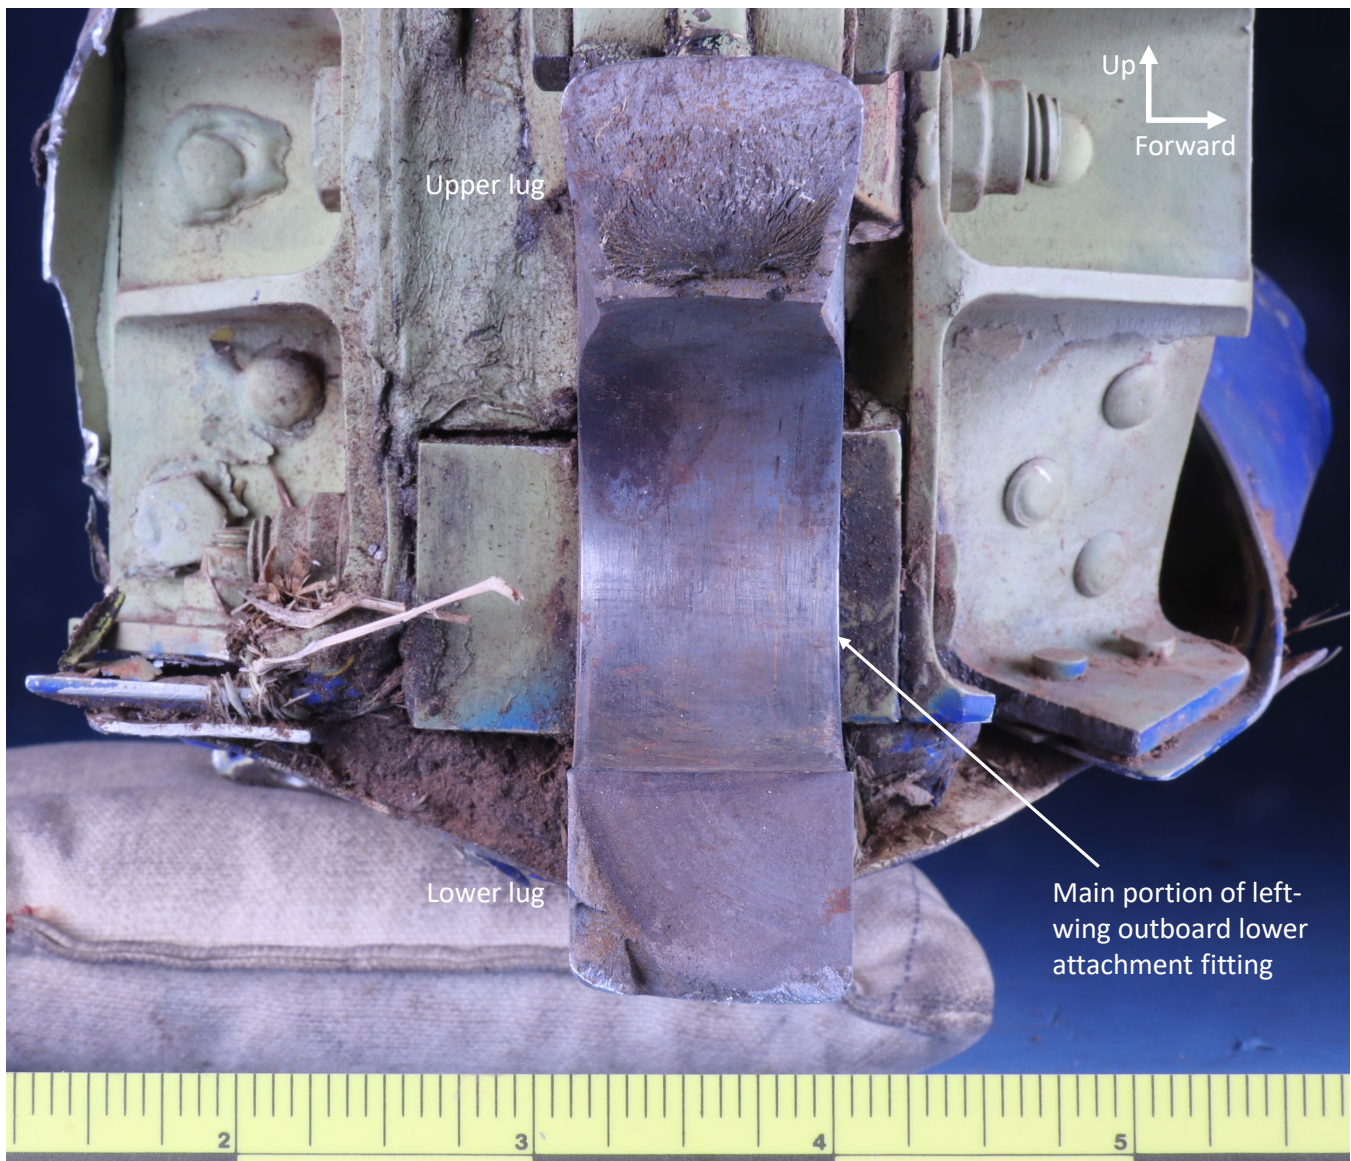
Figure 8 Closer view of the as-received left spar piece and the fractured end of the lower attachment fitting. The upper and lower lug fracture surfaces are identified.

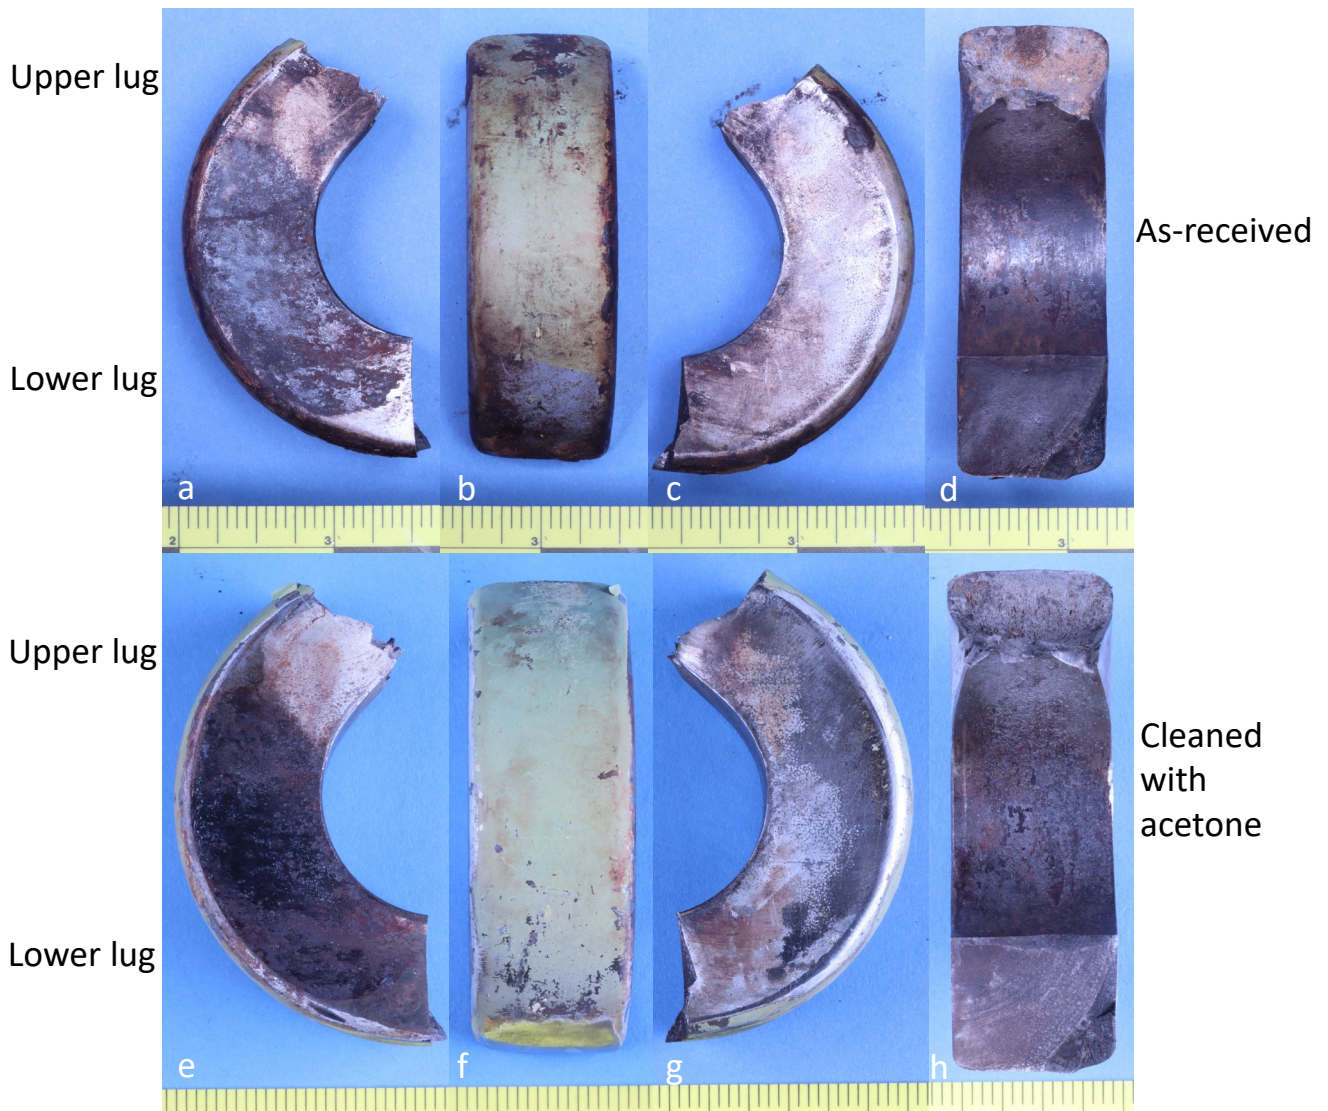
Figure 9 Views of the separated piece of the lower attachment fitting. The upper and lower fracture surfaces are identified.

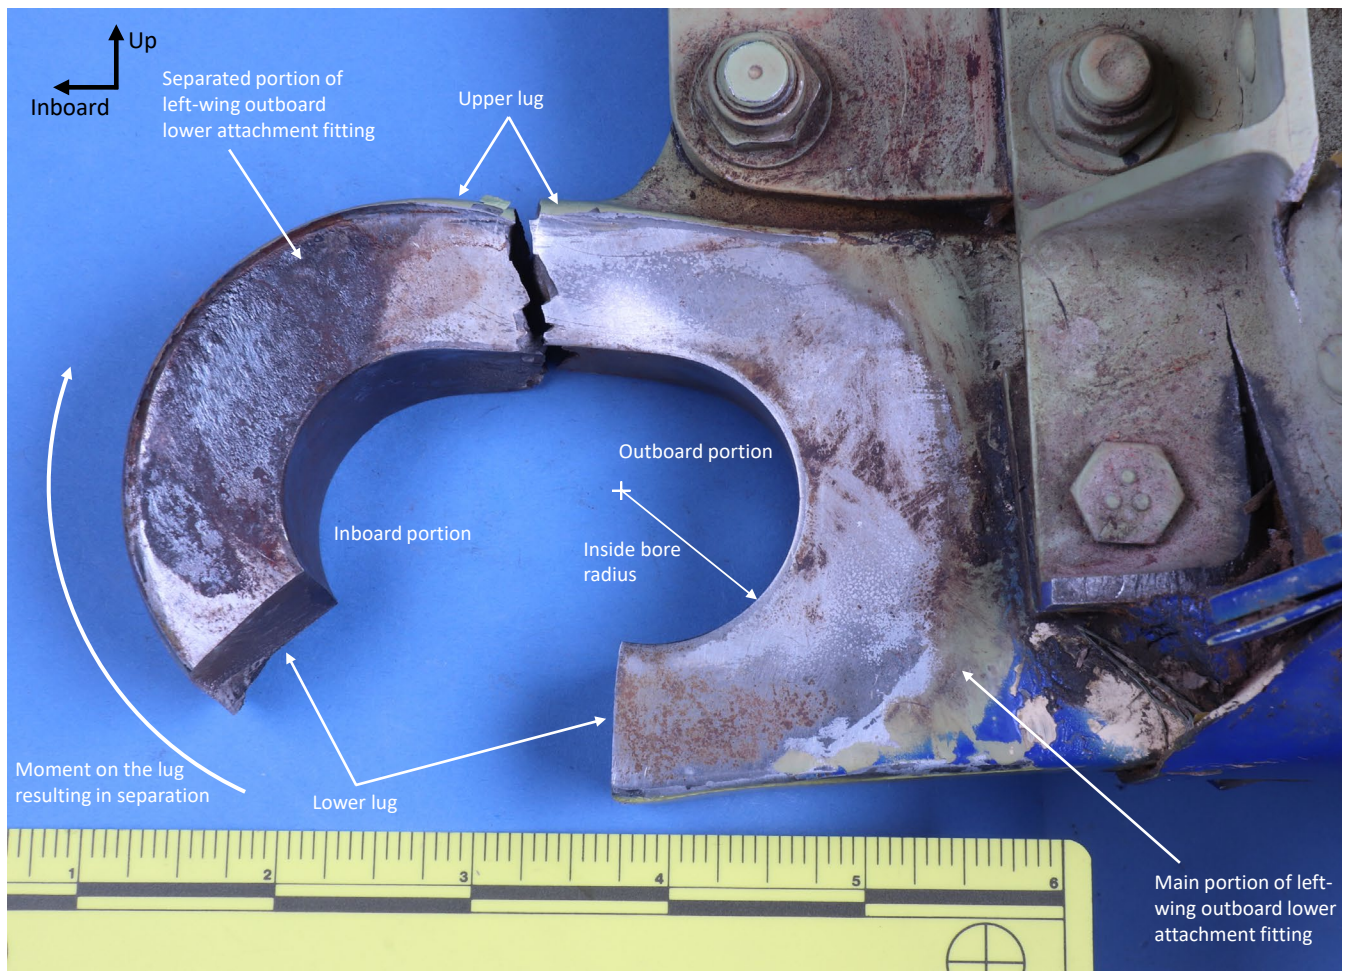
Figure 10 Close side view of the as-received fractured end of the lower attachment fitting with the separated piece of the fitting placed in the approximate location at the point of separation.

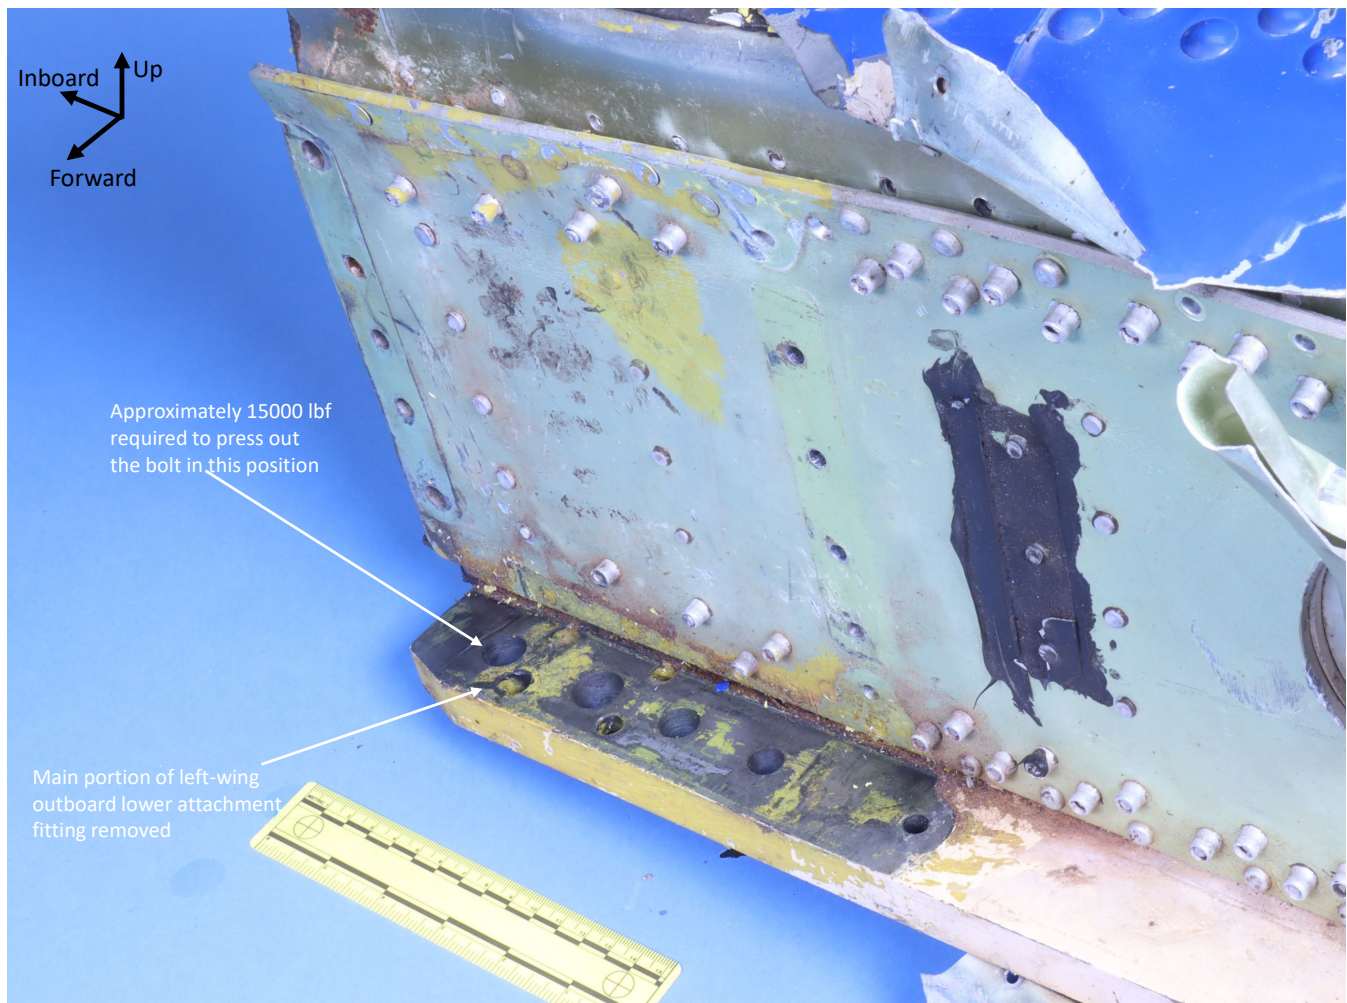
Figure 12 Oblique view of the spar piece after removal of the main lower attachment fitting piece.

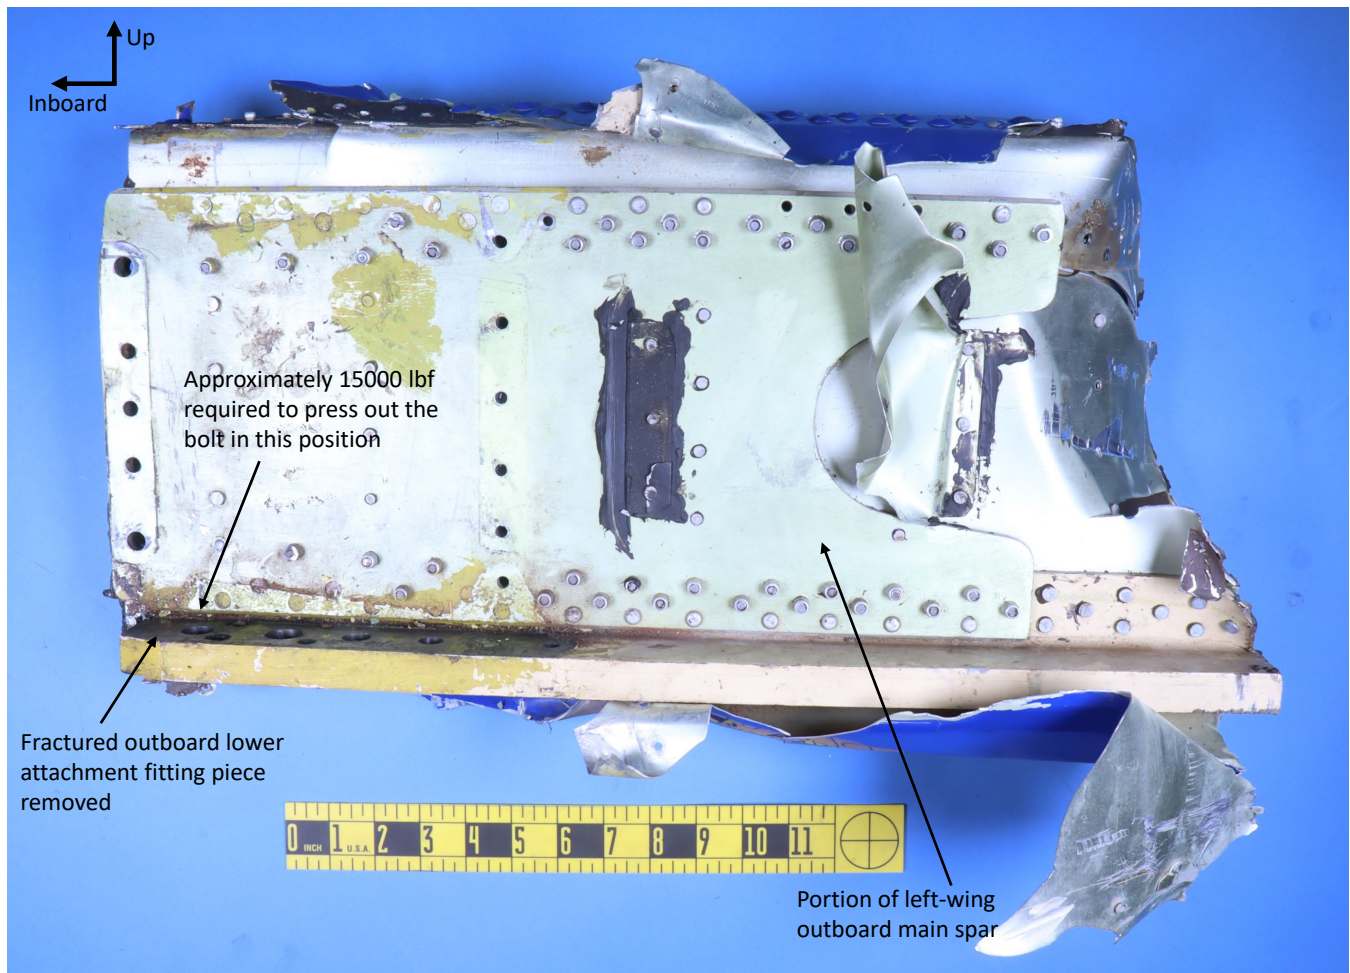
Figure 13 Side view of the spar piece after removal of the main lower attachment fitting piece.

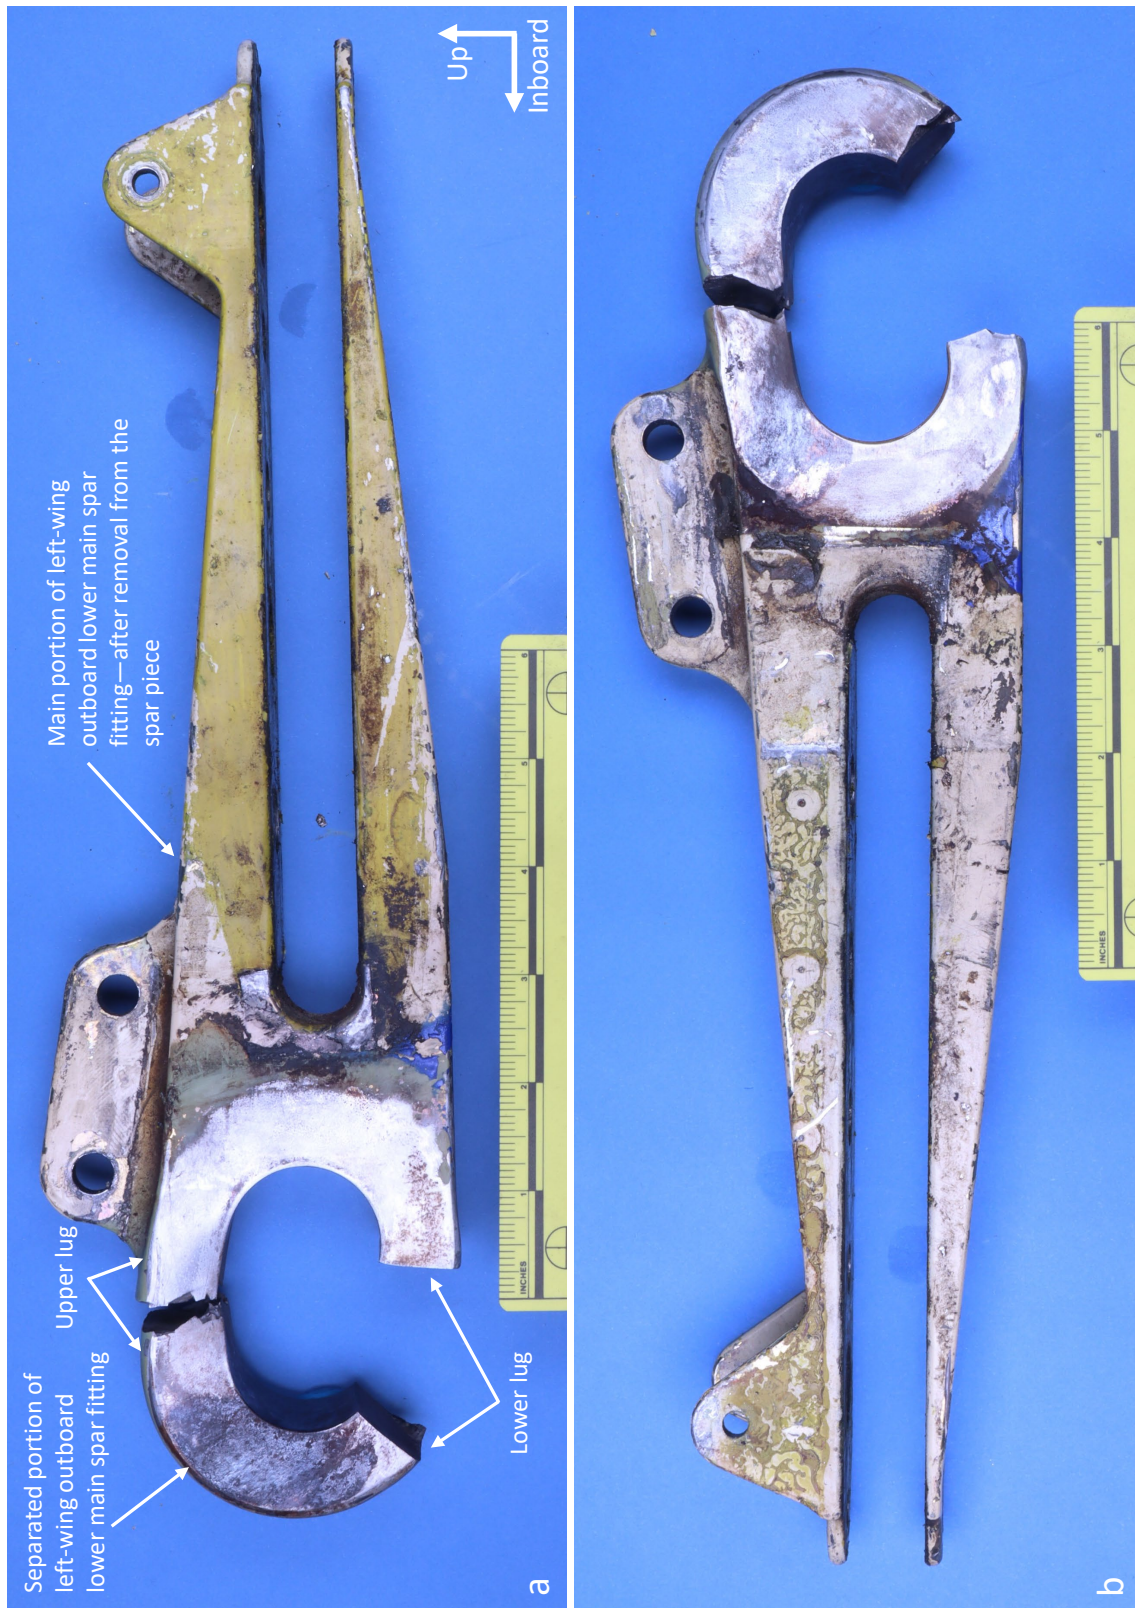
Figure 14 Side views of the lower attachment fitting pieces with the separated piece arranged to approximate its position at the point of separation.

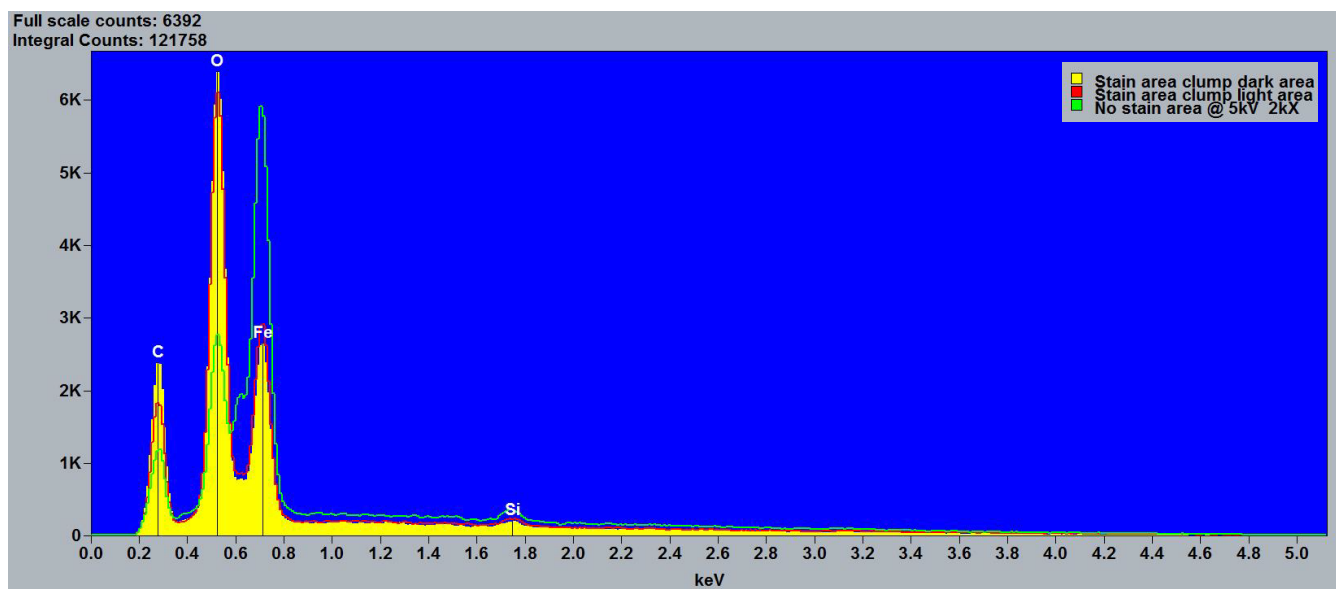
Figure 24 EDS spectra for the features identified in Figure 23b.

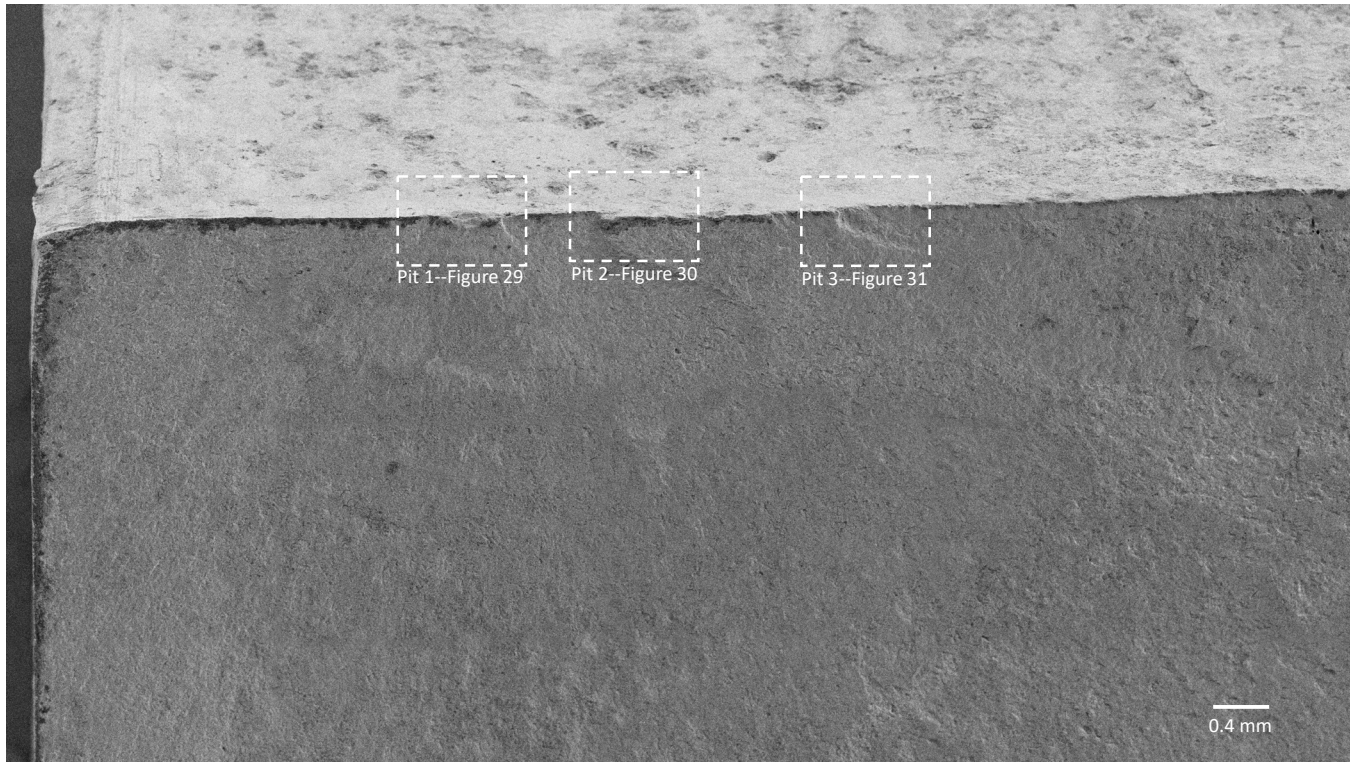
Figure 28 Secondary electron SEM fractograph of the fatigue crack origin region on the separated lower attachment fitting piece (in the acetone-cleaned condition).

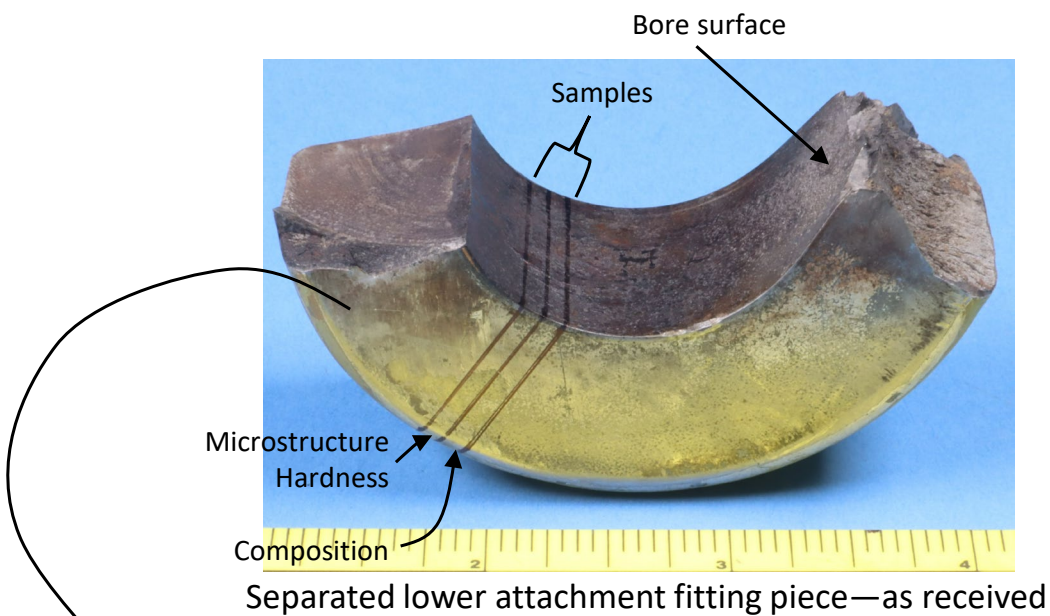
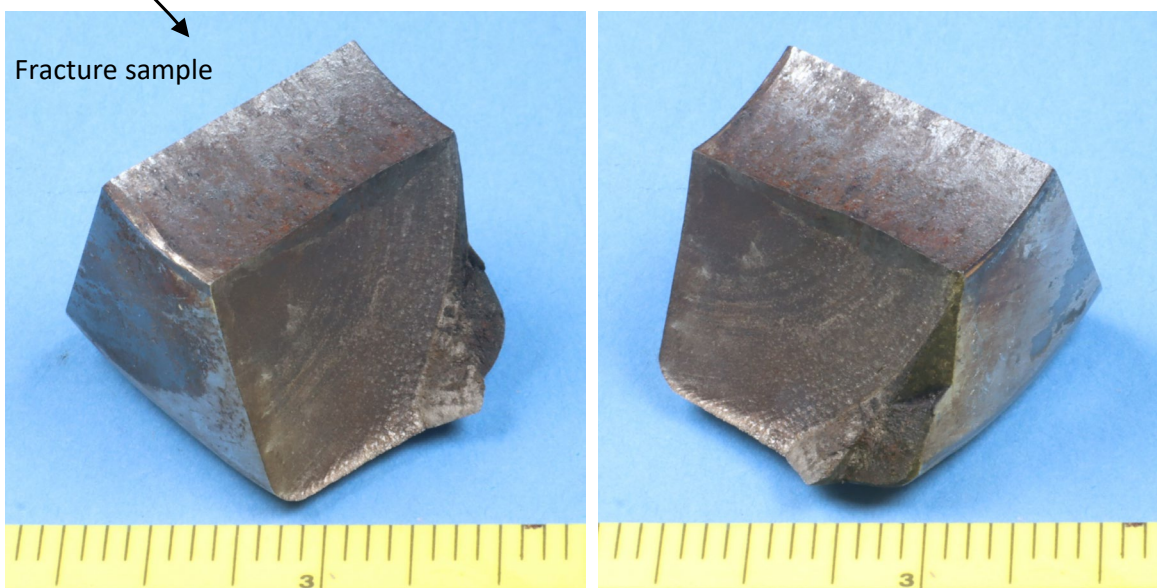
Sample with fracture to be progressively cleaned in Evapo-Rust®

Figure 34 Images showing the sections taken from the separated lower attachment fitting piece. Two thin slices were taken for hardness, microstructure, and compositional analysis. The larger fracture sample was cleaned in Evapo-Rust to remove corrosion product deposits.

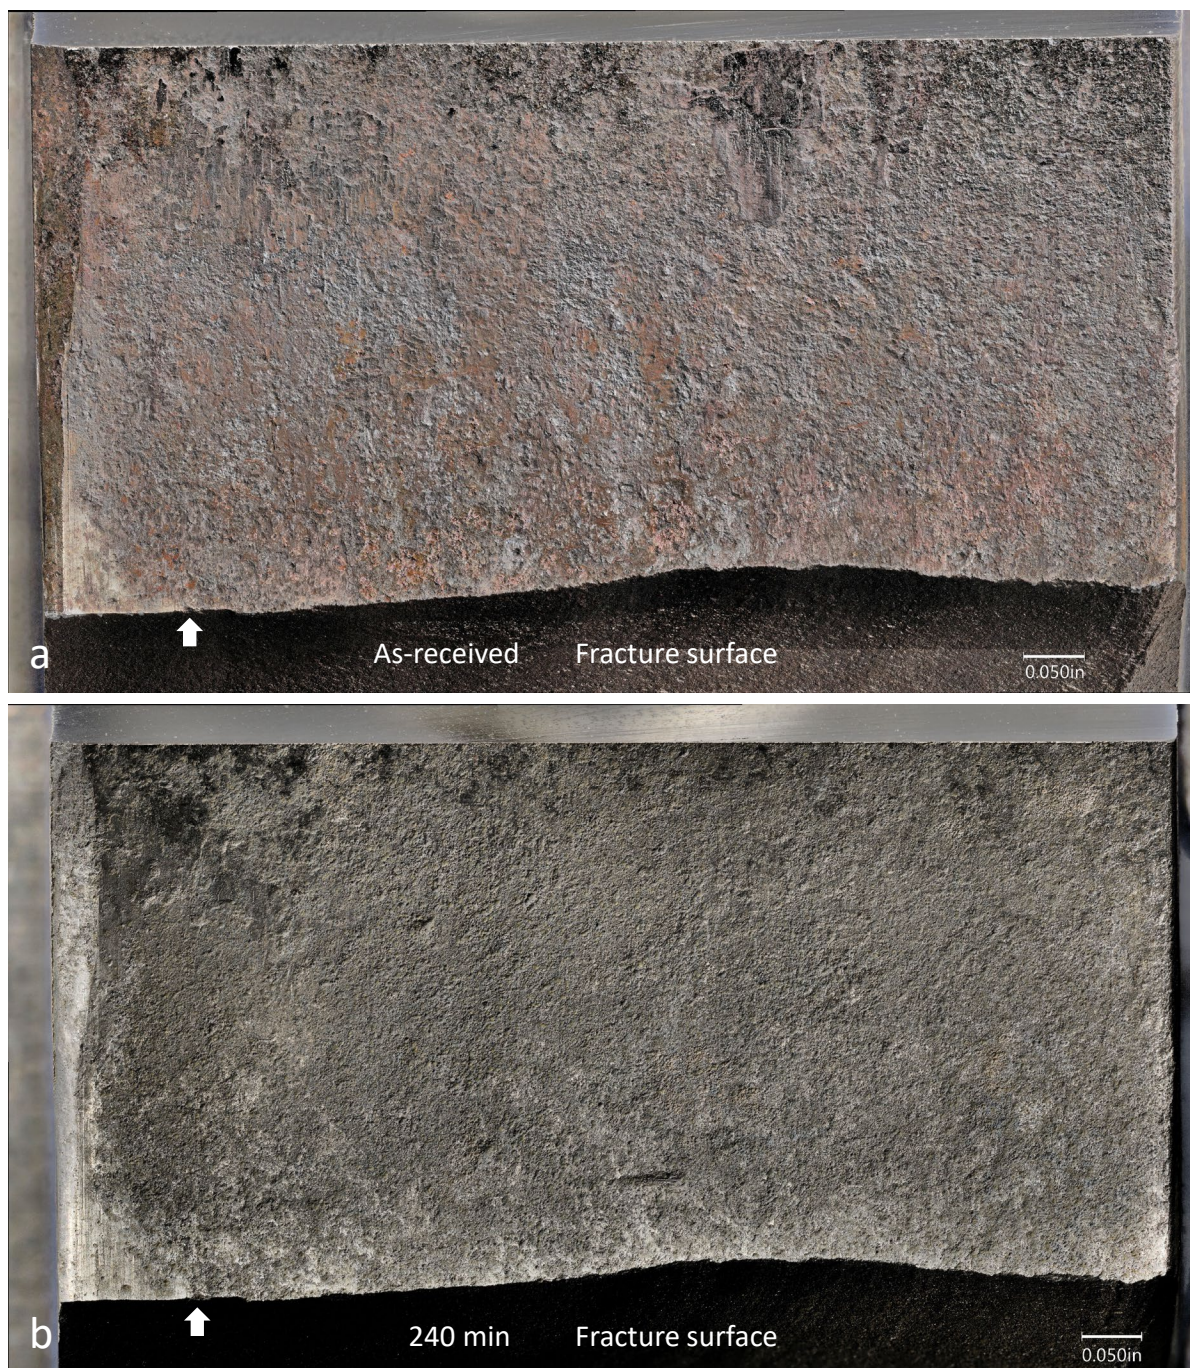
Figure 38 Top down digital microscope images (HDR) of the surface of the lug bore in the vicinity of the fracture face. The unmarked white arrow in the images is the location of Pit 1. View a is in the as-received acetone-cleaned condition. View b is the surface after 240 minutes of Evapo-Rust immersion followed by brush cleaning to remove corrosion product deposits on the surface.

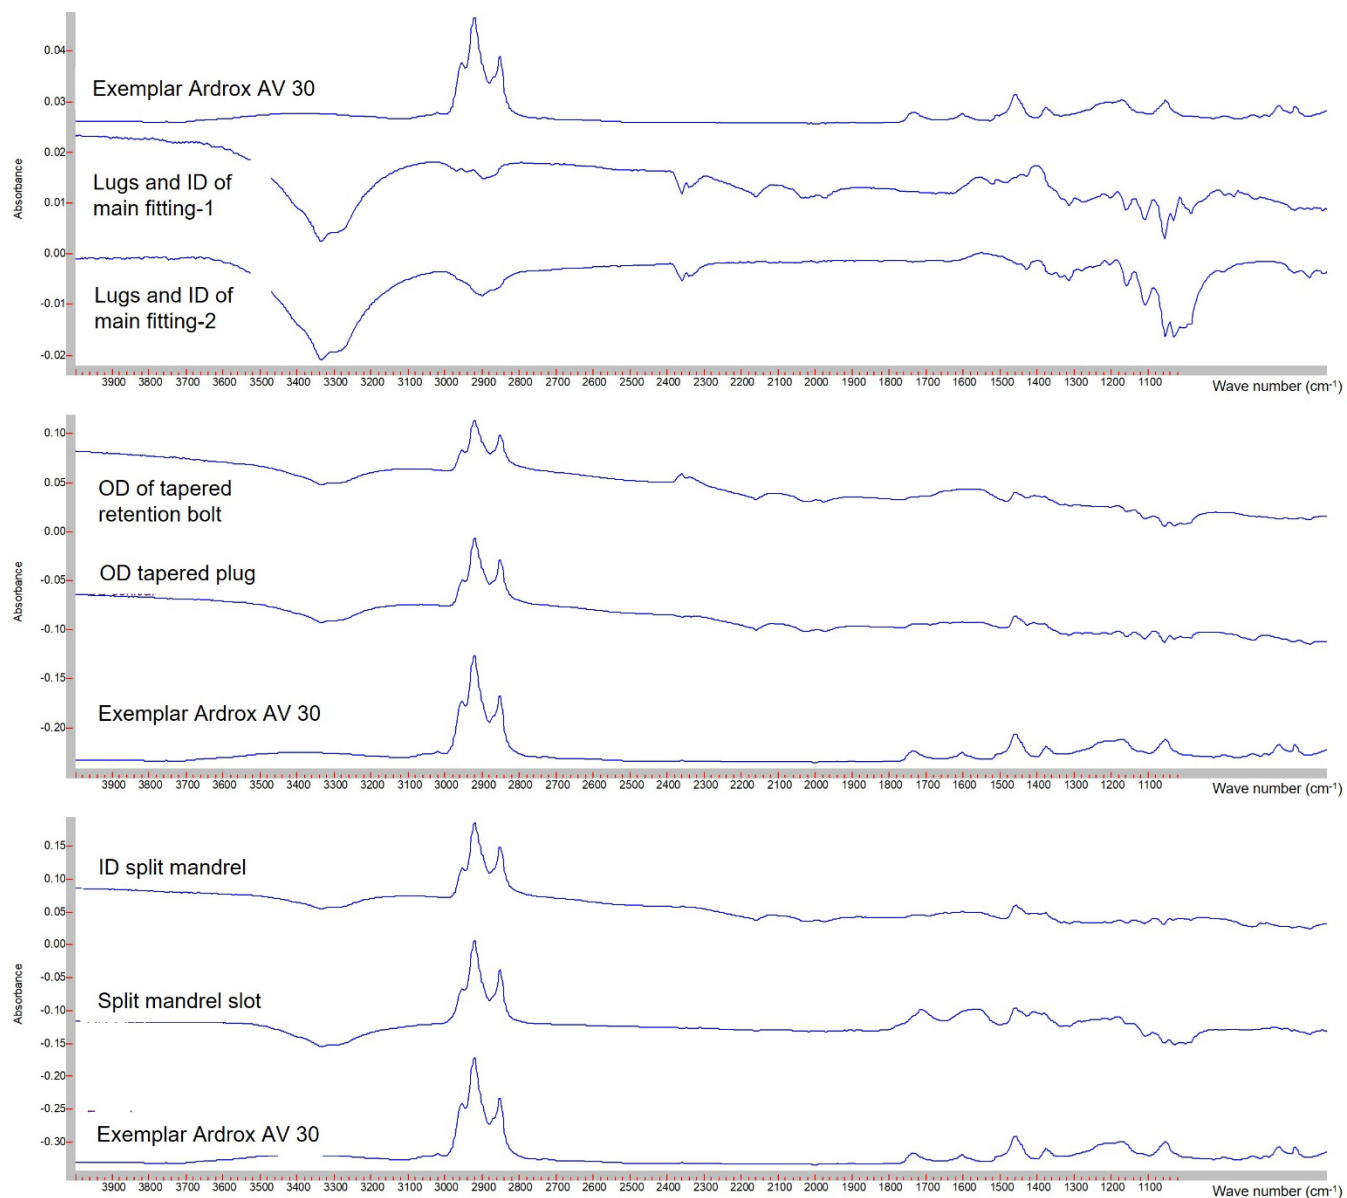
Figure 50 Fourier transform infrared spectra of surface deposits on components from the expansion mandrel assembly and the lug surfaces from the main lower attachment fitting piece. A reference spectrum for Ardrex AV 30 is included.

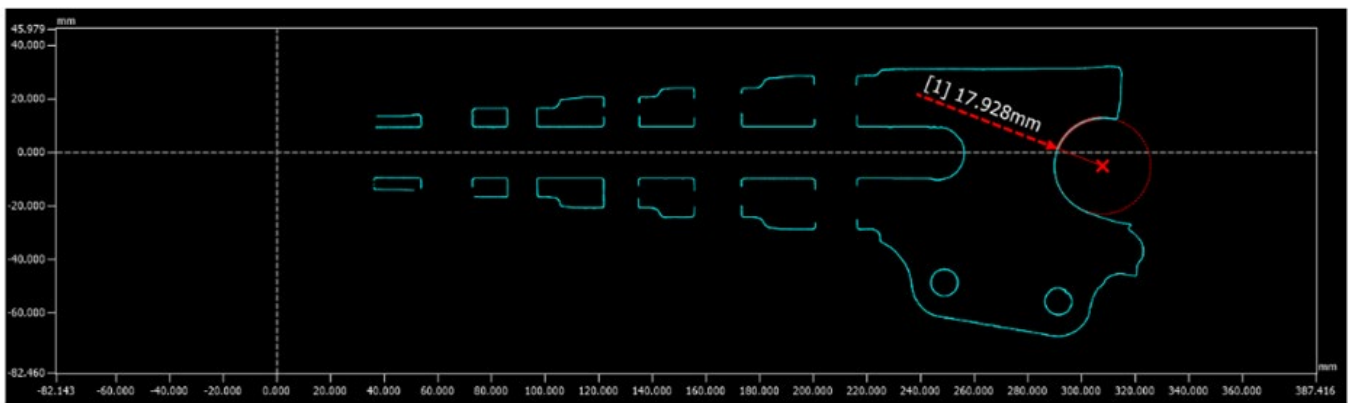
Figure 51 3D scanned image of the main portion of the lower attachment fitting showing the location of the arc radius measured within the lug bore. This image is for Arc 3 in Table 1.
