# NATIONAL TRANSPORTATION SAFETY BOARD

## MATERIALS LABORATORY FACTUAL REPORT

Report No. 21-054

Place : Seiling, Oklahoma  
Date : 07/12/2021  
Vehicle : WSK PZL Mielec M-18A Dromader (N9310R)  
NTSB No. : CEN21FA314  
Investigator : Tim Sorenson

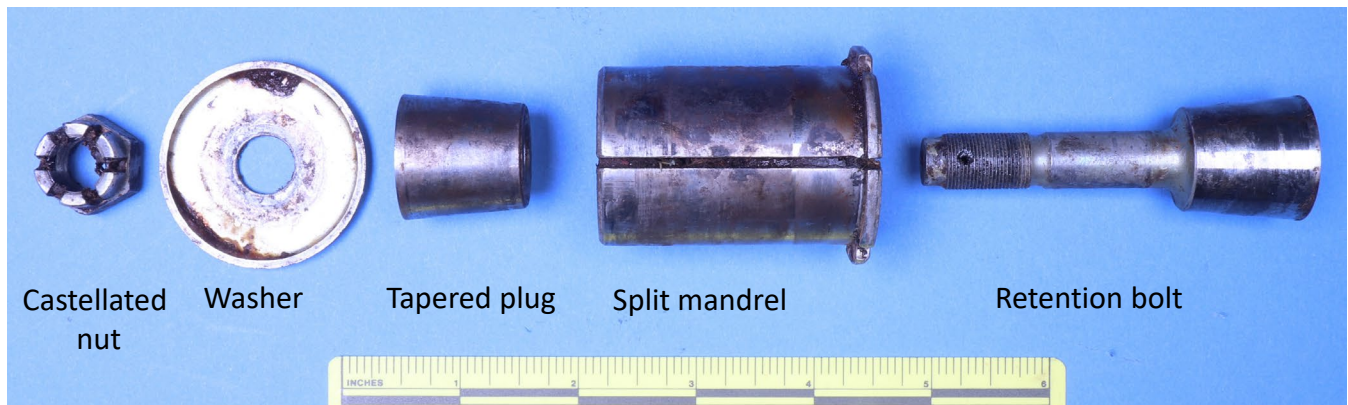
Figure 52 Image of the as-received expansion mandrel components.

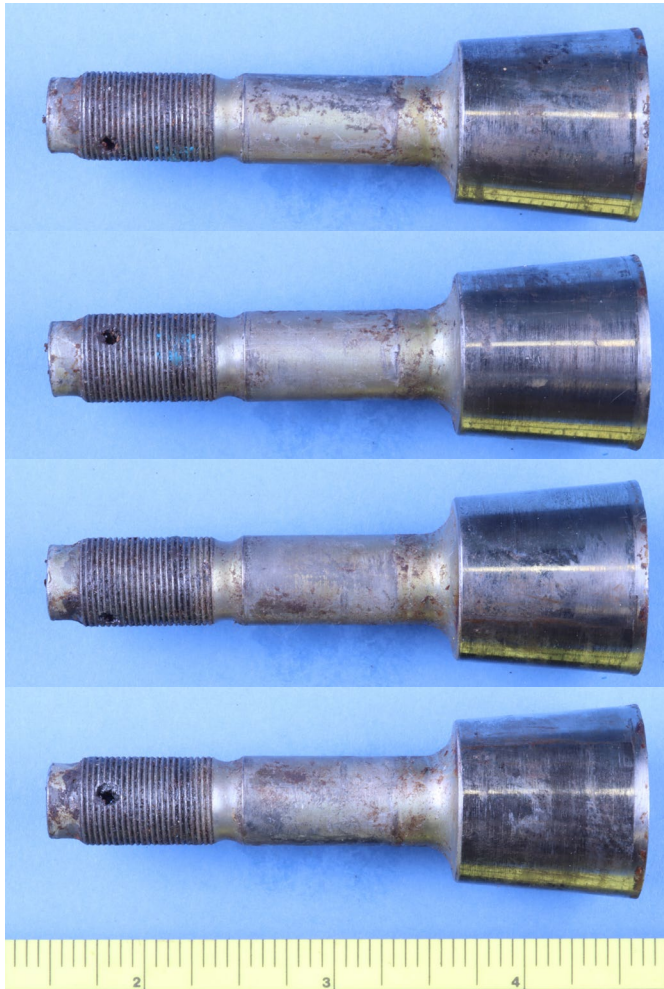
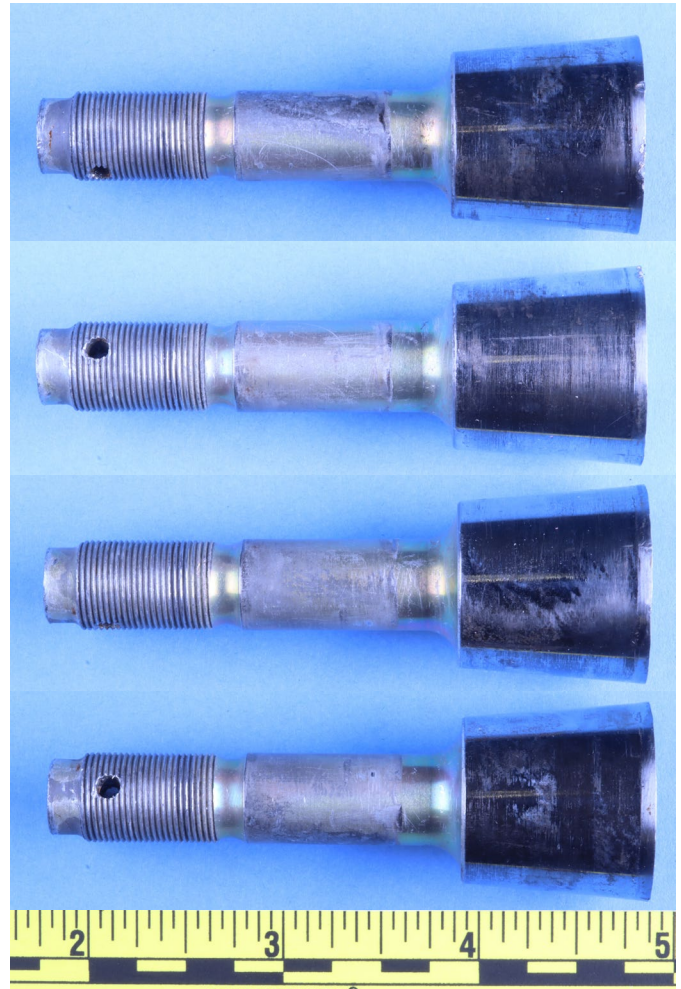
Detailed images of the retaining bolt at 90° intervals about the main axis are shown in Figure 55. Closer images of the surface of the tapered portion of the retaining bolt are shown in Figure 56. Annotations in the figure reveal the presence of two longitudinal marks consistent with marks that were created at the slot along the inside diameter (ID) of the split mandrel. A vibro-engraved mark present on the large end of the tapered portion of the retaining bolt is shown in Figure 57.

Figure 55 Views of the retention bolt from the expansion mandrel assembly in the as-received condition and after cleaning in acetone with ultrasonic agitation.

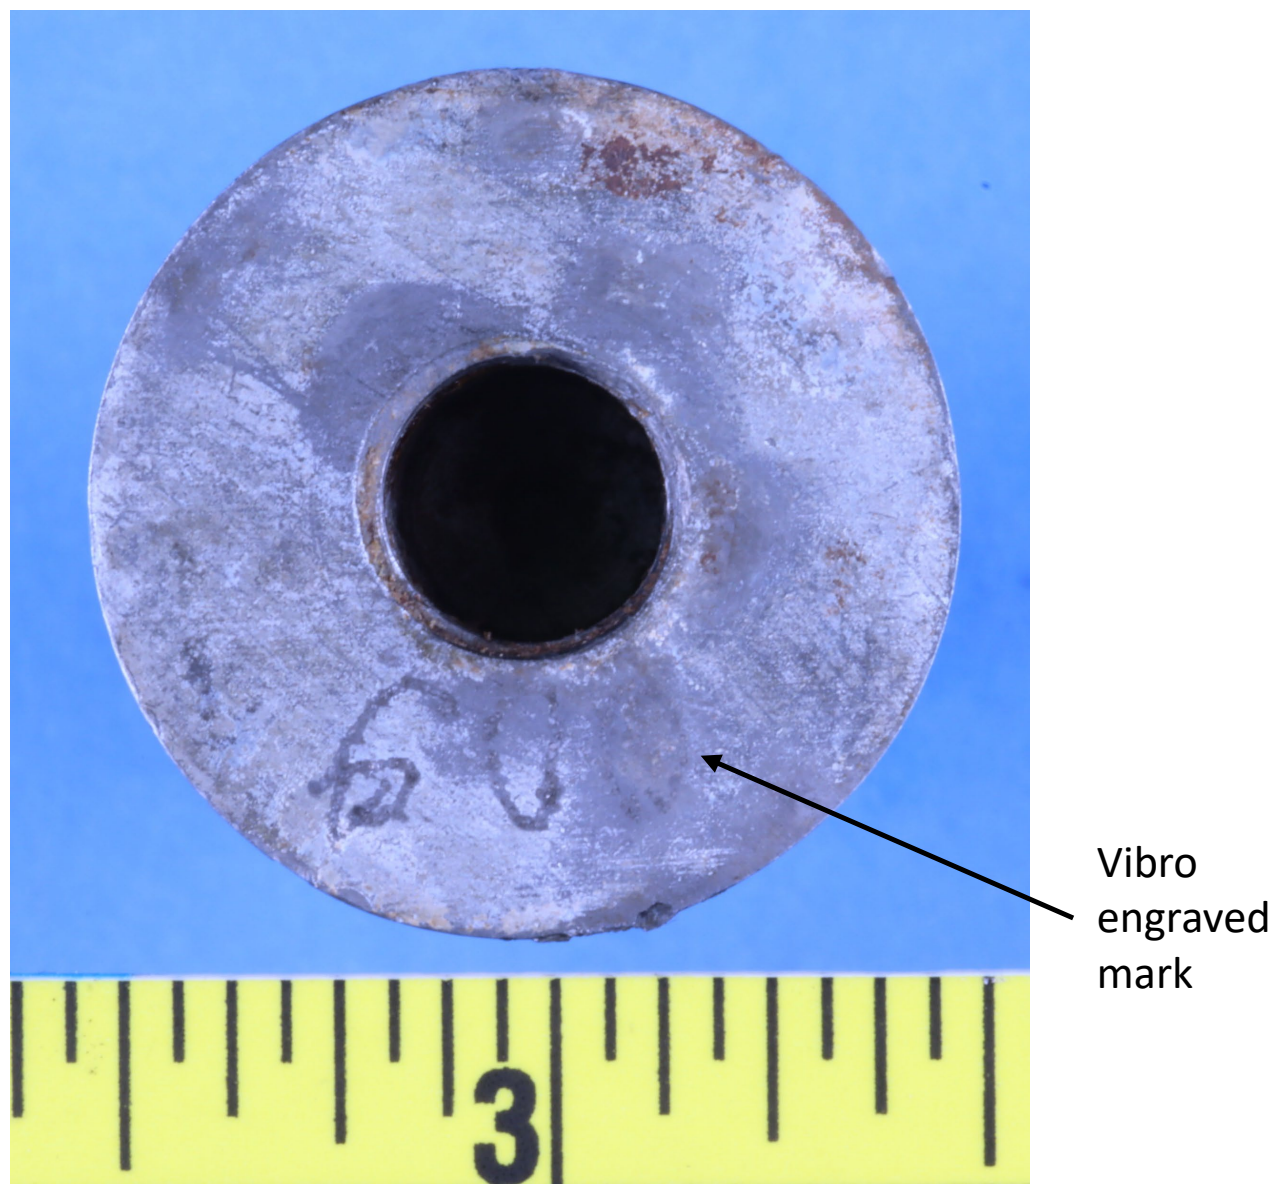
Figure 57 The large end of the retention bolt showing a vibro engraved mark.

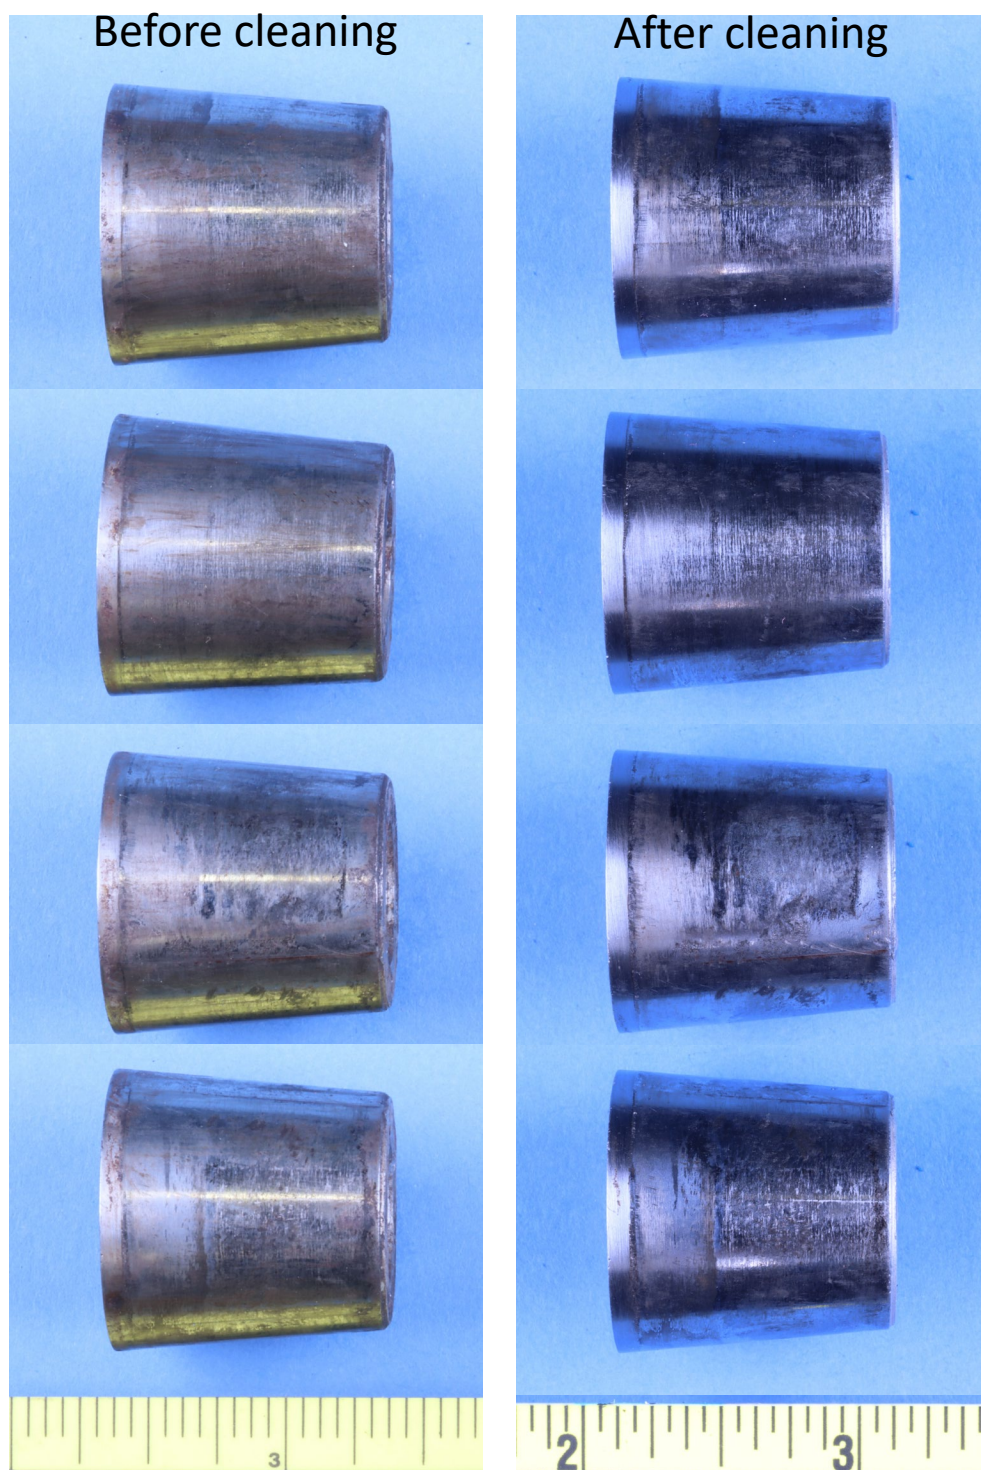
Detailed images of the tapered plug at 90° intervals about the main axis are shown in Figure 58. Closer images of the surface of the tapered portion of the plug are shown in Figure 59. Annotation in the figure reveals the presence of a longitudinal mark consistent with a mark created at the slot along the inside diameter (ID) of the split mandrel. A vibro-engraved mark present on the large end of the tapered portion of the retaining bolt is

Figure 58 Views of the tapered plug in the as-received condition and after cleaning in acetone with ultrasonic agitation.

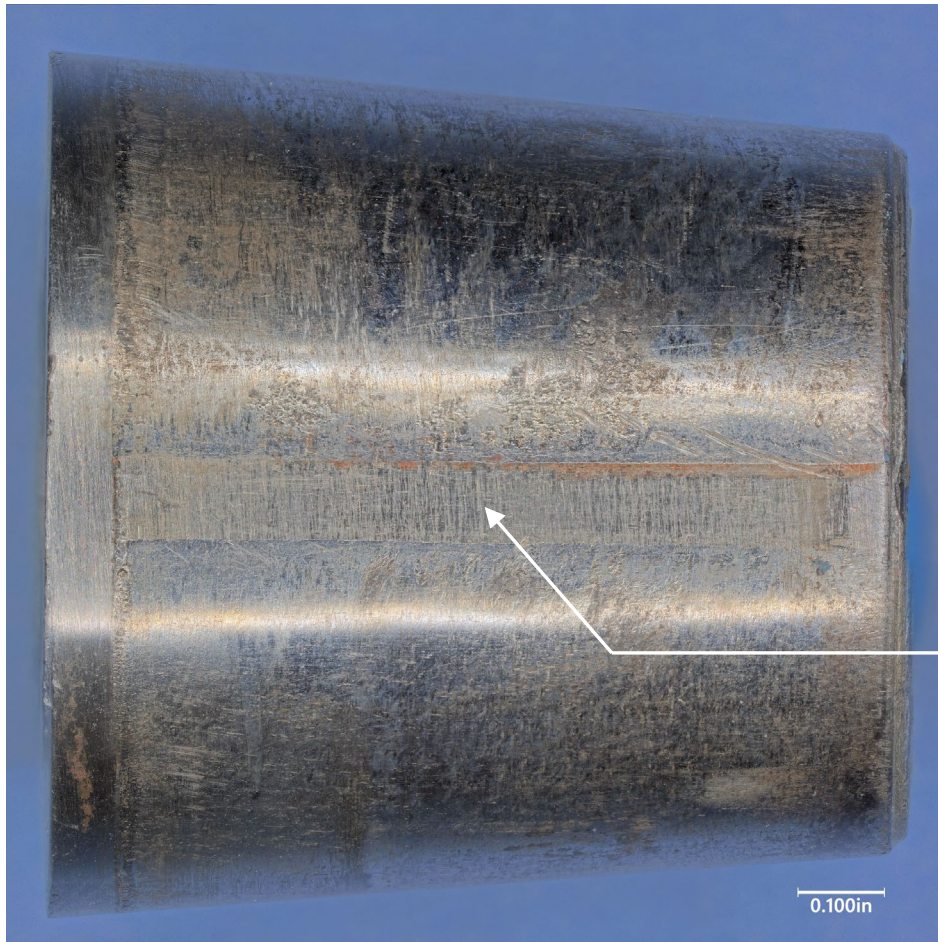
Longitudinal mark  
consistent with  
mandrel slot  
location

Figure 59 Close digital microscope view of the surface of the tapered plug, the annotation reveals a mark that is consistent with the location of the slot in the split mandrel.

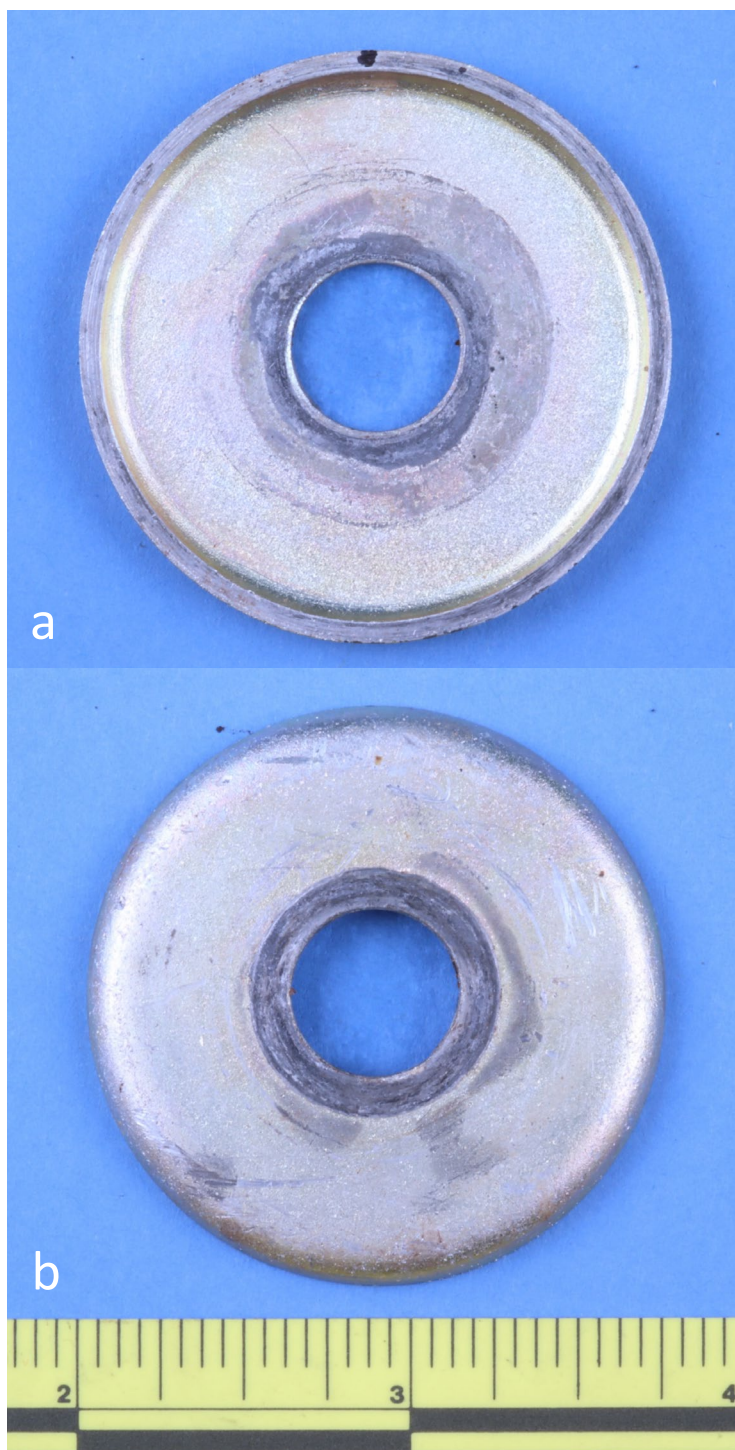
Figure 61 View of the obverse and reverse sides of the washer.

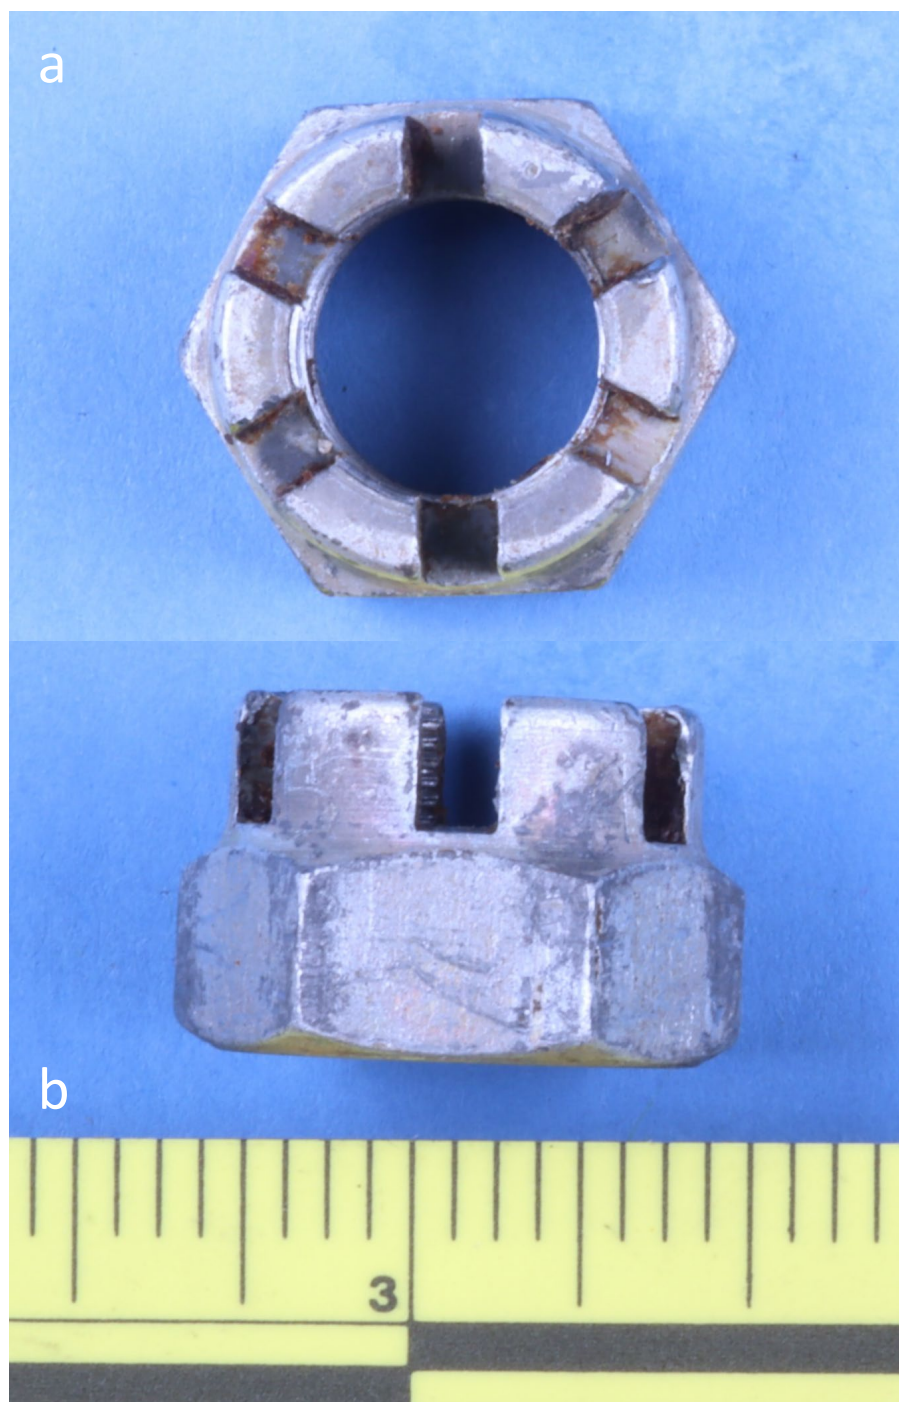
Figure 62 Top and side views of the castellated nut.

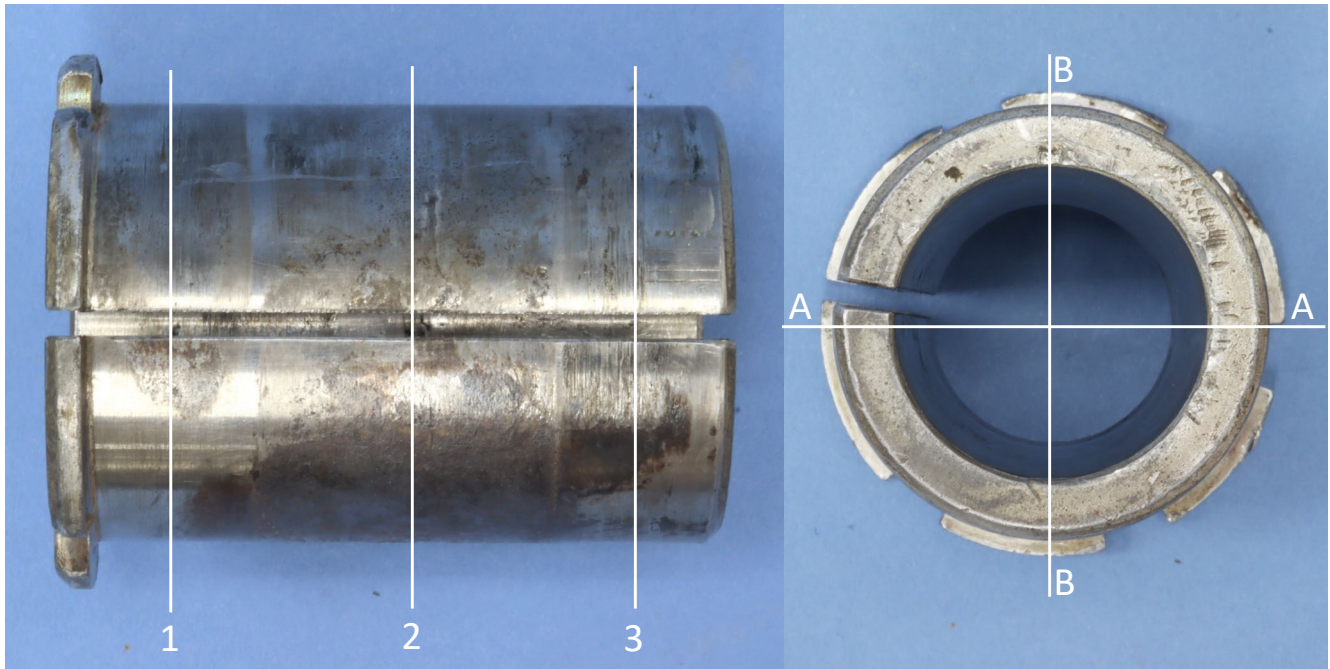
Figure 63 View of the split mandrel showing the locations where the outside diameters were measured (see Table 3).
