# National Transportation Safety Board

CEN21FA330

## **WRECKAGE EXAMINATION SUMMARY**

Location: Elgin, Minnesota  
Date: July 19, 2021  
Time: 1600 central daylight time (2000 UTC)  
Airplane: Robinson R44 II, Registration No. N44BJ

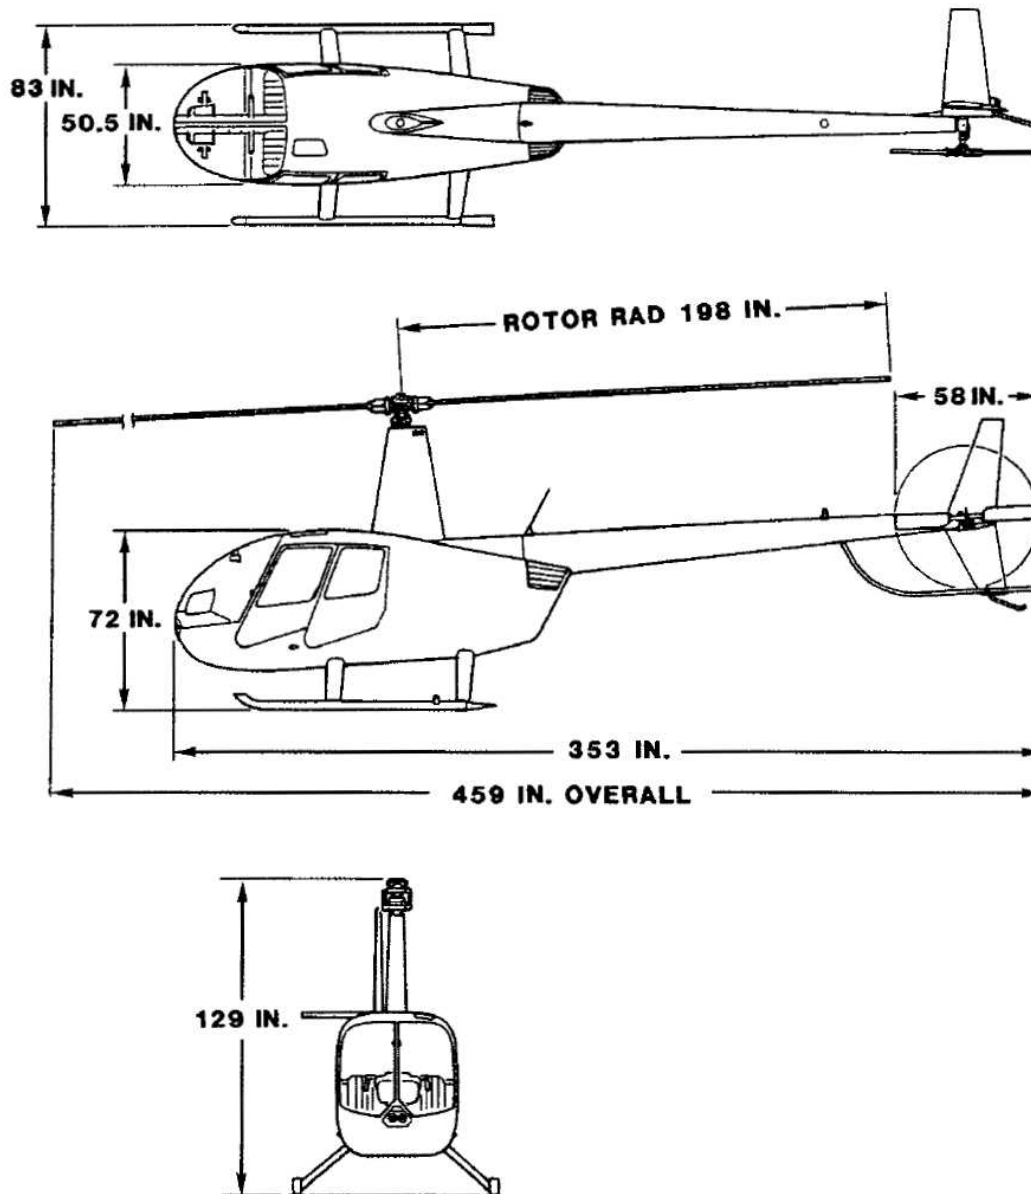
According to the Robinson R44 II Pilot Operating Handbook, the helicopter height is 129 inches (10.75 ft), as depicted in figure 1.

**Figure 1.** Robinson R44 II Dimensions
