**NATIONAL TRANSPORTATION SAFETY BOARD**  
**Office of Aviation Safety**  
**Washington, D.C. 20594**

**POWERPLANT GROUP CHAIRMAN'S FACTUAL REPORT**

**NTSB No: CEN21LA004**

Aircraft: Piper PA-46-500TP, registration number N62ZM

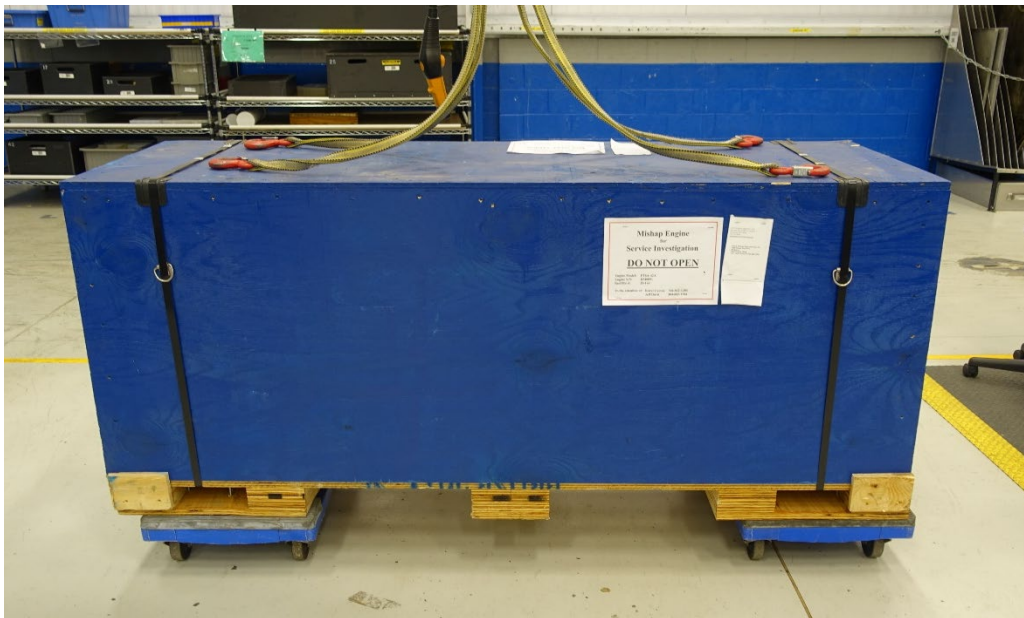
**Photo 1- Engine Shipping Container, as Received at PWC-Bridgeport, WV**

The engine was secured in a shipping container when the team arrived at PWC- Bridgeport, WV (**Photo 1**) and was removed and placed in a work stand for examination and disassembly (**Photos 2, 3, and 4**). The engine appeared to be in good condition with no evidence of radial uncontainment or undercowl fire. All external engine lines were intact and secure. The inlet screen was deformed radially inward toward the engine centerline and corn stalk/earthen debris was collected in the screen around the engine circumference. (**Photo 5**). The Ng spool was rotated through a pad on the accessory gearbox (AGB) and spun smoothly. When the Ng spool was rotated, a light rubbing noise was audible from the compressor module. The Nf spool spun smoothly when the prop shaft was manually rotated by hand. The magnetic chip detector (MCD) plugs were removed from the AGB and reduction gearbox (RGB) and there was no debris accumulation on either plug (**Photo 6**). The engine oil filter was removed from the AGB, and no debris was visible in the filter pleats.

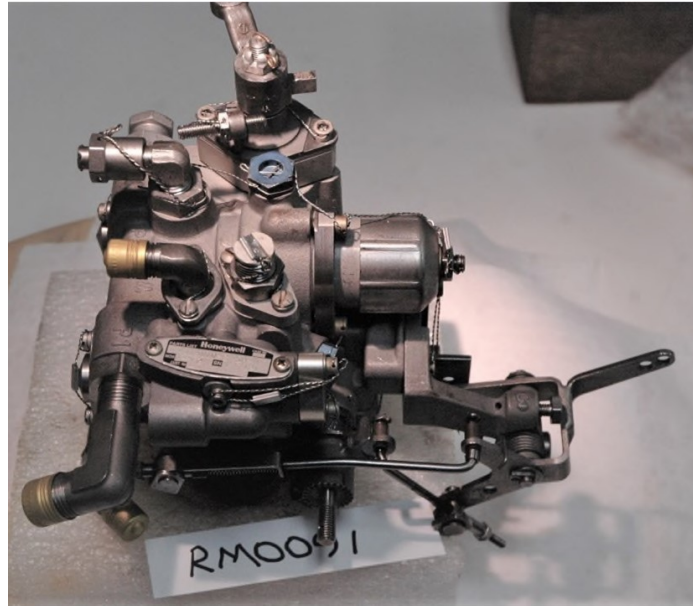
**Photo 16- Fuel Control Unit, as Received (Photo Courtesy of PWC)**

The FCU, P/N 3052899-02, S/N C77121, was manufactured by Honeywell. The FCU exterior was lightly soiled. The driveshaft with normal resistance and the throttle lever moved freely over the full range. The fuel control was tested in accordance with Honeywell component maintenance manual (CMM) 73-20-35 Revision 1. Multiple test points were outside of test specification limits but were within normal range for a service run unit. The FCU was partially disassembled and there were no internal anomalies identified that would have affected normal operation.
