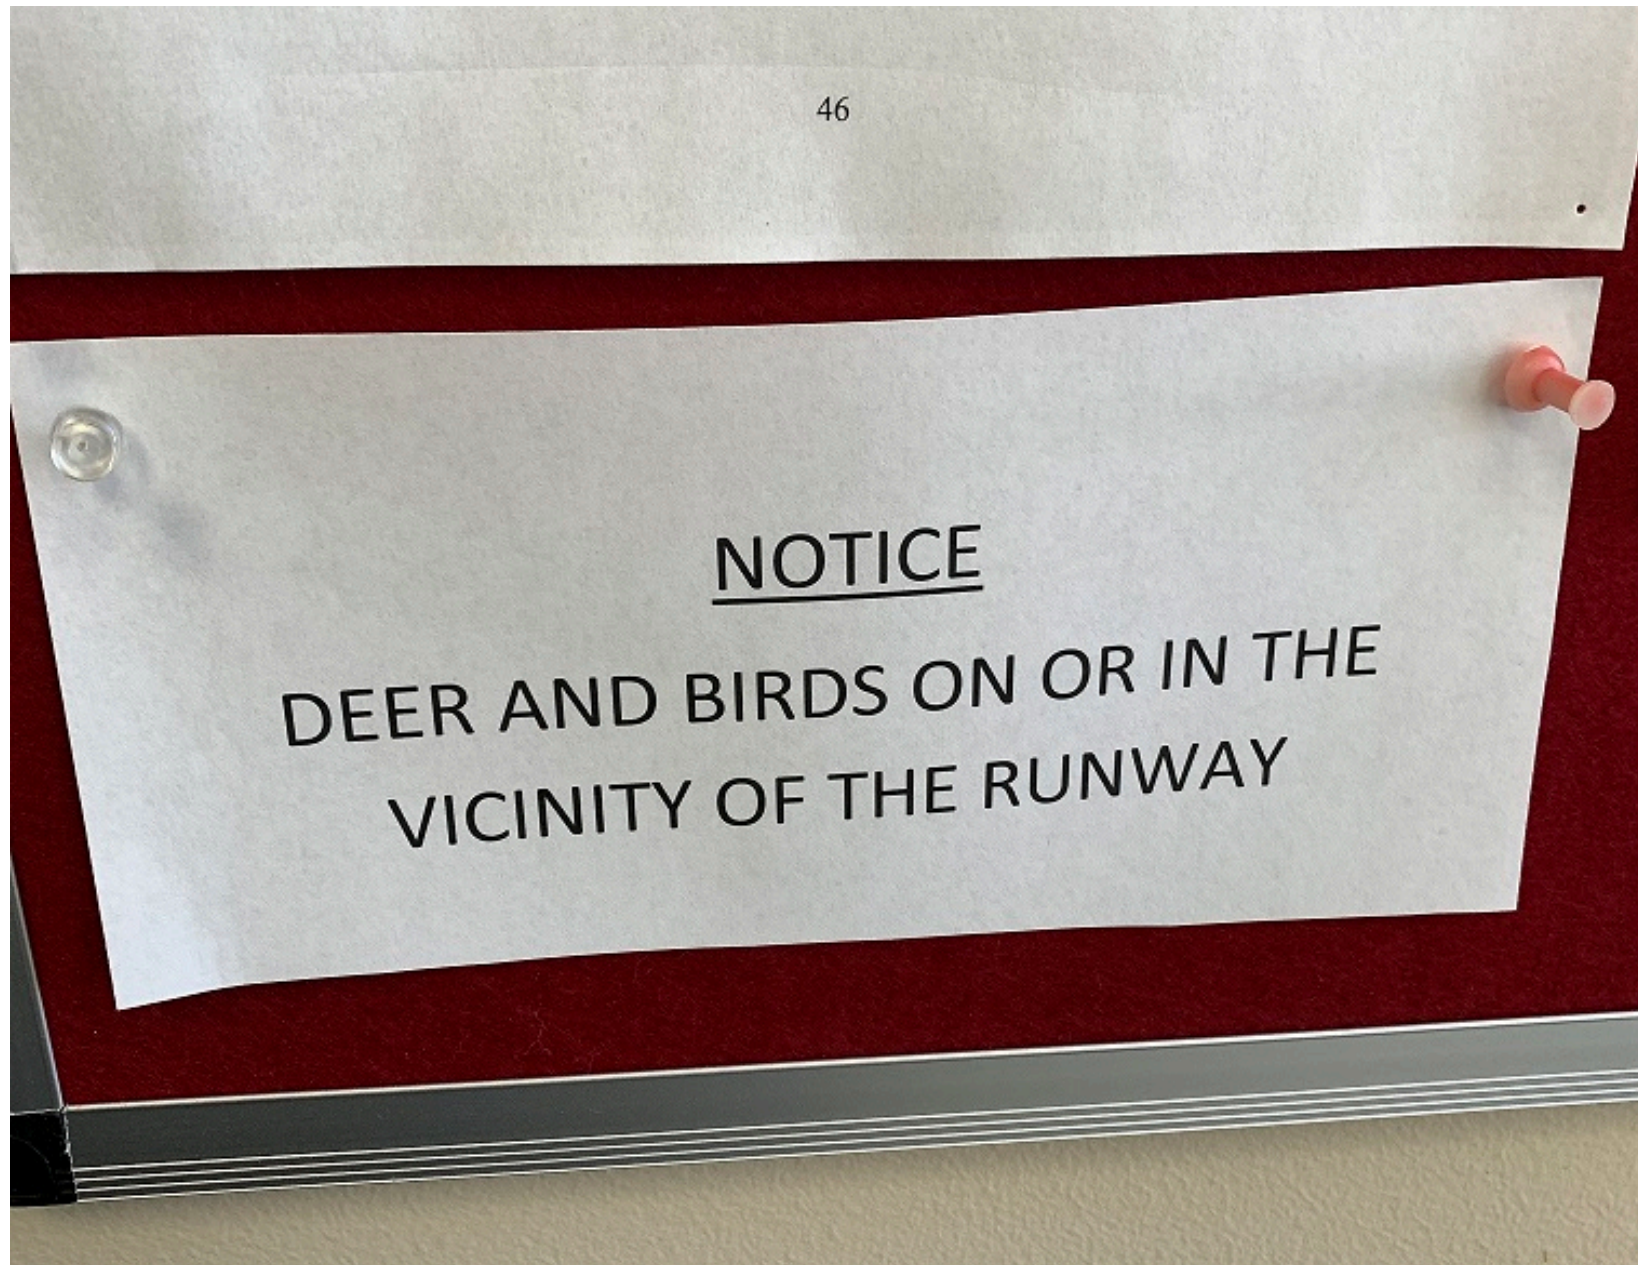
**Photo 5 – View of the deer caution notice in the terminal building at the Greene County – Lewis A. Jackson Regional Airport (I19) in Xenia, Ohio (courtesy of the I19 Airport Manager).**
