# Lake County / Leadville Airport

## Eclipse Aircraft accident – Landing on RW 16 Overshooting

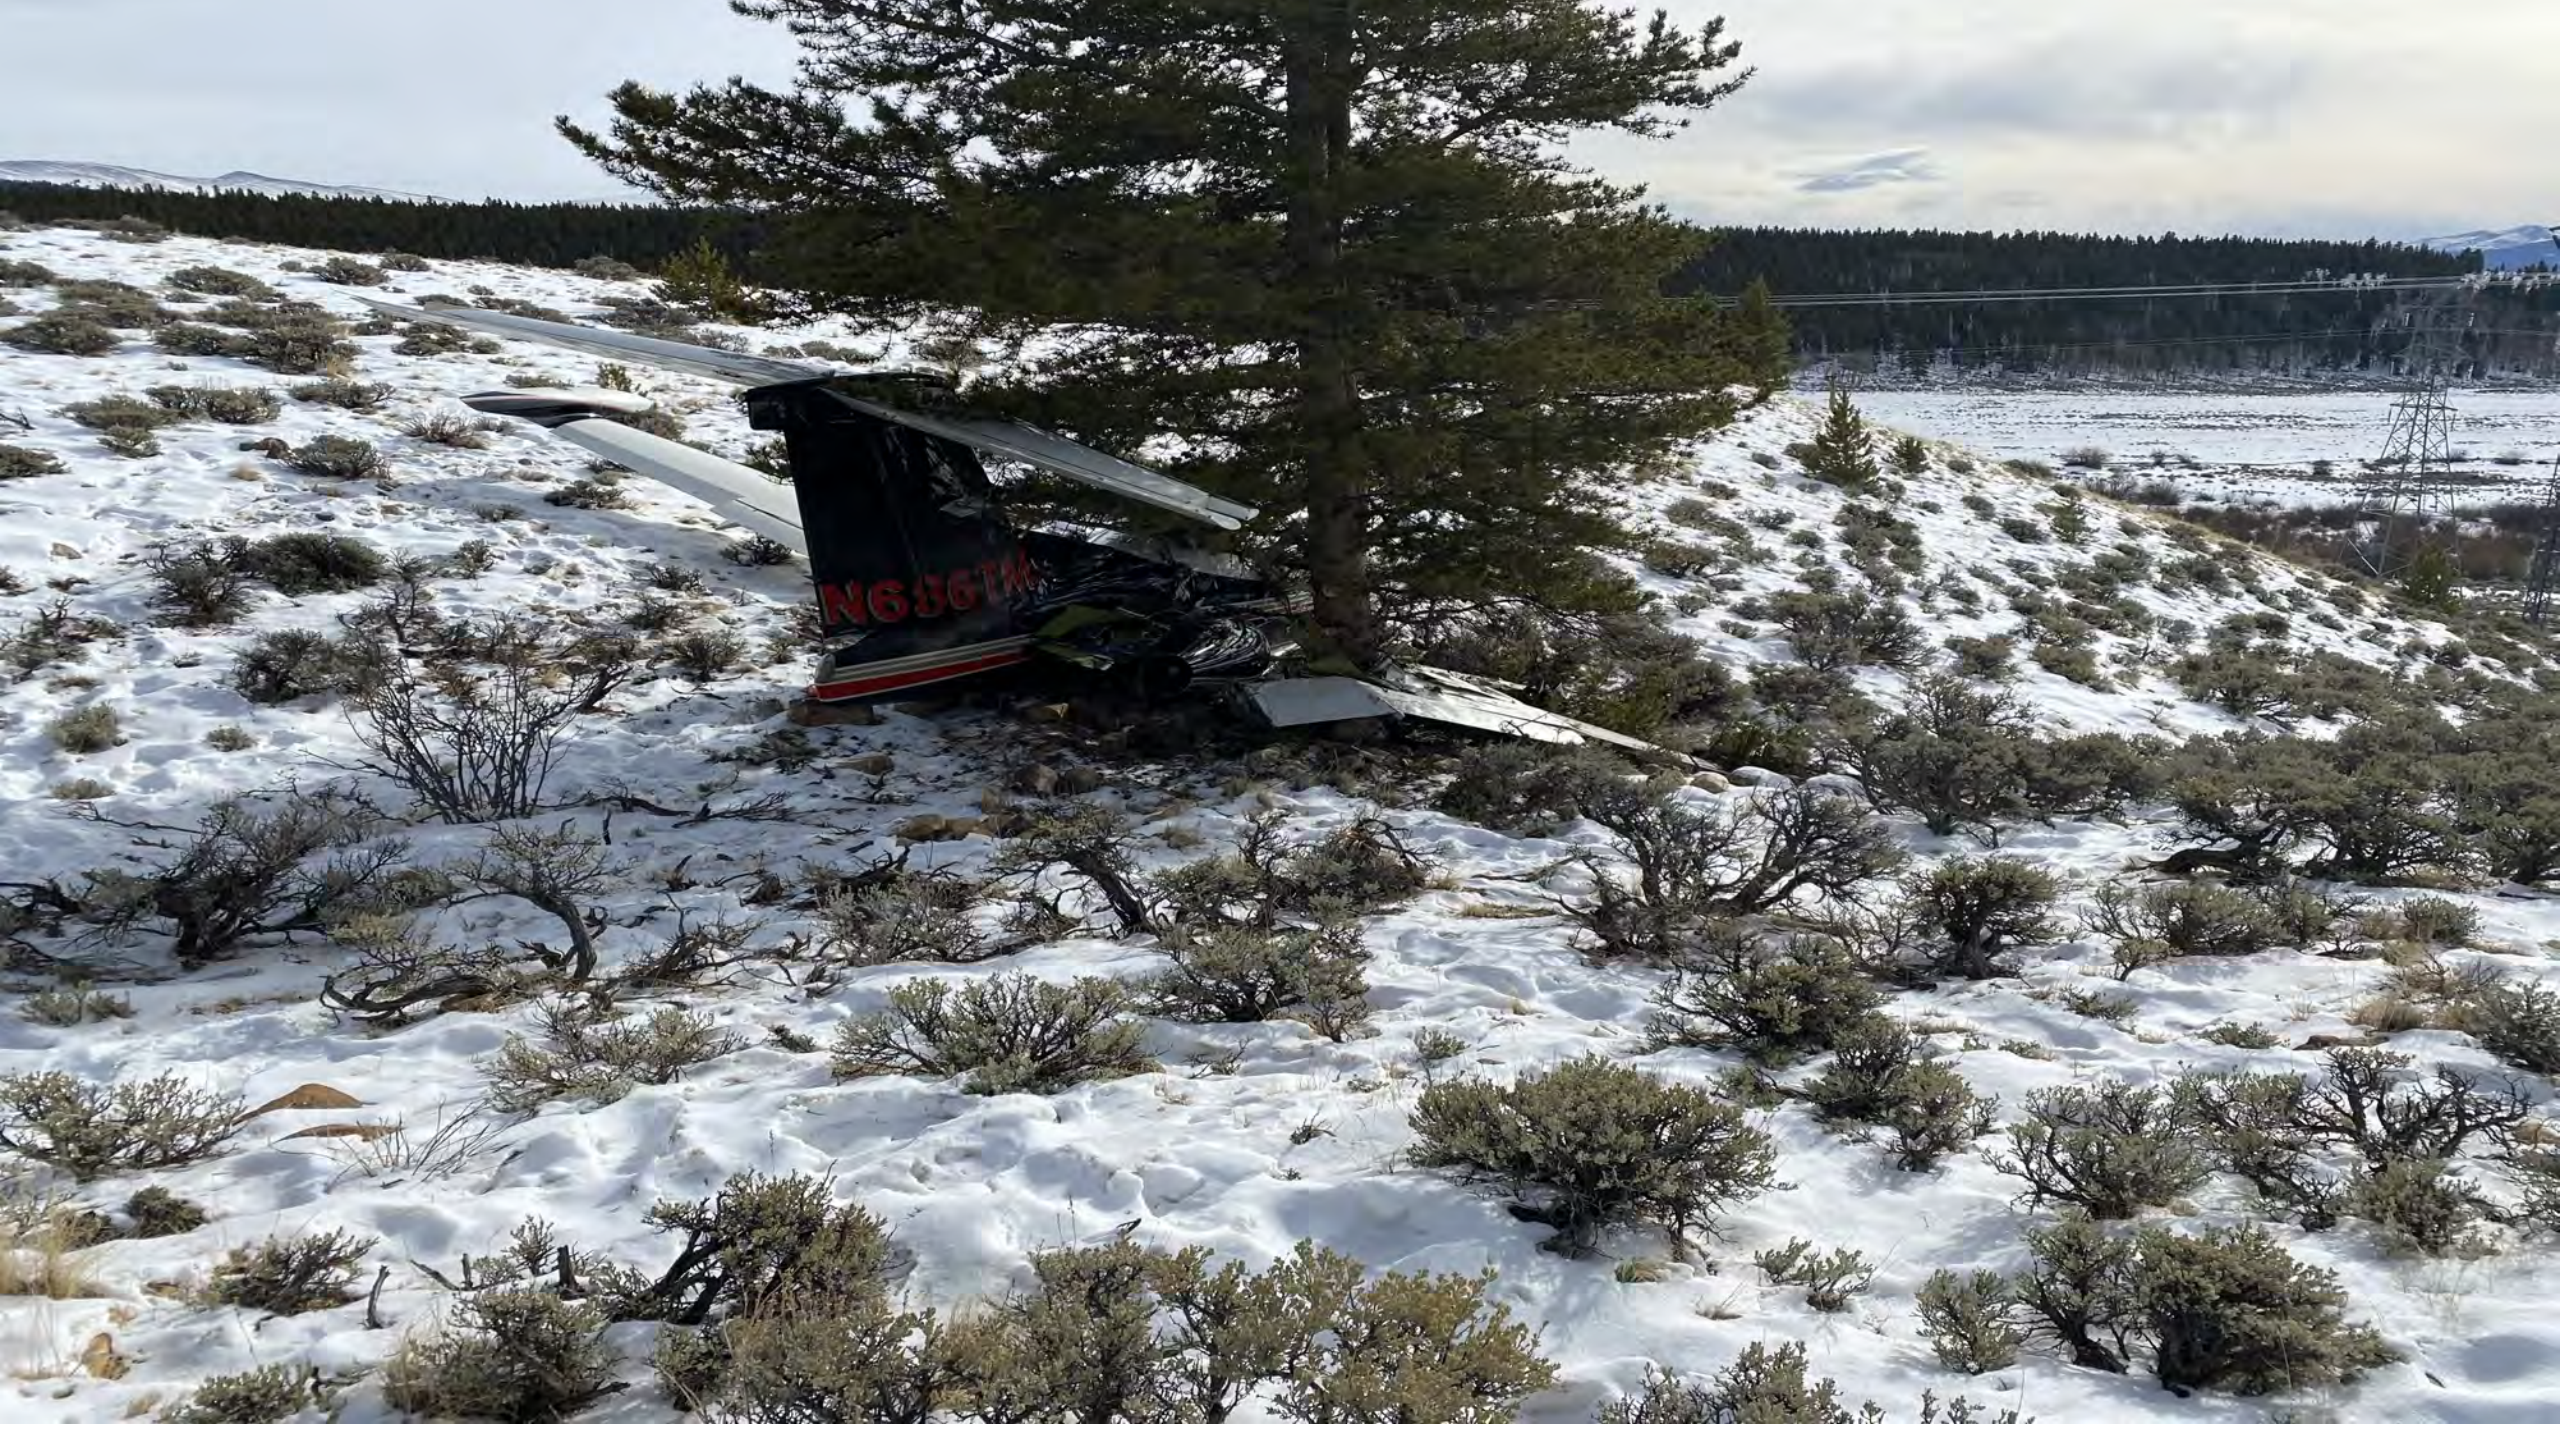
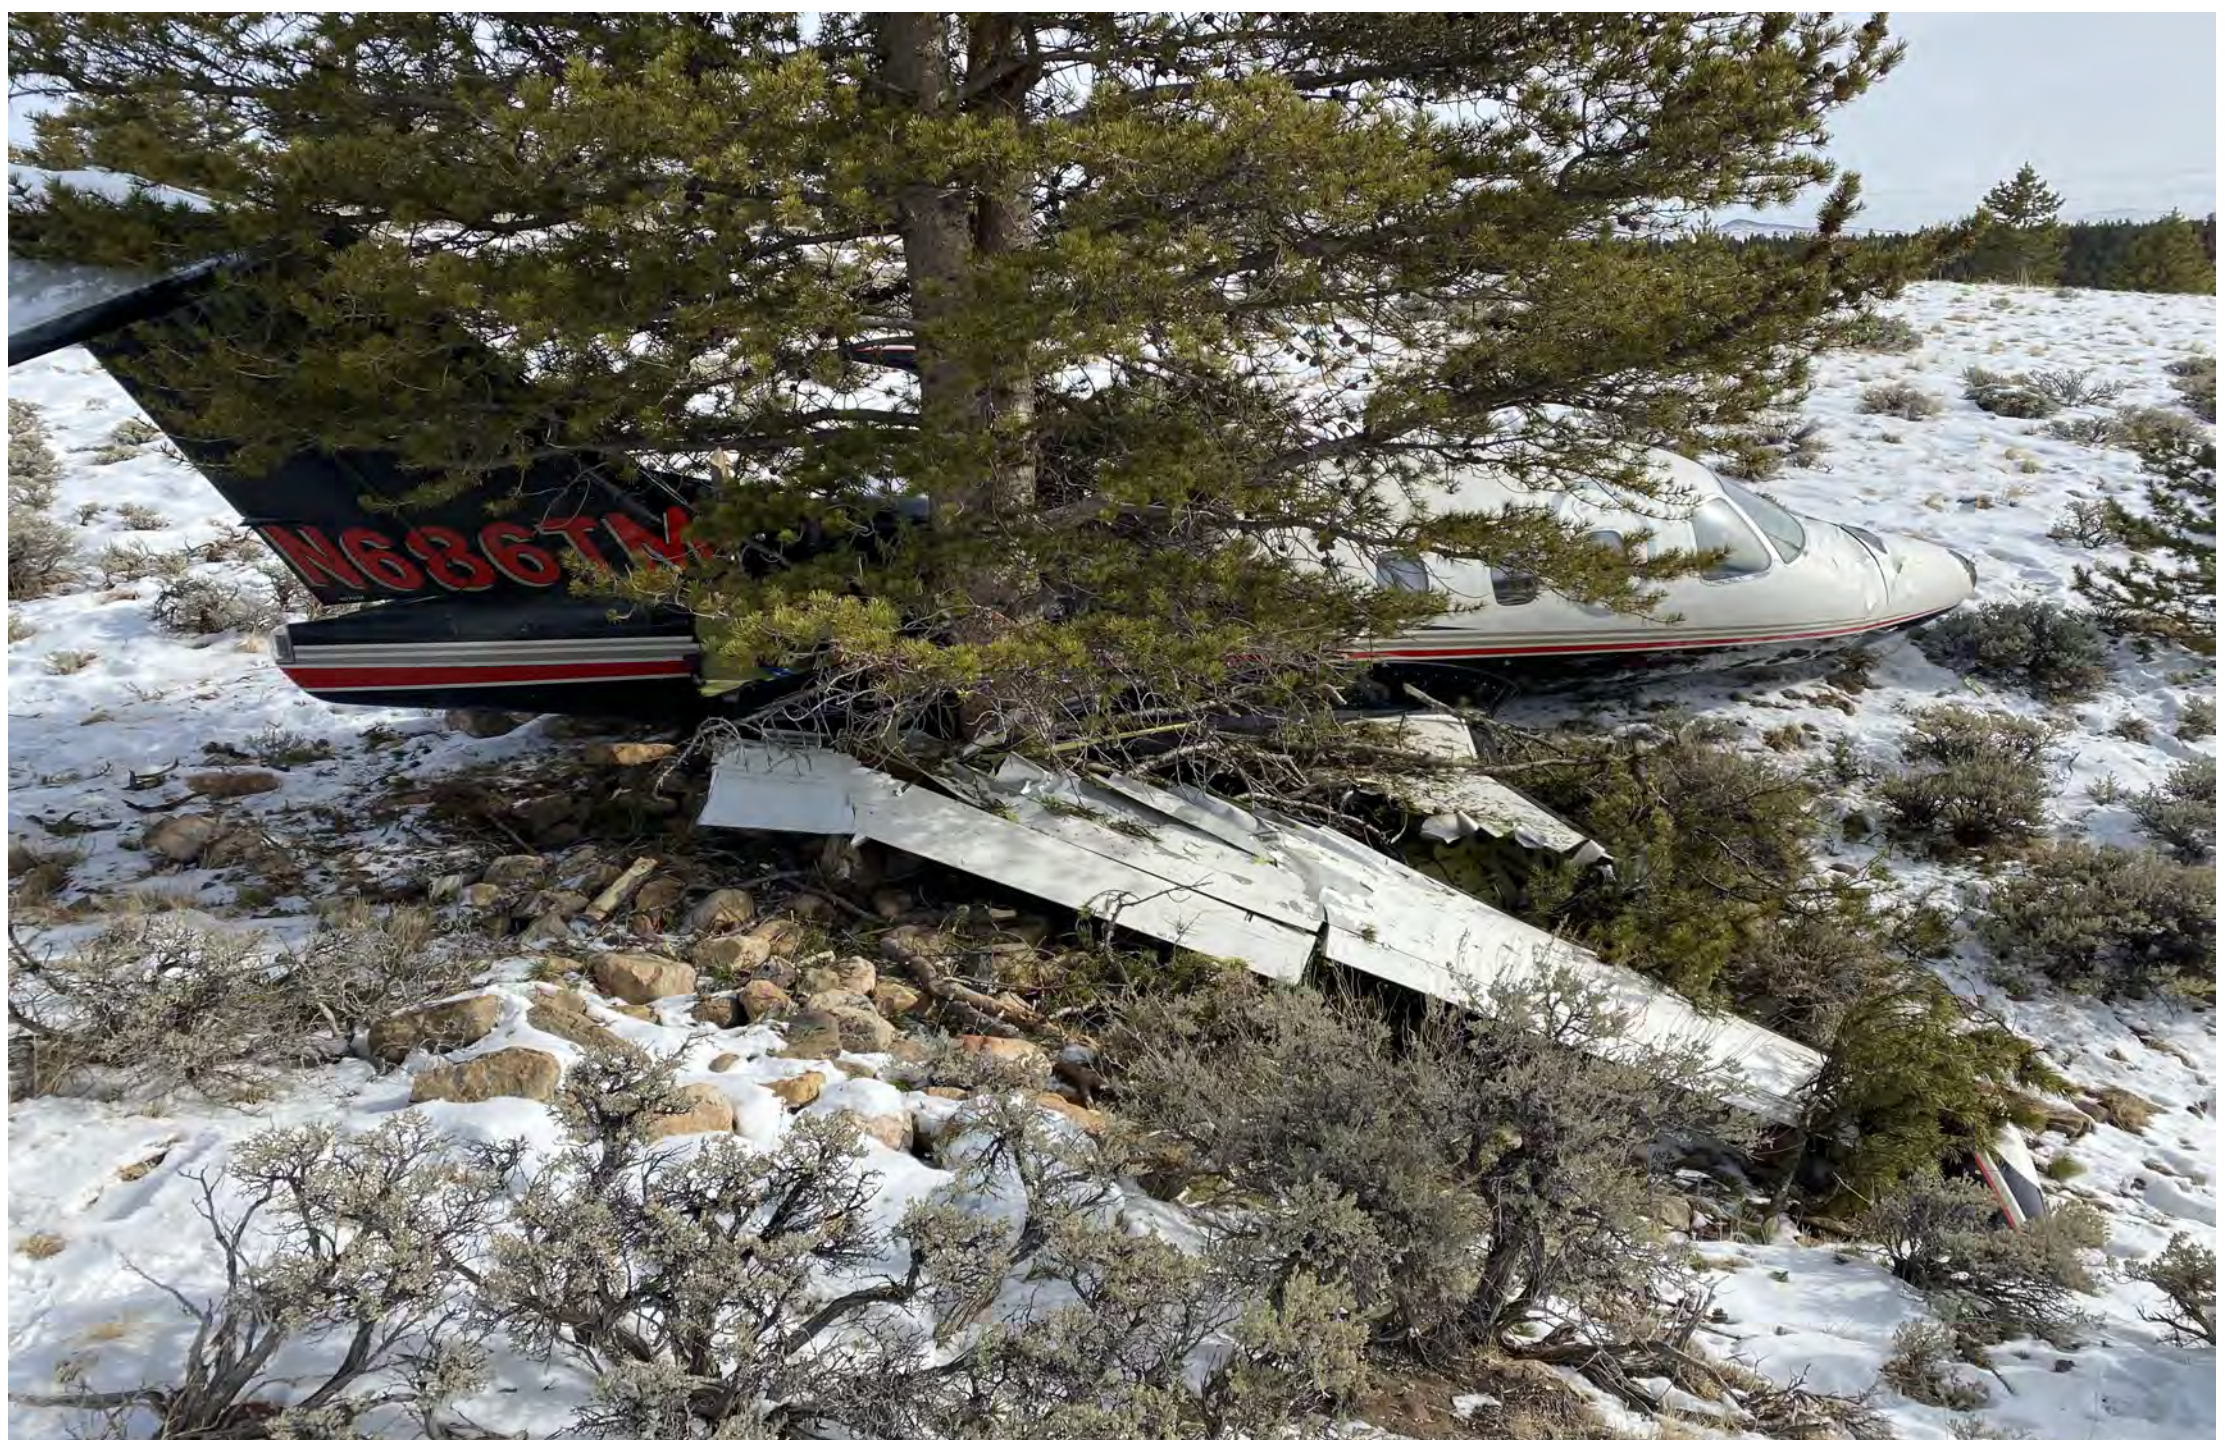
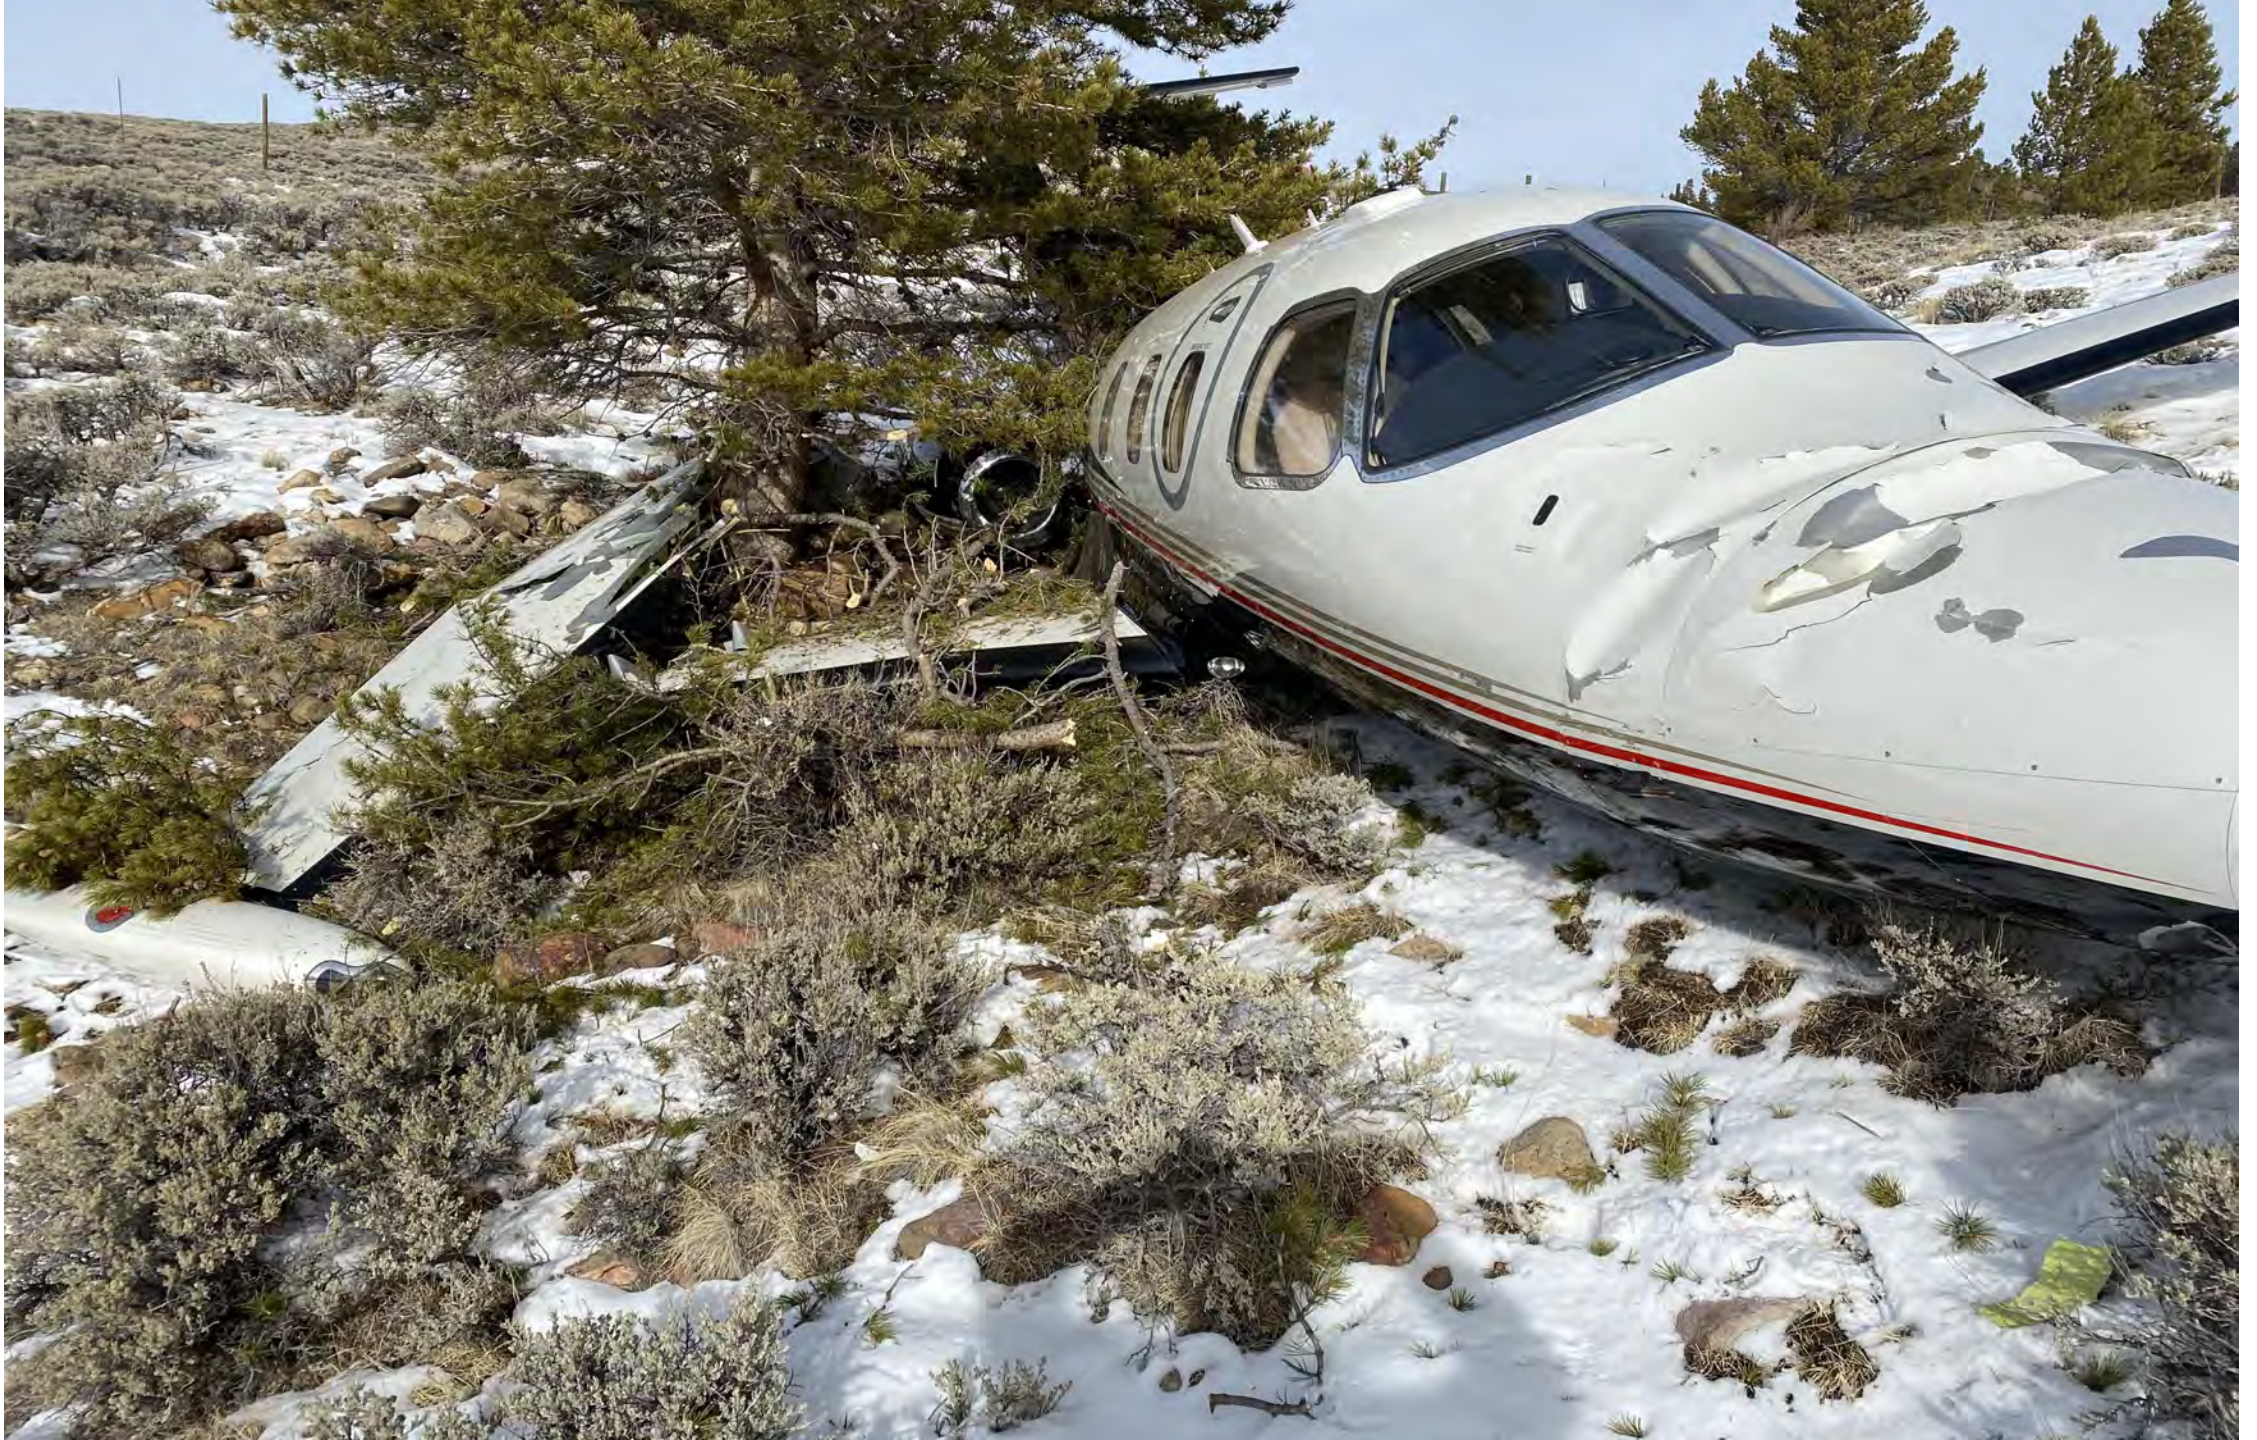
Upon touching down or shortly there after the aircraft began to skid down the runway leaving tire skid marks. The aircraft overshot the runway, breaking several Runway End Identifier Lights and leaving an equally distinctive trail in the snow through the safety area and to the edge of the embankment. At this point the ground left the aircraft and the airplane left no ground markings until ~ 50’ down the steep embankment landing on the ground again and then tearing out of the ground ~ 100’ of heavy wildlife fencing snapping fence poles. The aircrafts nose wheel tire was left just prior to the fencing minus the rim. The aircraft continued for another 75~ feet before striking a large evergreen tree with its right wing tearing the right wing off ~7 ‘ from the root and immediately coming to rest. The pilot called his wife who was waiting on the ramp informing her he had gone off the end of the runway and was going to walk to her. German was notified by the wife, called 911 and responded to the runway end. There German saw a light from the pilot at the aircraft. He went to the plot and escorted him up the hill. EMS took over interactions with the pilot. He and his wife left for home after being checked out.
