| <b>Rolls-Royce</b> | Rolls-Royce Corporation<br>450 S. Meridian Street<br>Indianapolis, Indiana<br>46225-1103, USA | <b>REPORT NO.</b><br>21FAE-055 | <b>REV.</b><br>Initial | <b>PAGES</b><br>1 of 108 |
| <b>TITLE</b><br><b>METALLURGICAL INVESTIGATION OF A THIRD STAGE TURBINE WHEEL, P/N 23065818, REMOVED FROM AN M250, ENGINE S/N CAE835942, OPERATED BY SIGNATURE UTILITY SERVICES</b> | | <b>PREPARED</b><br>Digitally signed by Alexander Sheridan_9782(Bldentity)<br>Date: 2022.05.03 10:26:22 -04'00' | | |

| Part Name: | Third Stage Turbine Wheel |
| Engine Model: | M250-C20B |

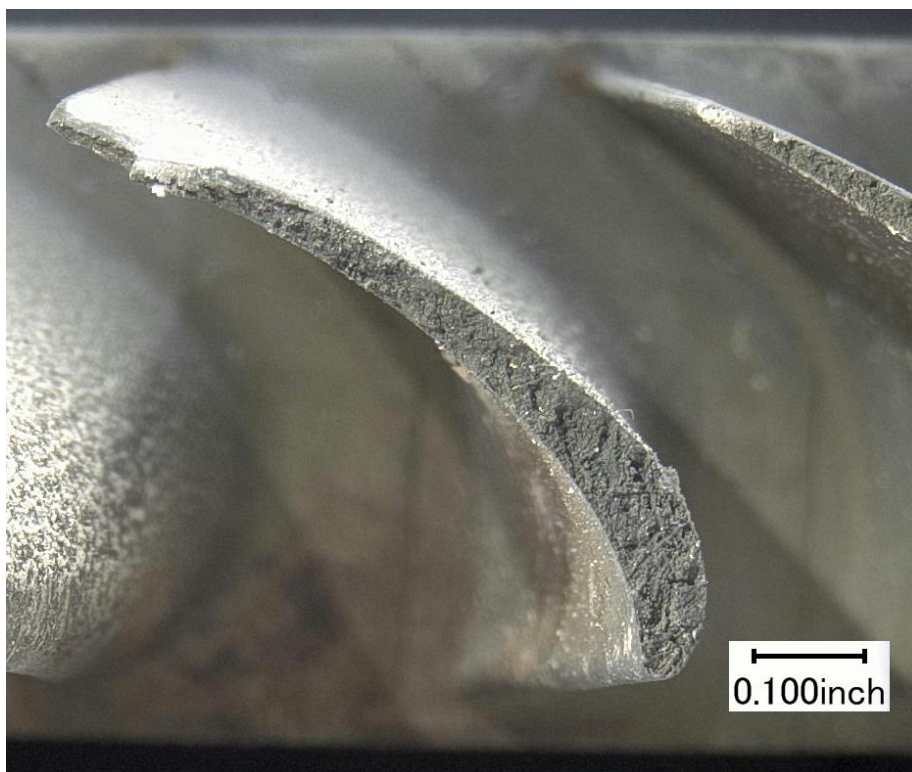
Detailed optical examination of the airfoil fracture surfaces (prior to cleaning for FPI) revealed interdendritic features consistent with overload fracture intermixed with smearing damage. Figure 11 shows detailed views of the fracture surfaces on the first (#1) and last (#7) airfoils in the packet before cleaning, both of which exhibited interdendritic fracture features consistent with overload. The fracture surfaces on the other airfoils, shown after ultrasonic cleaning in Figure 12 through Figure 14, also exhibited interdendritic features consistent with overload.

**Figure 13.** Fracture surfaces on blades #4 (top) and #5 (bottom) prior to cleaning. The green dashed line shows the approximate location of the radial-longitudinal section near the leading edge of blade #4 (LE4).

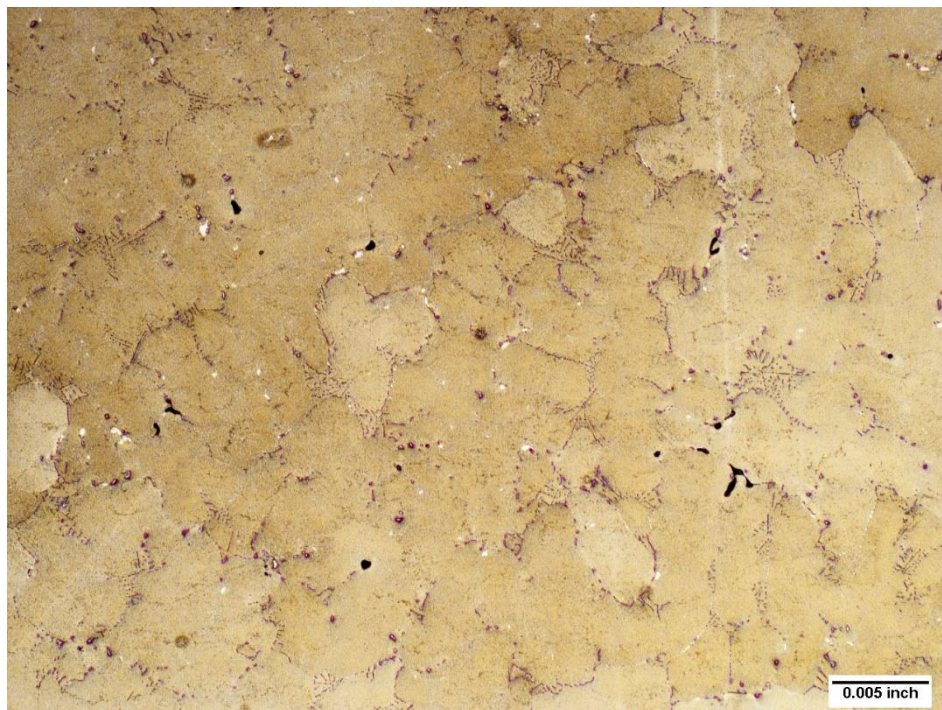
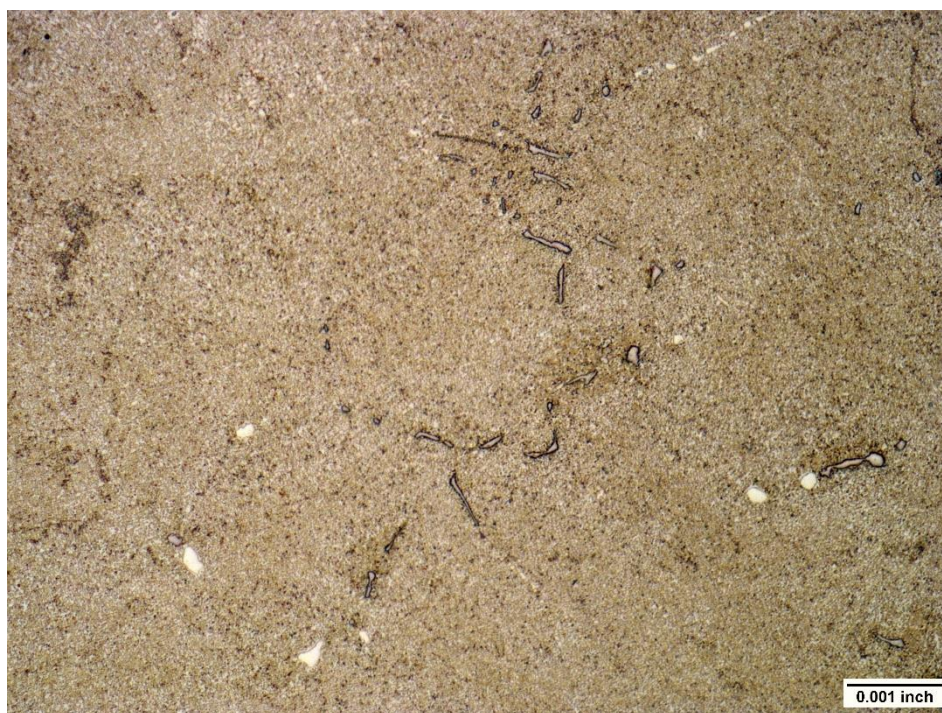
**Figure 24. Representative microstructure in the rim of the wheel on cross-section LE1. Etchant: MT.**

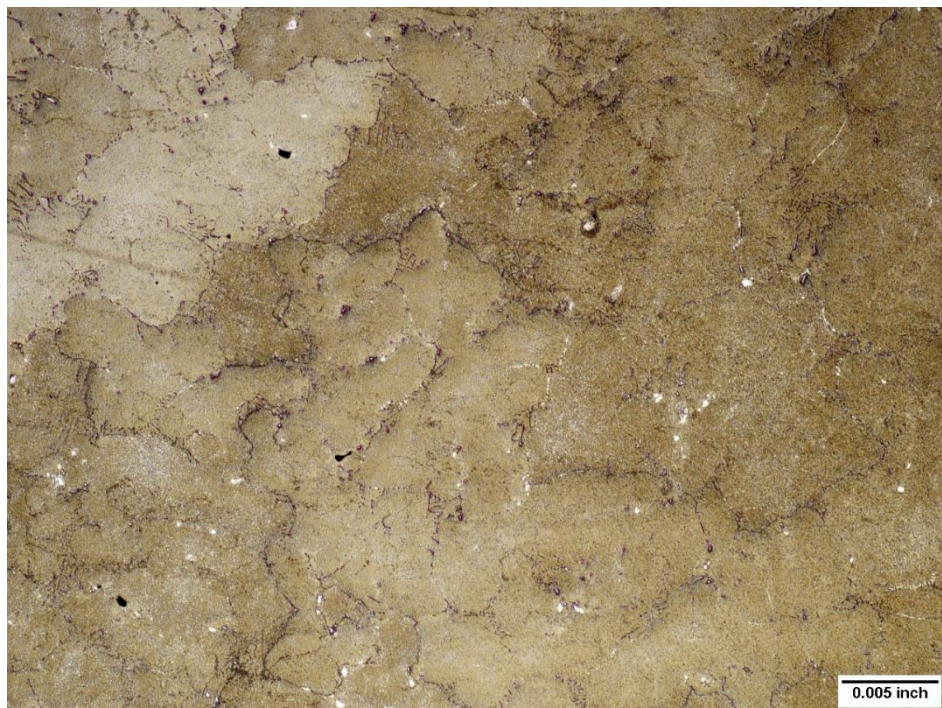
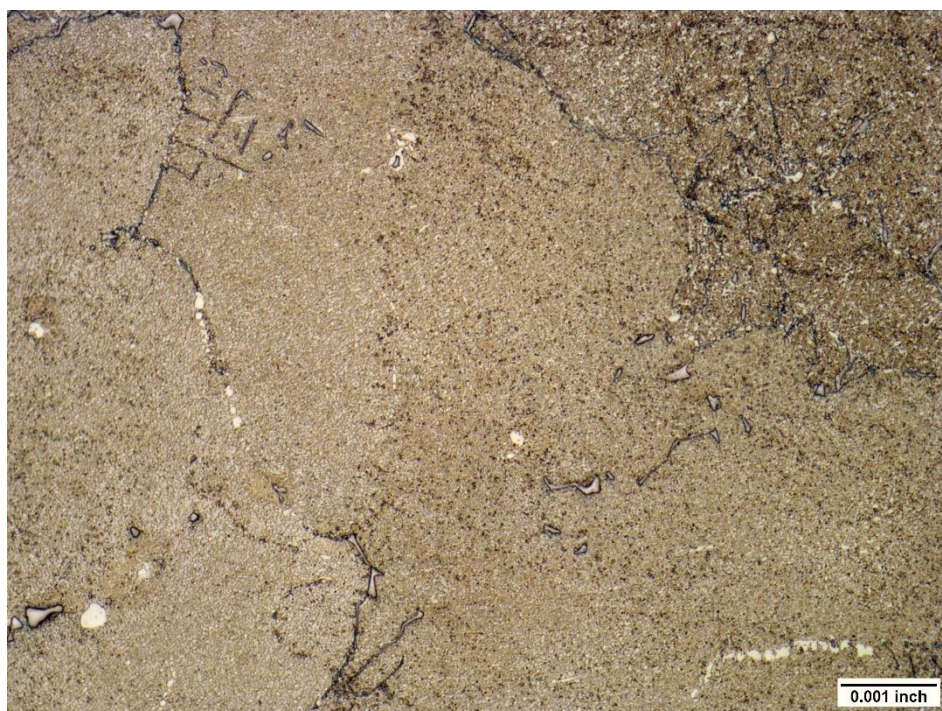
**Figure 25. Representative microstructure in the root of the blade on cross-section LE1. Etchant: MT.**

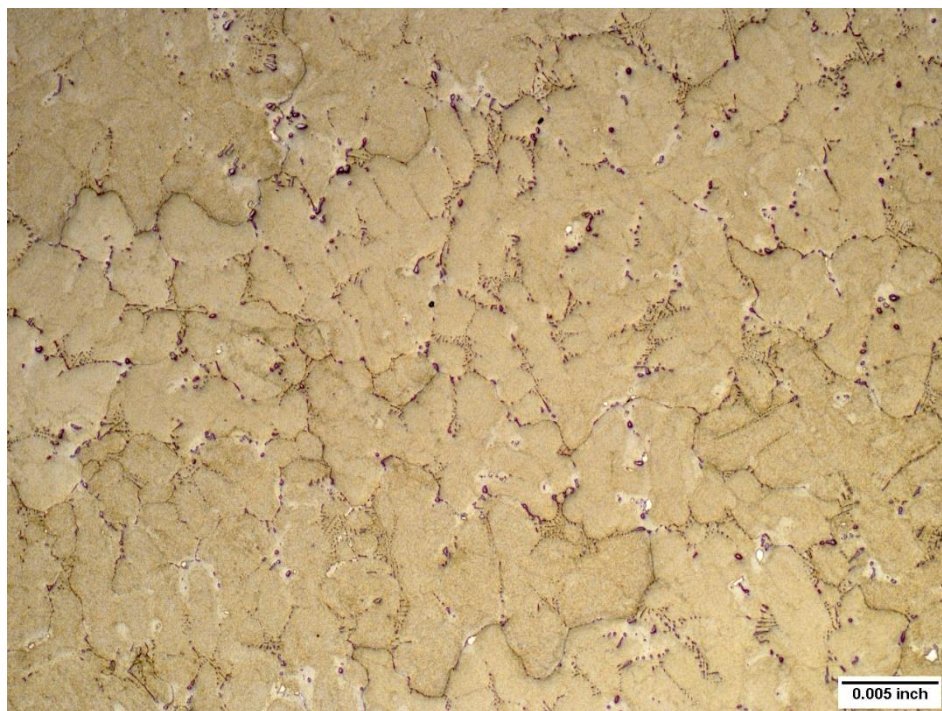
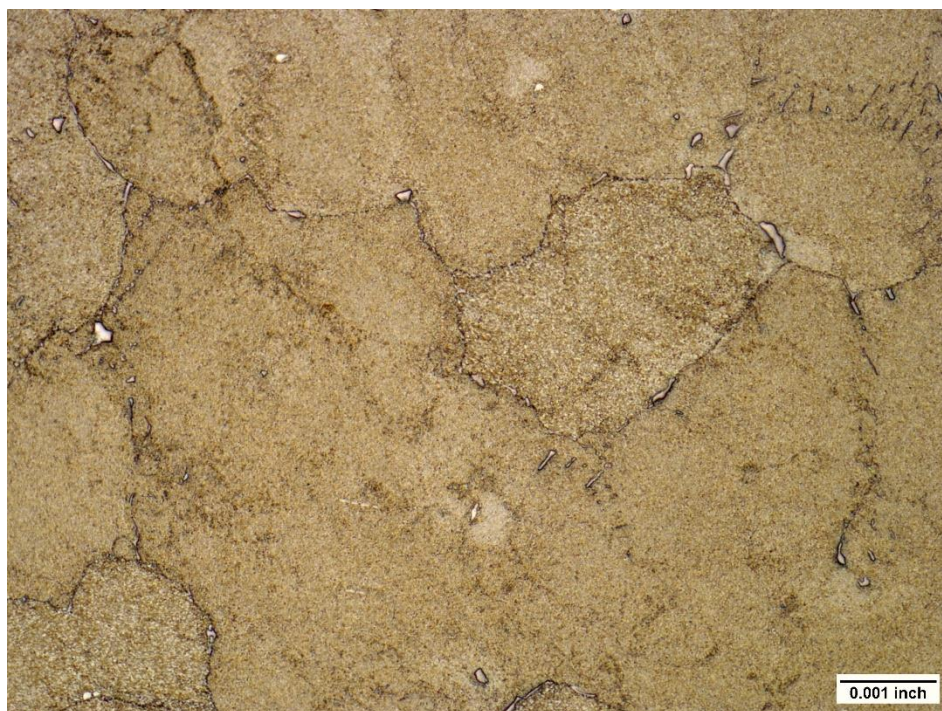
Figure 22 shows overall views of cross-section LE1 near the leading edge of blade #1. The outboard portion of the blade etched lighter than the inboard span. There was no evidence of stress rupture void formation on the cross-section as shown in Figure 23. Detailed views of the microstructure in the rim of the wheel, the root of the blade, the lighter etching area, and near the fracture surface are shown in Figure 24 through Figure 27. In the lighter etching area, the gamma prime structure appeared finer than in the rest of the blade consistent with re-solutioned and re-precipitated gamma prime from elevated temperature exposure. SEM examination of other third stage turbine blade cross-sections with similar lighter etching areas where the gamma prime appeared finer, including the trailing edge section of the same airfoil, revealed refined gamma prime, discussed later. SEM examination was not conducted on cross-section LE1.

**Figure 26. Representative microstructure in the lighter etching thermally distressed area of the blade on cross-section LE1. Etchant: MT.**

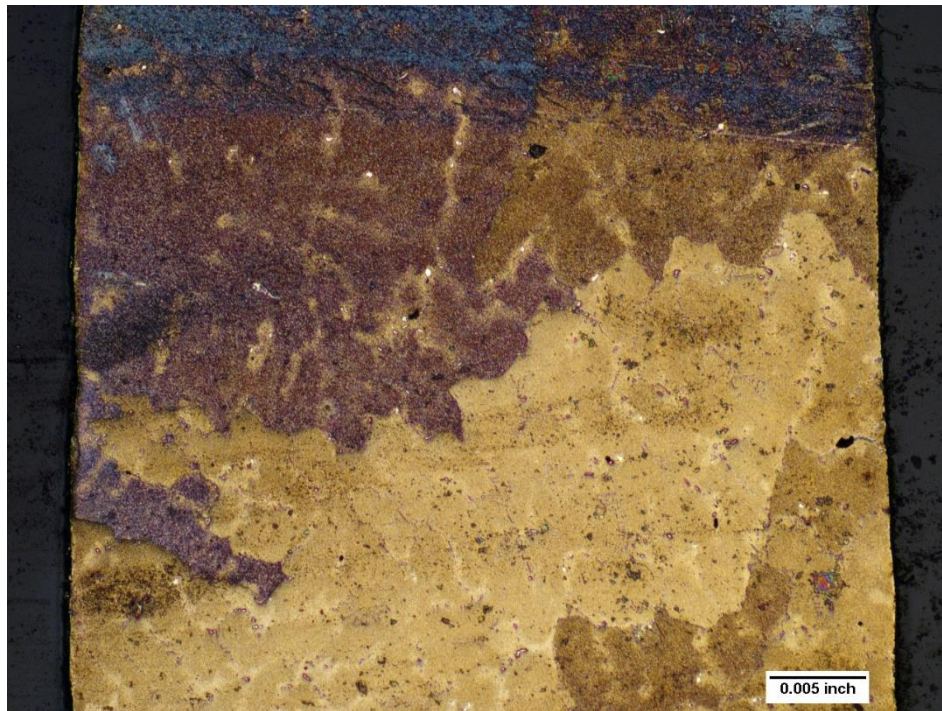
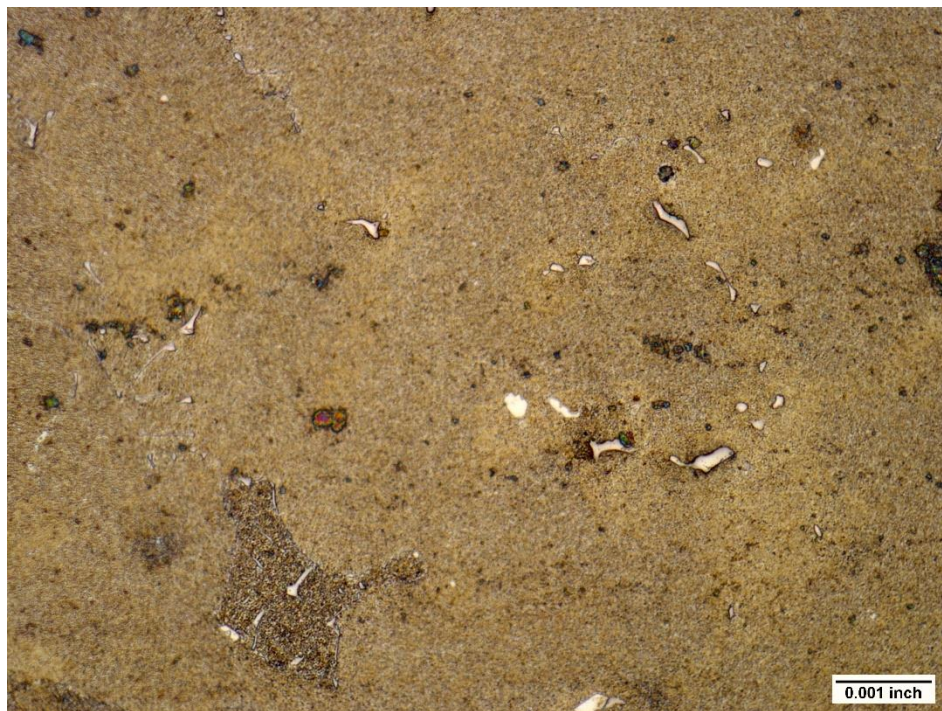
**Figure 27. Representative microstructure near the fracture on cross-section LE1. The dark purple-etching area near the tip was overetched during etching and does not indicate thermal distress to the microstructure. Etchant: MT.**

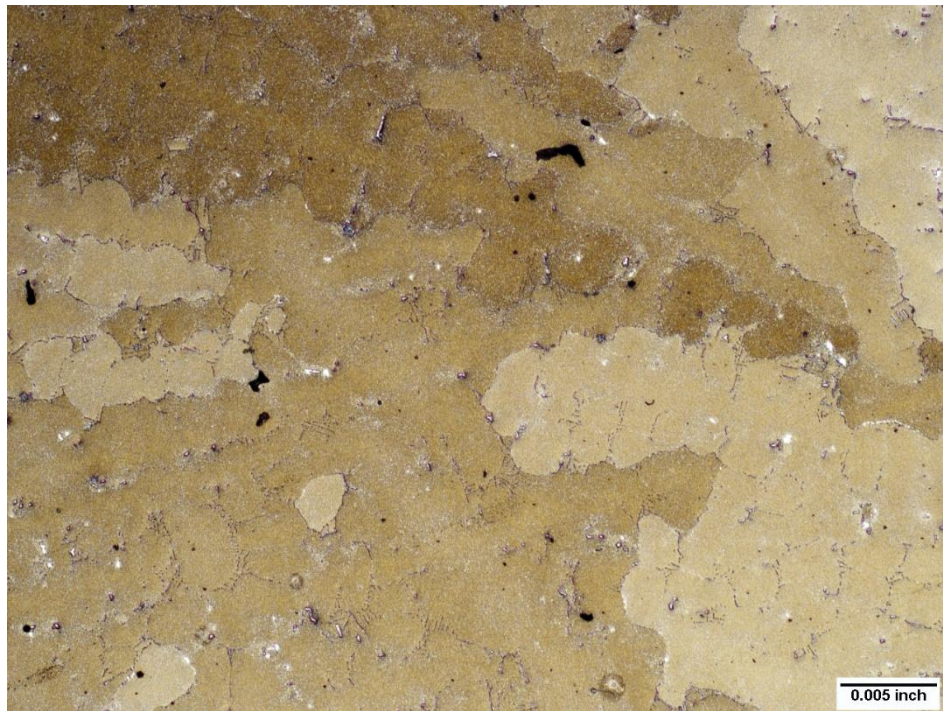
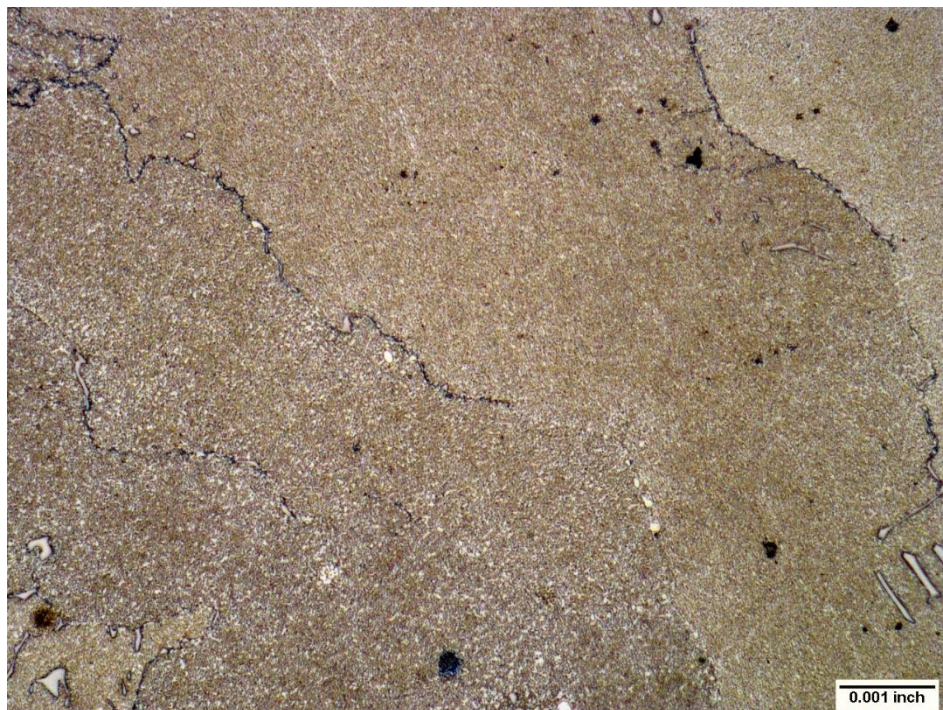
**Figure 30. Representative microstructure in the rim of the wheel on cross-section TE1. Etchant: MT.**

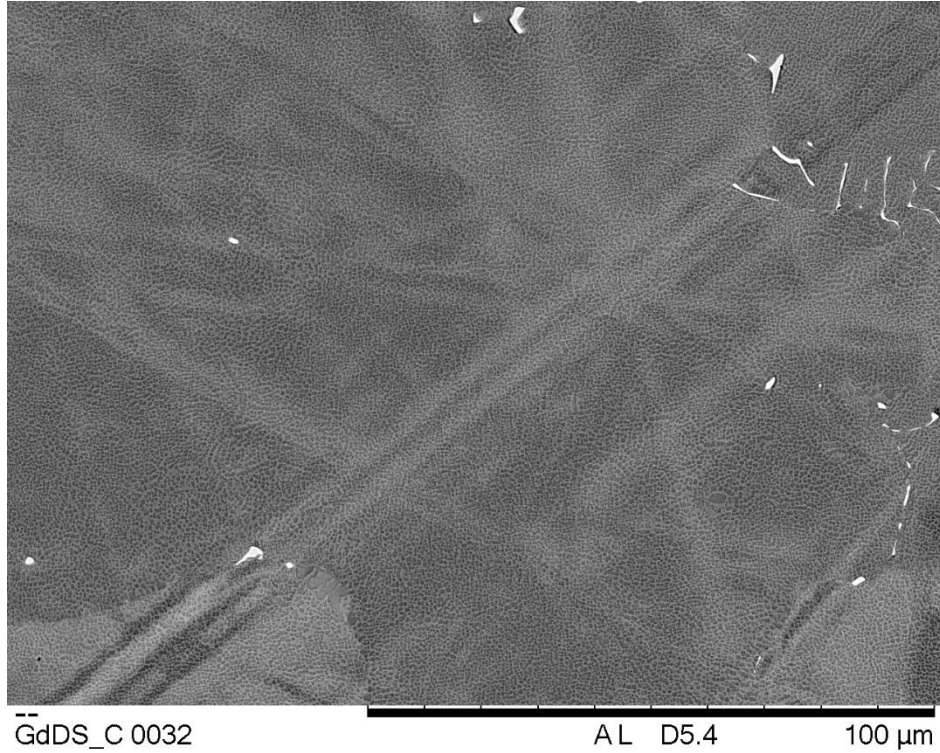
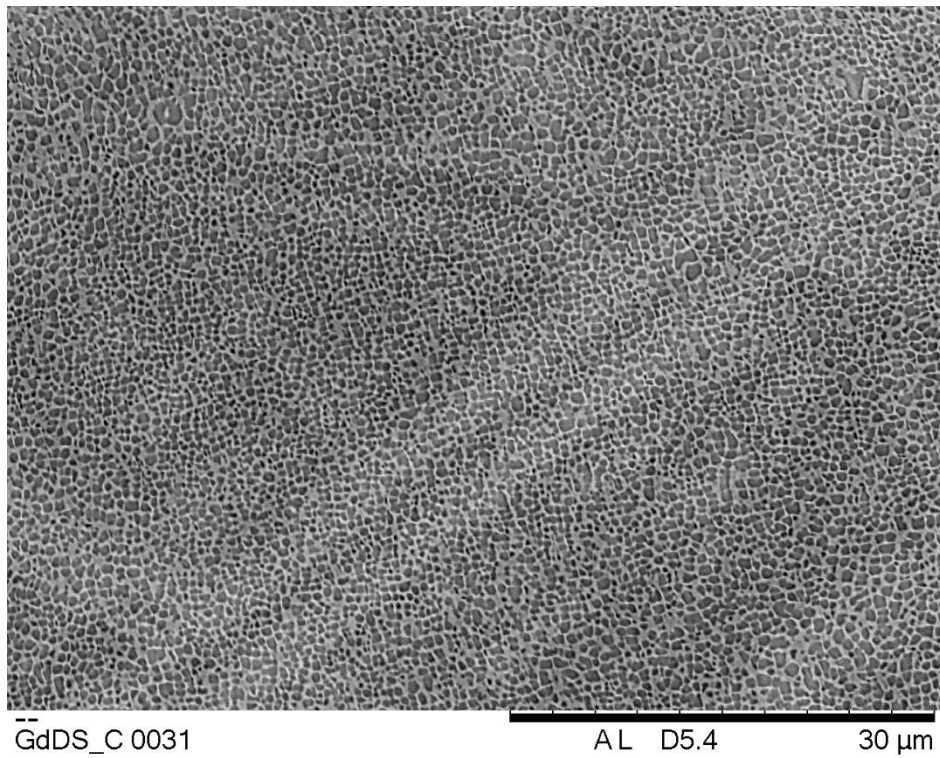
**Figure 31. Backscattered electron SEM images showing the gamma prime structure in the rim of the wheel on cross-section TE1. Etchant: MT.**

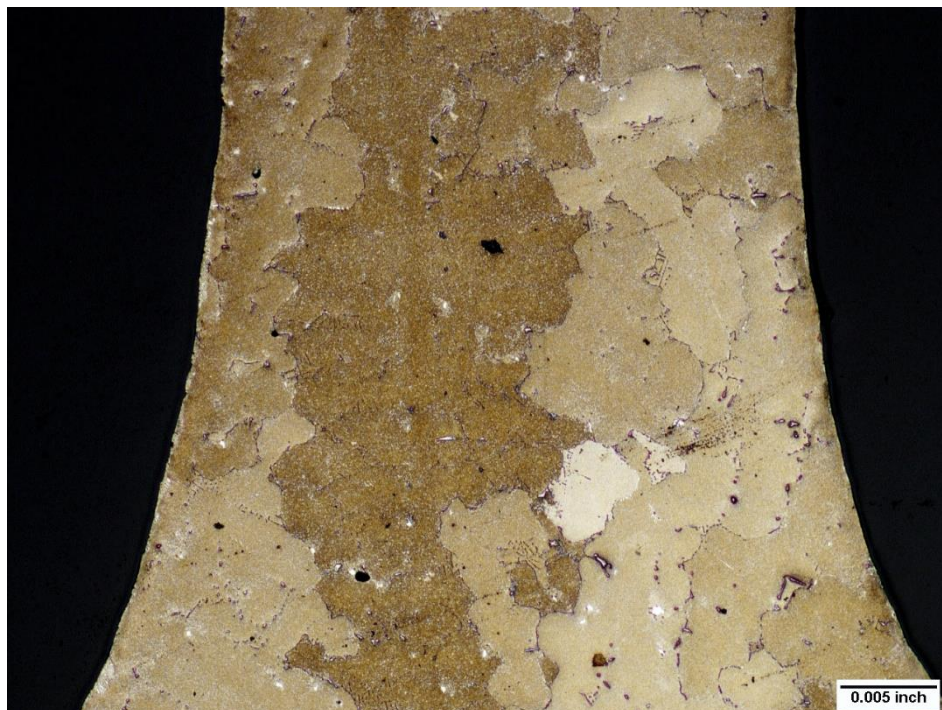
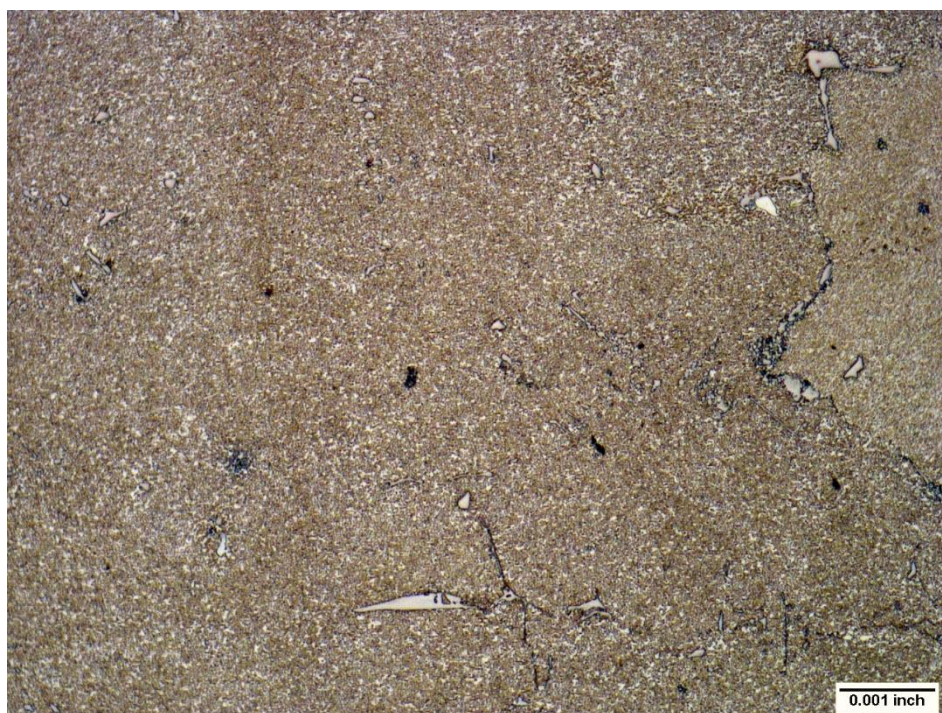
**Figure 32. Representative microstructure in the root of the blade on cross-section TE1. Etchant: MT.**

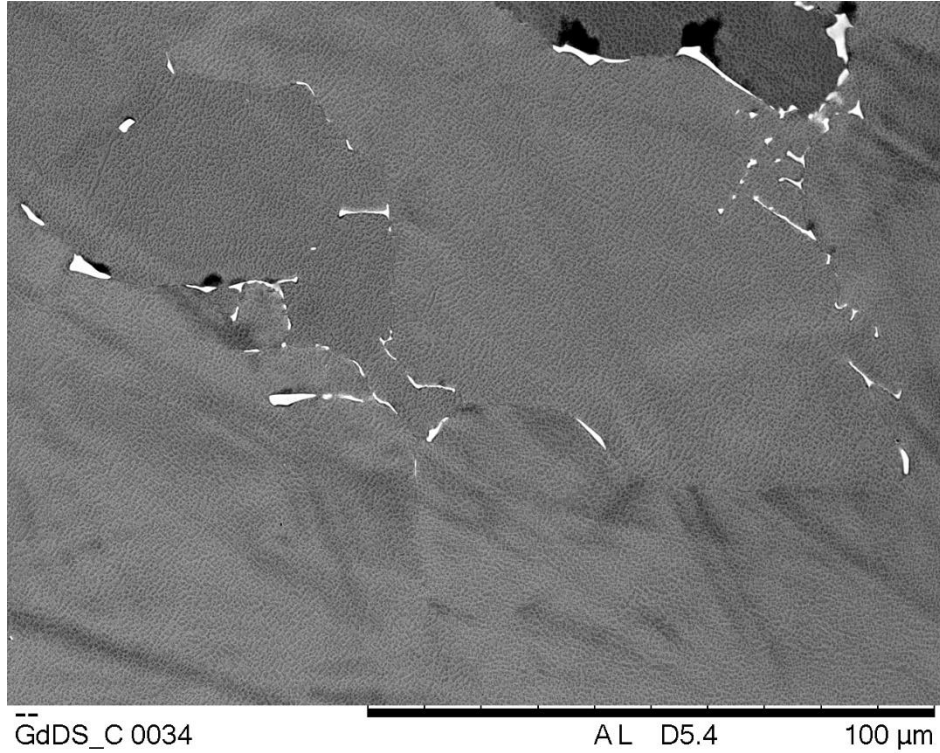
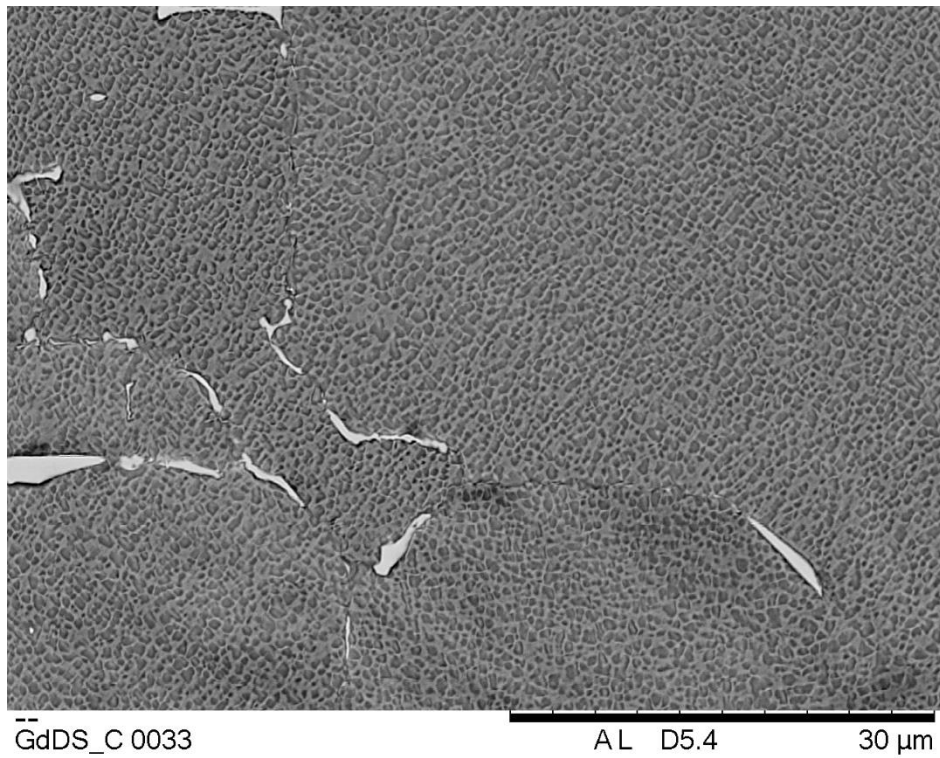
**Figure 33. Backscattered electron SEM images showing the gamma prime structure in the root of the blade on cross-section TE1. Etchant: MT.**

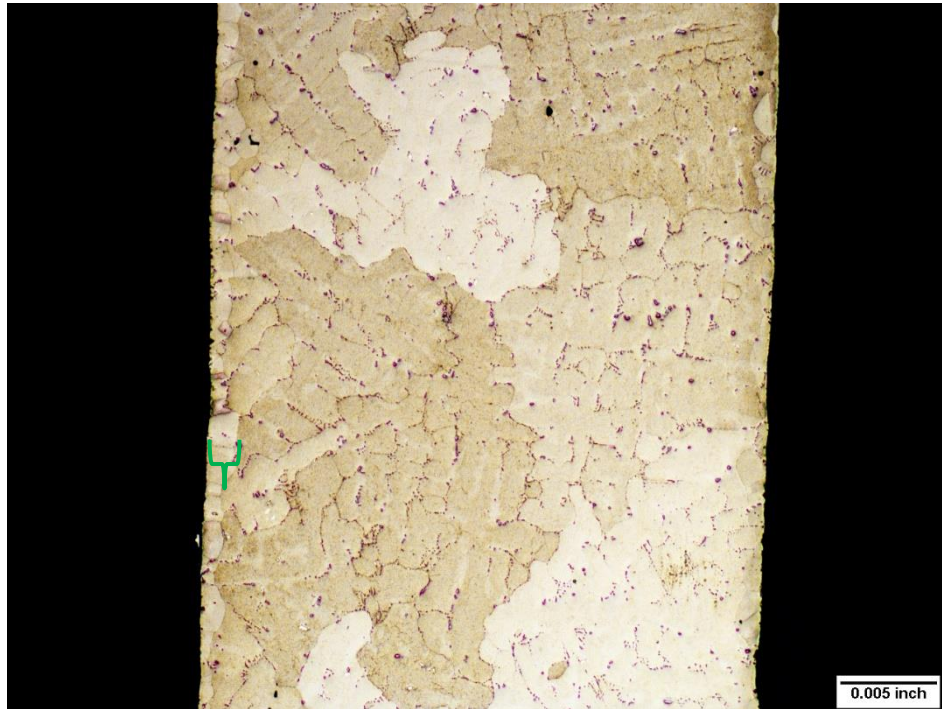
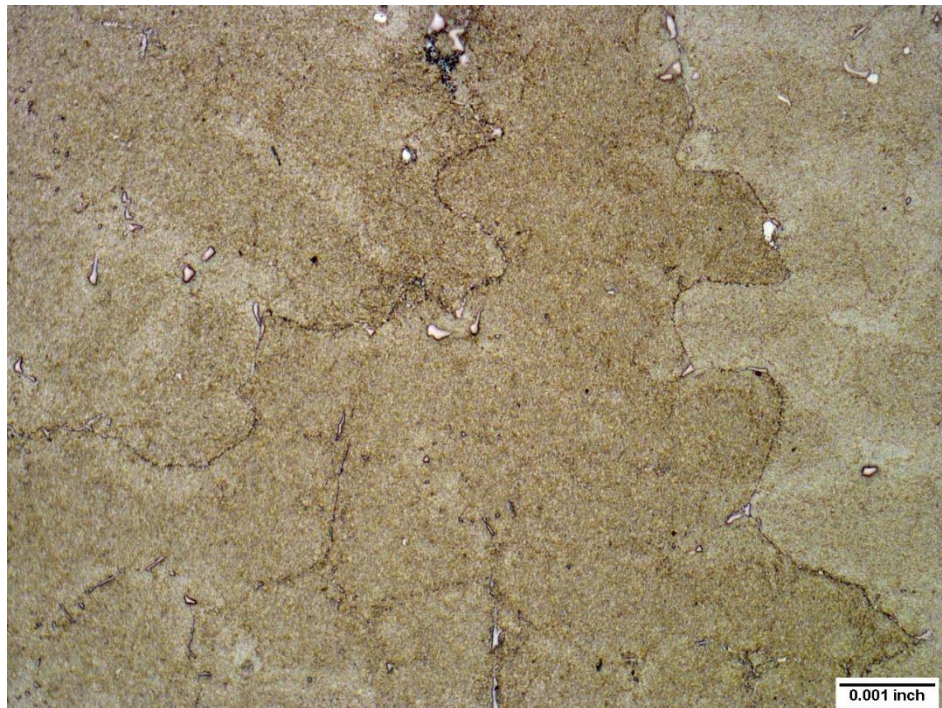
distress, and in the thermally distressed region are shown in Figure 30 through Figure 35. In the lighter etching area, the gamma prime was finer than in the root and platform, consistent with re-precipitated gamma prime formed after exposure above the re-solutioning temperature of approximately 2150°F for an EMS73648-3 (IN-713) type material. A re-crystallization layer was found on the airfoil surfaces in the thermally distressed area that was not present away from the thermal distress.

**Figure 34. Representative microstructure in the lighter etching thermally distressed area inboard of the fracture on cross-section TE1. Representative re-crystallization at the airfoil surfaces in the thermally-distressed area indicated by the green brace. Etchant: MT.**

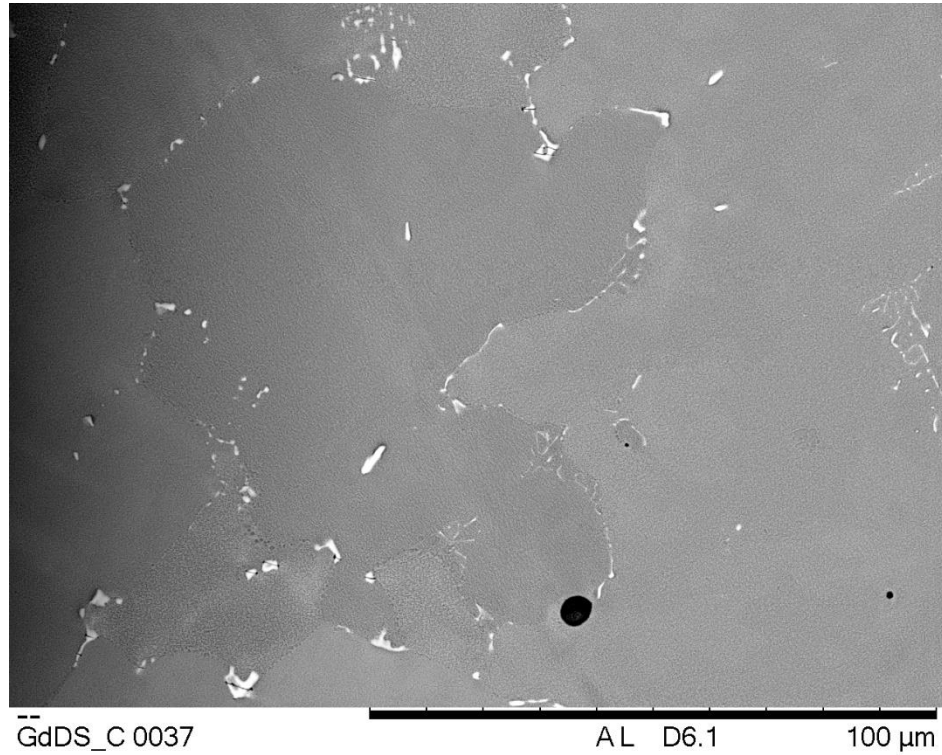
**Figure 35. Backscattered electron SEM images showing the gamma prime structure in the thermally distressed area inboard of the fracture on cross-section TE1. Etchant: MT.**

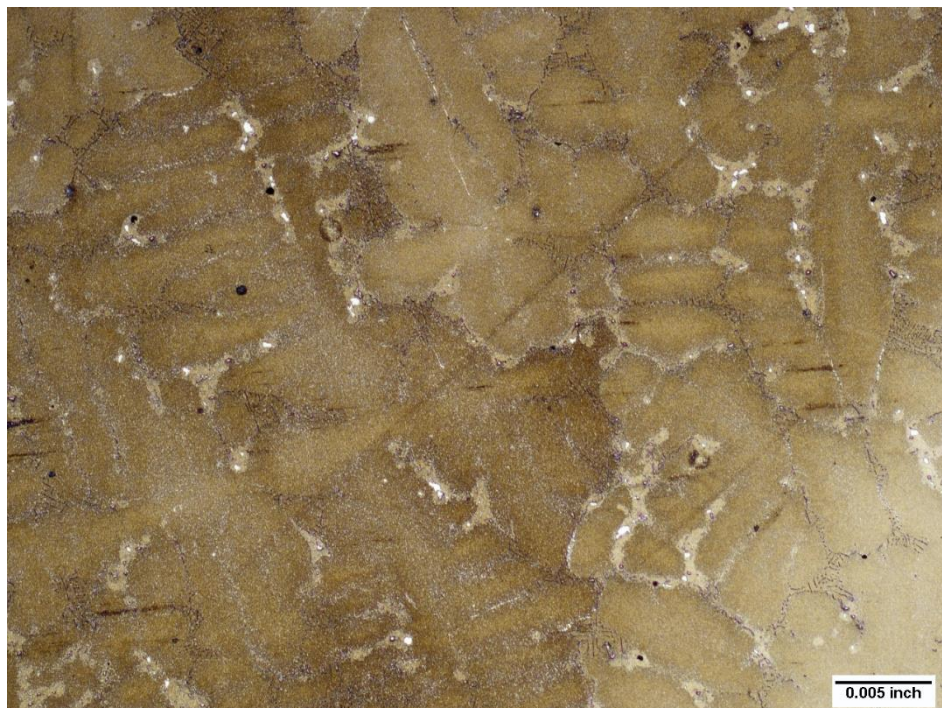
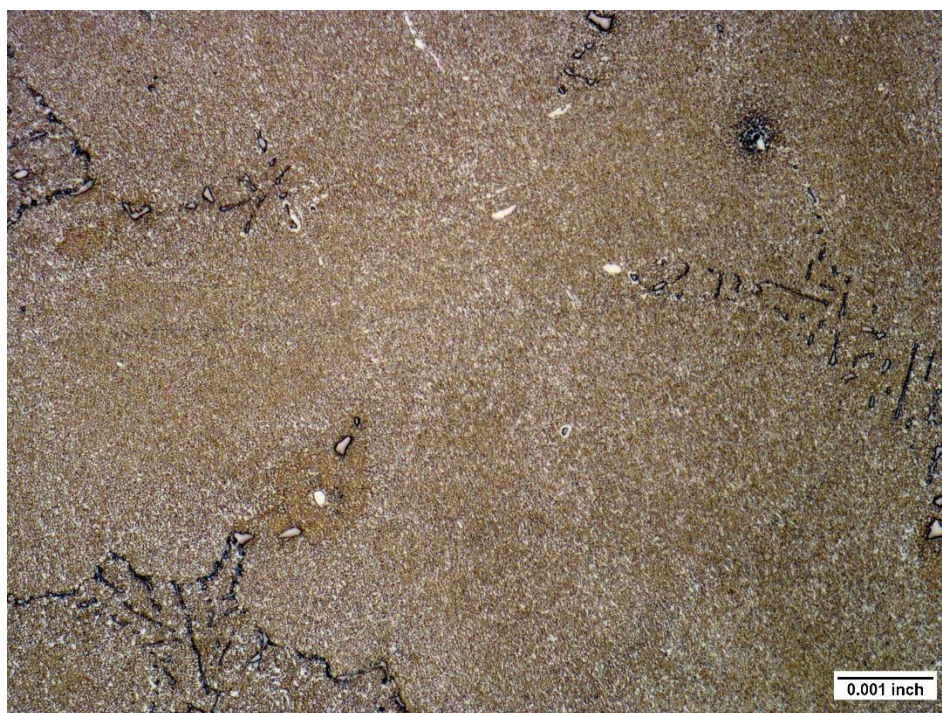
**Figure 38. Representative microstructure in the rim of the wheel on cross-section LE4. Etchant: MT.**

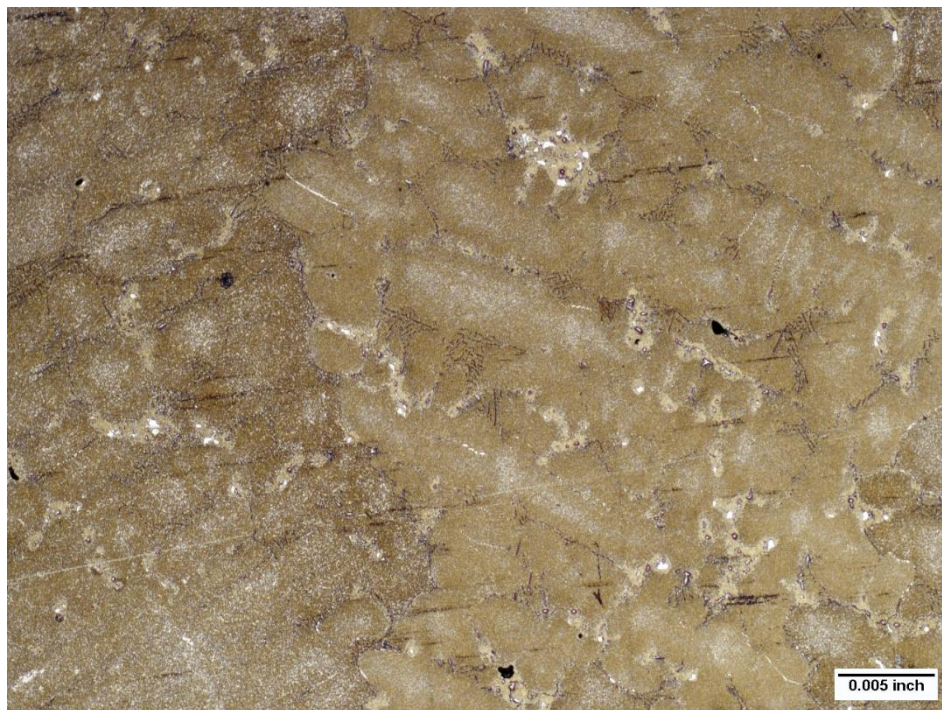
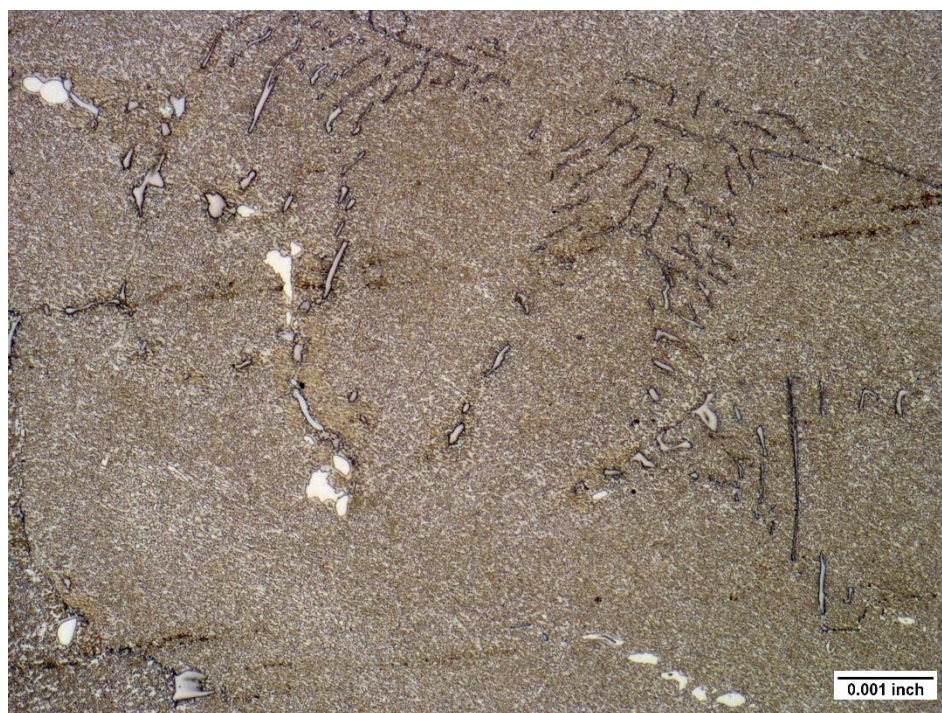
**Figure 39. Representative microstructure in the root of the blade on cross-section LE4. Etchant: MT.**

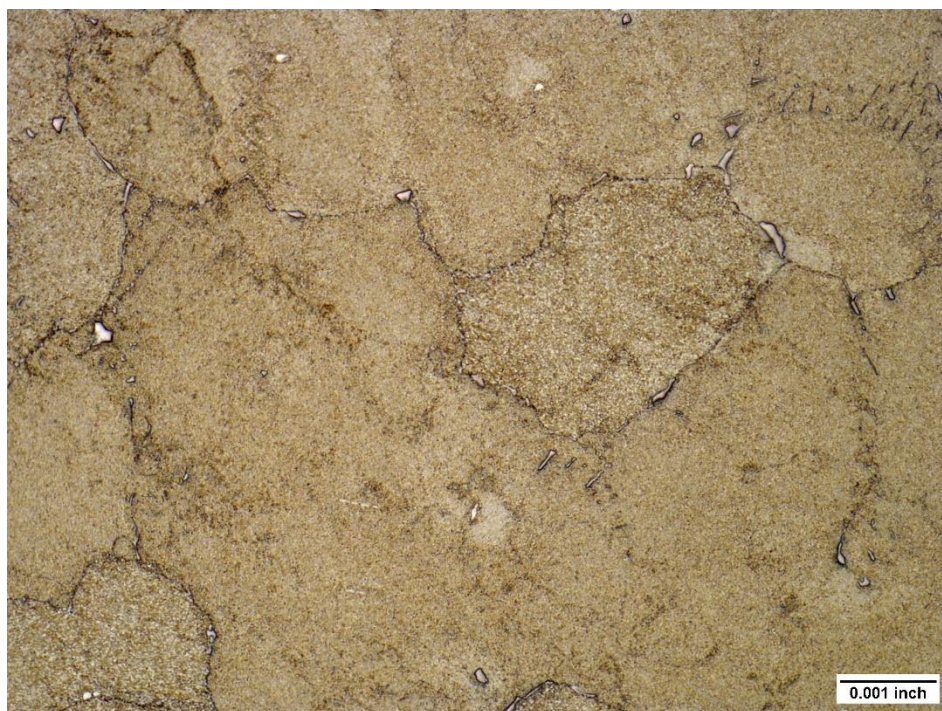
Figure 36 shows overall views of cross-section LE4 near the leading edge of blade #4. The outboard portion of the blade etched lighter than the inboard span. There was no evidence of stress rupture void formation on the cross-section as shown in Figure 37. The cross-section was examined in the etched condition with an optical metallograph, and representative images showing the microstructure in the rim of the wheel, in the root of the blade inboard of the thermal distress, in the thermally distressed region, and at the fracture surface are shown in Figure 38 through Figure 41. In the lighter etching area, which extended to the fracture surface, the gamma prime was finer than in the root and platform consistent with re-precipitated gamma prime.

**Figure 40. Representative microstructure in the lighter etching thermally distressed area inboard of the fracture on cross-section LE4. Etchant: MT.**

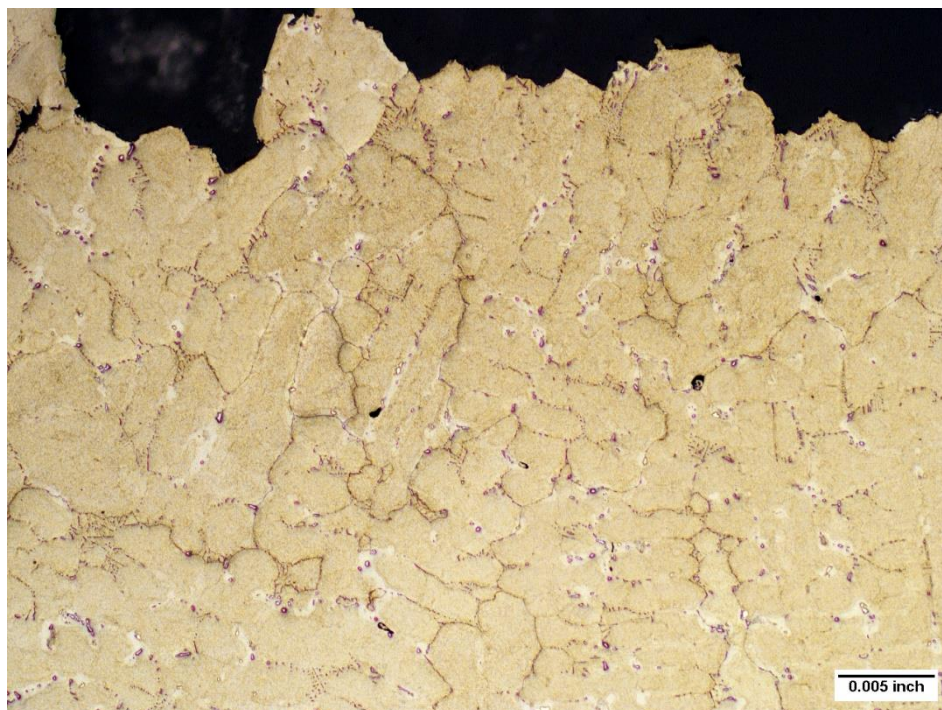
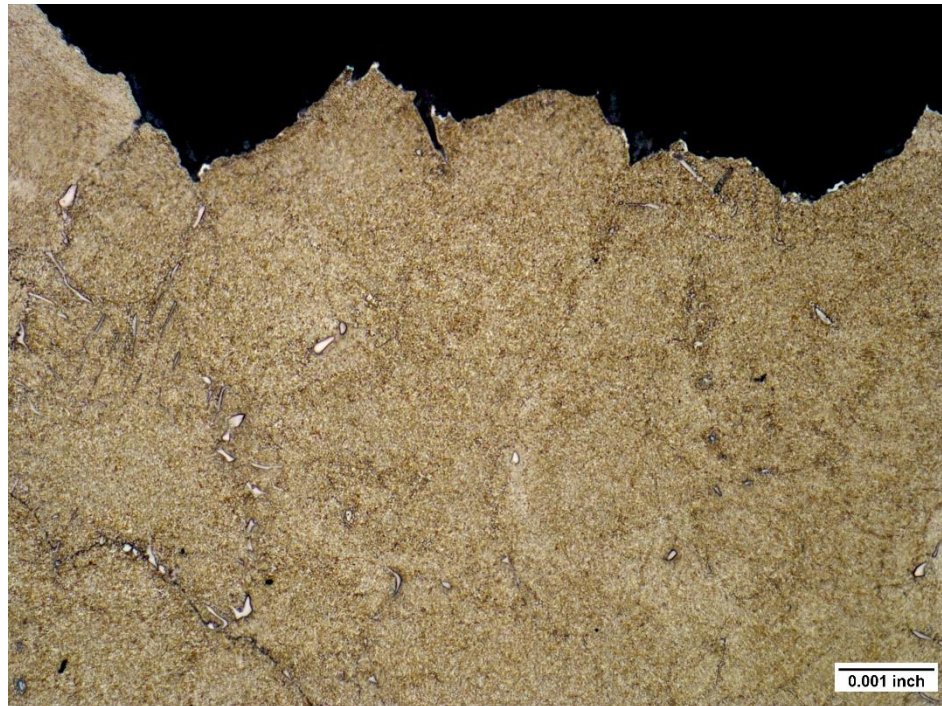
**Figure 41. Representative microstructure near the fracture on cross-section LE4. Etchant: MT.**

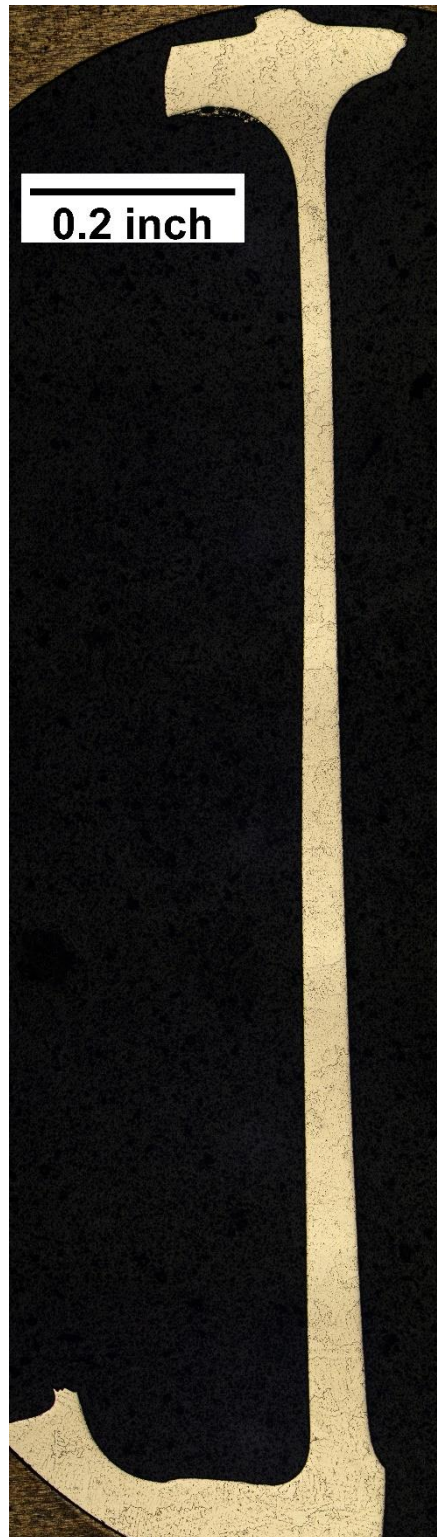
Figure 42 and Figure 43 show overall views of cross-section TE8 near the trailing edge of blade #8, which was unfractured. The microstructure etched lighter in an area measuring approximately 60% of the total airfoil span centered slightly outboard of midspan, consistent with thermal distress. There was no evidence of stress rupture void formation on the cross-section. The cross-section was examined in the etched condition with an optical metallograph and in the SEM under backscattered electron imaging, and representative images showing the microstructure and gamma prime structure in the rim of the wheel, in the root of the blade inboard of the thermal distress, in the thermally distressed region, and in the shroud are shown in Figure 45 through Figure 51. In the thermally distressed region, the gamma prime was finer than in the root and platform, consistent with re-precipitated gamma prime formed after exposure above the re-solutioning temperature of approximately 2150°F for an EMS73648-3 (IN-713) type material. There was also a re-crystallization layer present on the airfoil surfaces in the thermally distressed area that measured up to 0.002 inch deep that was not present away from the thermal distress.

**Figure 42.** Overall view of longitudinal cross-section TE8 near the trailing edge on unfractured blade #8. There was no evidence of stress rupture void formation on the cross-section. Unetched.

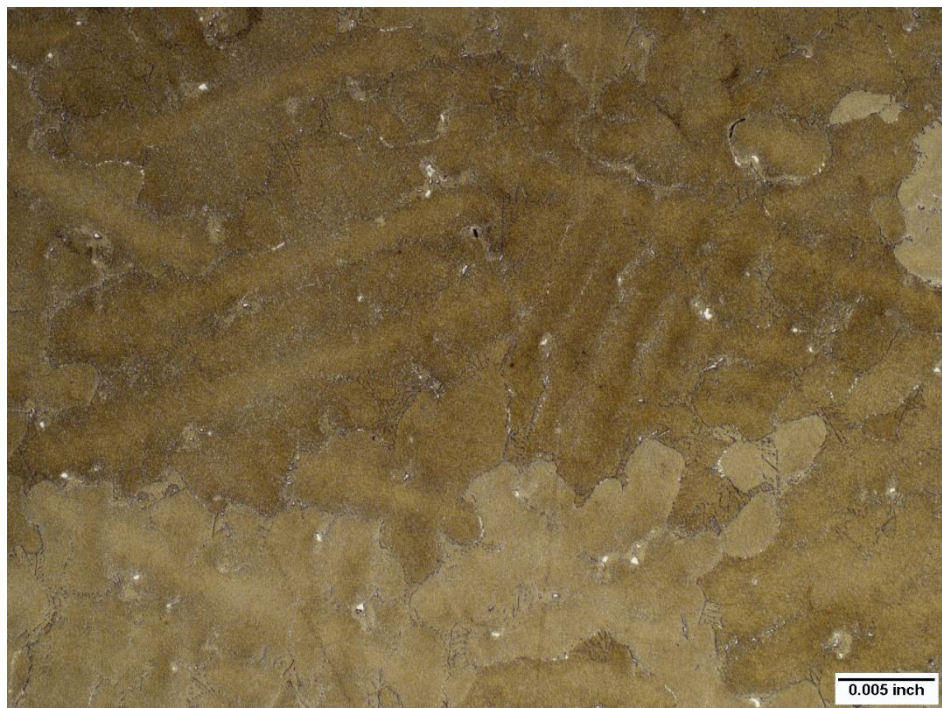
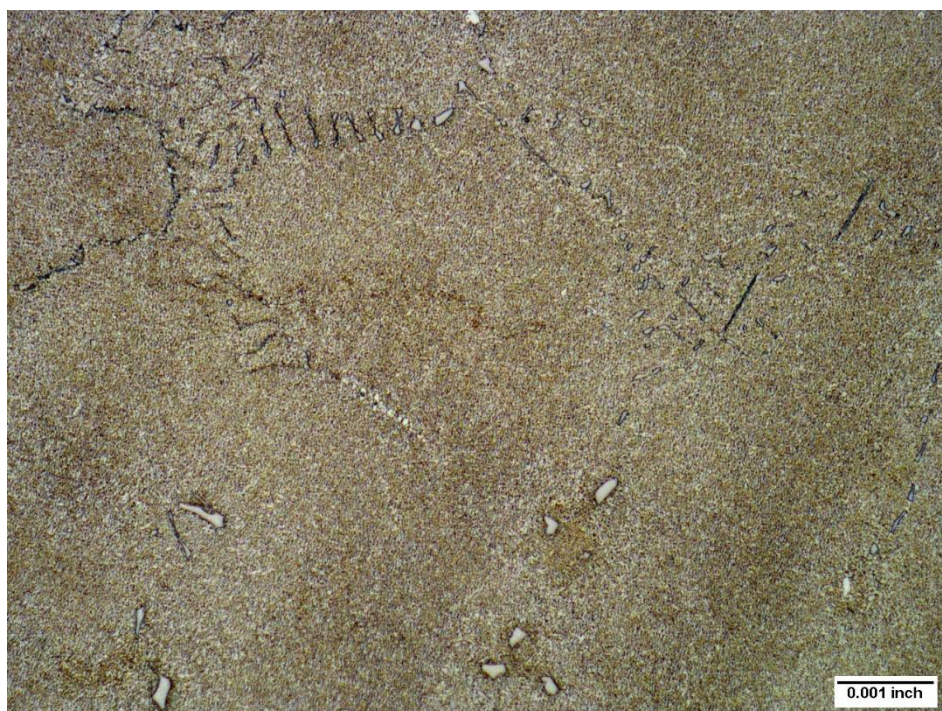
**Figure 44. Representative microstructure in the rim of the wheel on cross-section TE8. Etchant: MT.**
