| <b>Rolls-Royce</b> | Rolls-Royce Corporation<br>450 S. Meridian Street<br>Indianapolis, Indiana<br>46225-1103, USA | <b>REPORT NO.</b><br>21FAE-055 | <b>REV.</b><br>Initial | <b>PAGES</b><br>1 of 108 |
| <b>TITLE</b><br><b>METALLURGICAL INVESTIGATION OF A THIRD STAGE TURBINE WHEEL, P/N 23065818, REMOVED FROM AN M250, ENGINE S/N CAE835942, OPERATED BY SIGNATURE UTILITY SERVICES</b> | | <b>PREPARED</b><br>Digitally signed by Alexander Sheridan_9782(Bldentity)<br>Date: 2022.05.03 10:26:22 -04'00' | | |

| Part Name: | Third Stage Turbine Wheel |
| Engine Model: | M250-C20B |

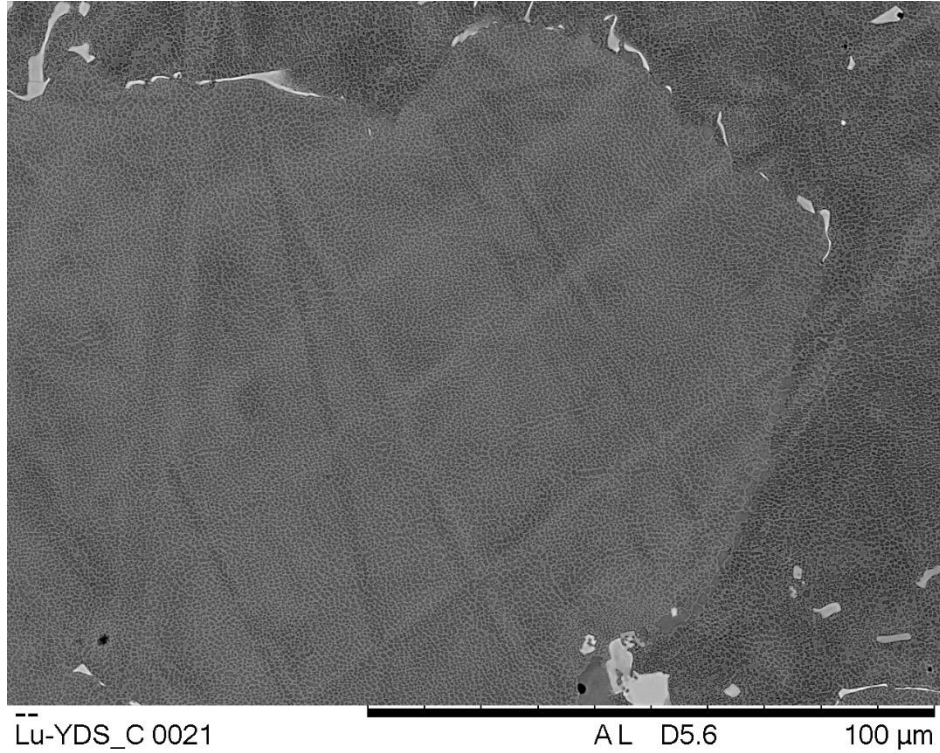
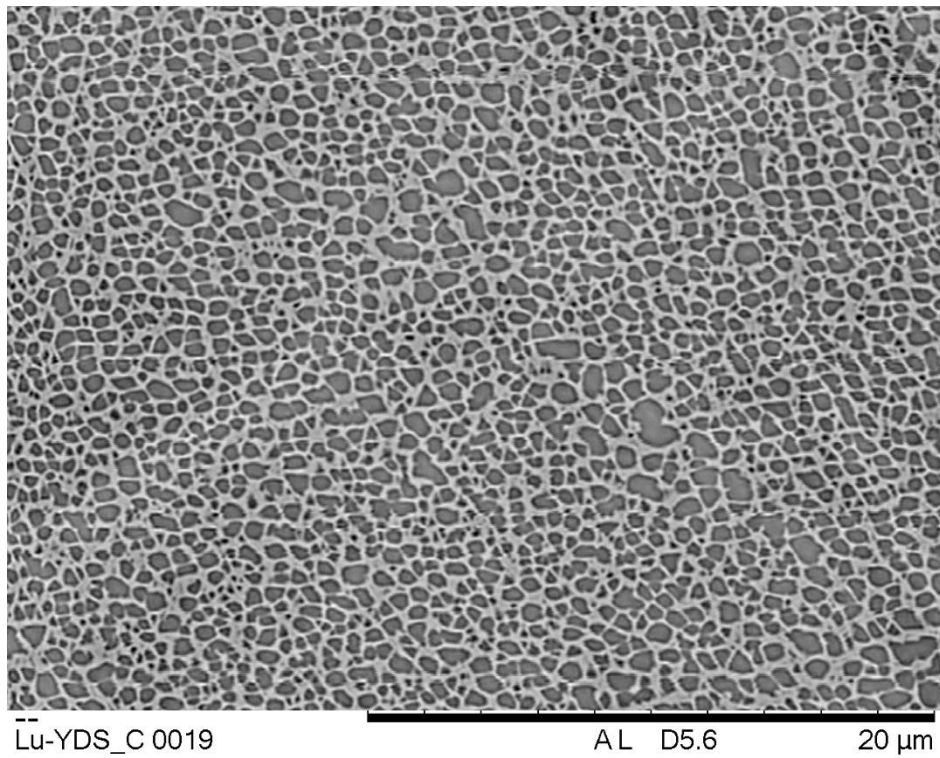
**Figure 45. Backscattered electron SEM images showing the gamma prime structure in the rim of the wheel on cross-section TE8. Etchant: MT.**

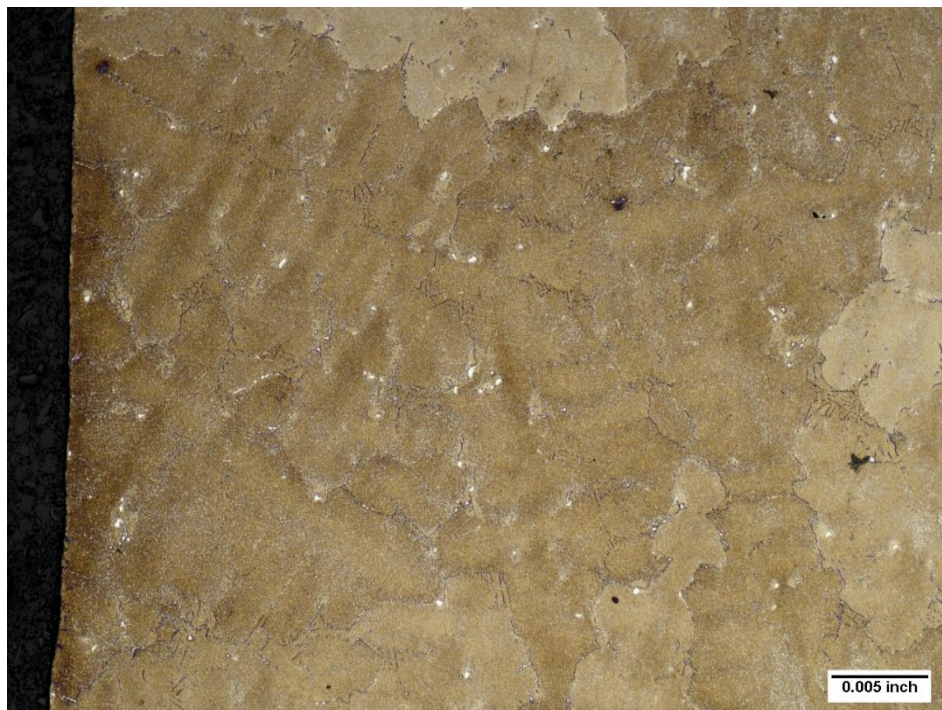
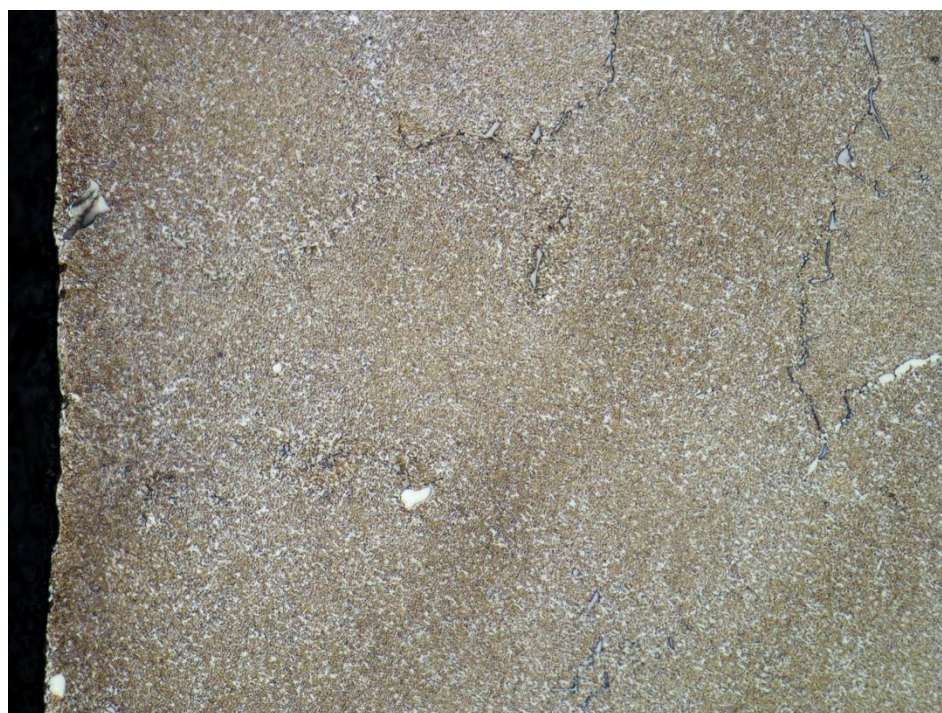
**Figure 46. Representative microstructure in the root of the blade on cross-section LE4. Etchant: MT.**

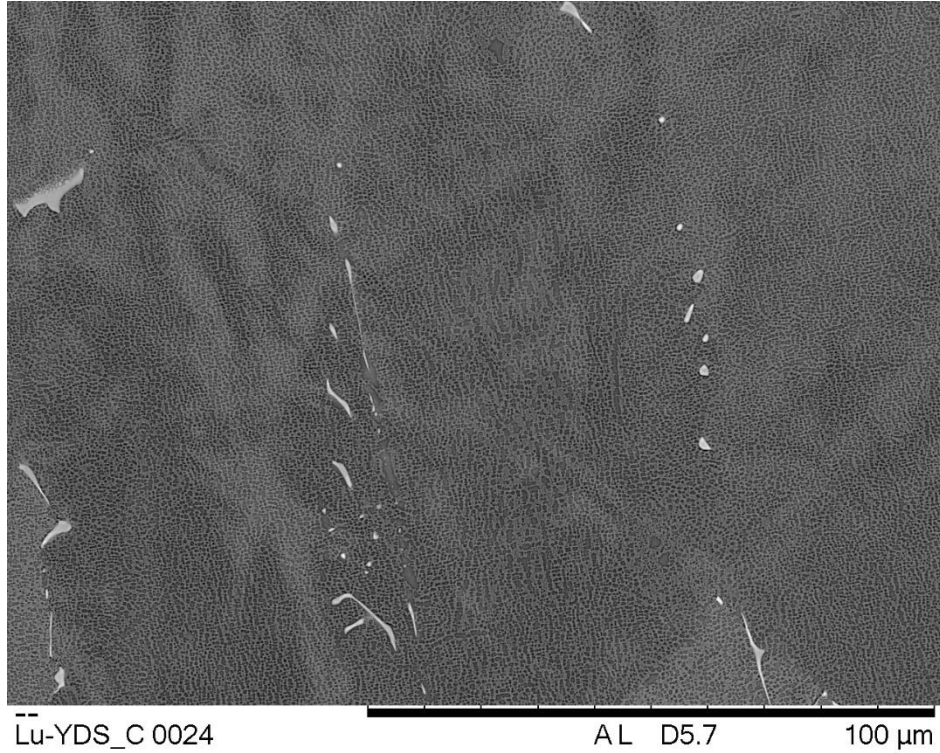
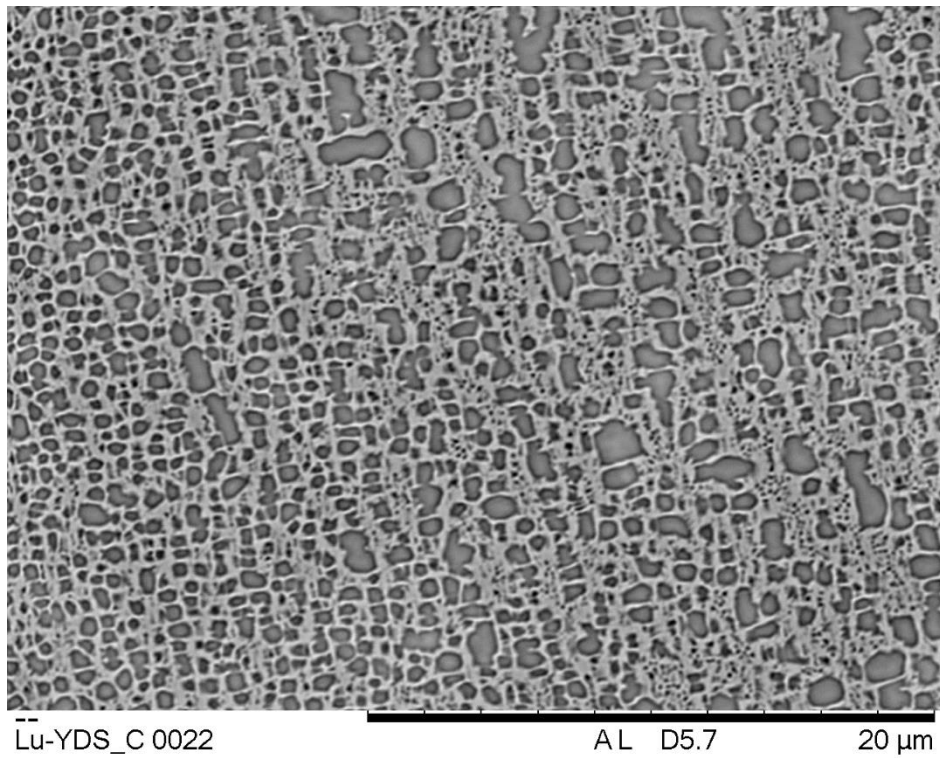
**Figure 47. Backscattered electron SEM images showing the gamma prime structure in the root of the blade on cross-section TE8. Etchant: MT.**

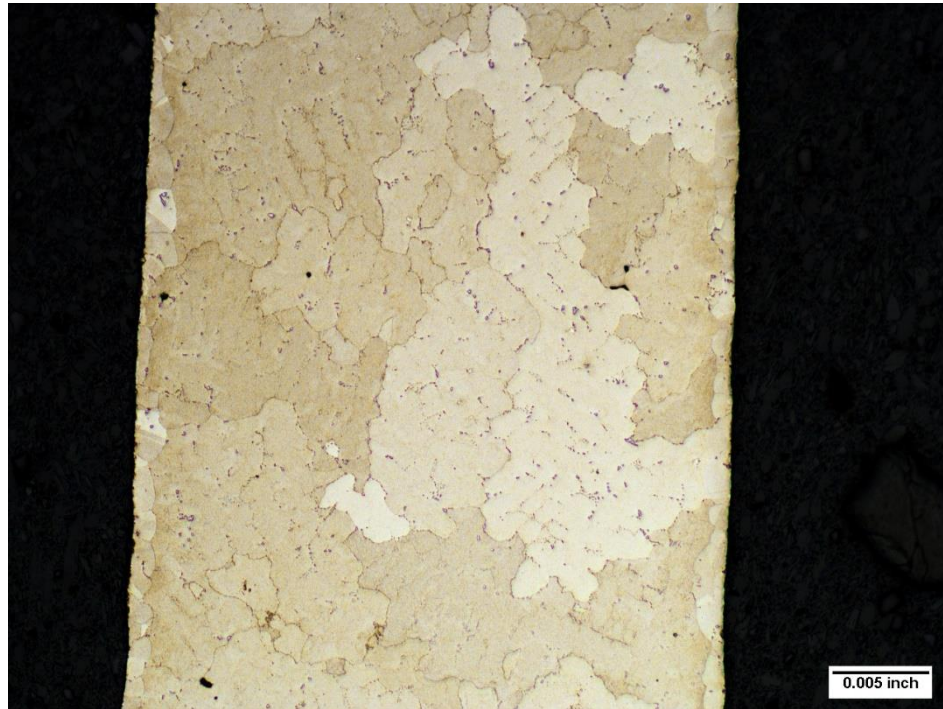
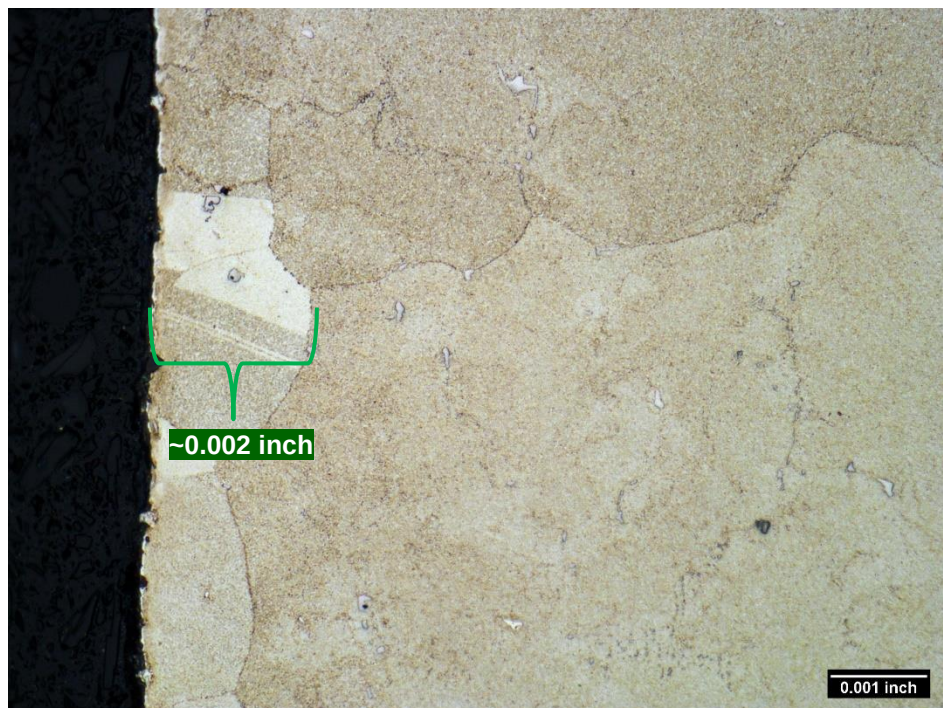
Figure 42 and Figure 43 show overall views of cross-section TE8 near the trailing edge of blade #8, which was unfractured. The microstructure etched lighter in an area measuring approximately 60% of the total airfoil span centered slightly outboard of midspan, consistent with thermal distress. There was no evidence of stress rupture void formation on the cross-section. The cross-section was examined in the etched condition with an optical metallograph and in the SEM under backscattered electron imaging, and representative images showing the microstructure and gamma prime structure in the rim of the wheel, in the root of the blade inboard of the thermal distress, in the thermally distressed region, and in the shroud are shown in Figure 45 through Figure 51. In the thermally distressed region, the gamma prime was finer than in the root and platform, consistent with re-precipitated gamma prime formed after exposure above the re-solutioning temperature of approximately 2150°F for an EMS73648-3 (IN-713) type material. There was also a re-crystallization layer present on the airfoil surfaces in the thermally distressed area that measured up to 0.002 inch deep that was not present away from the thermal distress.

**Figure 48. Representative microstructure in the lighter etching thermally distressed area surrounding midspan on cross-section TE8. Representative re-crystallization at the airfoil surfaces in the thermally-distressed area indicated by the green brace. Etchant: MT.**

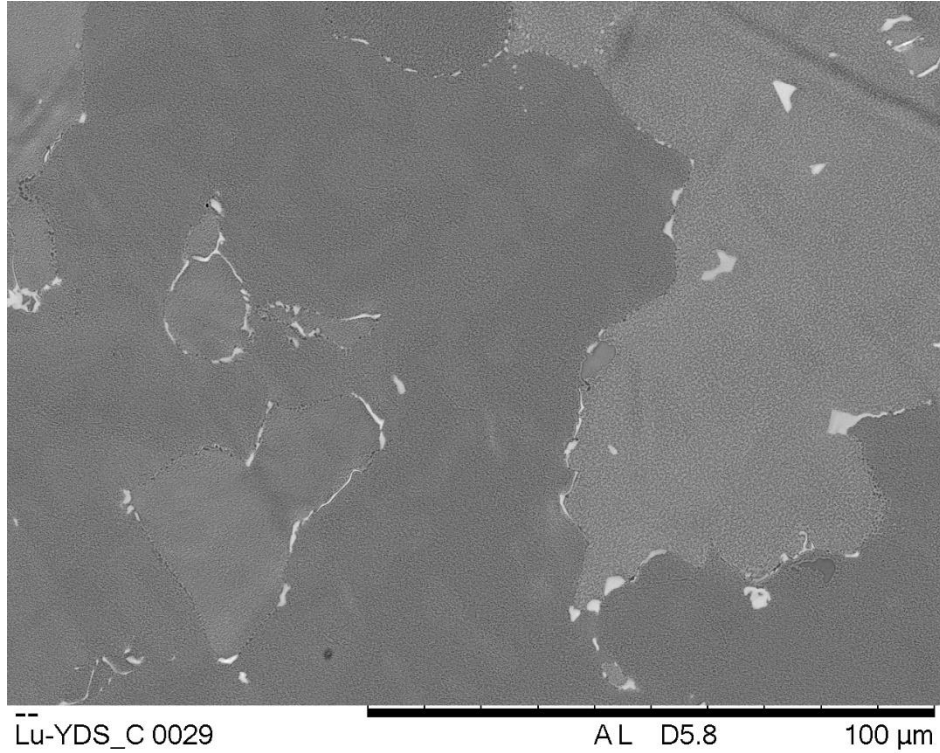
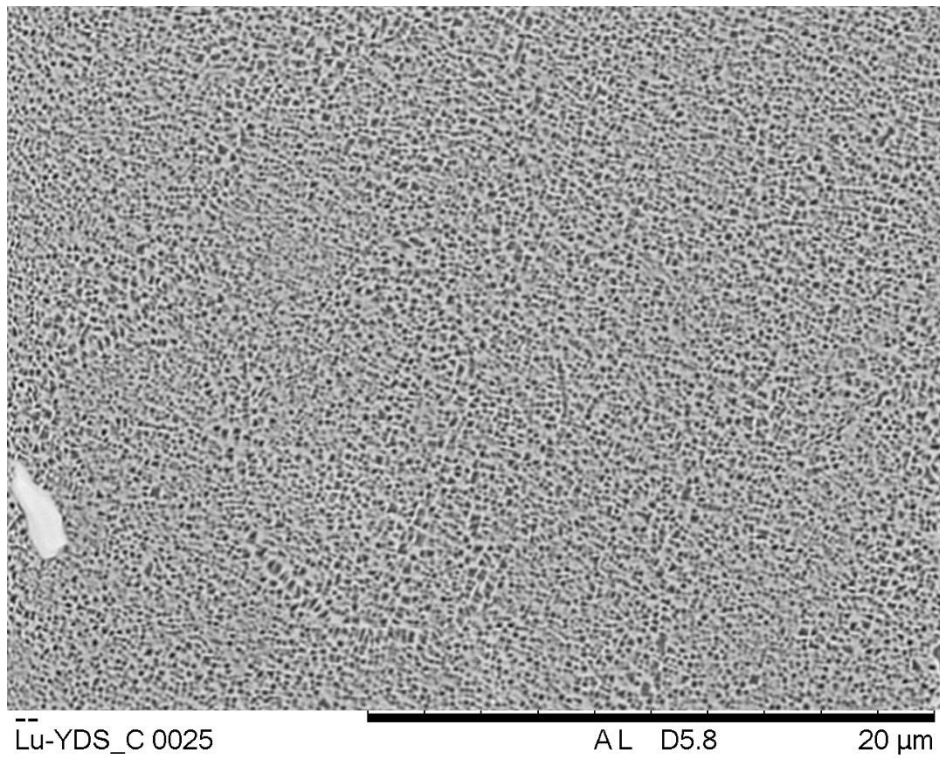
**Figure 49. Backscattered electron SEM images showing the gamma prime structure in the thermally distressed midspan area on cross-section TE8. Etchant: MT.**

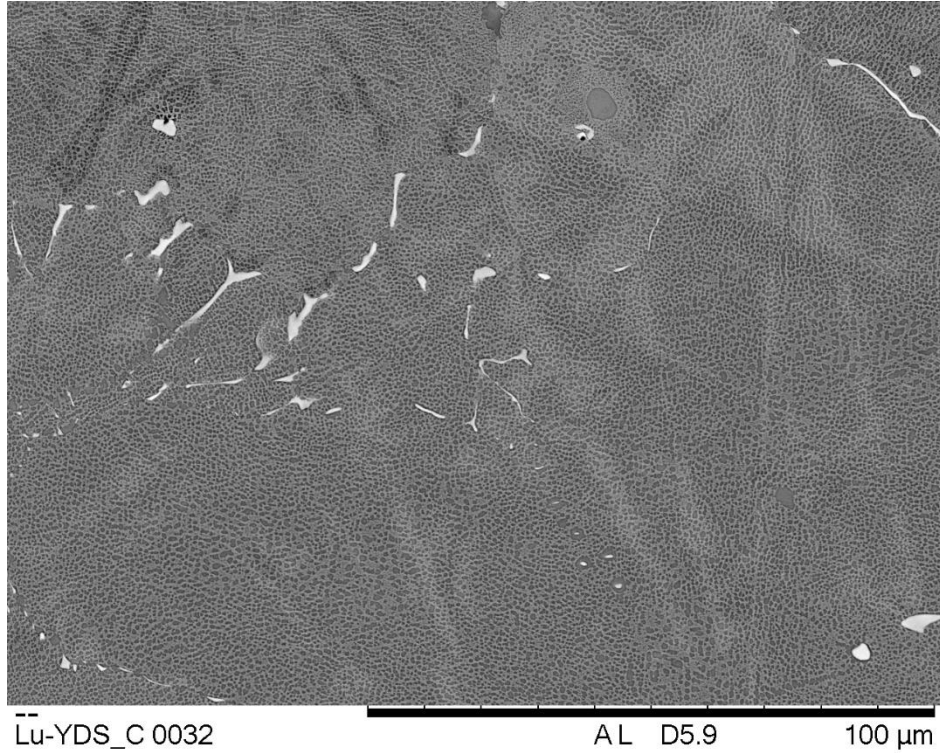
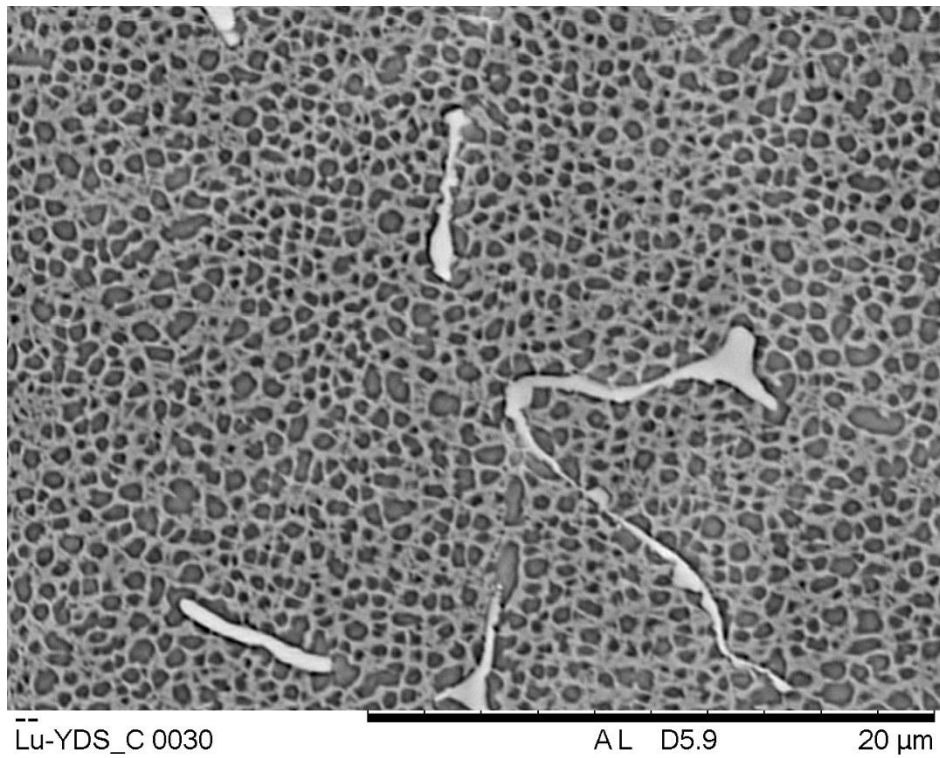
**Figure 51. Backscattered electron SEM images showing the gamma prime structure in the shroud on cross-section TE8. Etchant: MT.**

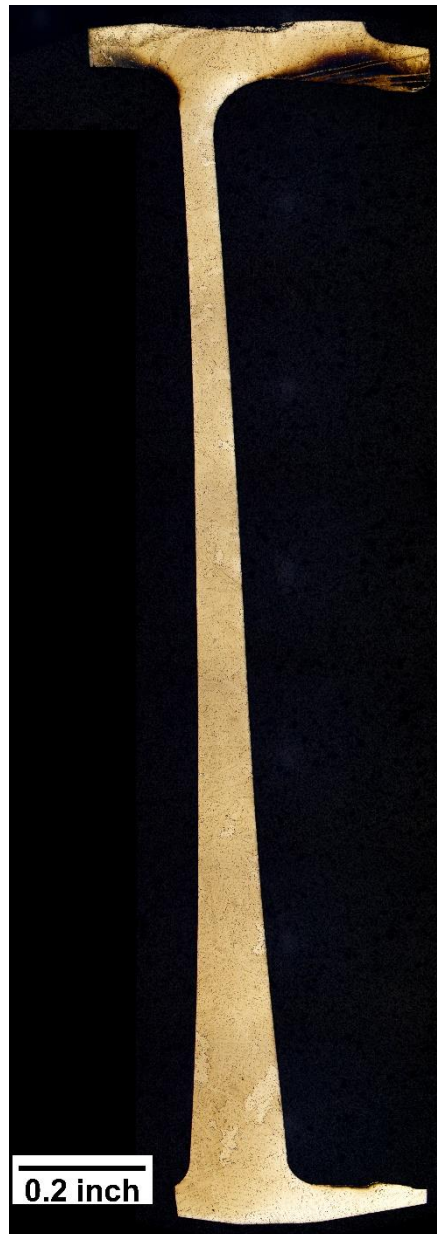
A longitudinal cross-section was prepared through blade #21 near the leading edge, shown in Figure 57. There was no apparent gradient in the etch response along the height of the airfoil. The cross-section was examined in the etched condition with an optical metallograph and in the SEM under backscattered electron imaging, and representative images showing the microstructure and gamma prime structure in the root of the blade, at approximately midspan, and in the shroud are shown in Figure 58 through Figure 63. The gamma prime in the

**Figure 57. Overall view of the longitudinal cross-section 4LE21 near the leading edge on fourth stage turbine blade #21. The dark brown areas in the shroud were overetched and the lighter-etching area in the rim of the wheel was underetched and are not consistent with thermal distress to the microstructure. Etchant: MT.**

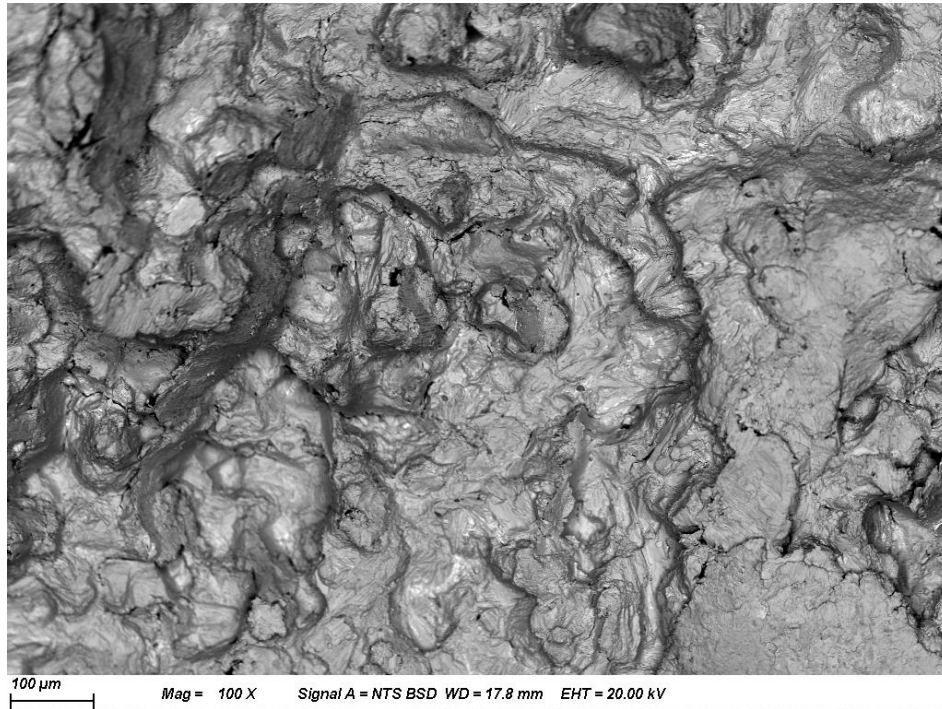
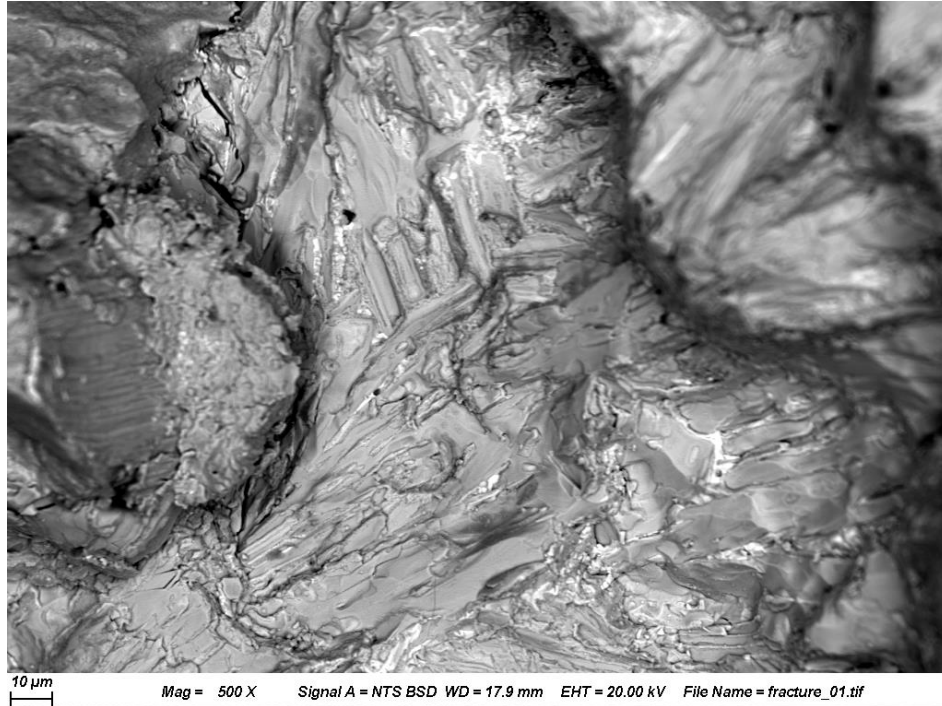
Detailed inspection of the vane airfoils revealed two of them, each the first in its respective packet, were fractured at the trailing edge root as shown in Figure 66. The fractures were jagged and rough in appearance, consistent with overload. One of the vanes was fractured along the entire chord length and was cut from the nozzle. The fracture surface was examined in the SEM. The fracture exhibited interdendritic features consistent with overload as shown in Figure 67 and Figure 68. The fracture also exhibited smearing damage.

**Figure 68. Backscattered electron SEM images showing representative interdendritic fracture features found on the fractured fourth stage turbine nozzle airfoil.**

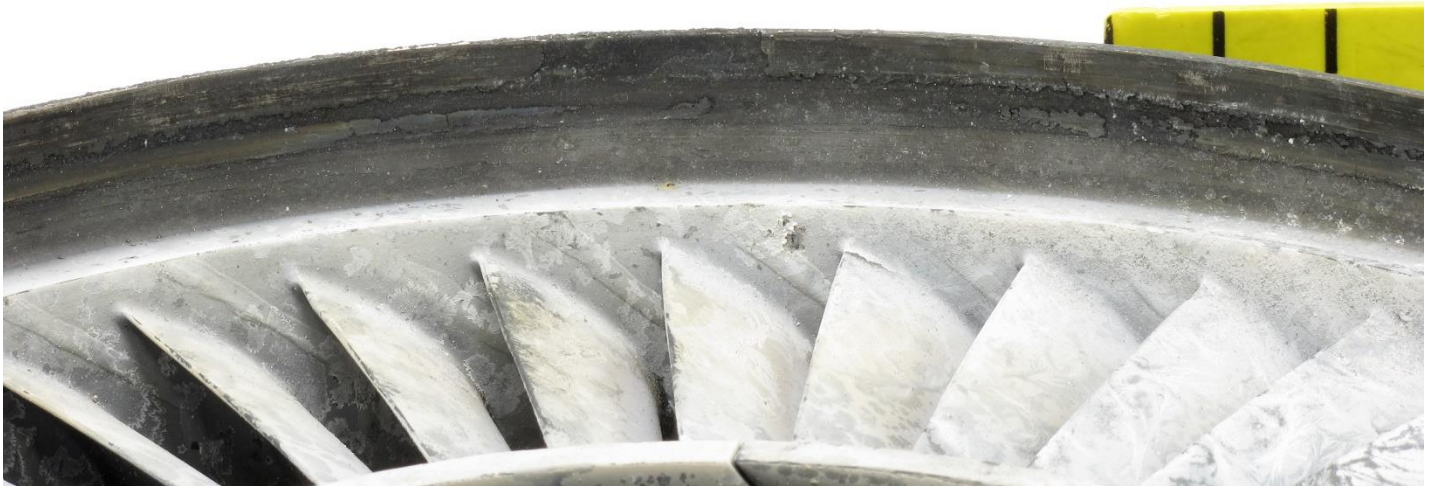
**Figure 71.** Detailed views showing the fourth stage turbine blade track in the fourth stage turbine nozzle. The nozzle was rotated 90° counterclockwise (FLA) for this succession of images. The blade track exhibited rub damage around the entire circumference. Divisions = cm.

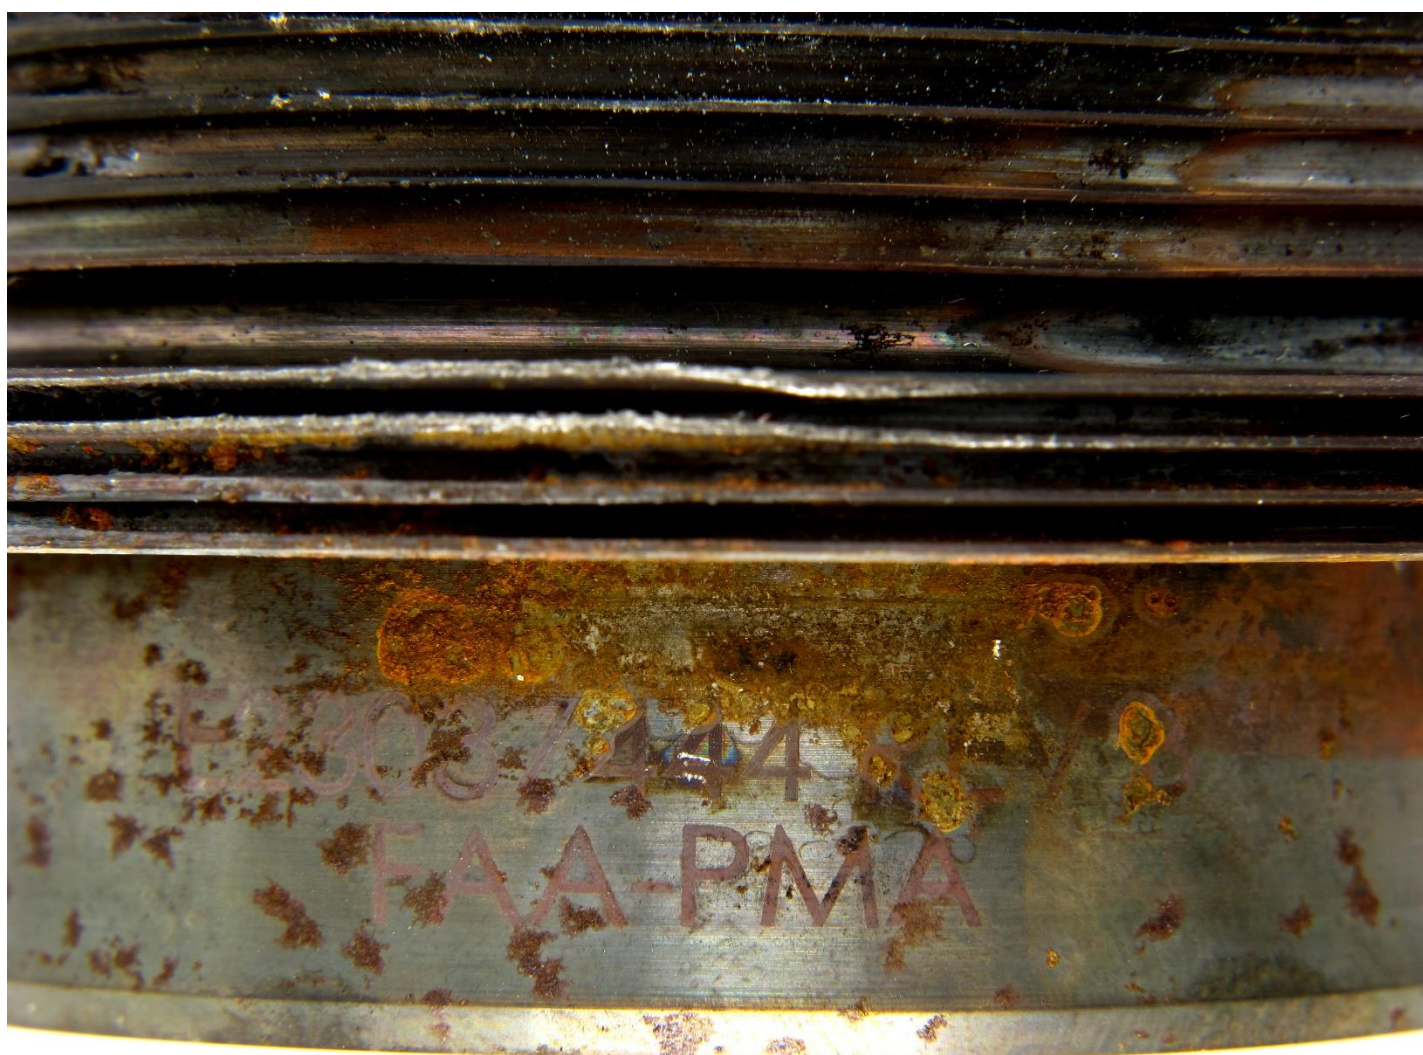
Figure 74 shows the power turbine labyrinth seal before the PT rotor was disassembled. The seal exhibited asymmetric rub damage, with the most severe rub damage located approximately 180° from the rotor match mark. Upon disassembly of the PT rotor, FAA-PMA part markings (Figure 75) were discovered on the labyrinth seal and it was not investigated further.

**Figure 75. PMA part markings found on the power turbine labyrinth seal.**

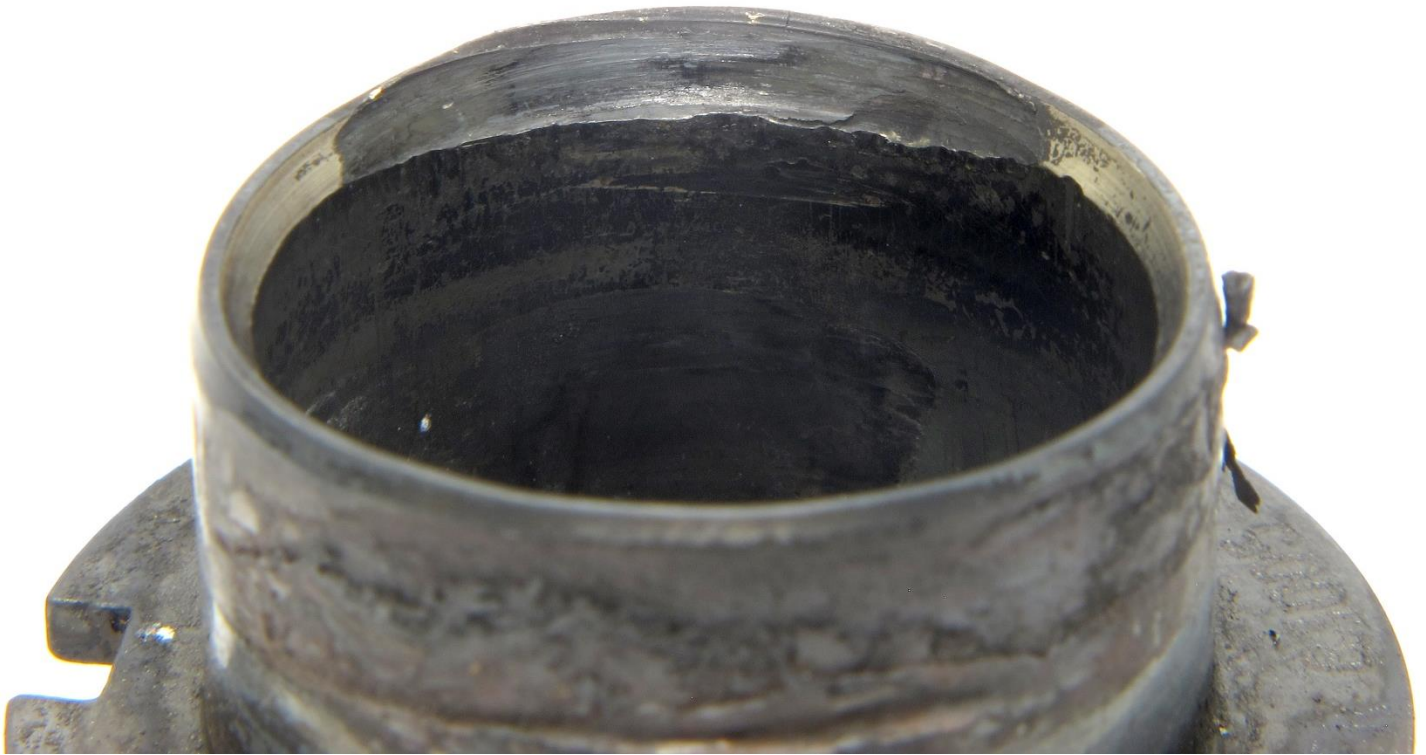
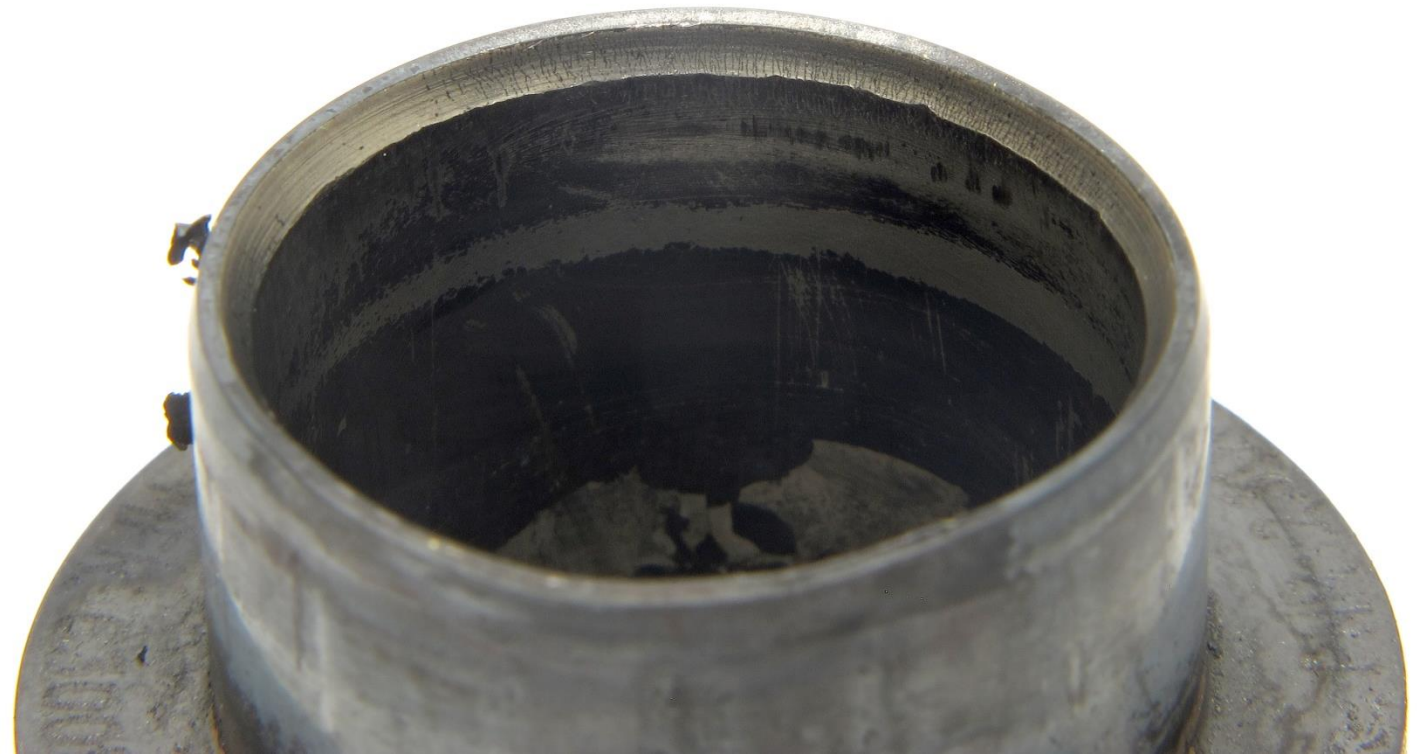
surface at the outboard deformation of the PTIS was smeared and discolored black consistent with rub damage as shown in Figure 78. After the PT rotor was disassembled, an approximately roller-width groove in the No.6 bearing raceway on the PTIS was found diametrically opposed to the outboard deformation as shown in Figure 79 and Figure 80. Additionally, a circumferential crack was found on the shaft forward of the flange in line with the outboard deformation. The remainder of the raceway surface was relatively less severely damaged and did not exhibit any evidence of the bearing operating with insufficient lubrication. The outboard deformation, circumferential fracture, and groove in the raceway are consistent with an instantaneous high load condition on the shaft and the attached rotor.

**Figure 78.** Detailed views showing the inner diameter of the PTIS at the outboard deformation (top) and opposite the deformation (bottom). The surface at the deformation was smeared and discolored. No scale provided.

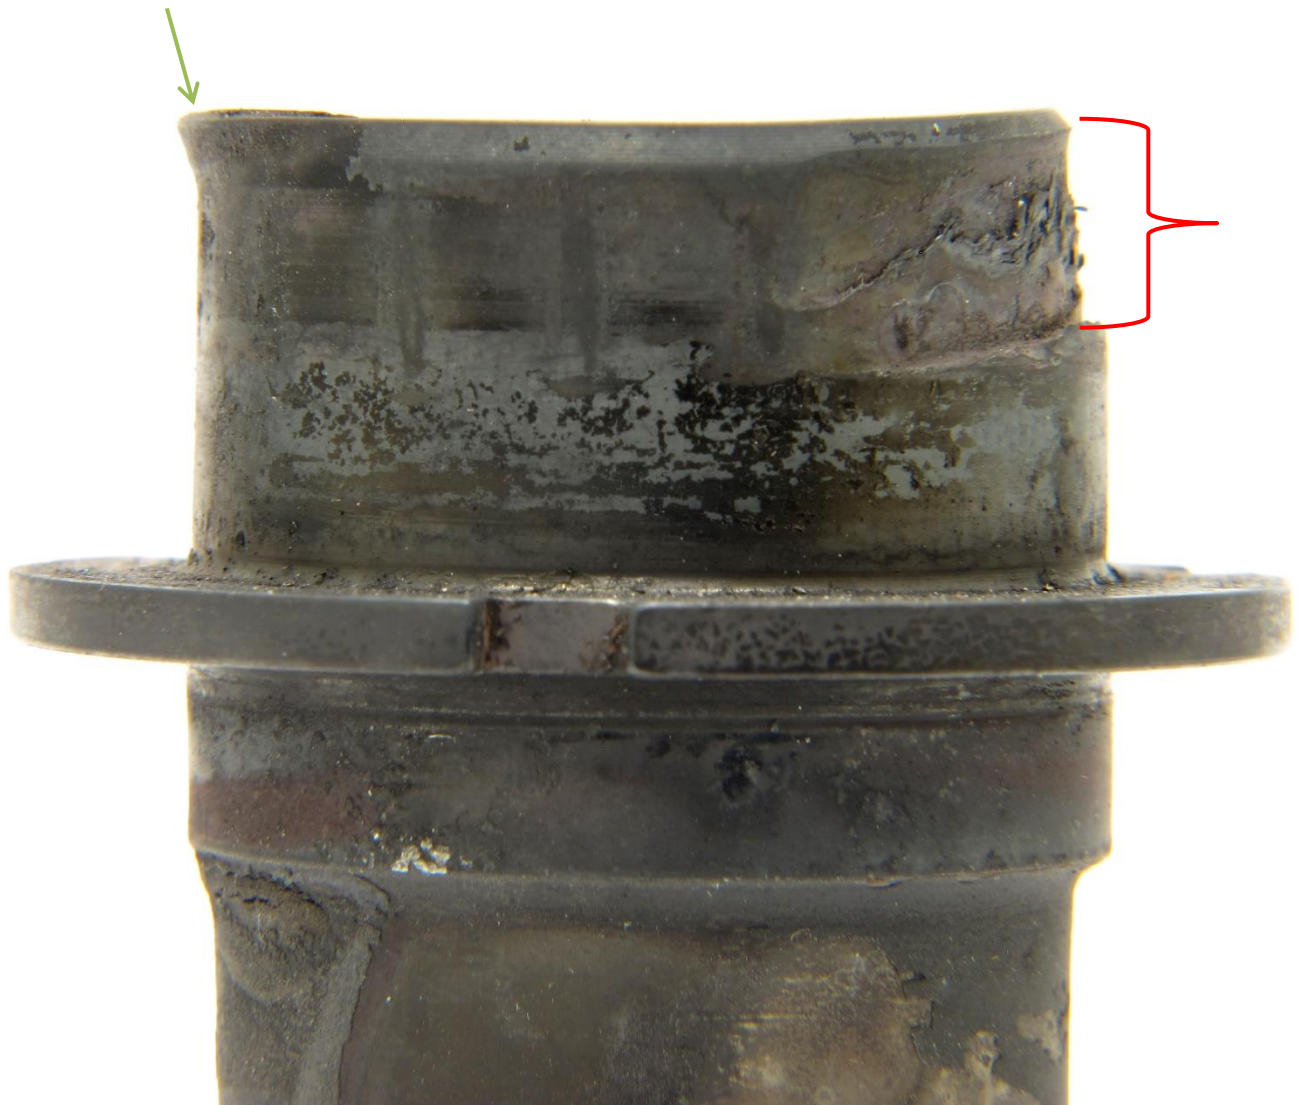
**Figure 79.** Detailed view of the No. 6 bearing inner raceway on the power turbine inner shaft after the PT rotor was disassembled. The raceway exhibited a groove on one side that corresponded to the width of the bearing rollers (red brace). The groove was located opposite the outboard deformation of the shaft (green arrow) shown in the previous figures. No scale provided.

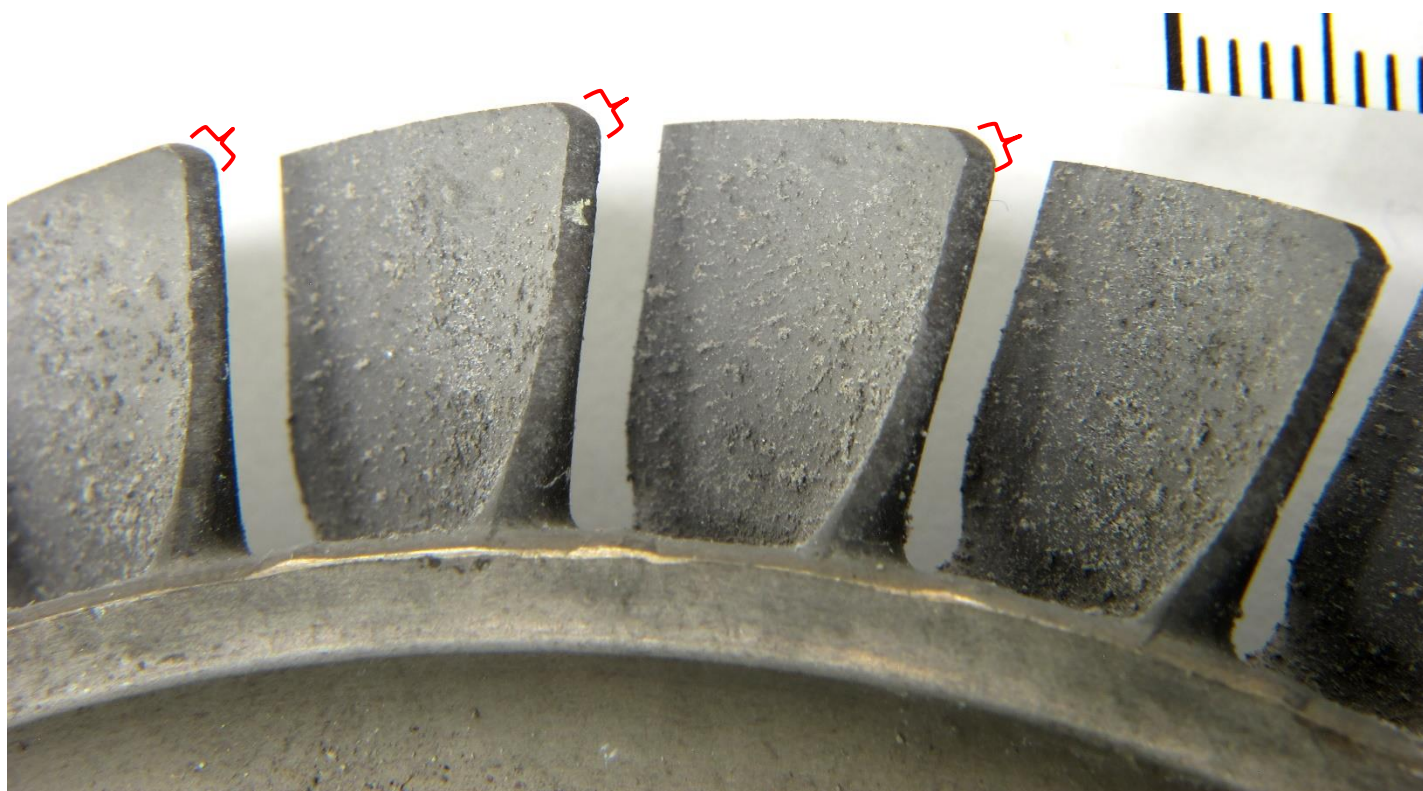
Figure 83 shows the as-received condition of the first stage turbine wheel. The airfoils exhibited powdery white deposits consistent with airframe fire retardant, and there was some debris found on the leading edge side web. Detailed examination of the first stage turbine airfoils revealed erosion to the leading edge tips as shown in Figure 84. The blade tips exhibited circumferential witness marking consistent with tip rub as shown in Figure 85. The tip witness marking was consistent around the wheel and did not exhibit any apparent asymmetry.

**Figure 84. Leading edge side view showing representative leading edge tip erosion (red braces) on the first stage turbine blades. Divisions = mm.**

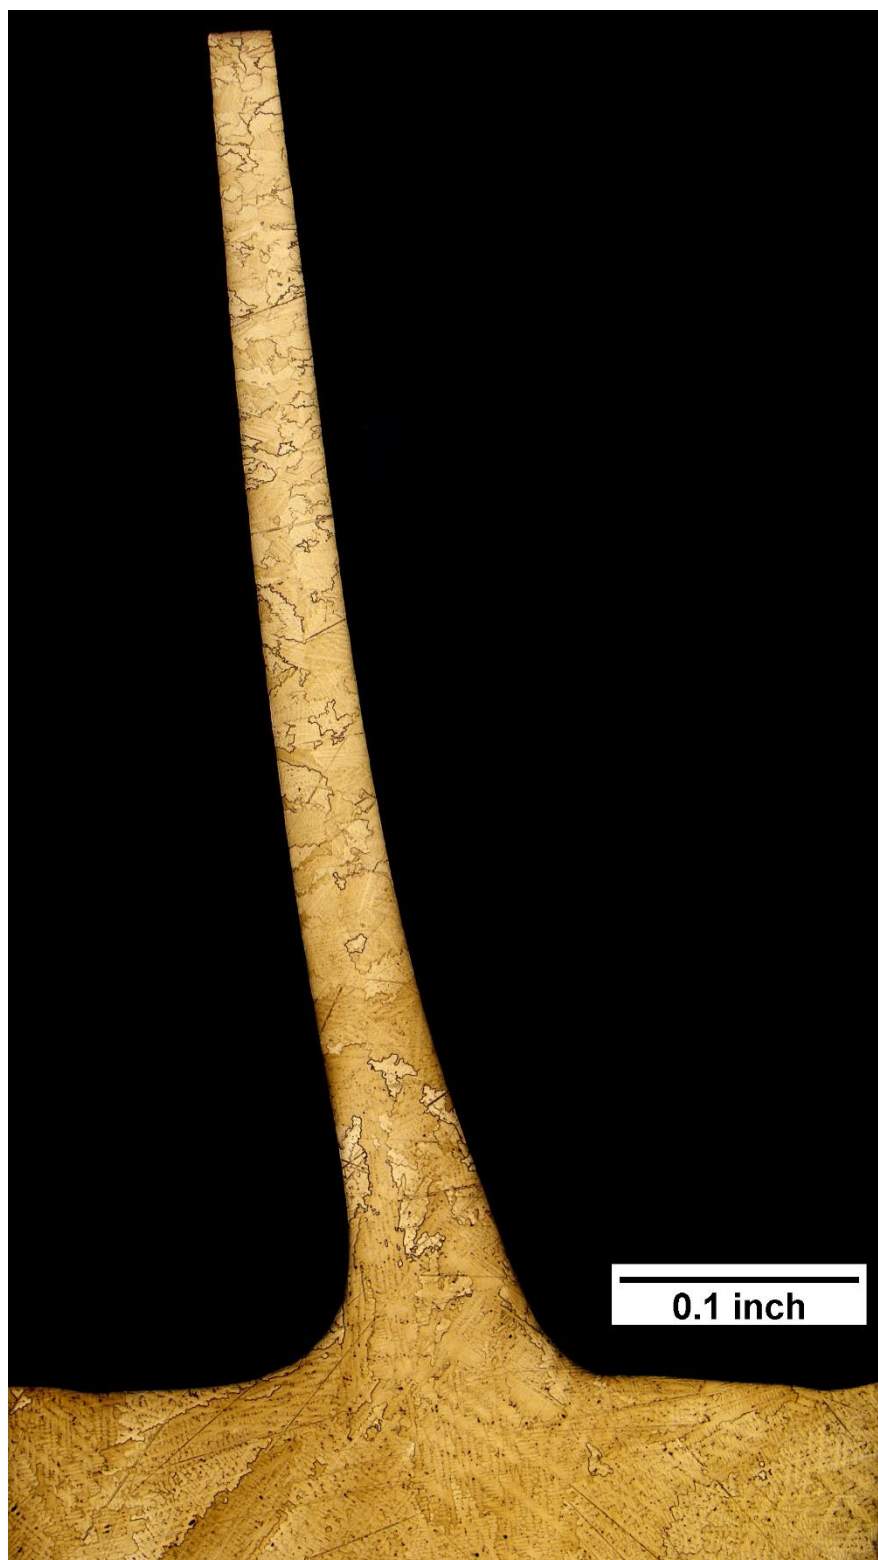
A longitudinal cross-section was prepared through a representative first stage turbine blade near the trailing edge as shown in Figure 86. The cross-section was examined in the etched condition with an optical metallograph and in the SEM under backscattered electron imaging, and representative images showing the microstructure and gamma prime structure in the rim of the wheel, in the root of the blade, and near midspan are shown in Figure 87 through Figure 92. In the rim and the root of the wheel, the gamma prime structure was mostly cuboidal and did not exhibit any apparent coarsening or rafting. At midspan, the gamma prime was coarser and less regularly shaped, with some rafting. Coarsening and rafting are expected changes from exposure to normal engine operating temperatures over the life of the component. It could not be conclusively determined if there was any re-precipitated gamma prime or if the amount of coarsening and rafting were indicative of exposure to higher than normal engine operating temperatures.

**Figure 86. Overall view of the longitudinal cross-section 1TE near the trailing edge on a representative first stage turbine blade. Etchant: MT.**

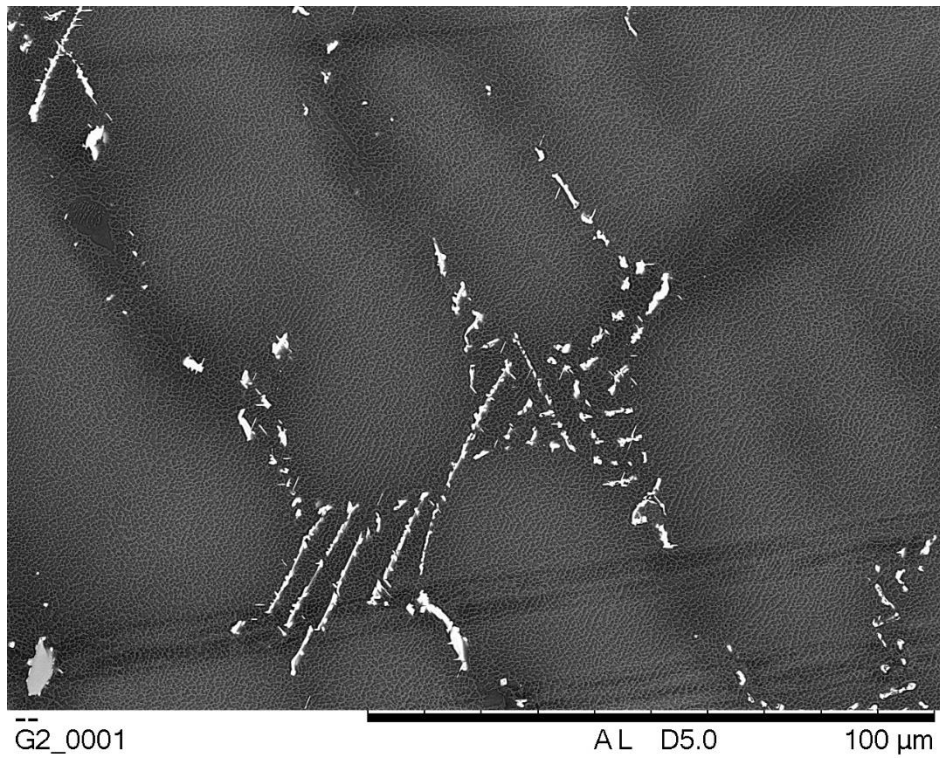
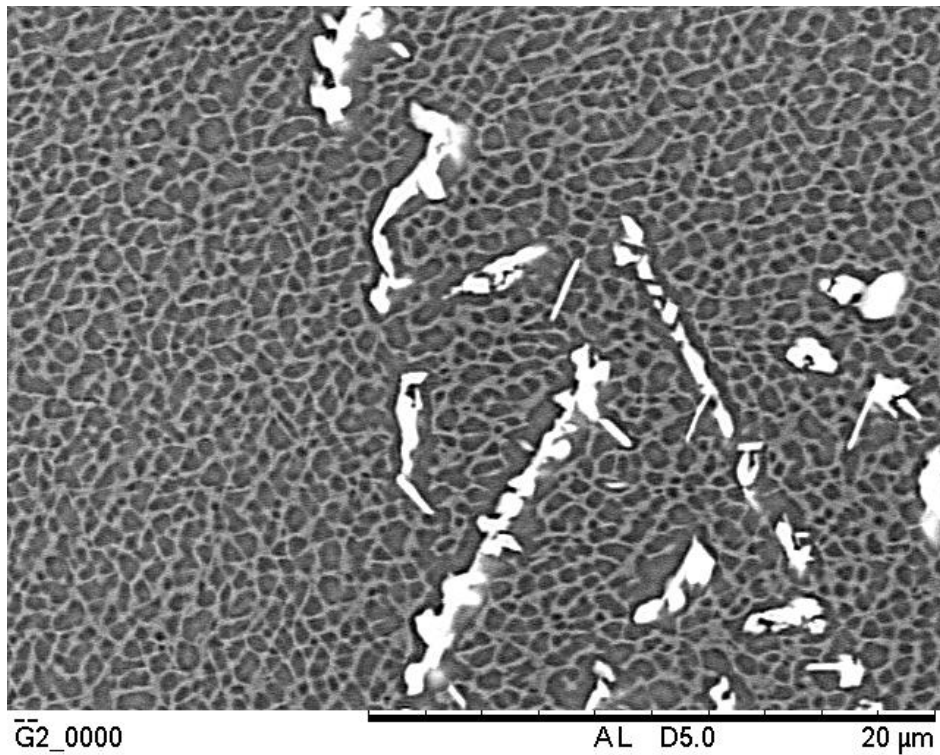
**Figure 88. Backscattered electron SEM images showing the gamma prime structure in the rim of the wheel on cross-section 1TE. Etchant: MT.**
