| <b>Rolls-Royce</b> | Rolls-Royce Corporation<br>450 S. Meridian Street<br>Indianapolis, Indiana<br>46225-1103, USA | <b>REPORT NO.</b><br>21FAE-055 | <b>REV.</b><br>Initial | <b>PAGES</b><br>1 of 108 |
| <b>TITLE</b><br><b>METALLURGICAL INVESTIGATION OF A THIRD STAGE TURBINE WHEEL, P/N 23065818, REMOVED FROM AN M250, ENGINE S/N CAE835942, OPERATED BY SIGNATURE UTILITY SERVICES</b> | | <b>PREPARED</b><br>Digitally signed by Alexander Sheridan_9782(Bldentity)<br>Date: 2022.05.03 10:26:22 -04'00' | | |

| Part Name: | Third Stage Turbine Wheel |
| Engine Model: | M250-C20B |

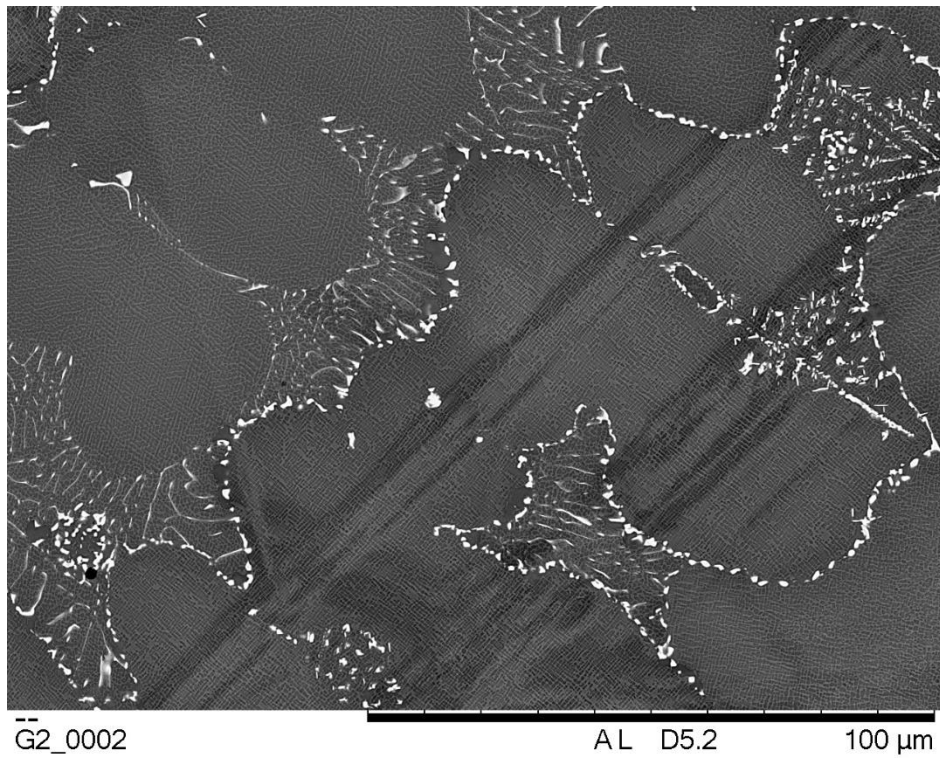
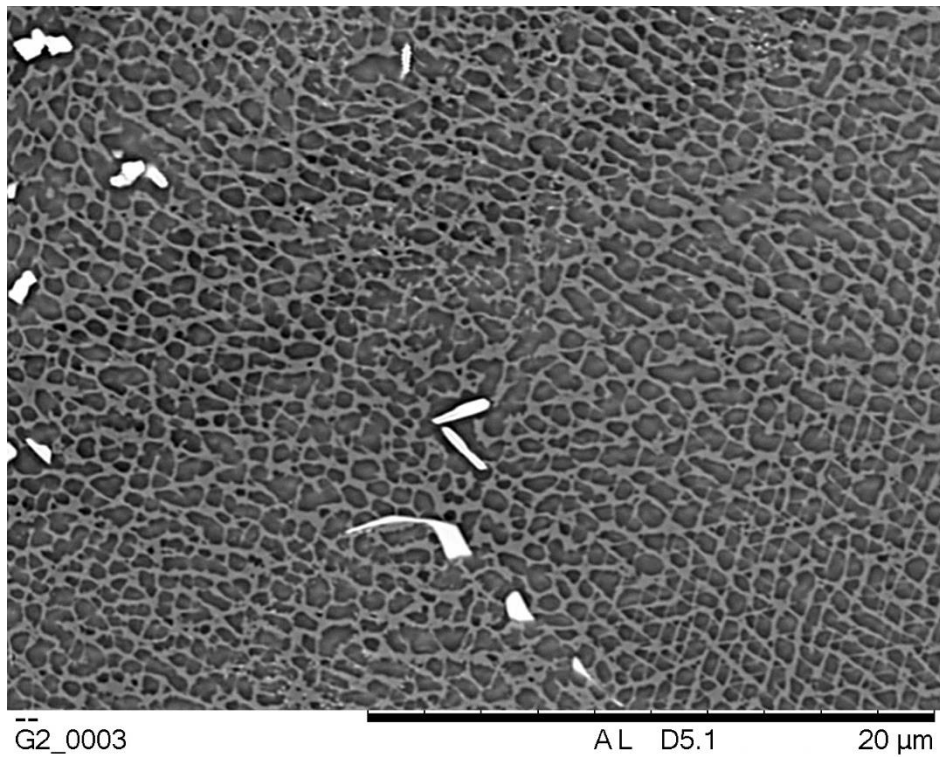
A longitudinal cross-section was prepared through a representative first stage turbine blade near the trailing edge as shown in Figure 86. The cross-section was examined in the etched condition with an optical metallograph and in the SEM under backscattered electron imaging, and representative images showing the microstructure and gamma prime structure in the rim of the wheel, in the root of the blade, and near midspan are shown in Figure 87 through Figure 92. In the rim and the root of the wheel, the gamma prime structure was mostly cuboidal and did not exhibit any apparent coarsening or rafting. At midspan, the gamma prime was coarser and less regularly shaped, with some rafting. Coarsening and rafting are expected changes from exposure to normal engine operating temperatures over the life of the component. It could not be conclusively determined if there was any re-precipitated gamma prime or if the amount of coarsening and rafting were indicative of exposure to higher than normal engine operating temperatures.

**Figure 90. Backscattered electron SEM images showing the gamma prime structure in the root of the blade on cross-section 1TE. Etchant: MT.**

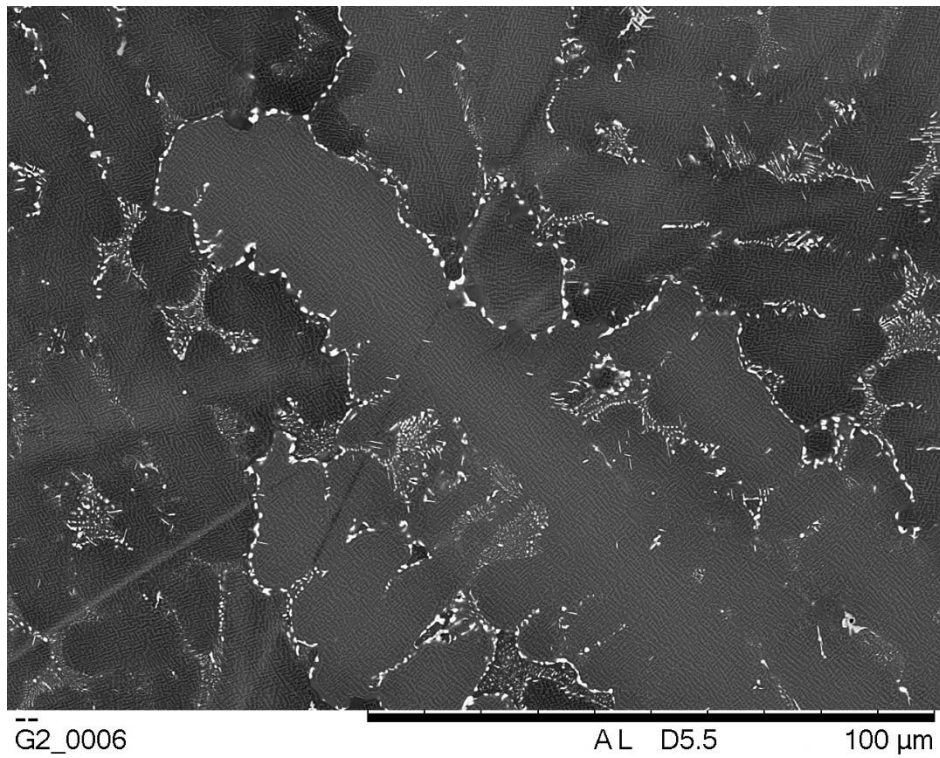
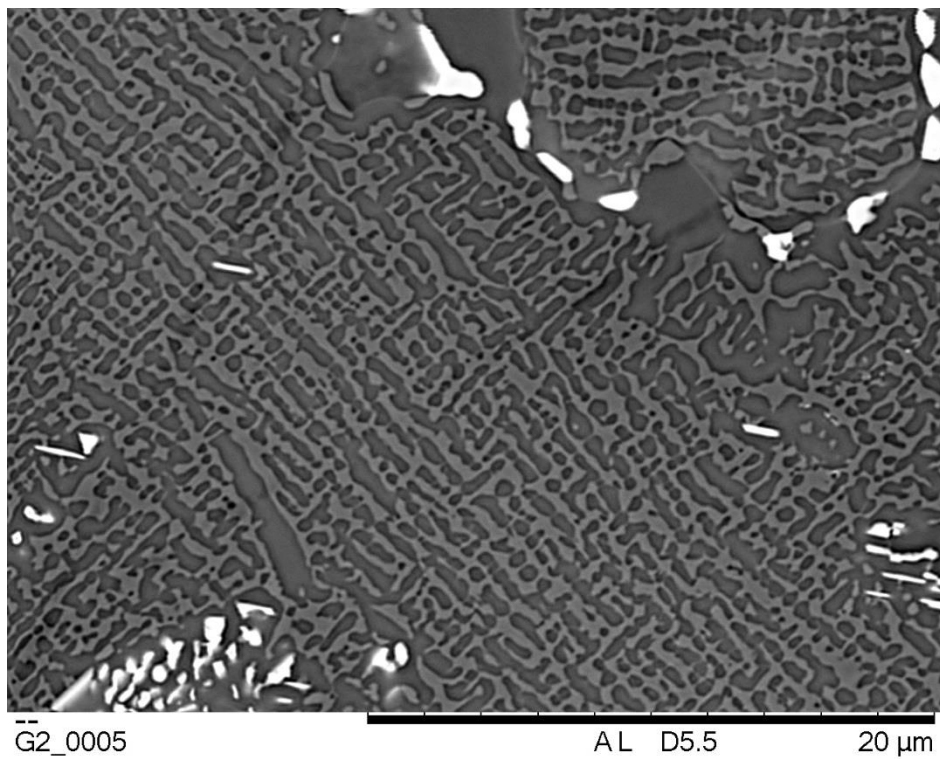
**Figure 92. Backscattered electron SEM images showing the gamma prime structure near midspan on cross-section 1TE. Etchant: MT.**

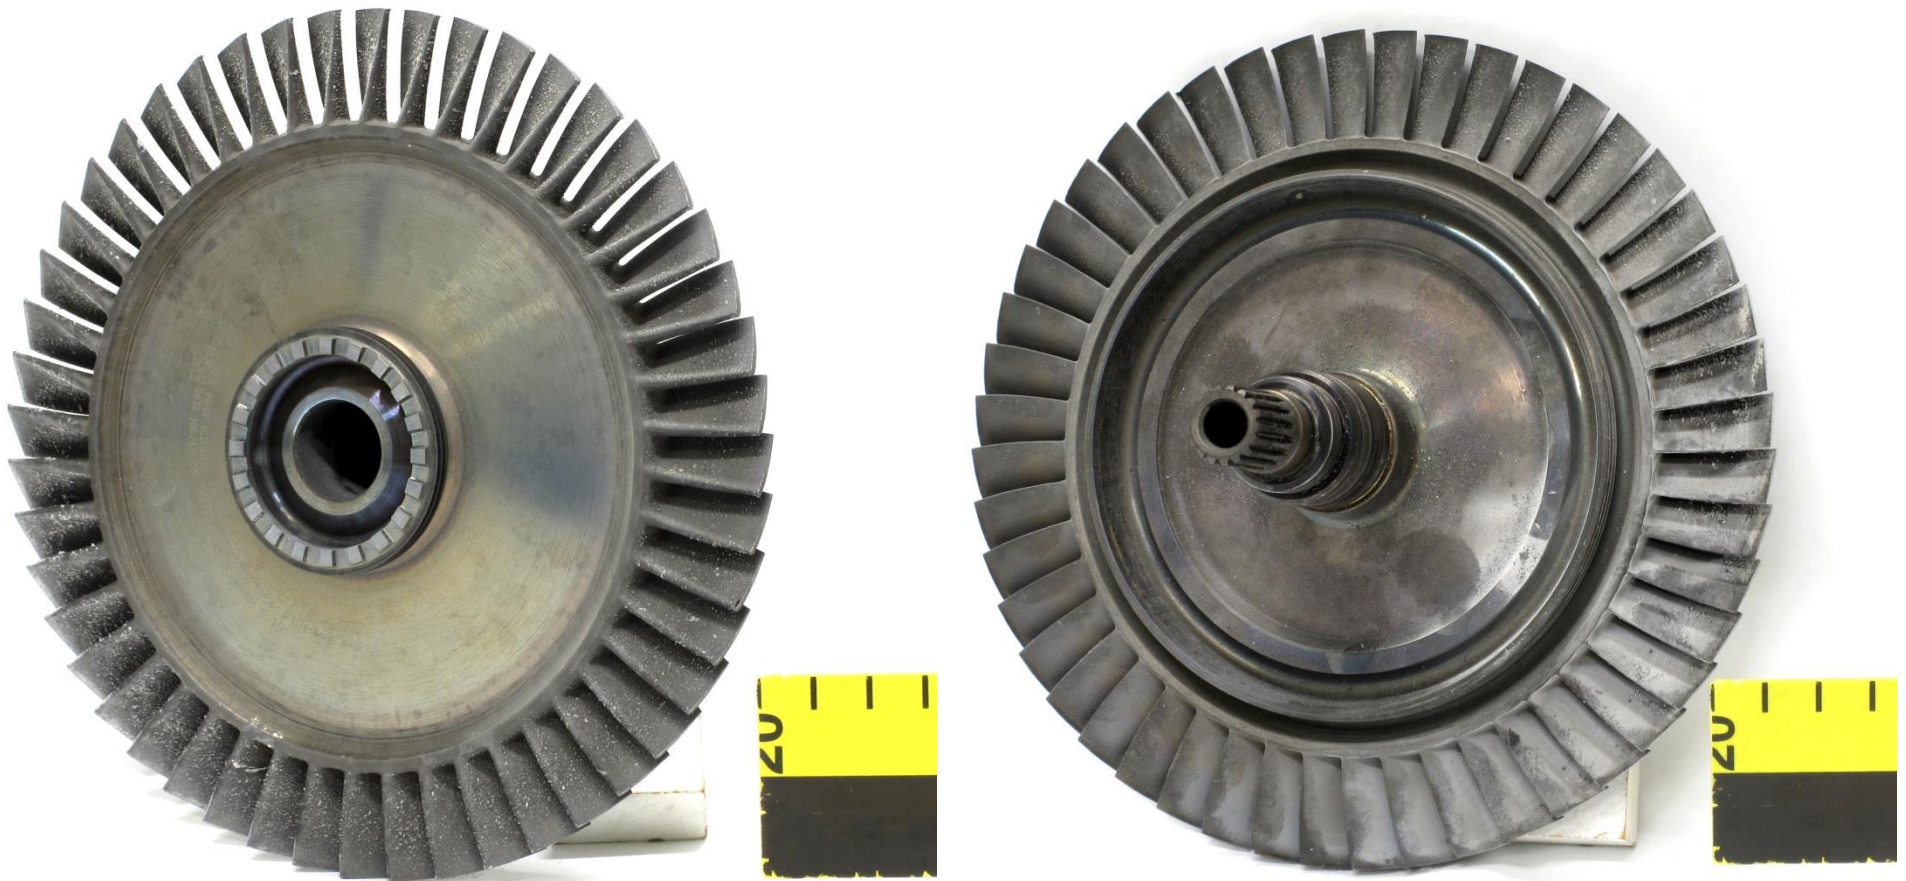
Figure 93 shows the as-received condition of the second stage turbine wheel. The airfoils exhibited powdery white deposits consistent with airframe fire retardant, and there was some debris found on the leading edge side web. Detailed examination of the blade tips revealed circumferential witness marking consistent with tip rub as shown in Figure 94. The tip witness marking was consistent around the wheel and did not exhibit any apparent asymmetry.

**Figure 93. Leading edge (left) and trailing edge (right) side views showing the second stage turbine wheel. The airfoils exhibited white powdery deposits consistent with airframe fire retardant. Divisions = cm.**

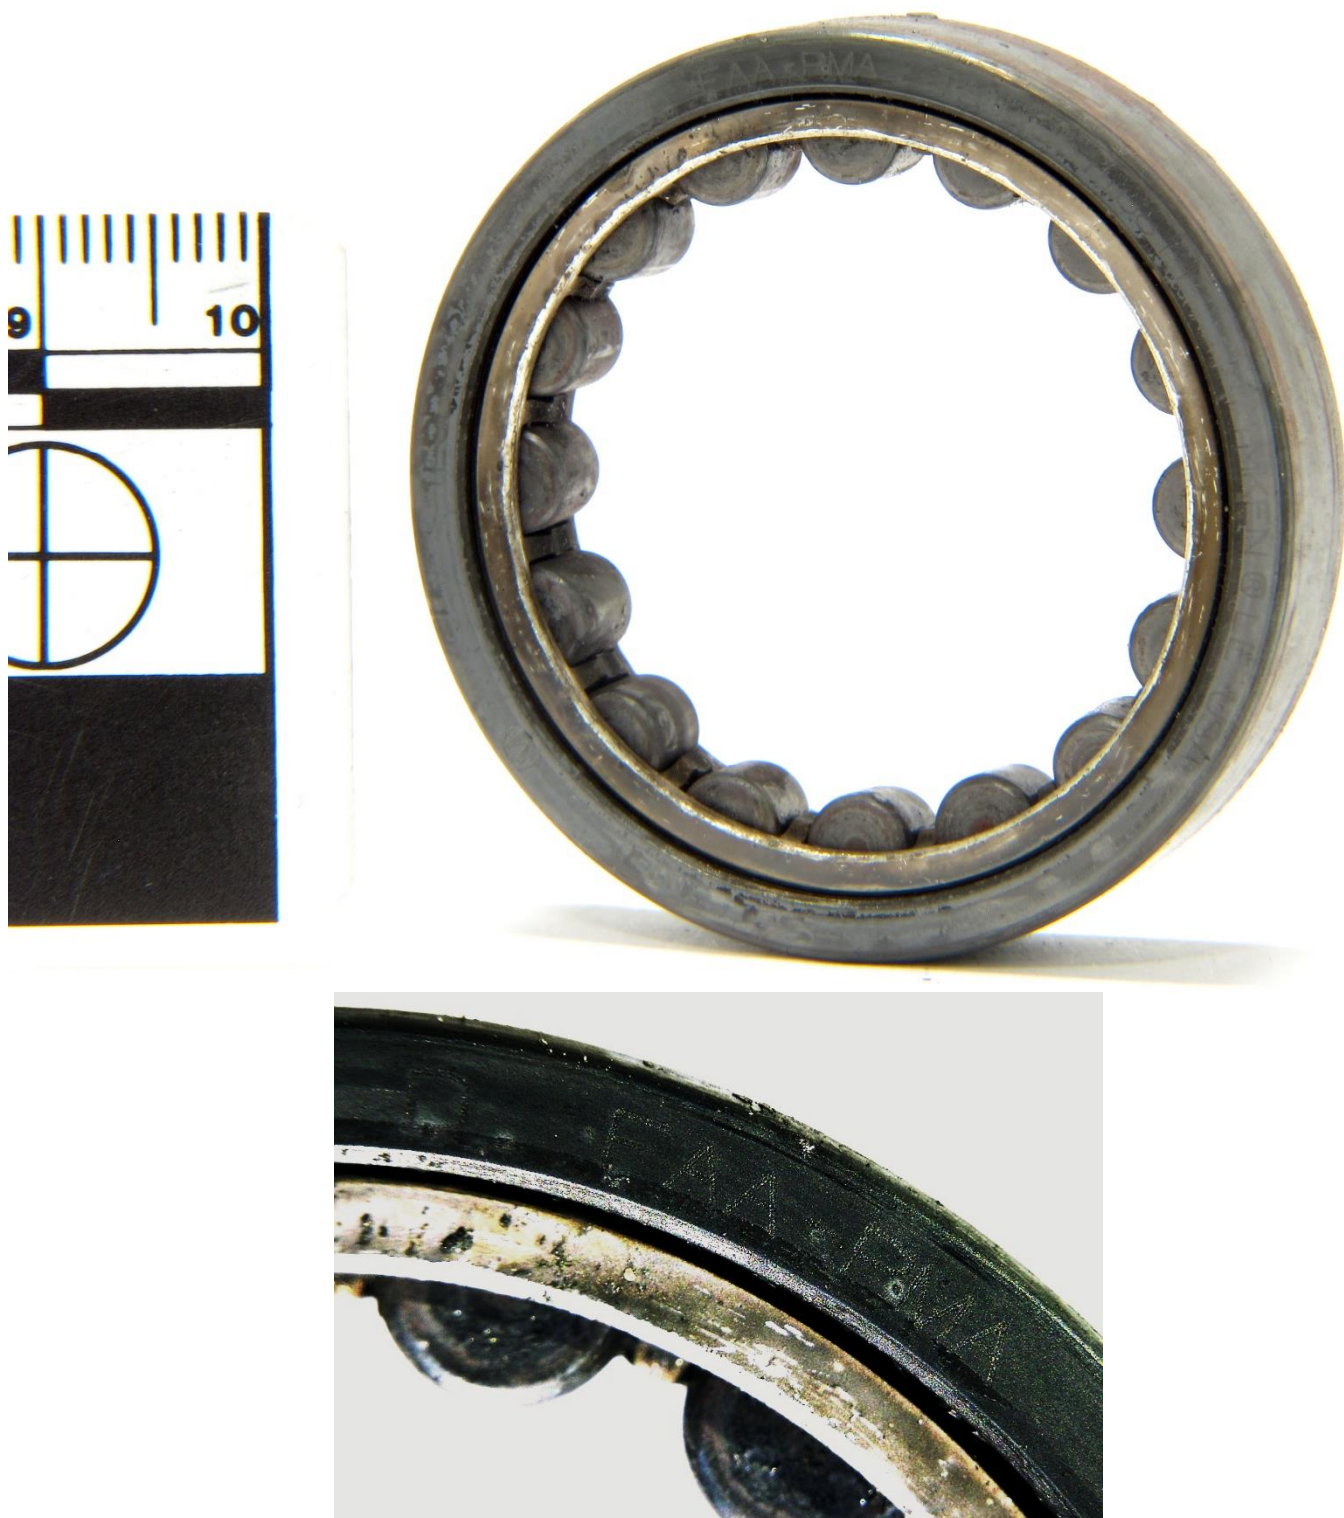
Figure 95 shows the No. 6 bearing, which had FAA PMA part markings and was not examined in detail. Figure 96 and Figure 97 show the Nos. 6 and 7 bearing sump in the PT support assembly. The No. 7 bearing and the spacer between the Nos. 6 and 7 outer rings were still installed in the bore of the PT support. An axial cut was made in the spacer to reveal the No. 7 bearing outer ring and part markings, which are shown in Figure 98. The No. 7 bearing had FAA PMA part markings and was not investigated further. Figure 99 shows the No. 8 bearing, which was still able to rotate smoothly and did not exhibit any evidence of operation with insufficient lubrication.

Figure 95. Overall view showing the No. 6 bearing (top) and the PMA part markings (bottom).  
Top: Divisions = mm.

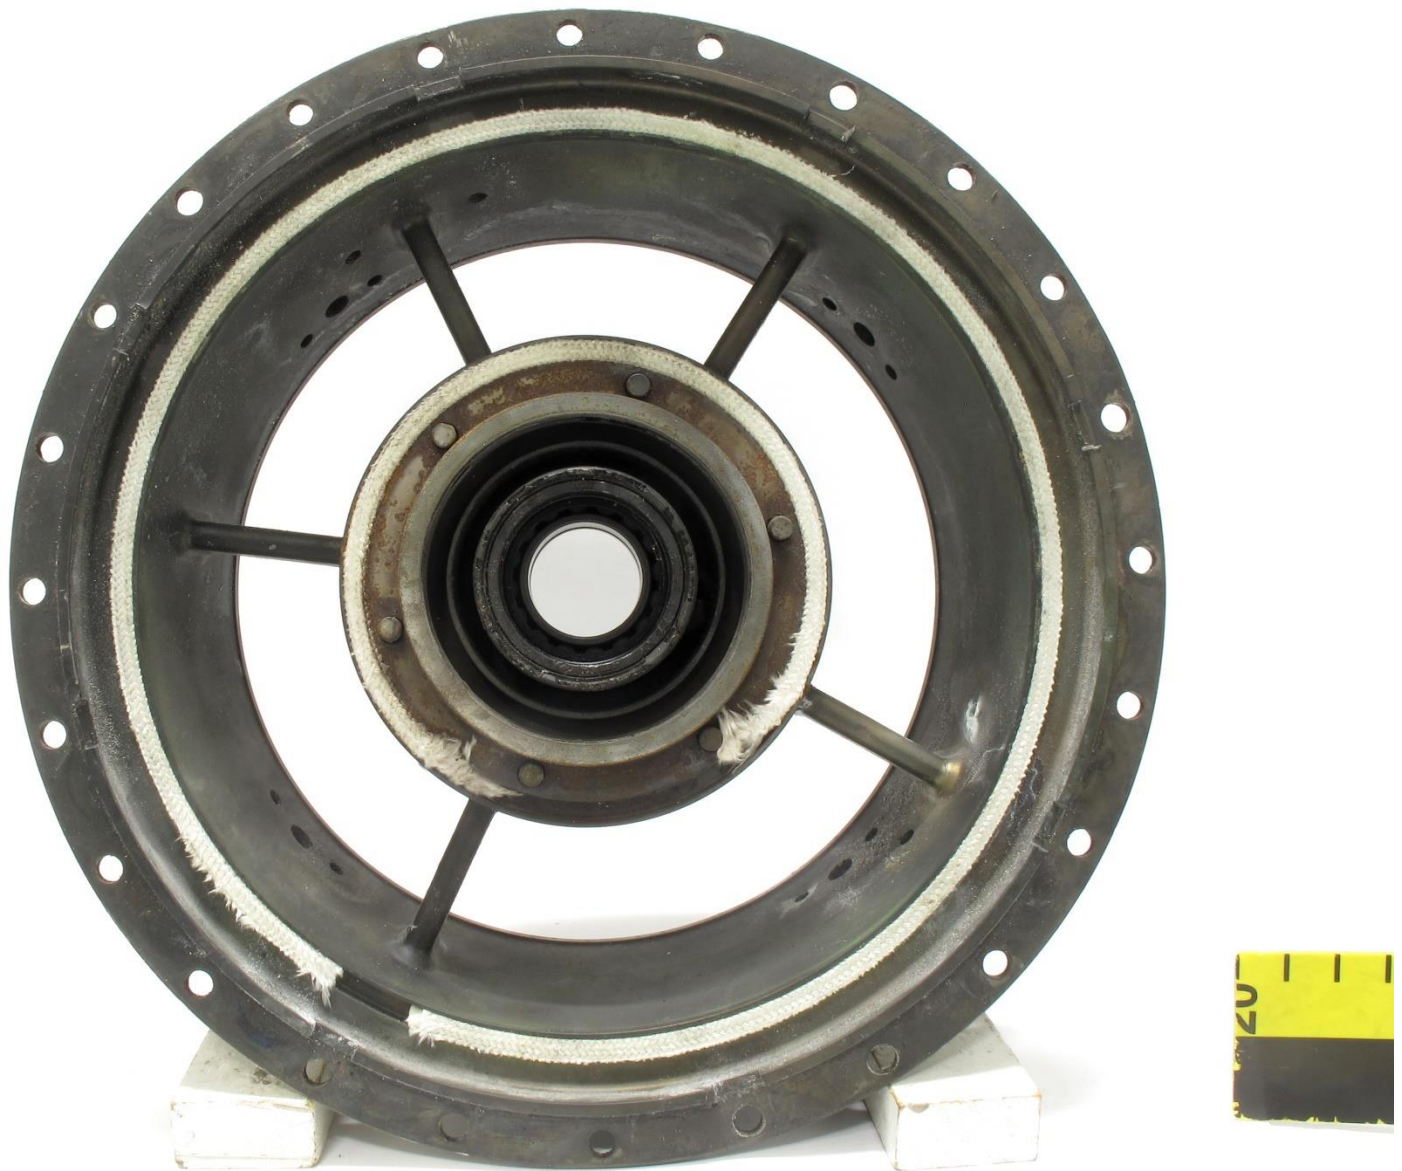
**Figure 96. Forward looking aft view showing the as-received condition of the PT support assembly. The No. 7 bearing was still installed in the bore, which is shown in more detail in the following figure. Divisions = cm.**

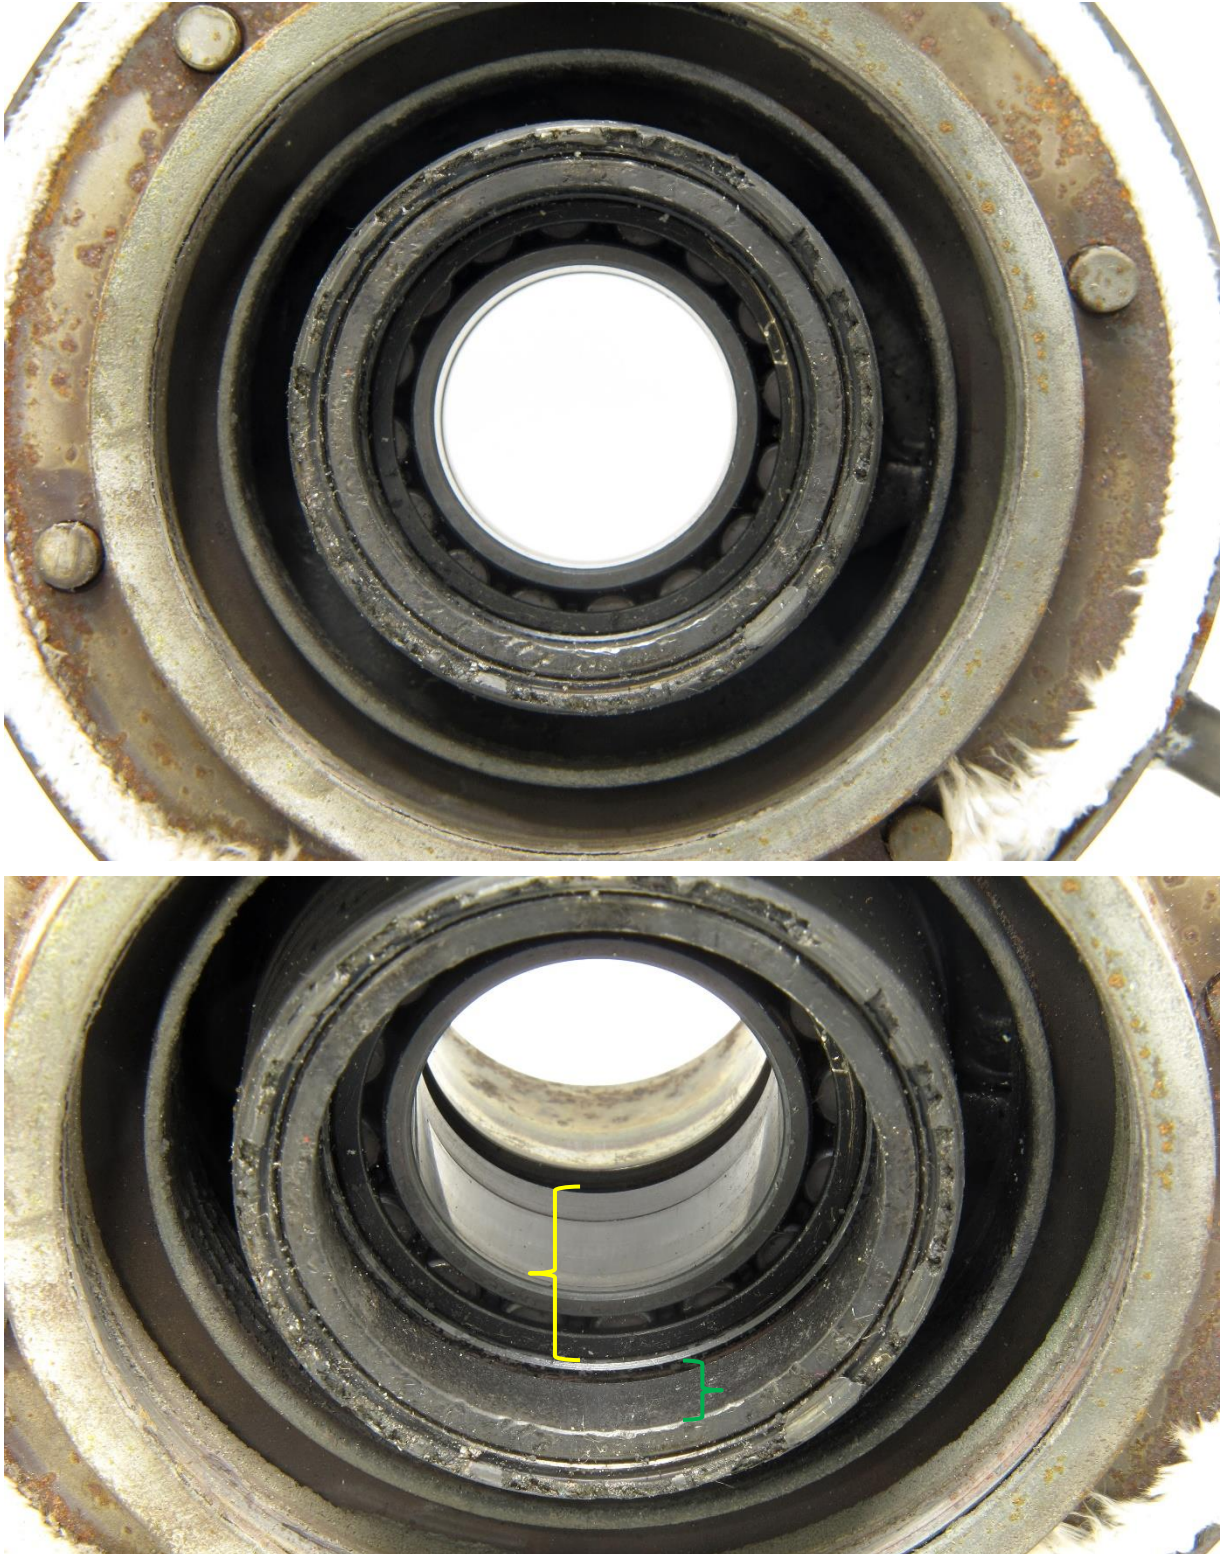
**Figure 97.** Detailed forward looking aft views showing the Nos. 6 and 7 bearing sump in the PT support. The No.6 bearing was returned to the laboratory separately, but the spacer (green brace) and the No. 7 bearing (yellow brace) were still installed in the sump. The spacer and No. 7 bearing were shifted forward from their nominal positions when assembled in the engine. No scale provided.

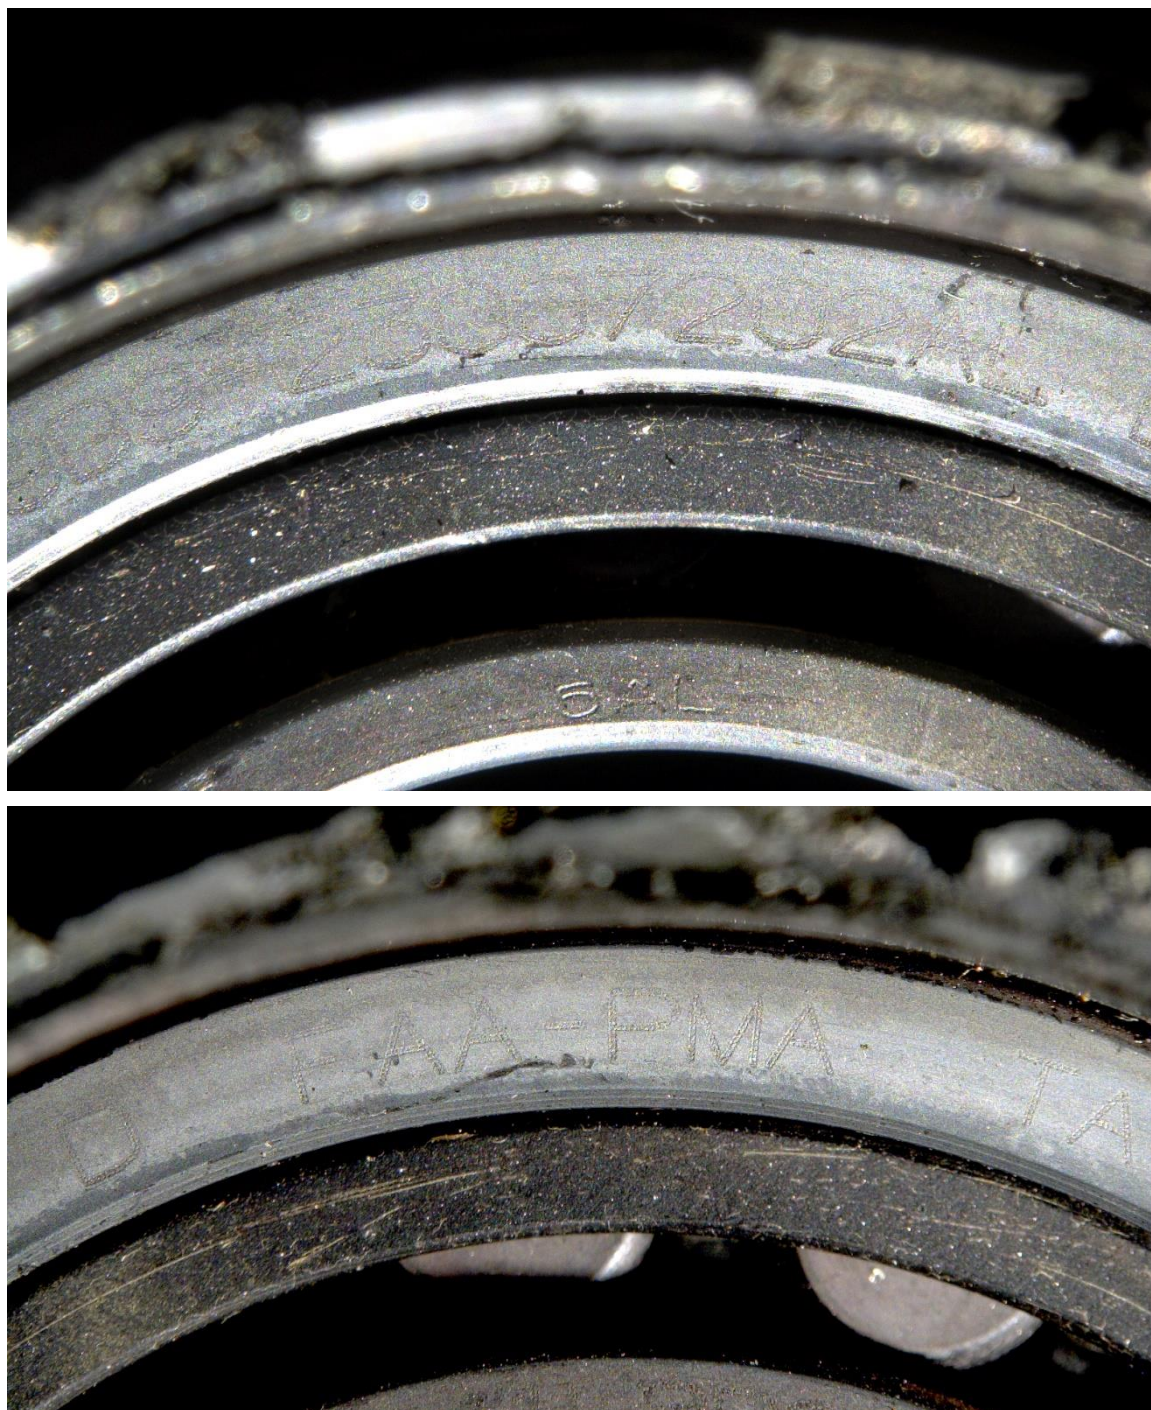
**Figure 98.** Detailed views showing the part number (top) and PMA (bottom) part markings on the No. 7 bearing. No scale provided.

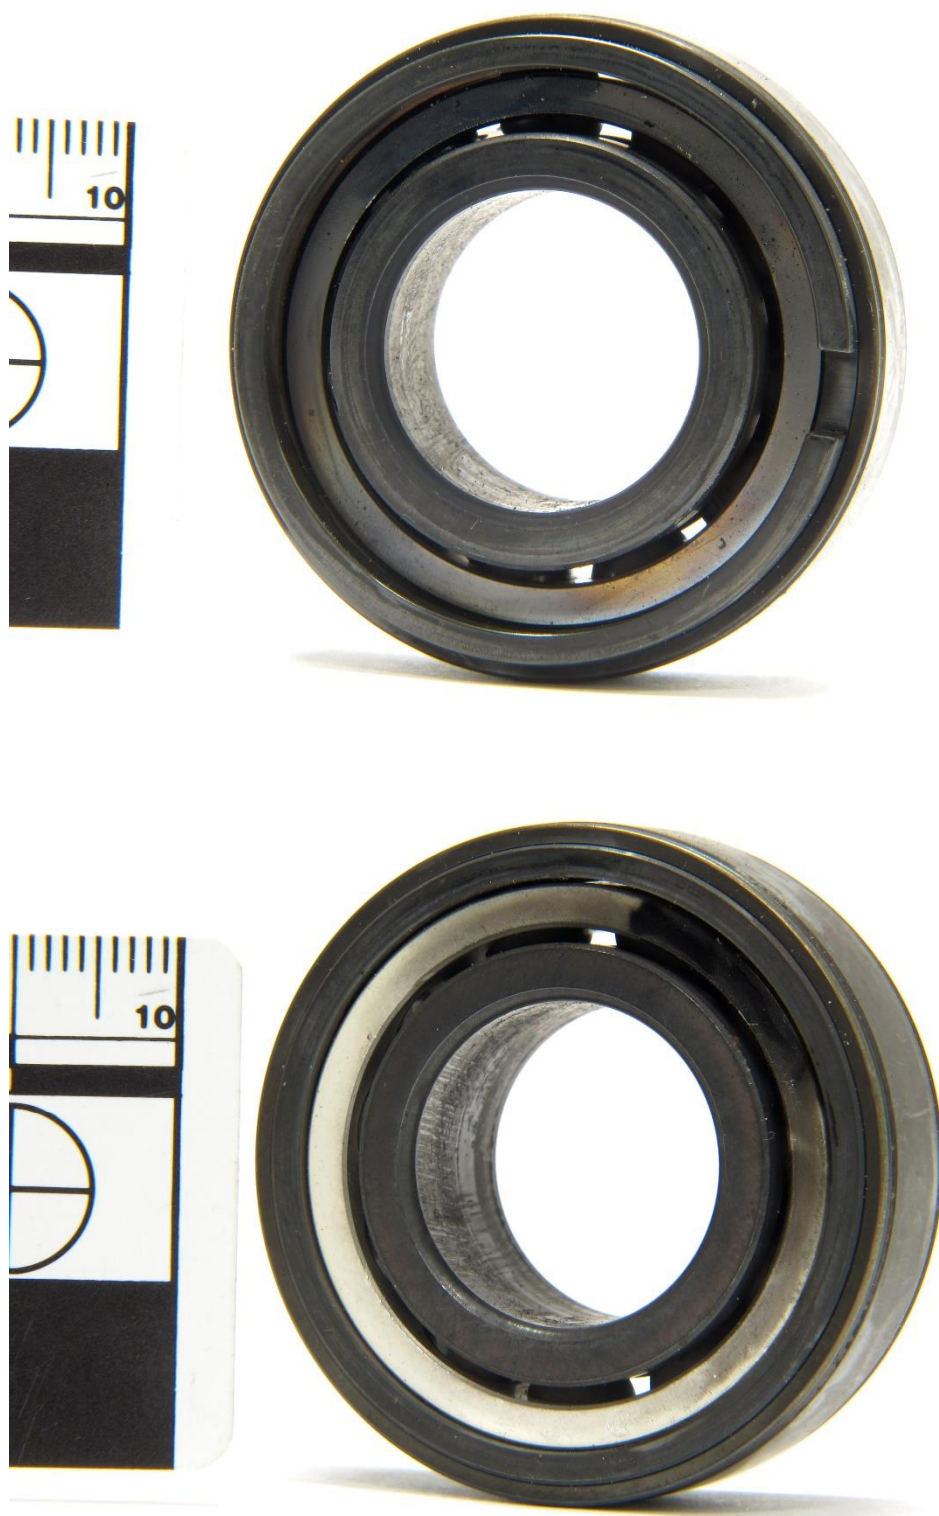
**Figure 99. Forward side (top) and aft side (bottom) views of the No. 8 bearing. Divisions = mm.**

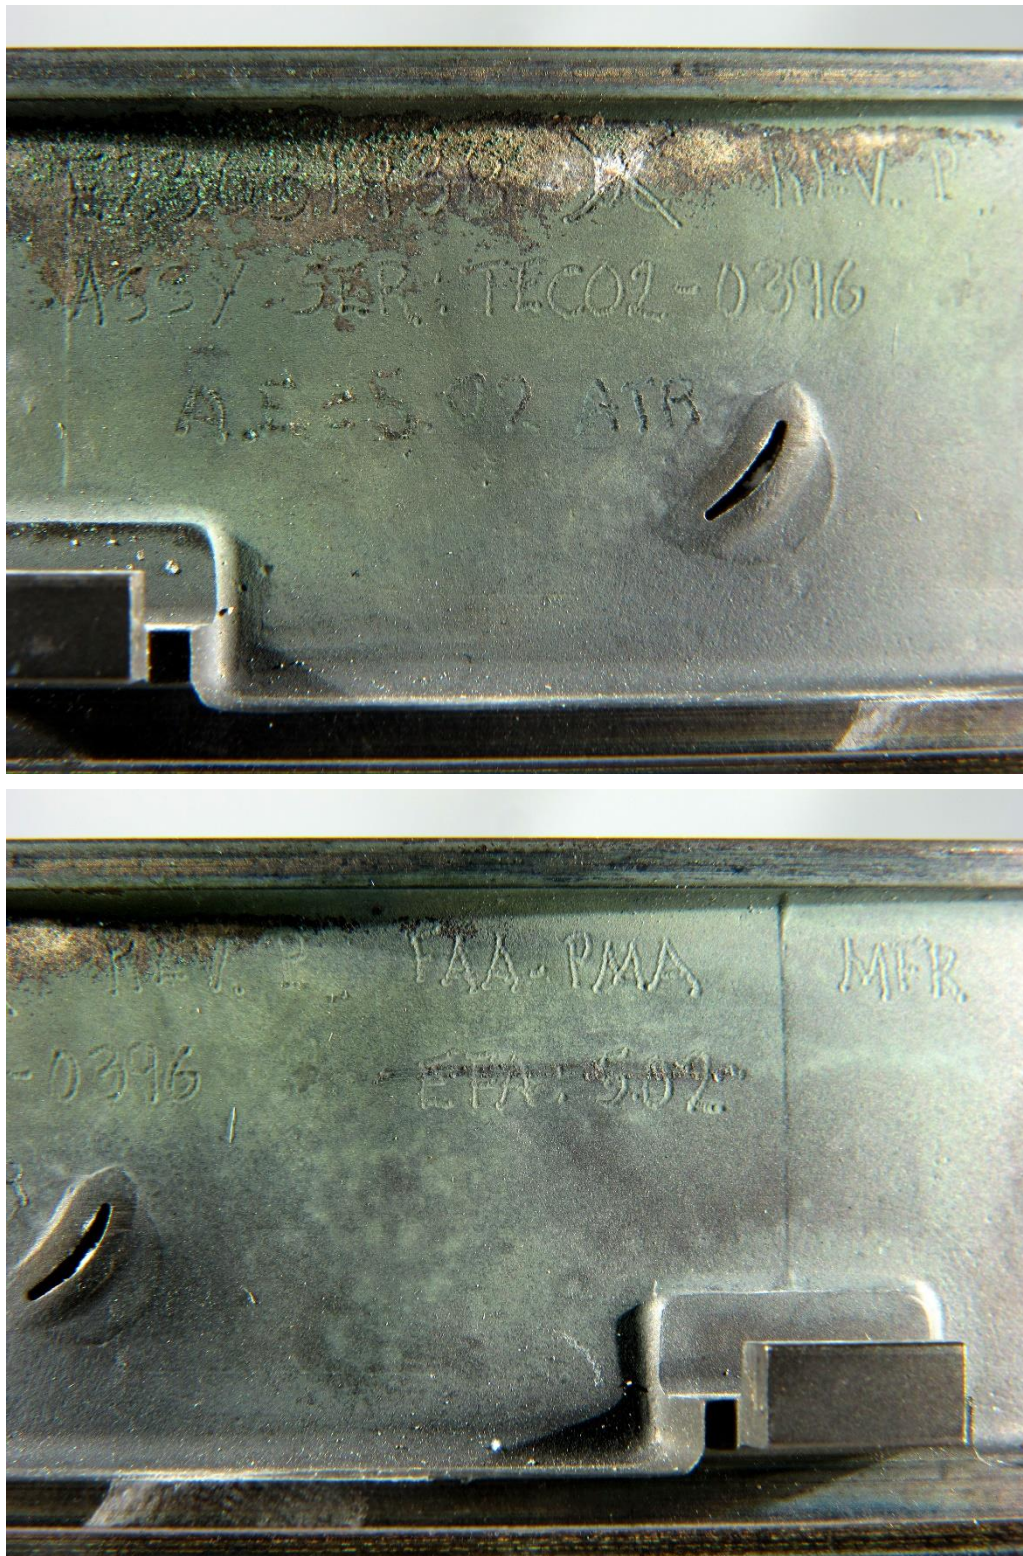
The second stage turbine nozzle assembly was an FAA PMA component as shown in Figure 100 and was not examined in detail.

**Figure 100. Part markings on the second stage turbine nozzle assembly, which was a PMA component (bottom).  
No scale provided.**
