## **NATIONAL TRANSPORTATION SAFETY BOARD**

# **AIRFRAME AND ENGINE EXAMINATION**

**CEN21LA109**

Location: Albany, TX  
Date: January 9, 2021  
Aircraft: Robinson R44, Registration N322SH, Serial #13391  
NTSB IIC: Samantha Link

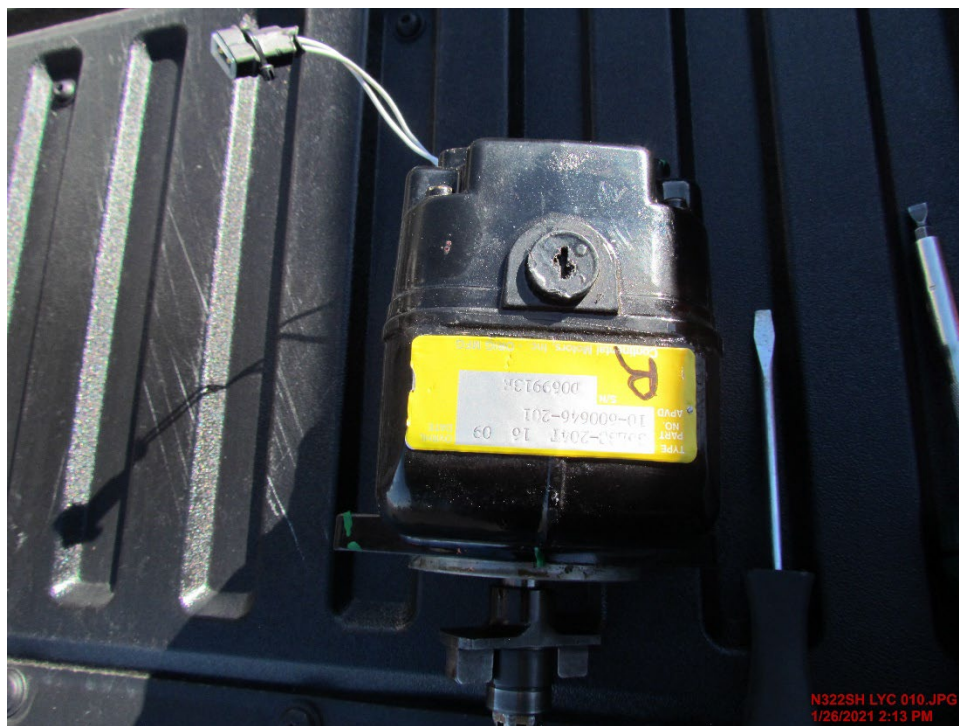
Figure 6: Right Magneto

- The magnetos were removed from the engine and the caps were removed.
  - All internal components were consistent with normal operations.
  - There were no abnormal indications or discoloration.
