**From:** Fox Todd  
**Sent:** Wednesday, February 8, 2023 10:17 AM  
**To:** LARIMORE Bryan (SAFRAN HELICOPTER ENGINES USA)  
**Cc:** Fox Todd; Rodi Jennifer  
**Subject:** RE: CEN21LA187 - Engine Run Report  
**Attachments:** A-2021-004 Engine Exam Report.pdf

| <b>INVESTIGATION REPORT</b> | Preliminary <input type="checkbox"/> |

| Data | | | | |
|---|---|---|---|---|
| EC120 | 1403 | N421PB | | |
| Arrius 2F | 34455 | 1432.7 as of 18FEB21 | | |

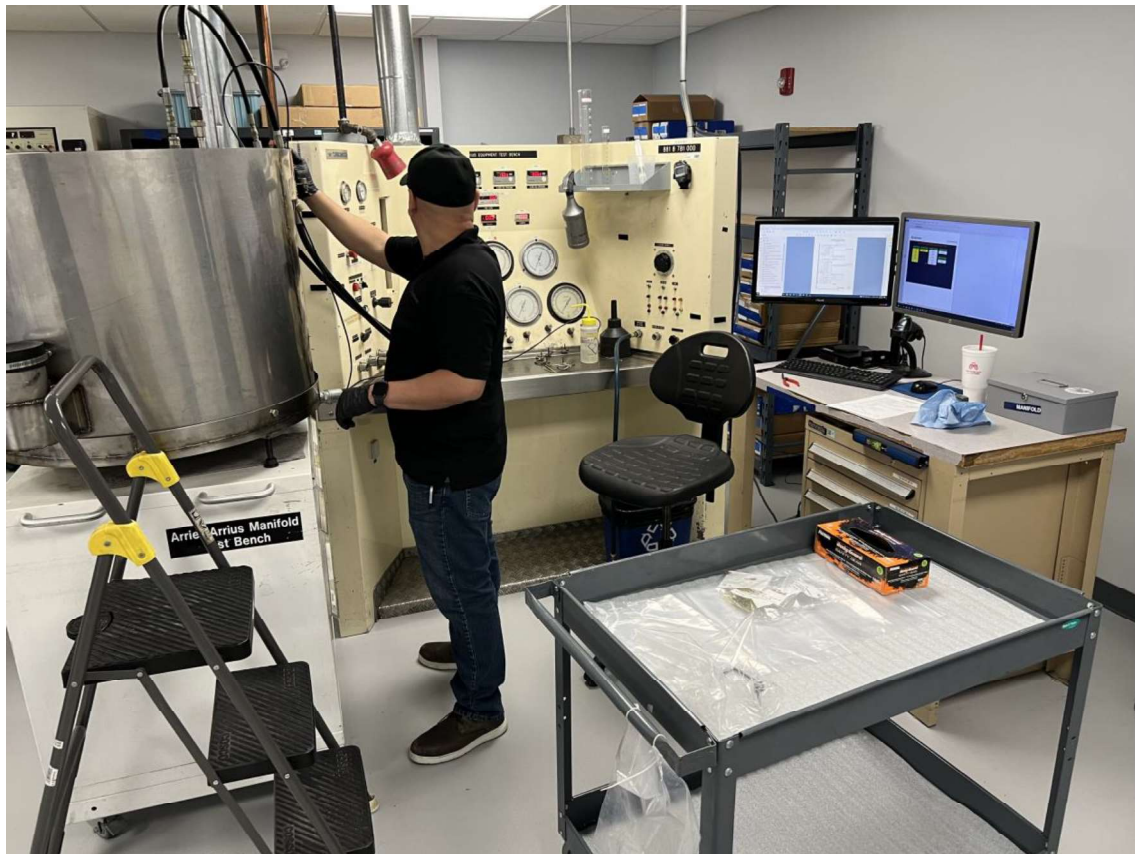
Left and Right injection manifolds. Preference Injector.

Manifold testing bench

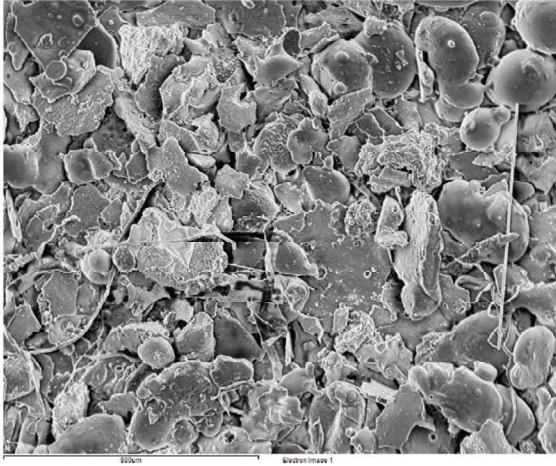
General Visual Information

| SPECTRO JET-CARE | | DEBRIS & FILTER ANALYSIS REPORT | |
|---|---|---|---|
| Description § | Debris from Fuel Sample | Report Issue | 1 |
