**Record of Examination**  
**CEN21LA208**  
**Date of Examination: August 2, 2021**  
**Performed By: Mitchell Gallo**

The aircraft, a Beech Aircraft Corporation 23, serial number M102, N2378Z, was examined by the NTSB Investigator-In-Charge at Beegles Aircraft Service, Greeley, Colorado, on August 2, 2021.

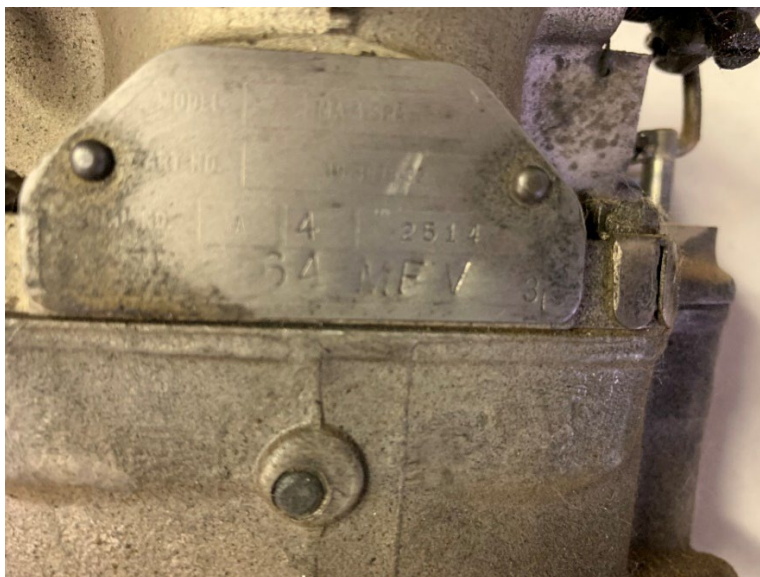
**Photo 8: Carburetor Data Plate**

The carburetor was removed for further examination. The carburetor data plate is shown in Photo 8.

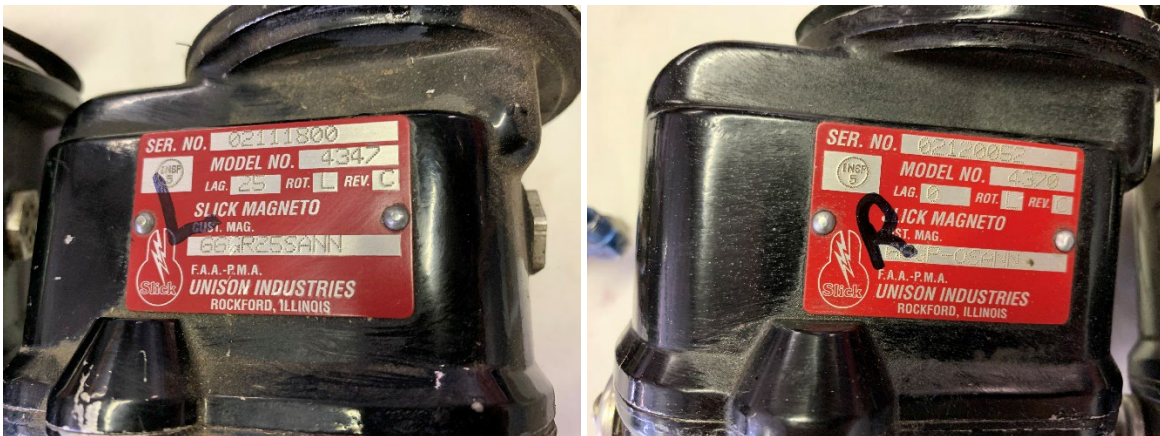
**Photo 9: Left (L) and Right (R) Magnetos**

The left and right magneto data plates are shown in Photo 9.

The ignition harness was attached and secured at both magnetos and at all spark plugs. Both magnetos were attached, secure, and were unable to be rotated/moved while mounted to the engine accessory case using hand pressure. Engine to left magneto timing was about 26° before top dead center (BTDC), and the engine to right magneto timing was about 25° BTDC. The engine data plate indicated the spark advance for the engine was 25°. Both magnetos were removed for bench testing and a check of internal timing. All plugs were of the massive electrode type and displayed “normal wear” consistent with the Champion Aviation Service Manual AV-6R. Comparative spark plug features of the top and bottom spark plugs with the Champion Check-A-Plug chart is shown in Photo 10.
