**NATIONAL TRANSPORTATION SAFETY BOARD**

**Office of Aviation Safety**

**INVESTIGATION SUMMARY**

**CEN21LA224**

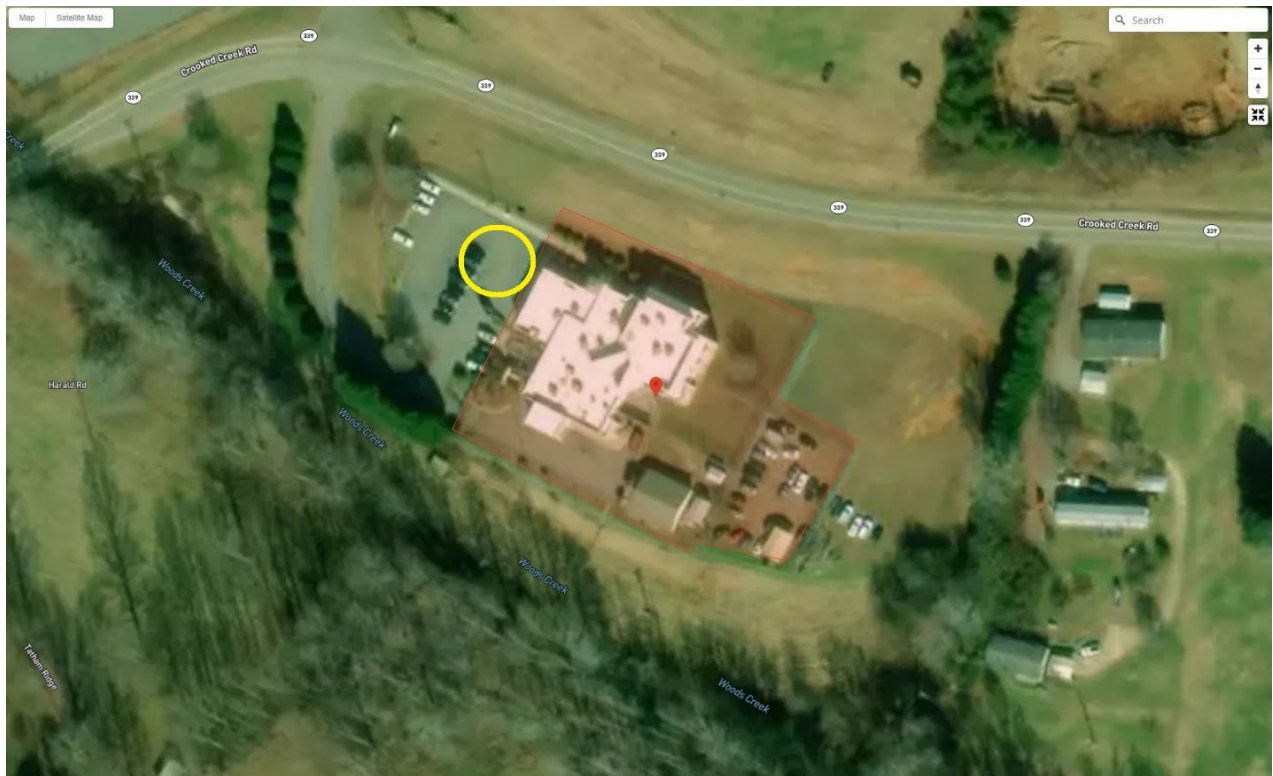
Figure 2. Restricted Zone highlighted in red and approximate accident location circled in yellow.

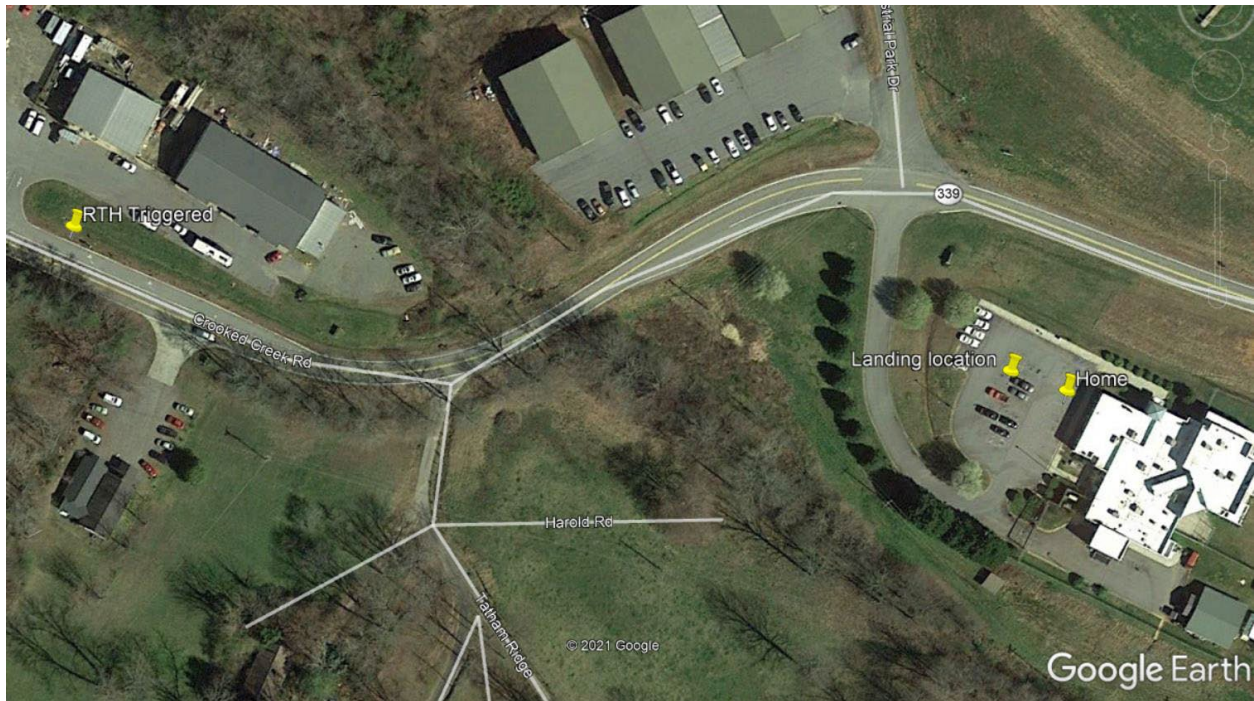
Figure 4. Flight event locations pinned in yellow.

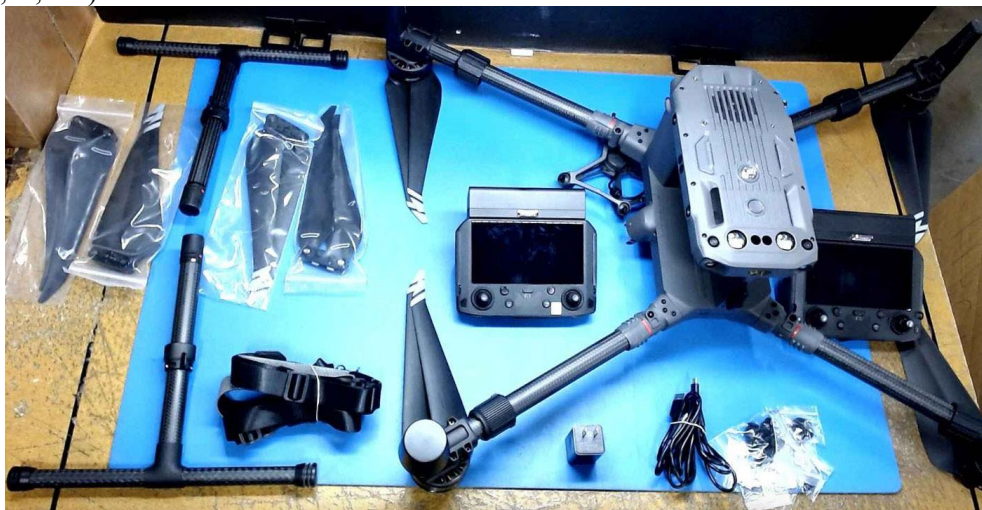
Figure 5. Condition of the parts received from the operator.

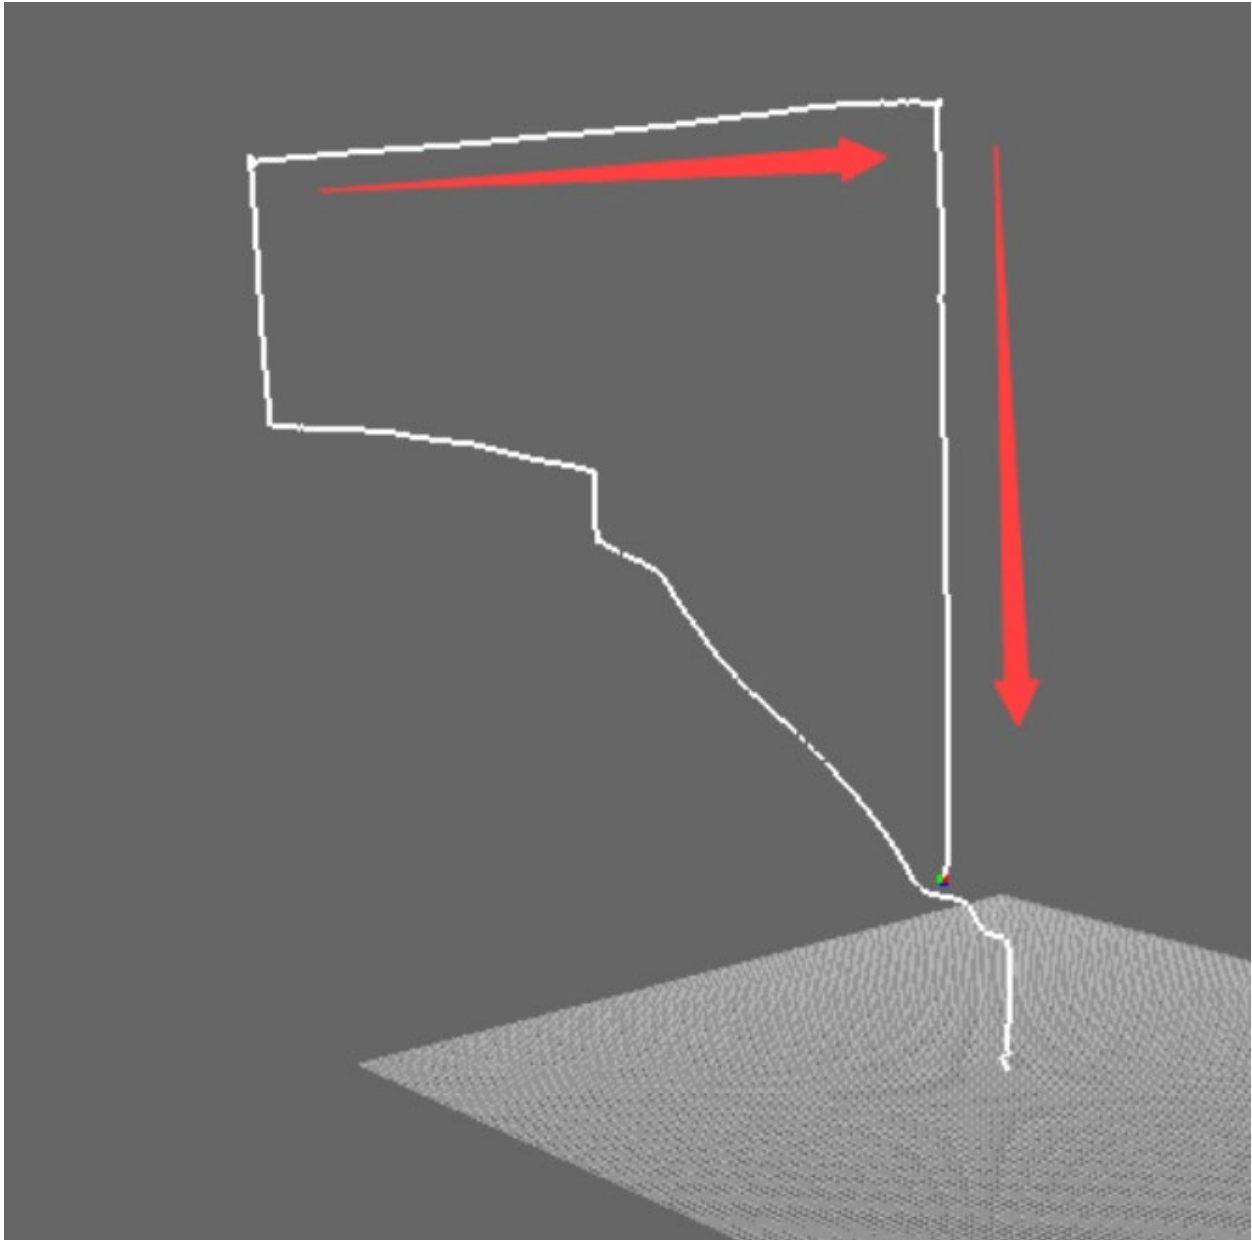
- T=120s, Take-off. The aircraft worked under GPS mode and responded well to the pilot's command.
- T=363s, Aircraft reached its farthest point at 34.9847287 x -83.8320778, 393.7 ft height, 892.3 ft distance from home point.
- T=556s, H=393.7 ft the pilot triggered RTH at coordinate 34.9847275 x -83.8320819. The preset RTH altitude was 125 ft and the aircraft started to return home at current height. Battery level was 75%. Unit estimated 26.02 minutes of flight time remained.

Figure 7. 3D flight path after the pilot triggered RTH.

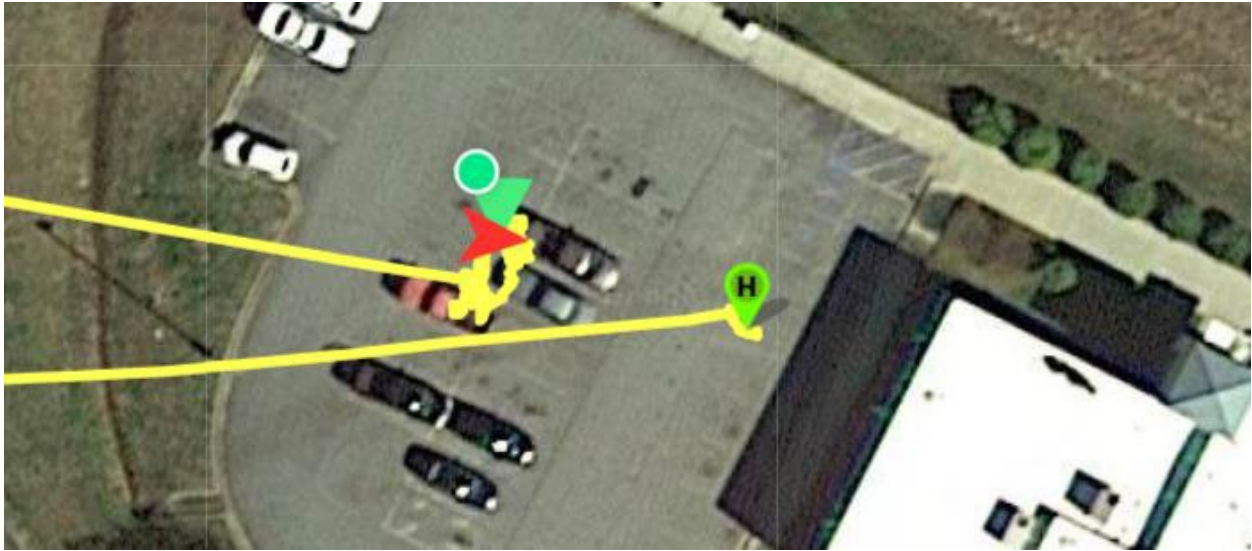
- Since the aircraft detected obstacles in close range, RTH locked the aircraft at current position. The aircraft was not responsive to pilot stick command as designed. The GPS coordinate on Google Map indicates a parking lot.

Figure 12. Aircraft flight path above the parking lot at the accident location.

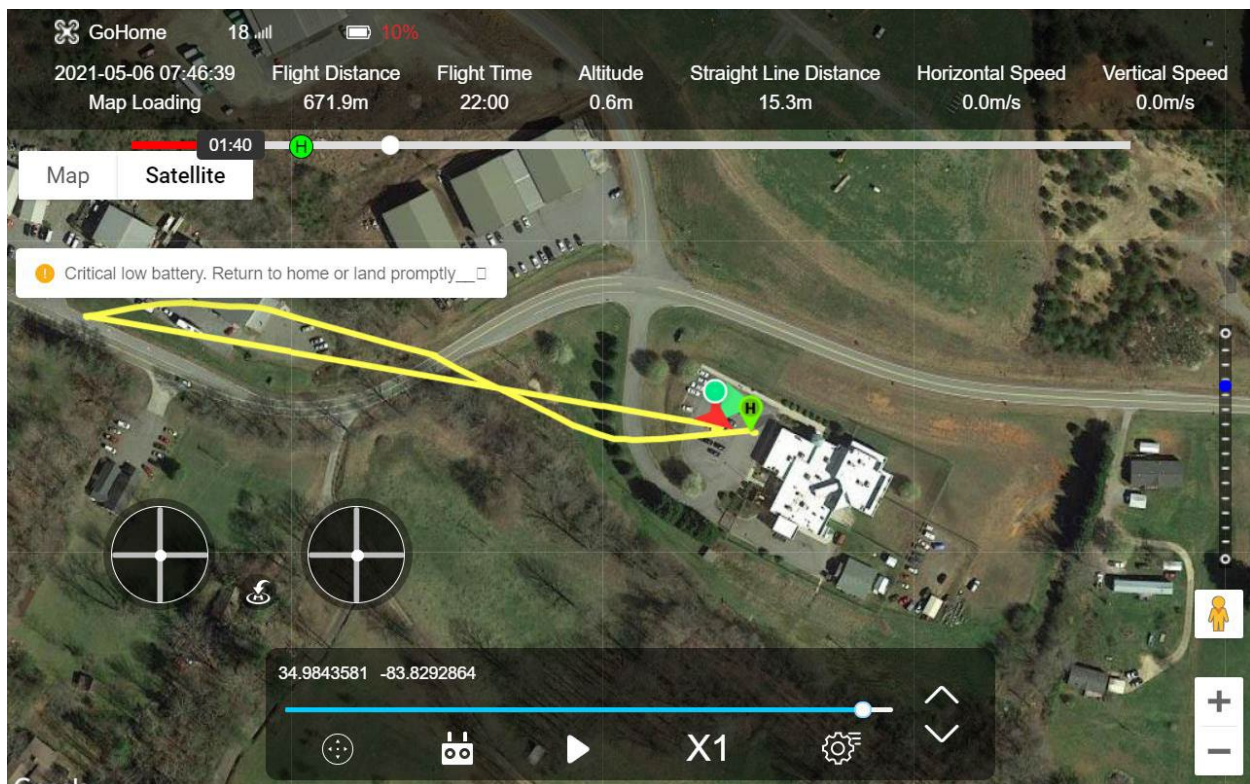
- T=1454s, the aircraft entered low power landing mode.
- A warning was prompted at 10% battery level.

Figure 14. Critical low battery warning.

- As the battery level reaches 9%, battery installation error was prompted, indicating the battery was loosened by external force.
