**HONEYWELL WRECKAGE REVIEW NOTES**  
**Celina, OH**  
**Grumman G-164B, Registration N8376K**  
**May 27, 2021**  
**NTSB Investigation CEN21LA237**

On May 27, 2021, a Grumman G-164B Agricultural aircraft crashed inverted into a waterway shortly after takeoff from the Lakefield Airport near Celina, Ohio. The aircraft was conducting aerial application in the area. The pilot sustained serious injuries. Aircraft damage was substantial. The aircraft was relocated to a hangar at the Lakefield Airport where a wreckage review was conducted on June 18, 2021. Representatives of Honeywell, Hartzell, FAA-FSDO Columbus, and the airport manager attended the review.

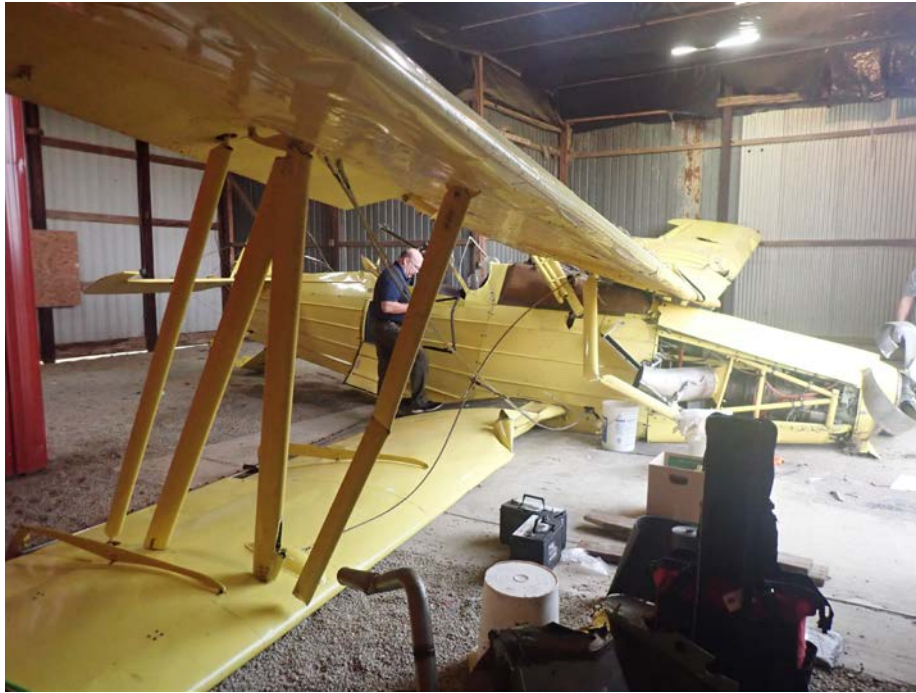
Figure 1. Grumman G-164 Registration N83476K

The aircraft was stored in a hangar on the airport property ([Figure 1](#)). The data plate on the aircraft identified the aircraft as G-164B, Serial No. 675B ([Figure 2](#)). The engine remained in the airframe with the side cowling removed. The propeller was removed for disassembly inspection ([Figure 3](#) and [Figure 4](#)). The remaining cowlings were removed ([Figure 5](#)) and the engine inspected prior to removal from the airframe.

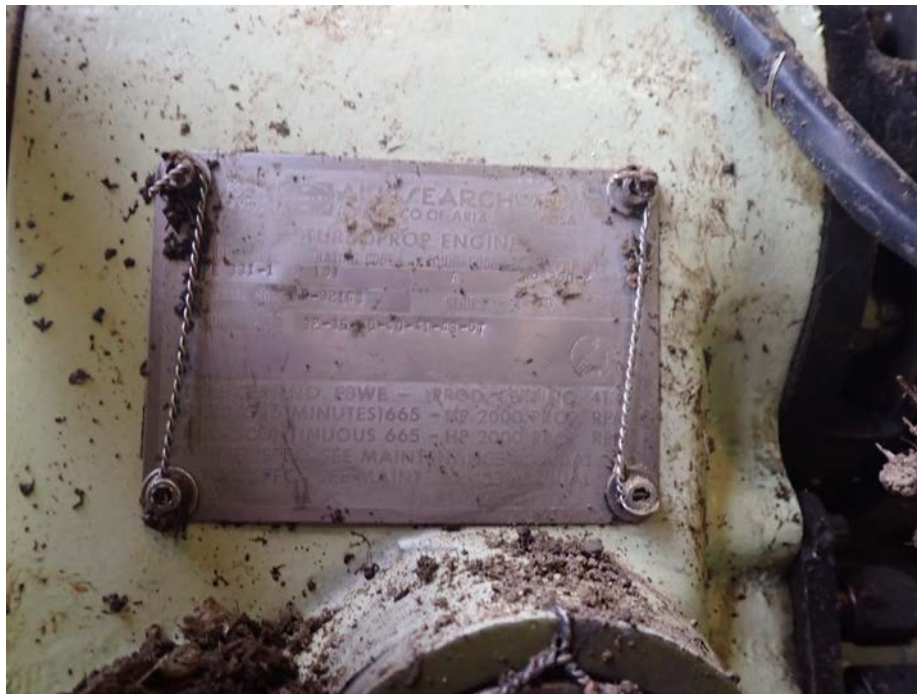
Figure 7. Engine S/N P-92143 Data Plate

- The engine was intact with no evidence of impact or fire damage ([Figure 6](#)).
- The engine data plate identified the engine as ([Figure 7](#))
  - o TPE3311-1-151A

- o Part No. 893250-2
  - o Serial No. P-92143
- Starter shaft was sheared ([Figure 8](#)) with the spline end remaining in gearbox ([Figure 9](#)). The starter remained with aircraft and was not returned with the engine.

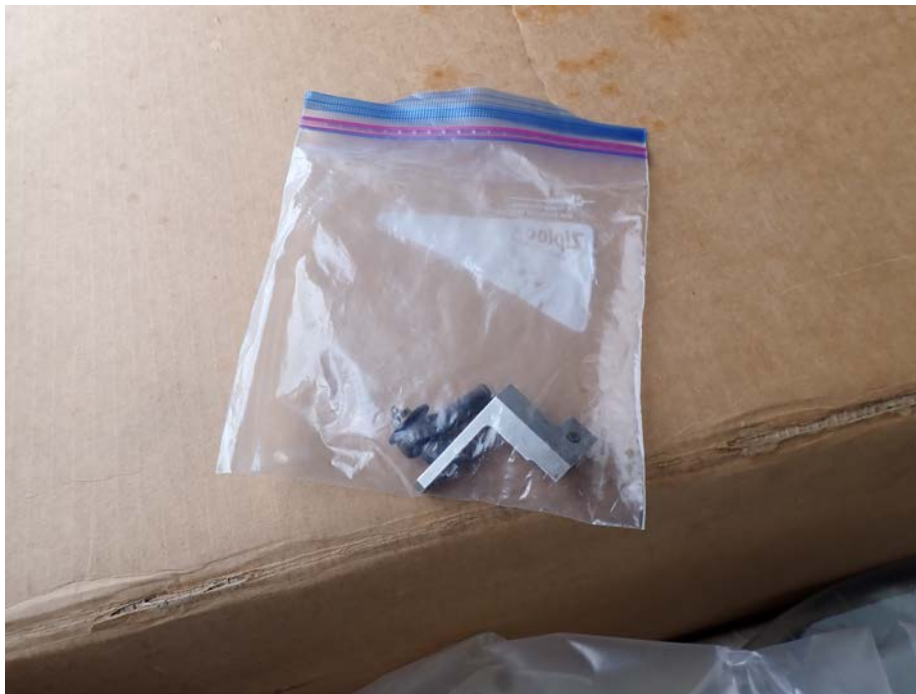
**Figure 26. Engine S/N P-92143 Propeller Pitch Control Linkage Bracket**

The bracket for the power lever linkage to the propeller pitch control was removed from the aircraft ([Figure 26](#)) and placed with the engine in the engine shipping container ([Figure 27](#) - [Figure 29](#)) for return to Honeywell facility in Phoenix, AZ
