# National Transportation Safety Board

CEN21LA237

## **POWERPLANTS**

Group Chair's Factual Report

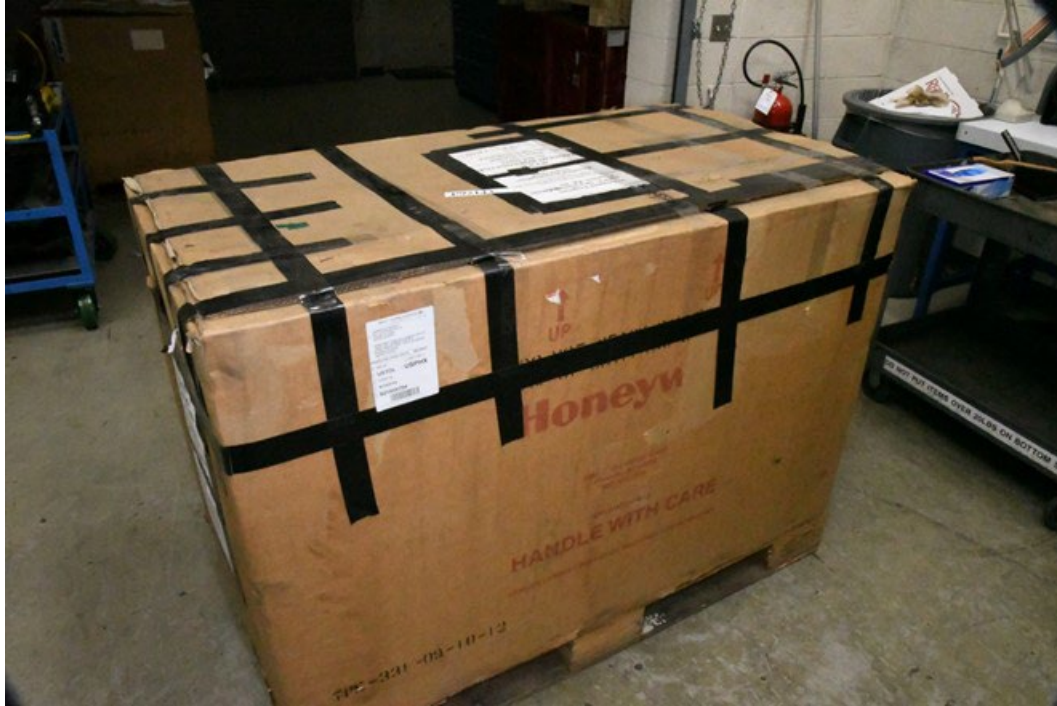
**Photo 1- Engine Shipping Box, as Received at Honeywell**

The engine was secured in a cardboard shipping box in the Honeywell Product Integrity Laboratory when the investigation team arrived (**Photos 1-4**). Earthen debris was adhered to the engine cases, external accessories, and lines. There was no evidence of undercowl engine fire or radial uncontainment. The 1<sup>st</sup> stage impeller was manually rotated by hand through the inlet and there was concurrent rotation of the 3<sup>rd</sup> stage turbine. The fuel pump mount studs on the accessory gearbox

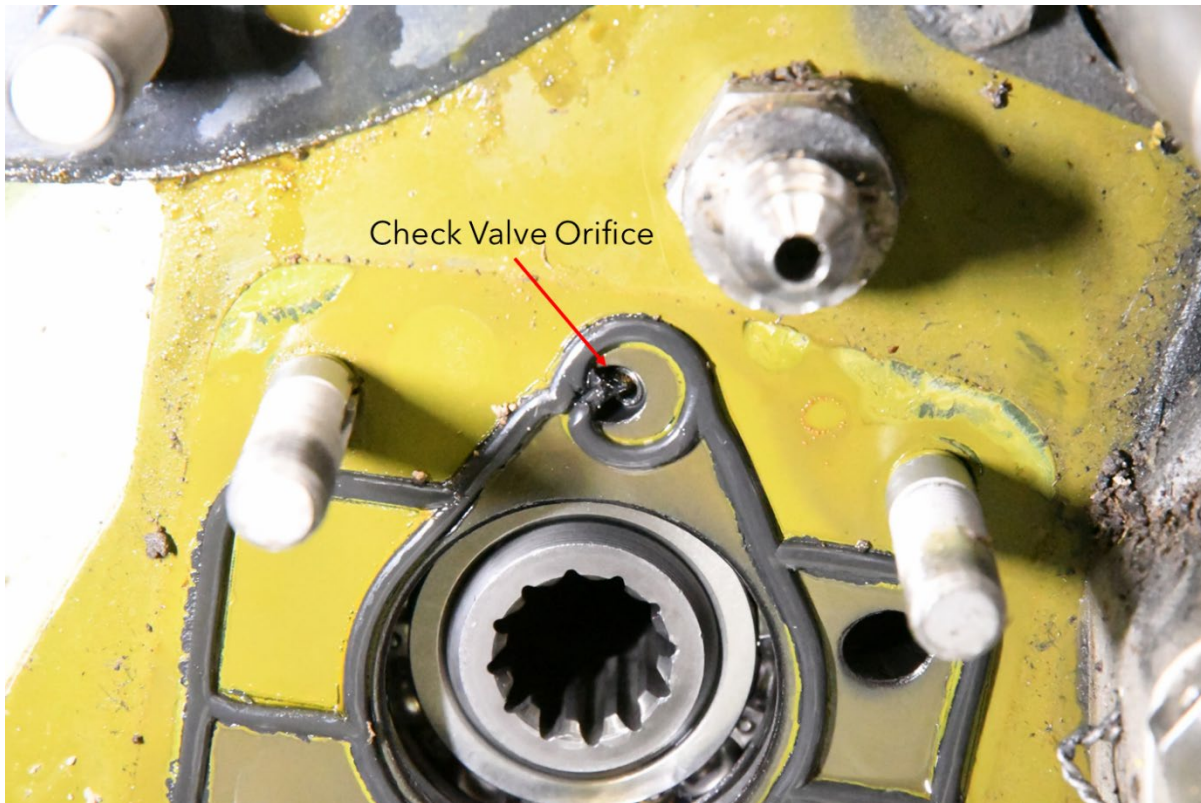
**Photo 9- Gearbox Case, Propeller Governor Spider Gasket, Check Valve Orifice**
