National Transportation Safety Board  
Office of Aviation Safety  
Washington, DC 20594

CEN21LA259

## **AIRCRAFT SYSTEMS**

Location: Aspen, Colorado  
Date: June 4, 2021  
Time: 0954 Local Time  
Airplane: Cessna 560XL, Serial Number 560-5016, N615RG

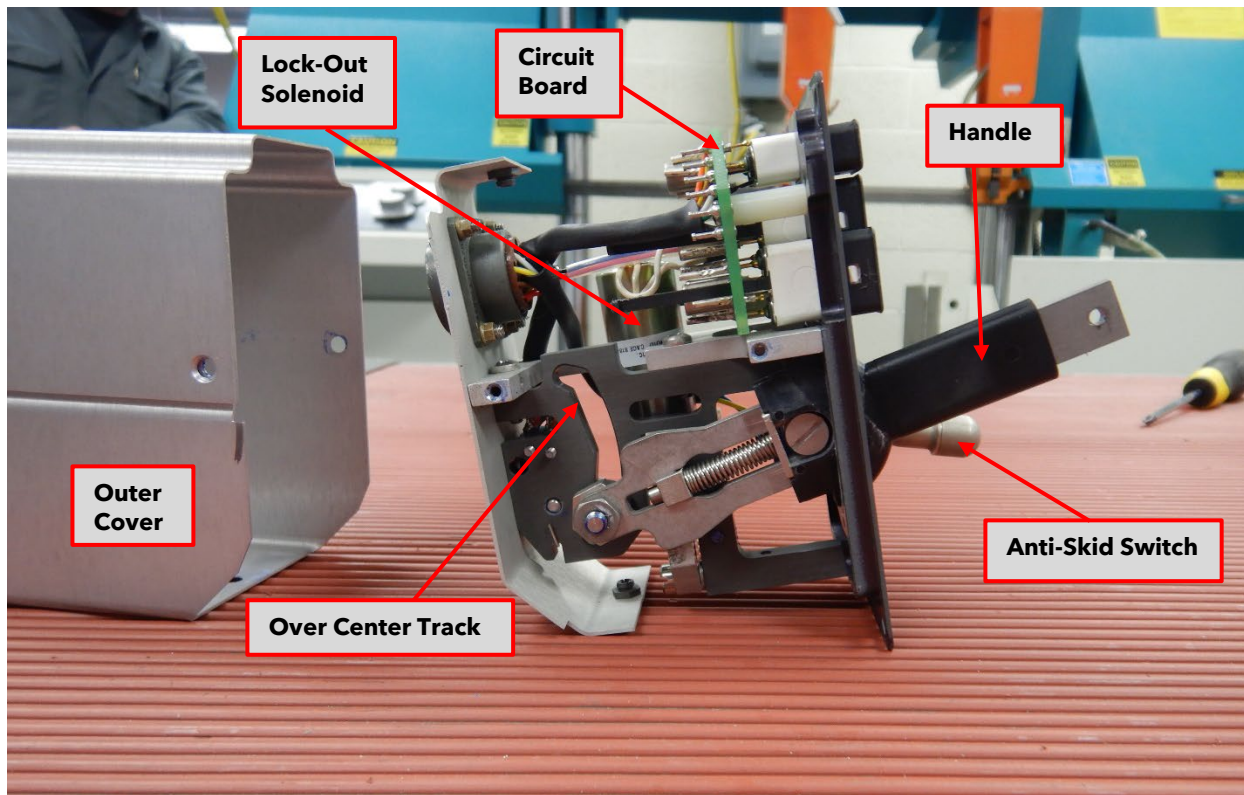
In the flight deck, the Landing Gear Control Panel contains the Landing Gear Control Handle, an audible warning system, three gear safe indicators and a red gear unlocked indicator. The Landing Gear Handle has two positions, full up and full down. The handle must be pulled out to clear a detent before it can be repositioned. Operation of the gear and gear doors will not begin until the handle has been positioned in one of the two detents. A gear handle locking solenoid activated by the

left main gear squat switch, physically prevents inadvertent movement of the gear handle while on the ground. See Figure 2.

**Figure 2.** Landing Gear Control Handle with components annotated.

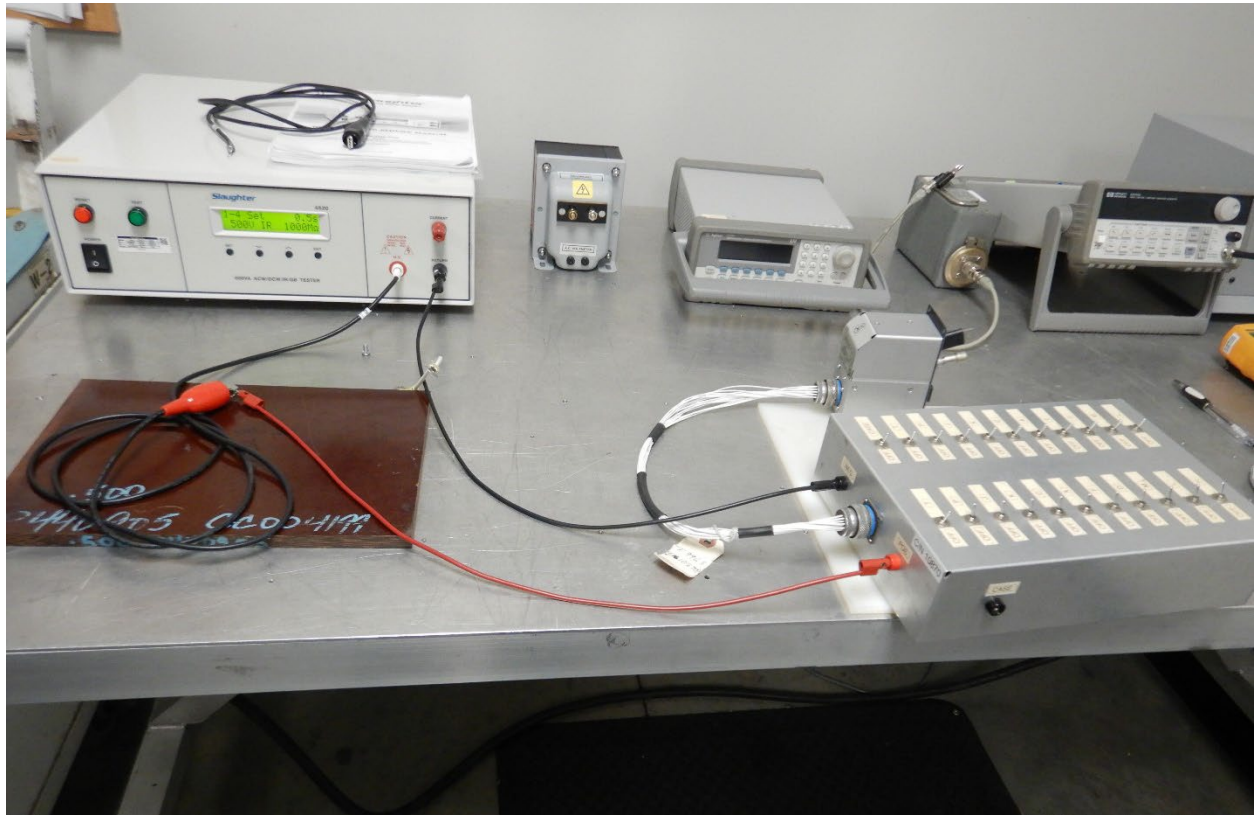
Functional testing of the Landing Gear Control Handle was accomplished per Textron ATP-049701, Sections 5.1, 5.3 and 5.4. A representative of Ontic (the Landing Gear Control Handle manufacturer) accomplished the testing at the Textron Aviation

Lab. Ontic provided the Landing Gear Control Handle Test Boxes (Part Numbers 049901 and 049902) necessary for the ATP testing. See Figure 5.

**Figure 5.** The Textron Landing Gear Control Handle Test Stand.

For ATP Section 5.1, Functional Test, the test elements were completed, with the unit passing all requirements except paragraph 5.1.1.5. ATP paragraph 5.1.1.5 requires that the landing gear handle returns to either the "UP" or "DOWN" position when released from any position. During the testing, the handle exhibited a tendency to stick in place when released. This tendency was repeated multiple times, with the handle released anywhere between mid-travel and within approximately 0.25 inch of the "RETRACT" detent. The handle remained in the position it was released in, on the retract half of the travel. When the handle was released on the "extend" side of travel, it would snap completely to the "extend" detent. When stuck in a position outside of the extend or retract detents, it would only transition further if vibration was applied to the case or the handle was manually transitioned.

It was noted that an "extend command" was provided as an output from the handle after moving less than 0.25" out of the "retract" position and the "extend command" was sustained throughout the remaining travel between the extend and retract detents. This allowed the handle to provide an "extend command" while the handle was stuck in a mid-travel position and with some vibration on the case, it
