## **NATIONAL TRANSPORTATION SAFETY BOARD**

# **AIRFRAME AND ENGINE EXAMINATION**

**CEN21LA265**

Location: Columbus, OH  
Date: June 14, 2021  
Aircraft: Cessna 180K, Registration N13159, Serial #18053166  
NTSB IIC: Samantha Link

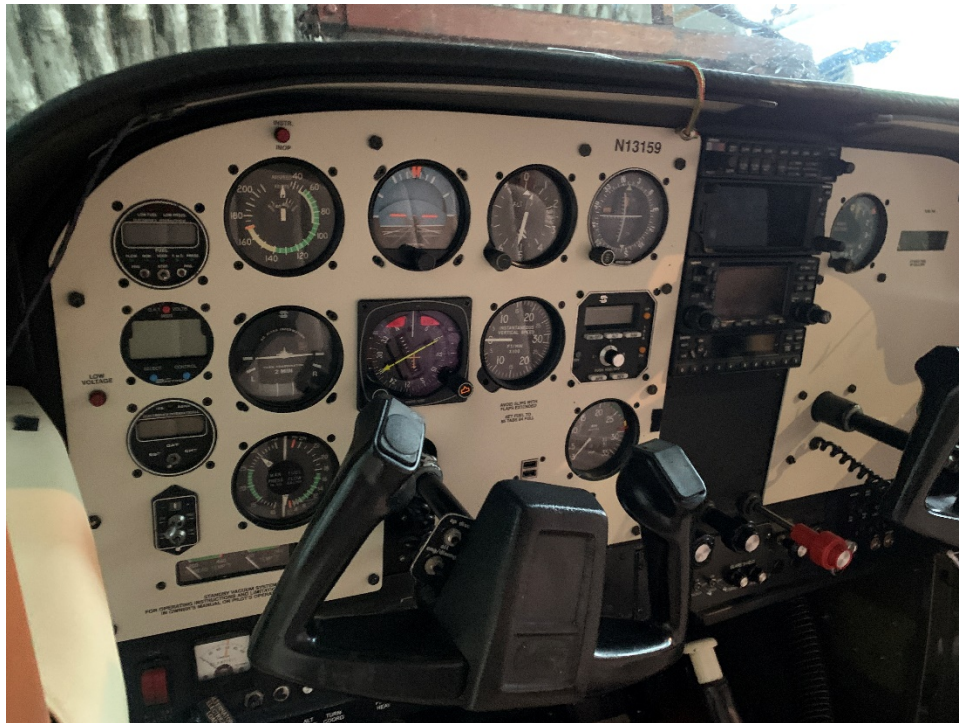
Figure 6: Instrument Panel

- All cockpit switches were found in the off position.
- The manual flap handle was found fully extended.
- Tachometer reading: 742.4 hours.
- Hobbs reading: 4687.8 hours.

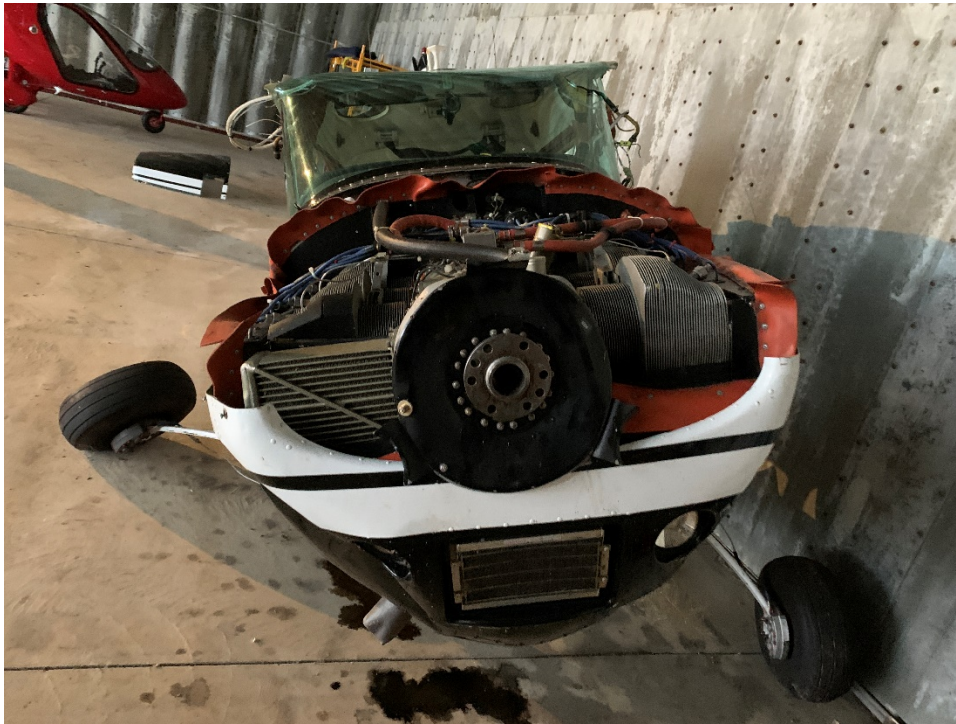
Figure 12: Front of Engine

- The engine cowling was removed and there were no visual signs of catastrophic failure.
- The fuel distributor was disassembled:
  - No fuel was observed within the distributor.
