Review and document all components of the torque sensor assembly. Analyze the debris of the submitted samples, oil filter, and magnetic chip detector.

| PART NAME: | Torque Sensor Assembly |
| MODEL/PROGRAM: | TPE331 |
| MODEL/PROGRAM S/N: | P92122C |

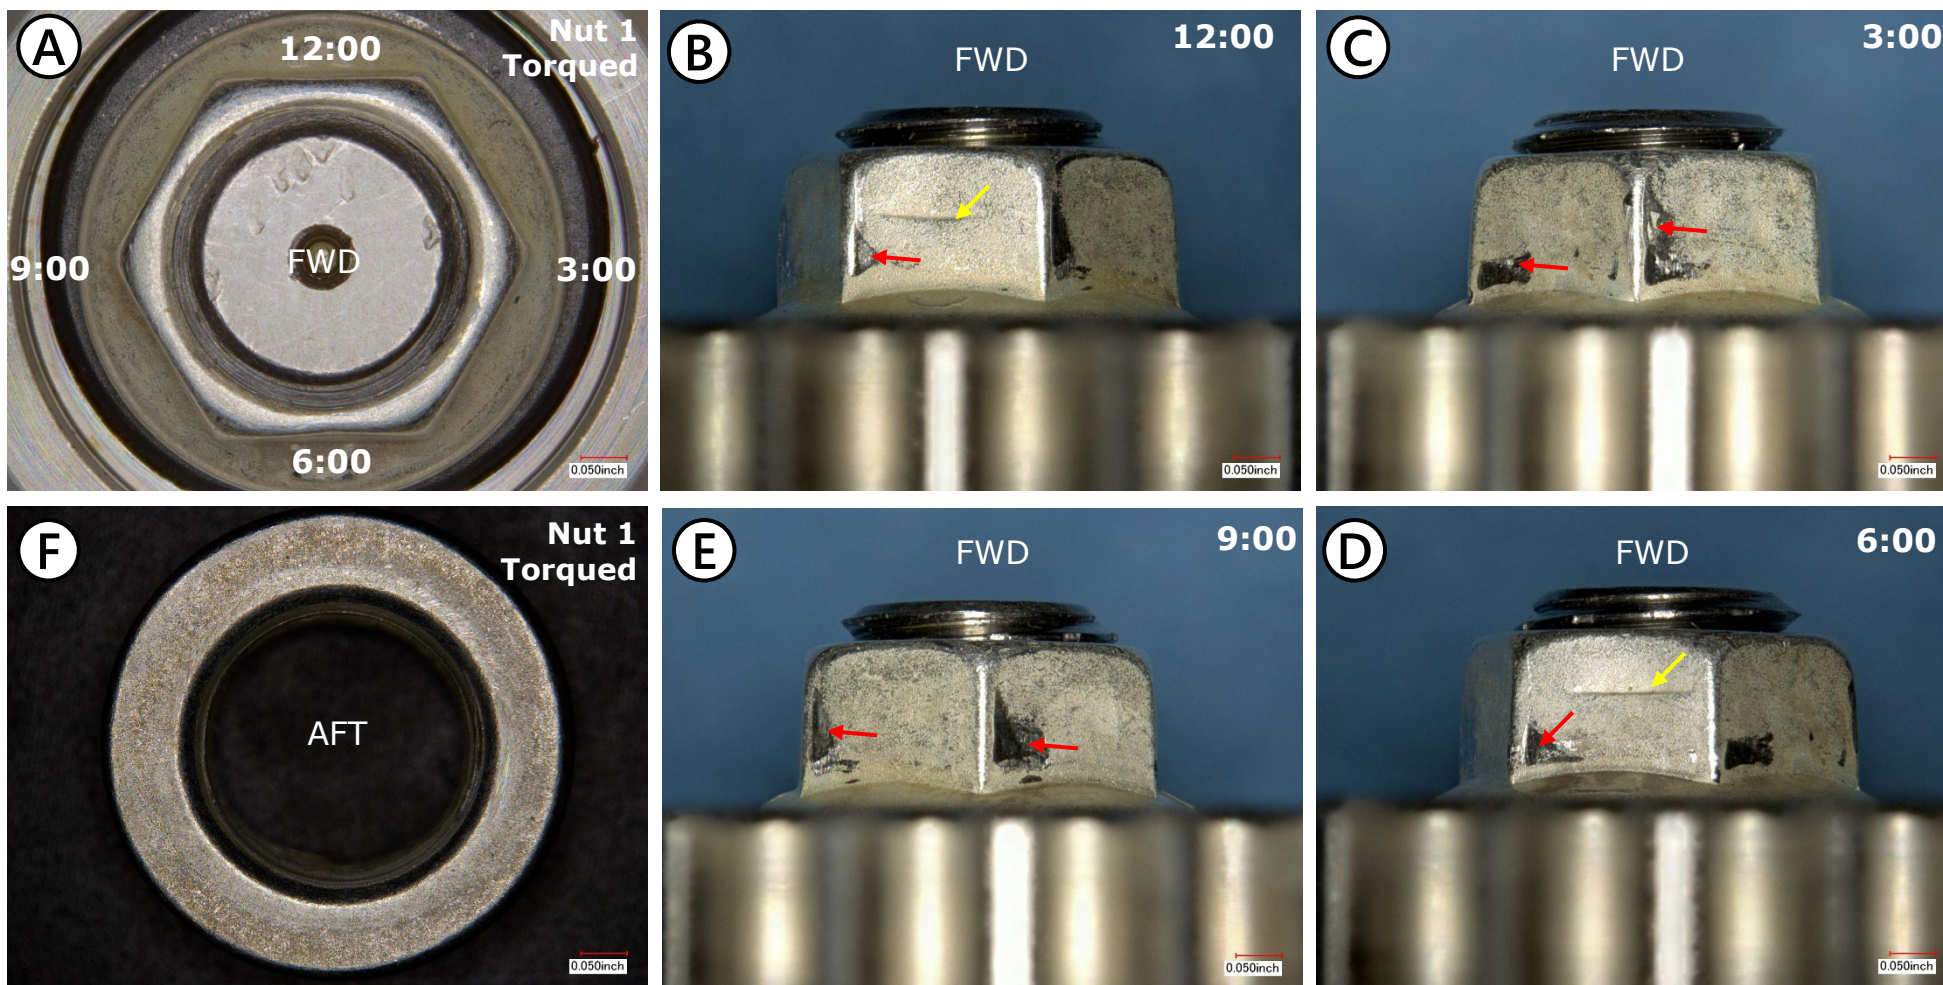
**Figure 22.**

Nut 1 was torqued to 200 lb/in using a torque wrench and exhibited wear marks on one side of each of the nut faces in the assembled state (Figure 22). After disassembly, wear marks were observed on both sides of each nut face (Figure 23). Wear was observed predominantly on the forward side of the threads. On the aft side of the threads, non-uniform wear

(A-F) Digital microscope images showing the condition of Nut 1 (P/N MS21043-5), which was a new nut torqued with no lubricant. The yellow arrows in (B) and (D) identify the locking tool marks. Wear marks were observed on one side of each of the nut faces (red arrows in (B-E)).

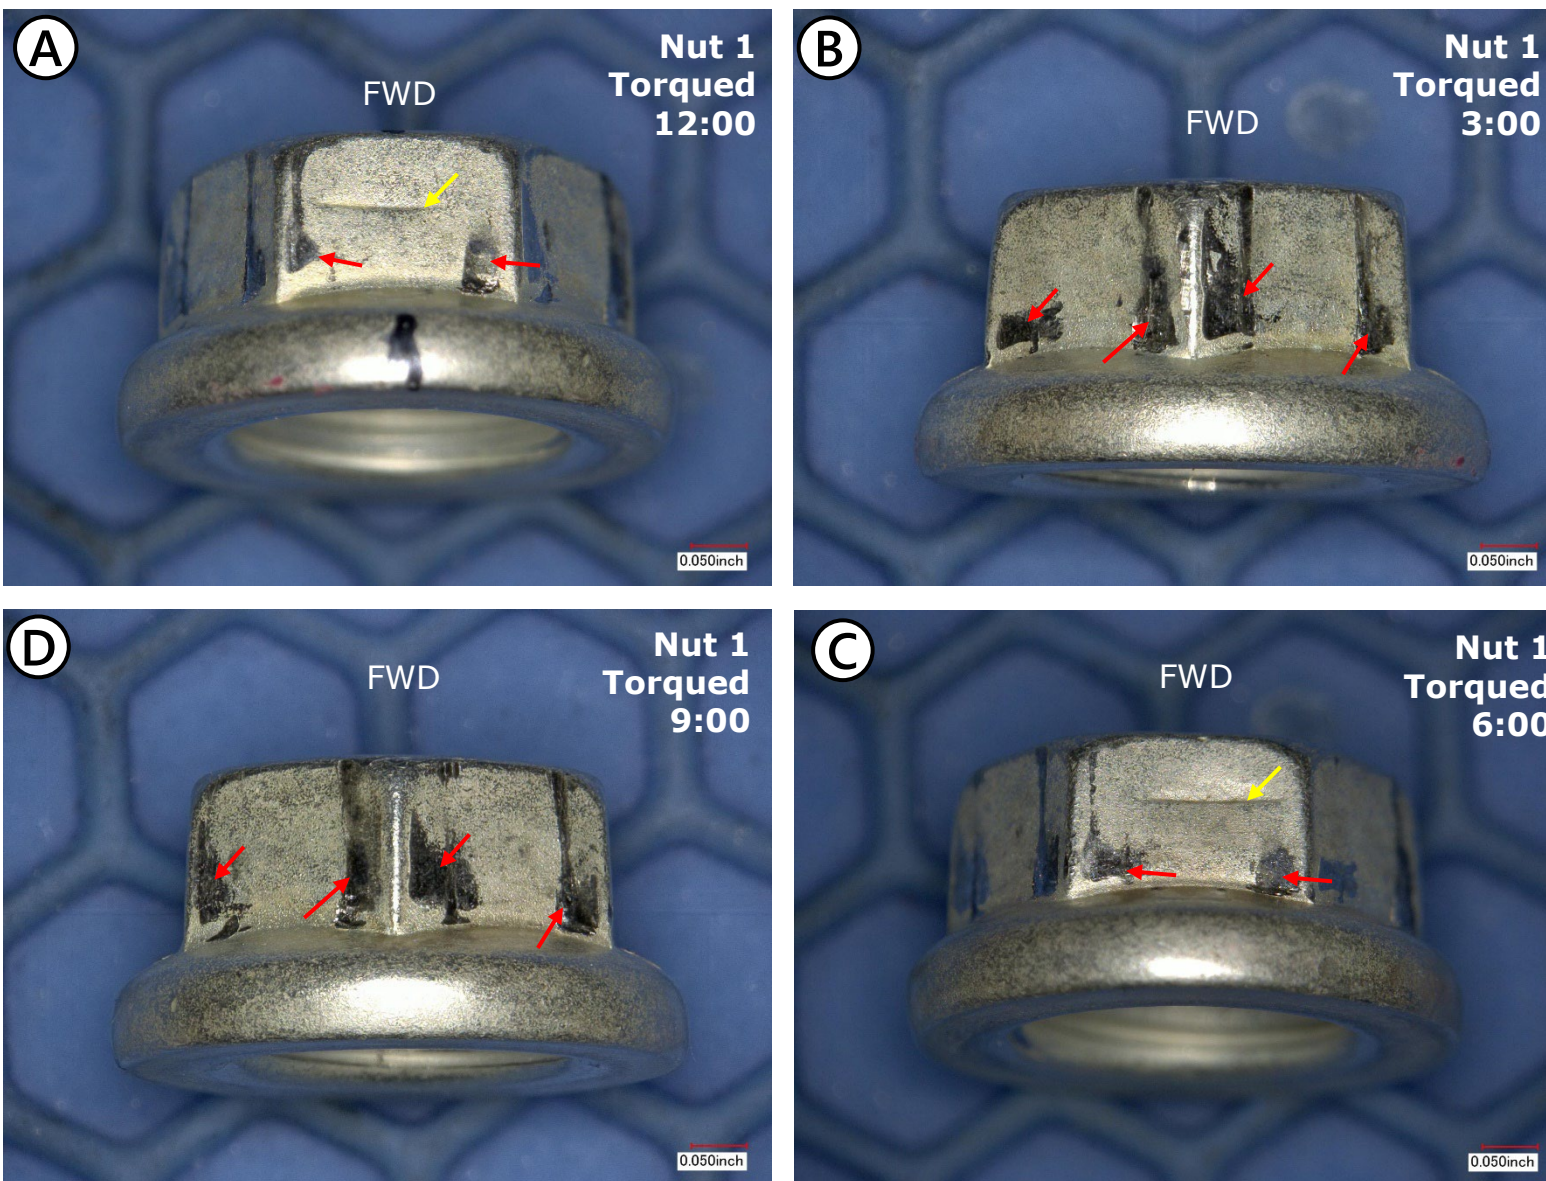
**Figure 23.**

(A-D) Digital microscope images showing the condition of Nut 1 (P/N MS21043-5) after removal from the assembly. The yellow arrows in (B) and (C) identify the locking tool marks. Wear marks were observed on both sides of each of the nut faces (red arrows).

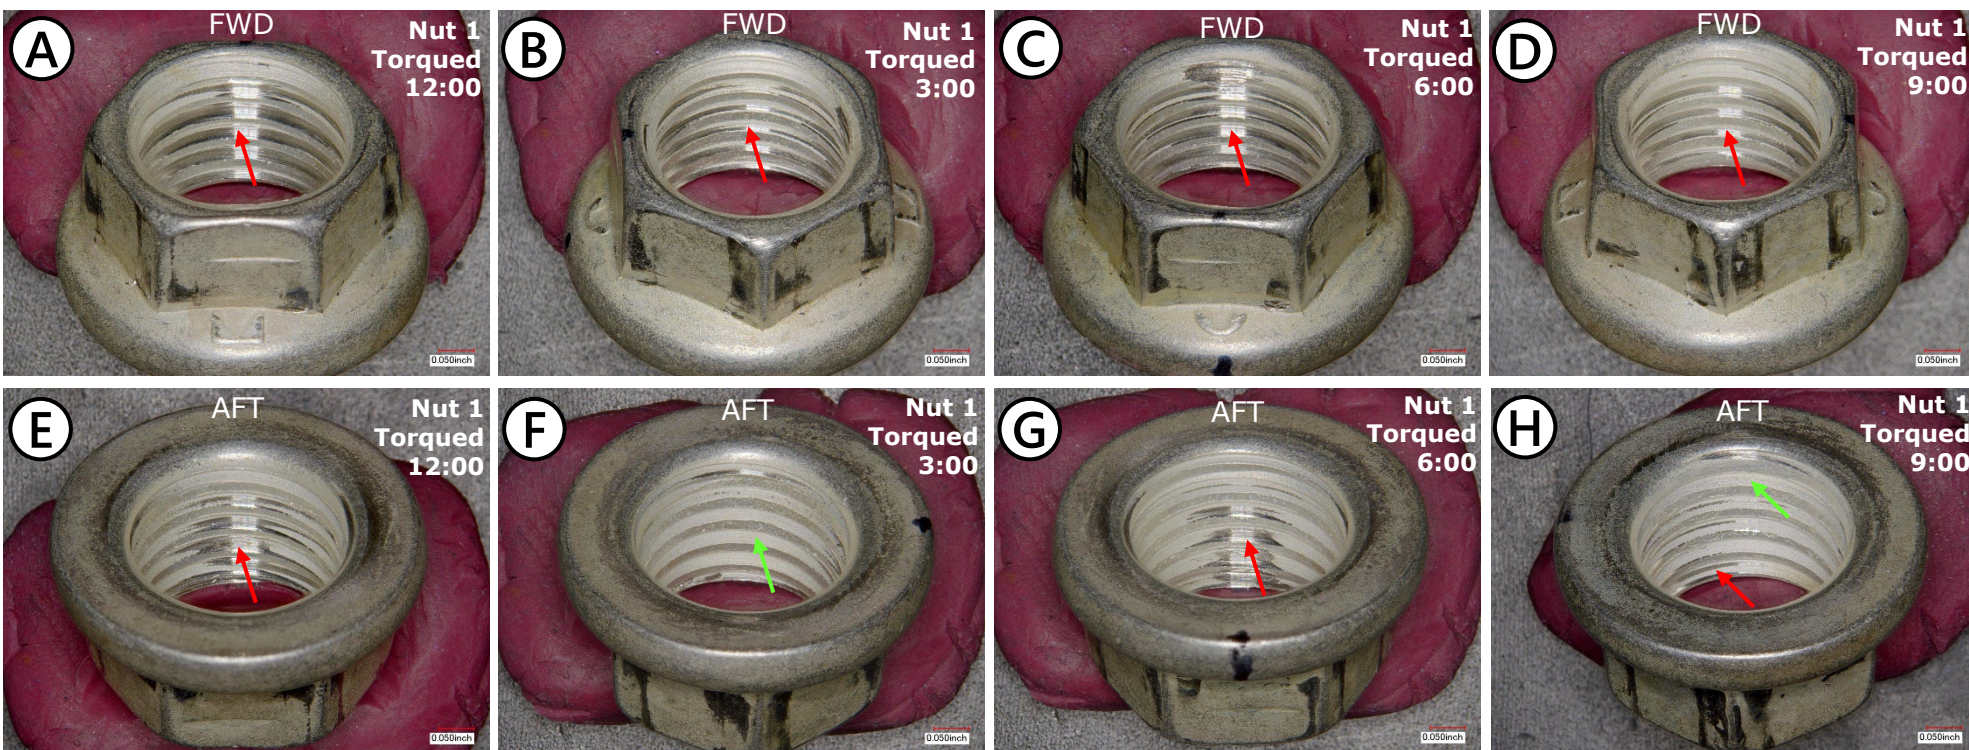
**Figure 24.**

marks were observed around the circumference (Figure 24).

Digital microscope images showing the condition of the threads as viewed from the (A-D) forward and (E-H) aft sides of Nut 1. The red arrows identify wear on the threads that had penetrated through the silver plating. Note that the contact on the aft side of the threads was not uniform around the circumference (green arrows).

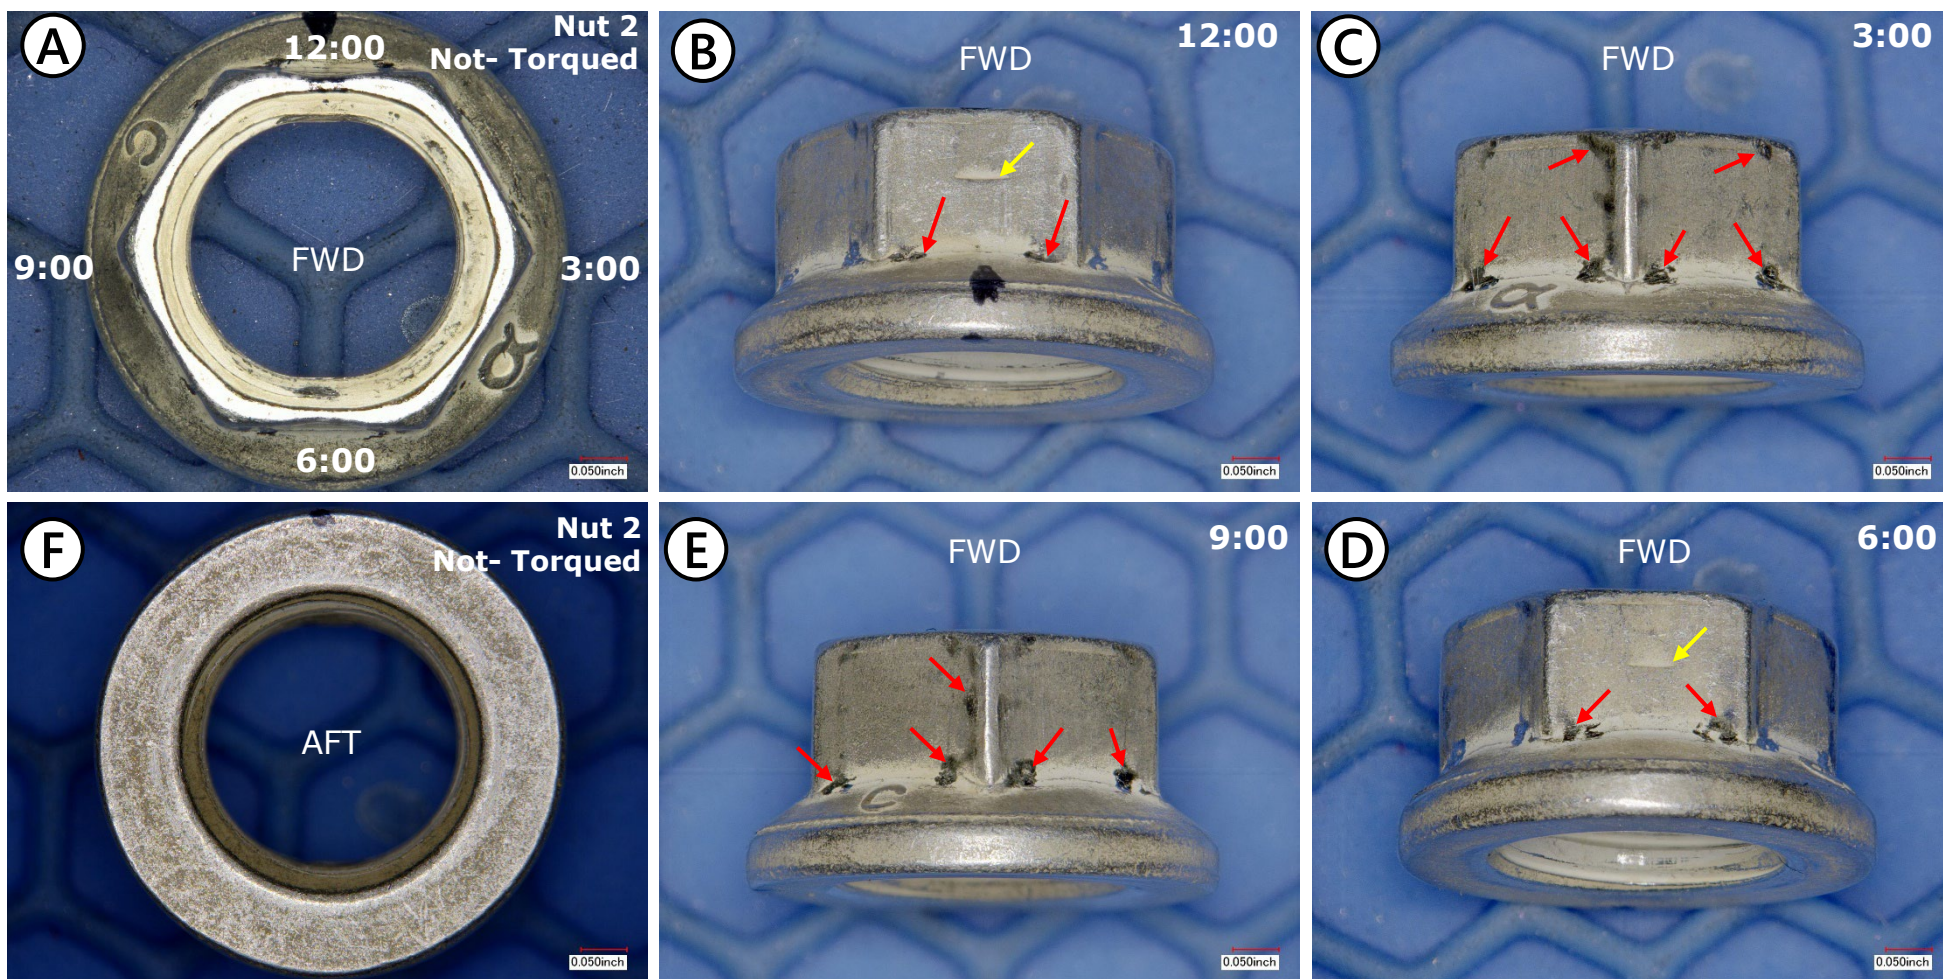
**Figure 25.**

Nut 2 was screwed into the assembly, but not torqued, and then disassembled using a torque wrench. After disassembly, wear marks were observed on both sides of each nut face (Figure 25). It was noted that the wear marks were smaller to those marks observed on Nut 1. Wear was observed predominantly on the forward side of the threads. On the aft side of the threads, wear marks were observed on three threads that aligned with the locking tool marks at the 12:00 and 6:00 positions near the forward end of the nut (Figure 26). The remaining aft side of the threads exhibited little to no wear marks.

(A-F) Digital microscope images showing the condition of Nut 2 (P/N MS21043-5) after removal from the assembly, which was a new nut screwed with no torque using lubricant. The yellow arrows in (B) and (D) identify the locking tool marks. Wear marks were observed on one side of each of the nut faces (red arrows in (B-E)).

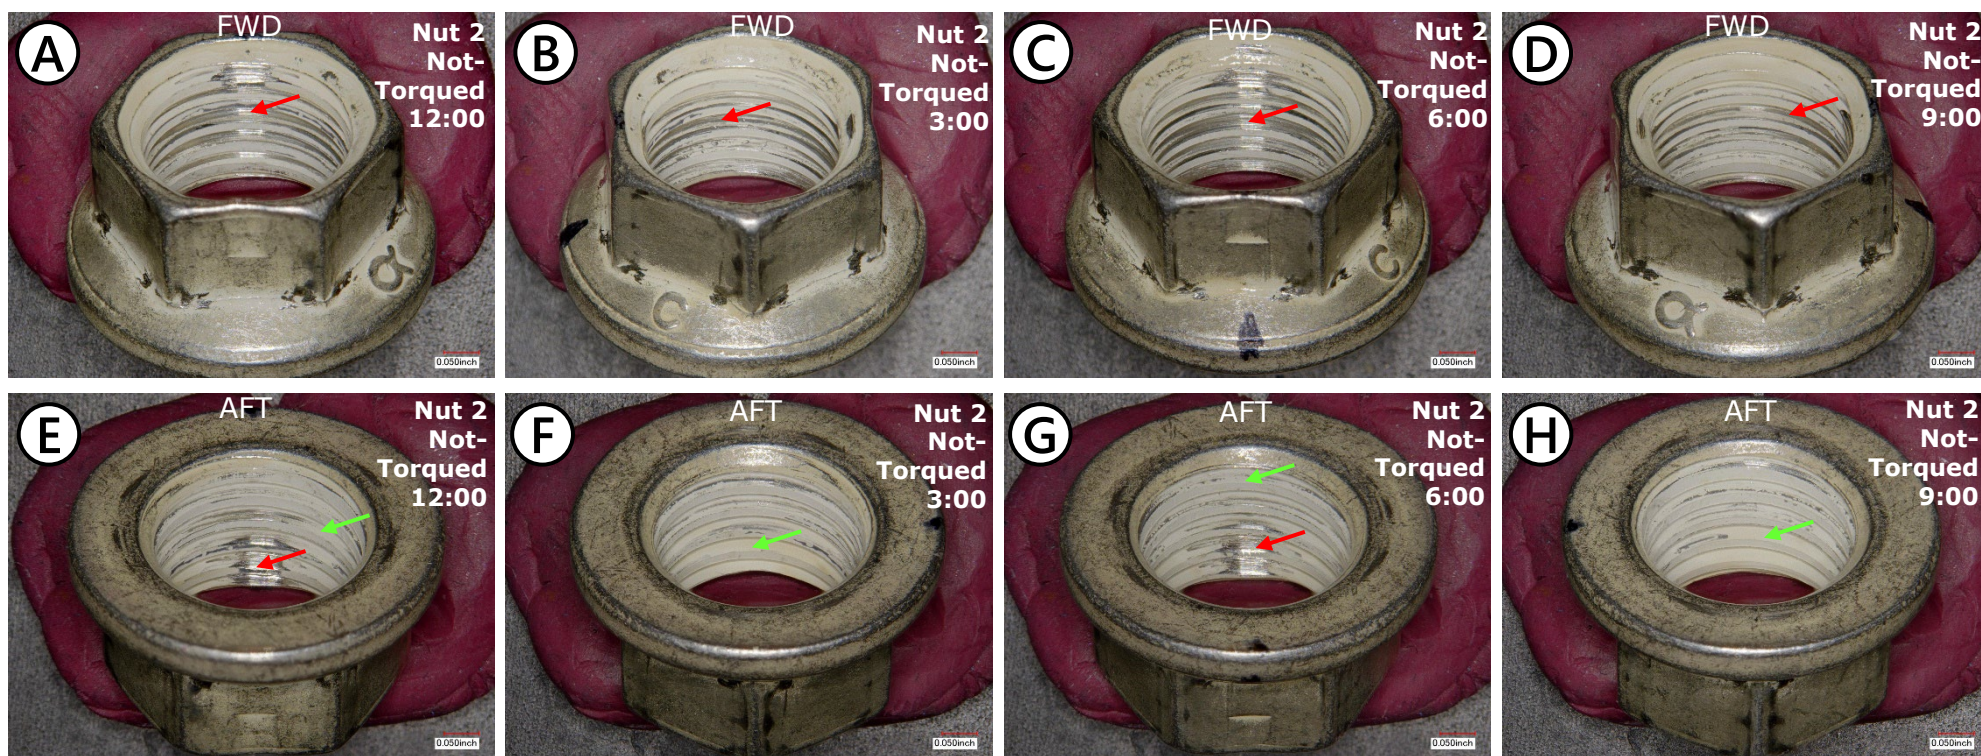
**Figure 26.** Digital microscope images showing the condition of the threads as viewed from the (A-D) forward and (E-H) aft sides of Nut 2. The red arrows identify wear on the threads that had penetrated through the silver plating. Note that the contact on the aft side of the threads was not uniform around the circumference (green arrows).

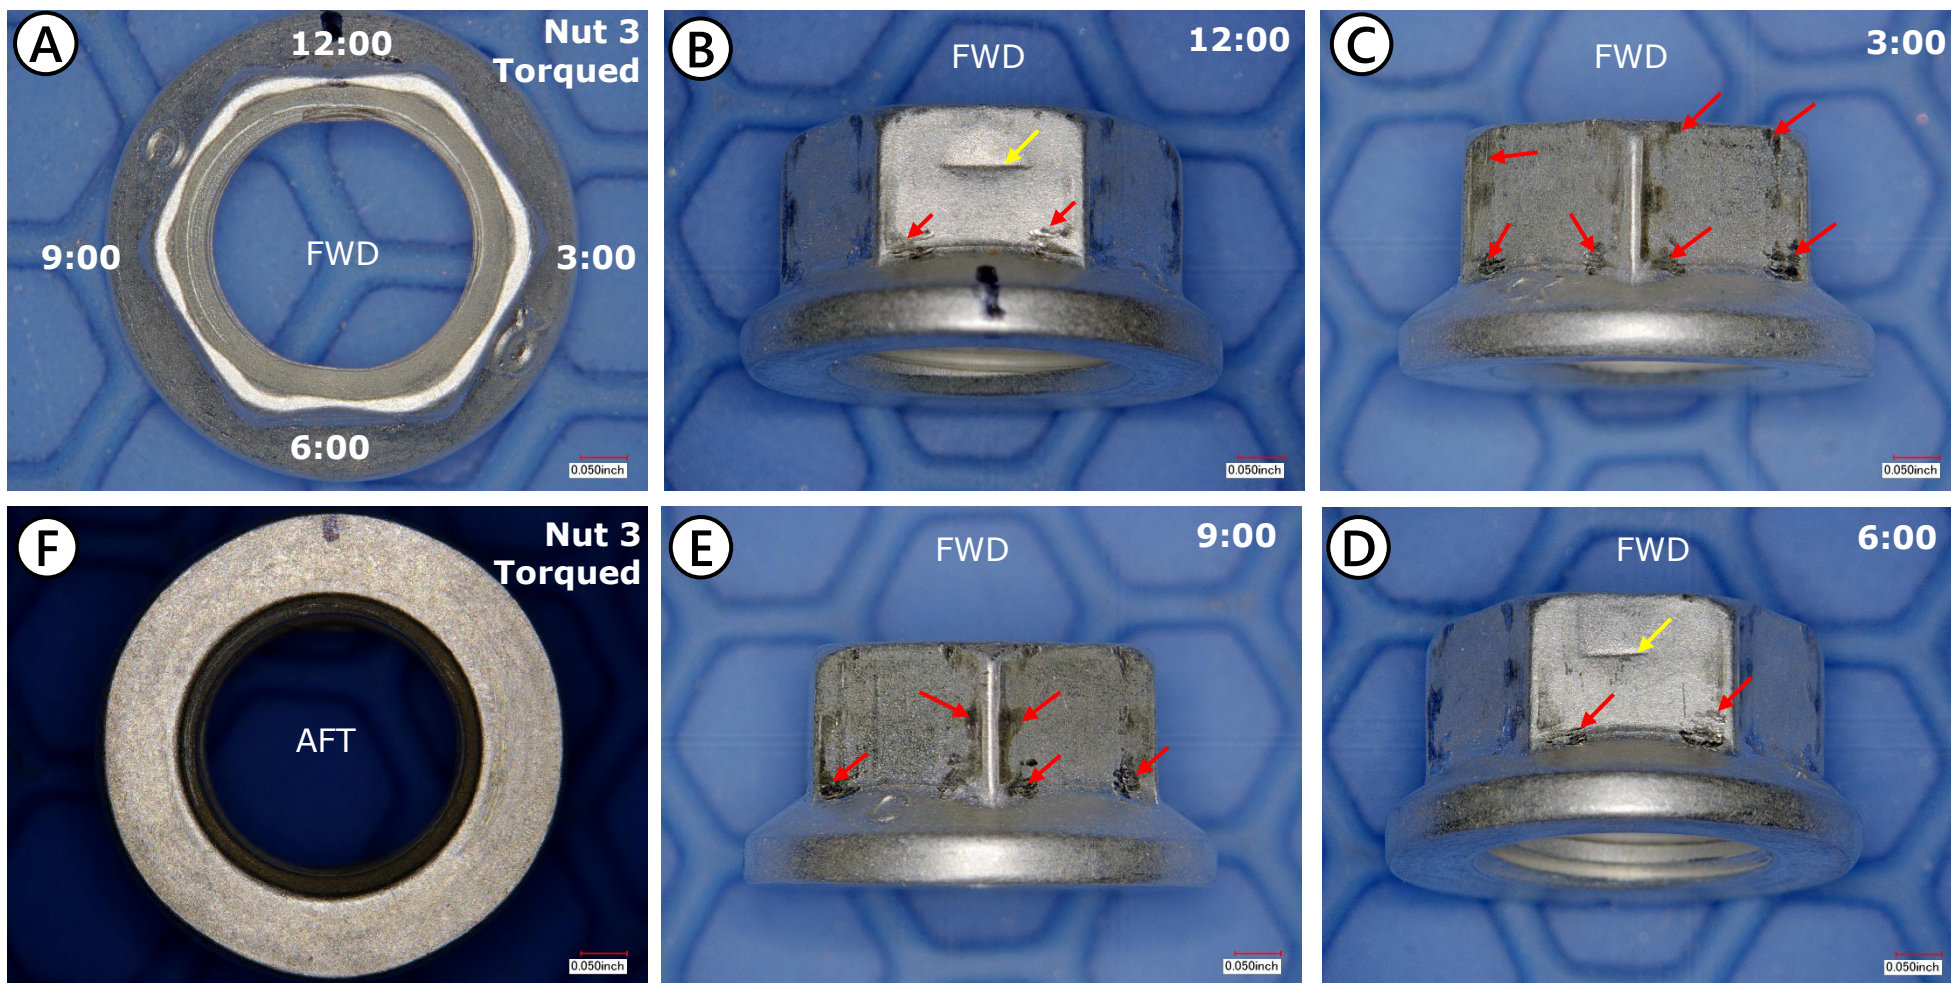
**Figure 27.**

Nuts 3 and 4 were torqued to 200 lb/in and then disassembled using a torque wrench. After disassembly, wear marks were observed on both sides of each nut face (Figures 27 and 29). Wear was observed predominantly on the forward side of the threads. On the aft side of the threads, non-uniform wear marks were observed around the circumference (Figures 28 and 30).

(A-F) Digital microscope images showing the condition of Nut 3 (P/N MS21043-5) after removal from the assembly, which was a new nut torqued without using lubricant. The yellow arrows in (B) and (D) identify the locking tool marks. Wear marks were observed both sides of each of the nut faces (red arrows in (B-E)).

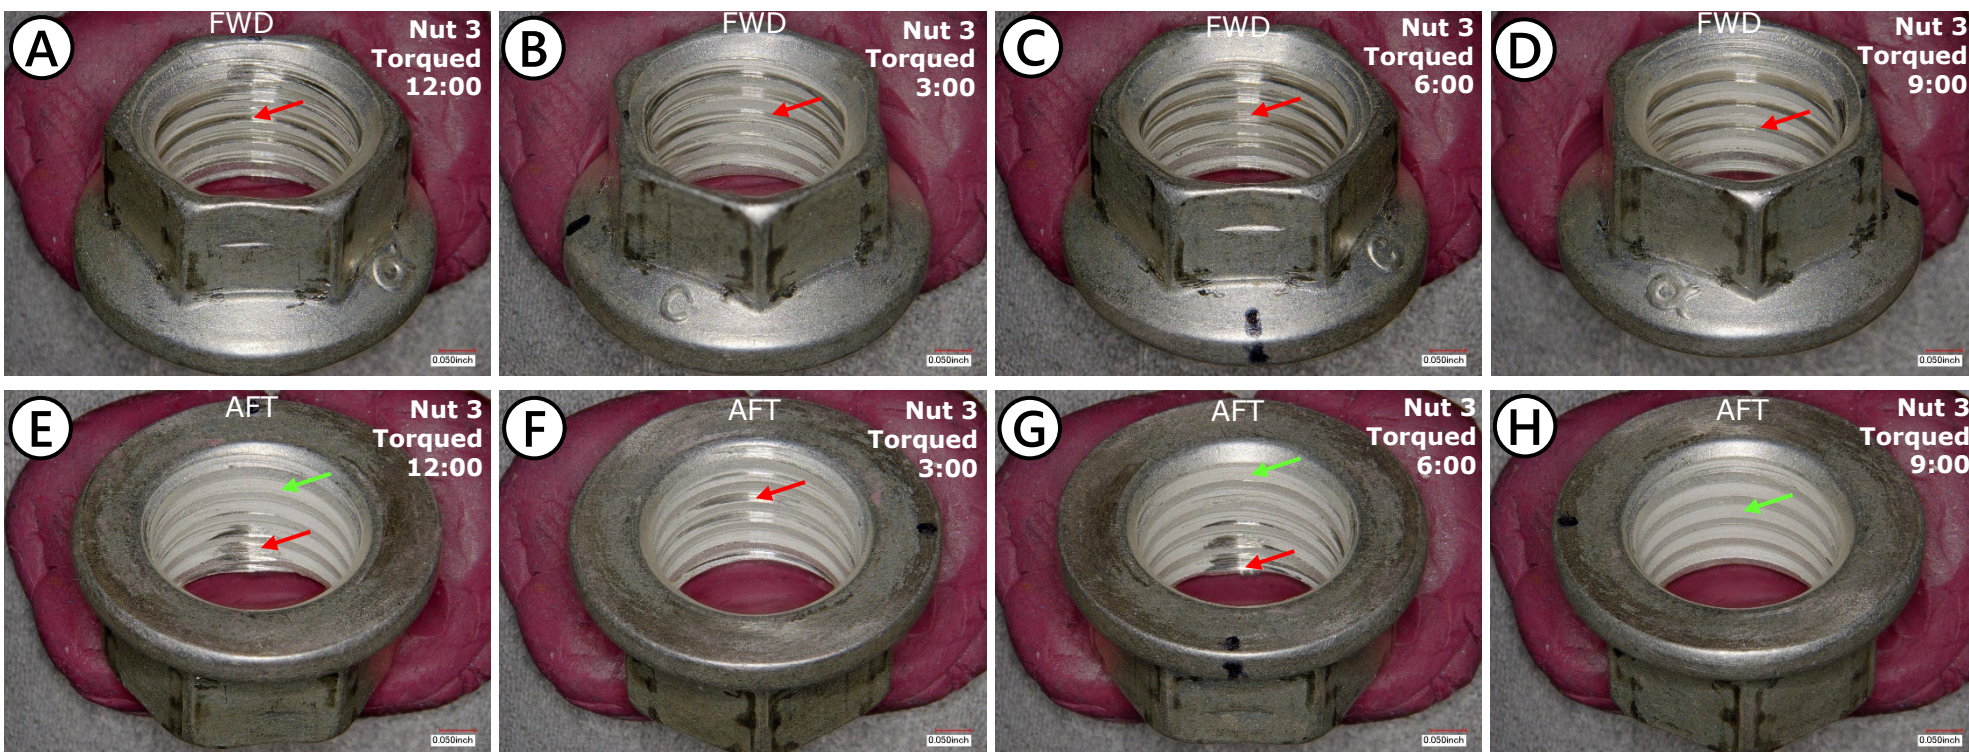
**Figure 28.**

Digital microscope images showing the condition of the threads as viewed from the (A-D) forward and (E-H) aft sides of Nut 3. The red arrows identify wear on the threads that had penetrated through the silver plating. Note that the contact on the aft side of the thread was not uniform around the circumference (green arrows).

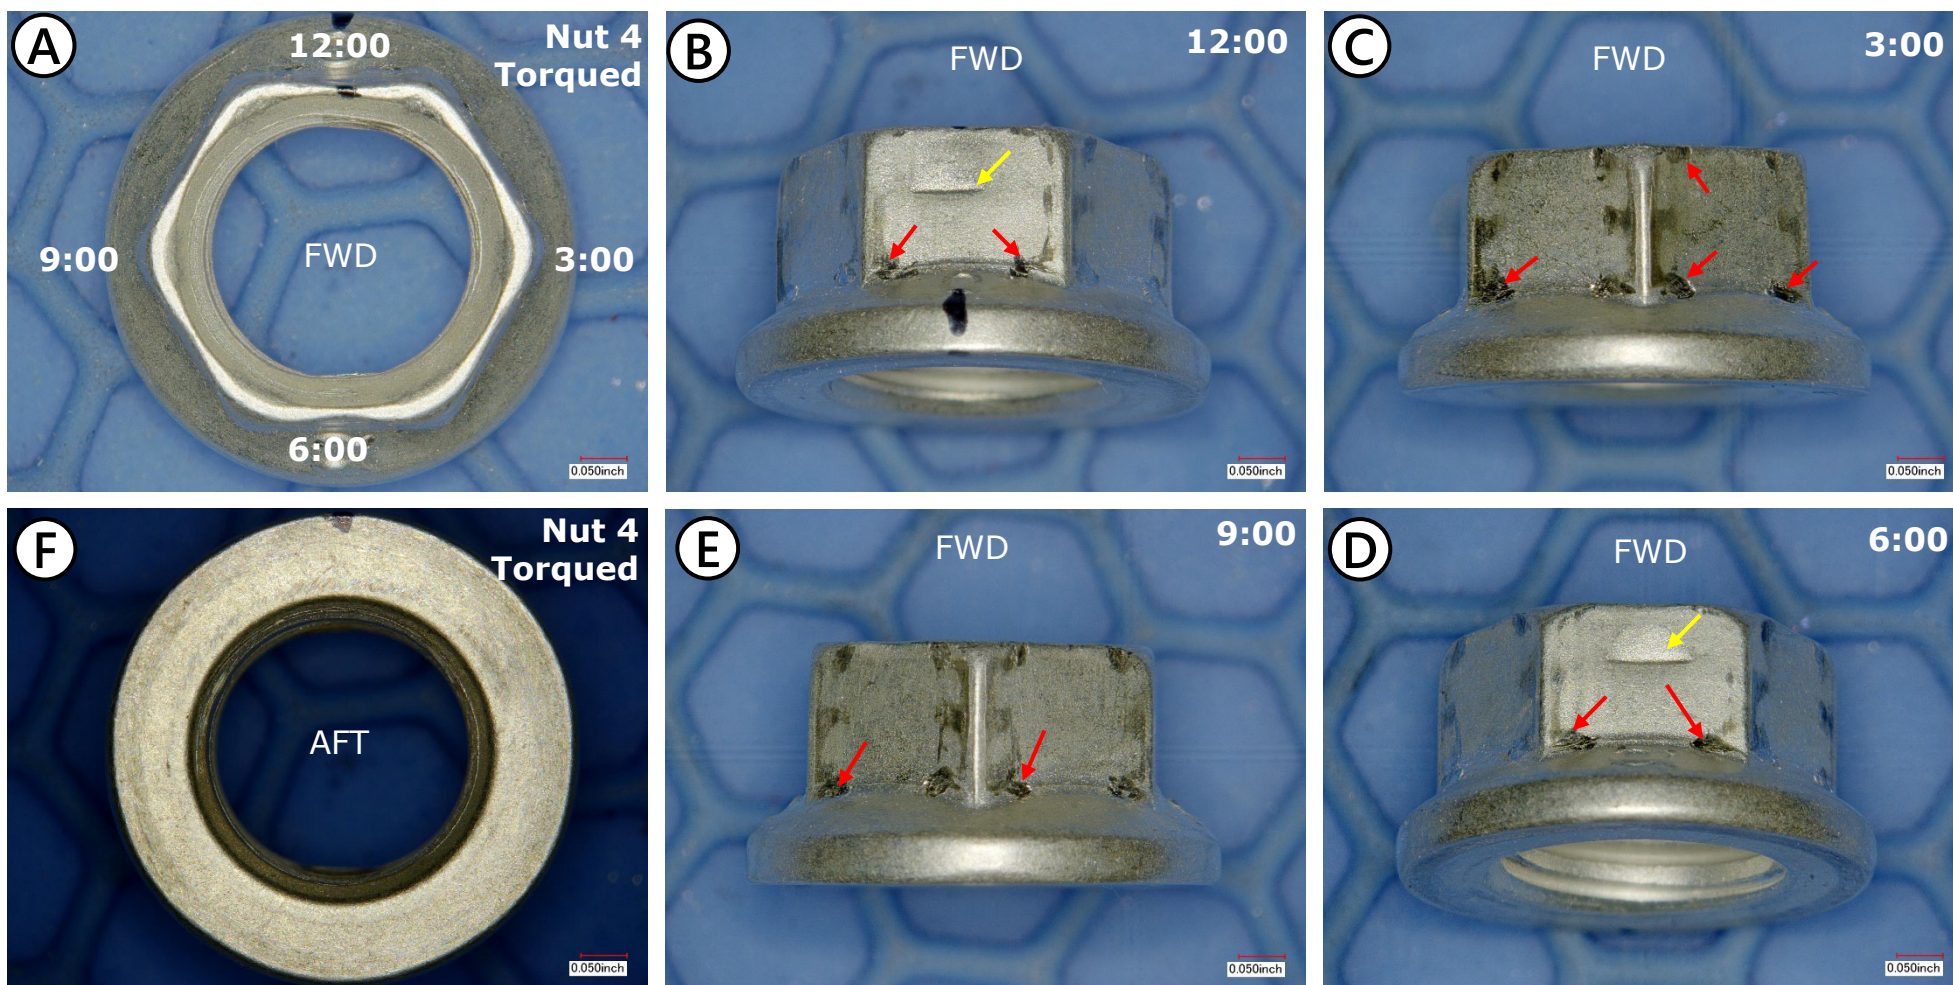
**Figure 29.**

(A-F) Digital microscope images showing the condition of Nut 4 (P/N MS21043-5) after removal from the assembly, which was a new nut torqued using lubricant. The yellow arrows in (B) and (D) identify the locking tool marks. Wear marks were observed both sides of each of the nut faces (red arrows in (B-E)).

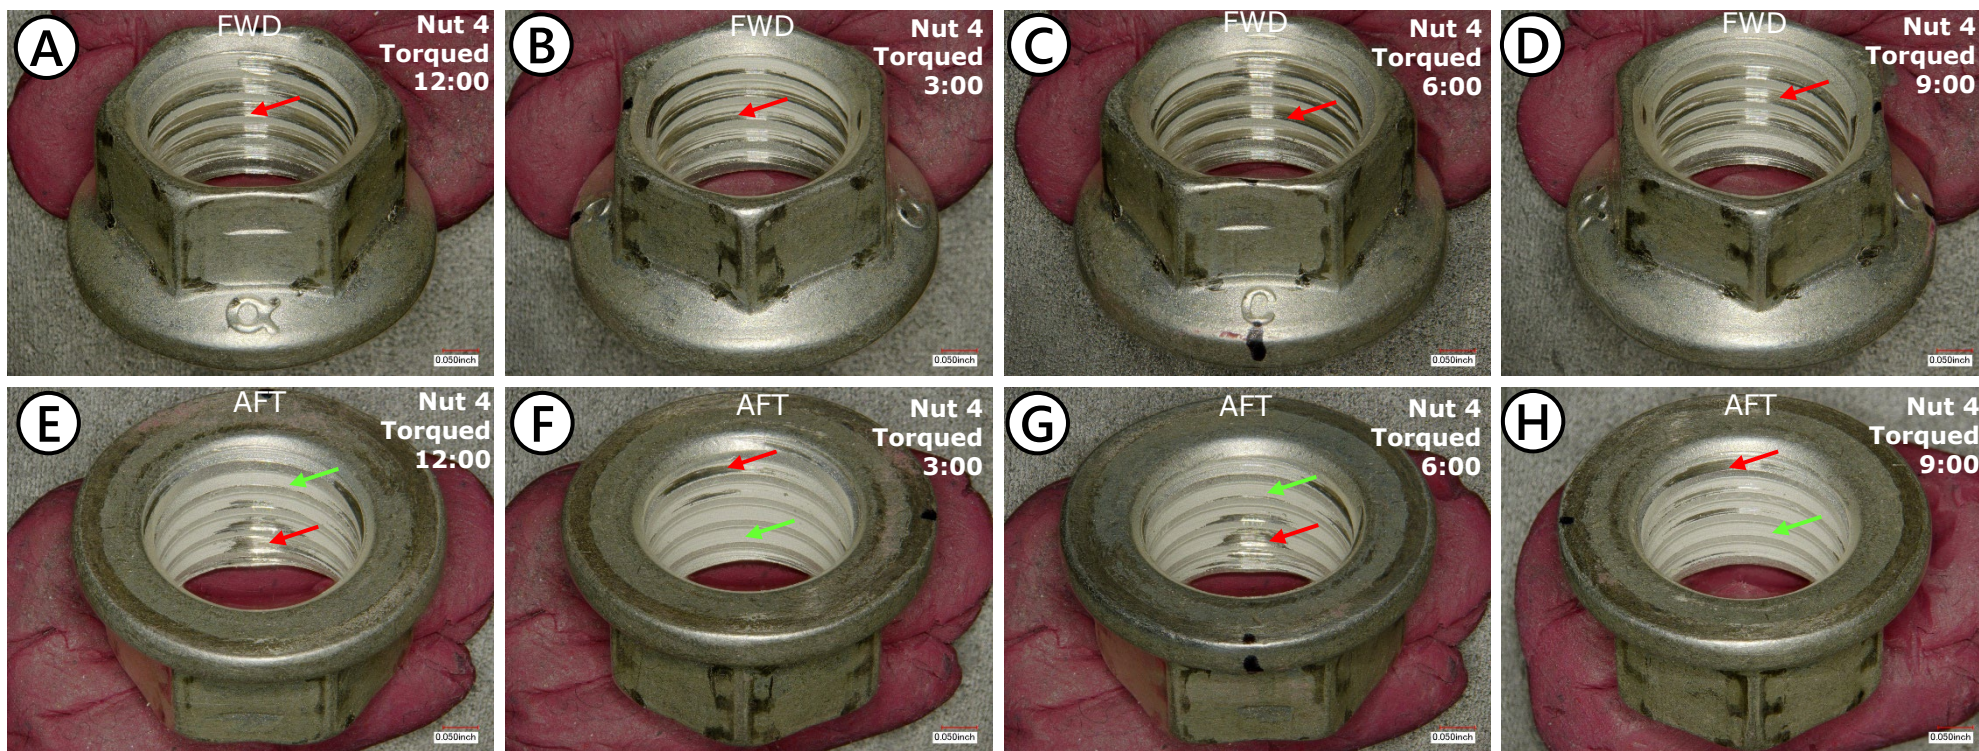
**Figure 30.** Digital microscope images showing the condition of the threads as viewed from the (A-D) forward and (E-H) aft sides of Nut 4. The red arrows identify wear on the threads that had penetrated through the silver plating. Note that the contact on the aft side of the thread was not uniform around the circumference (green arrows).

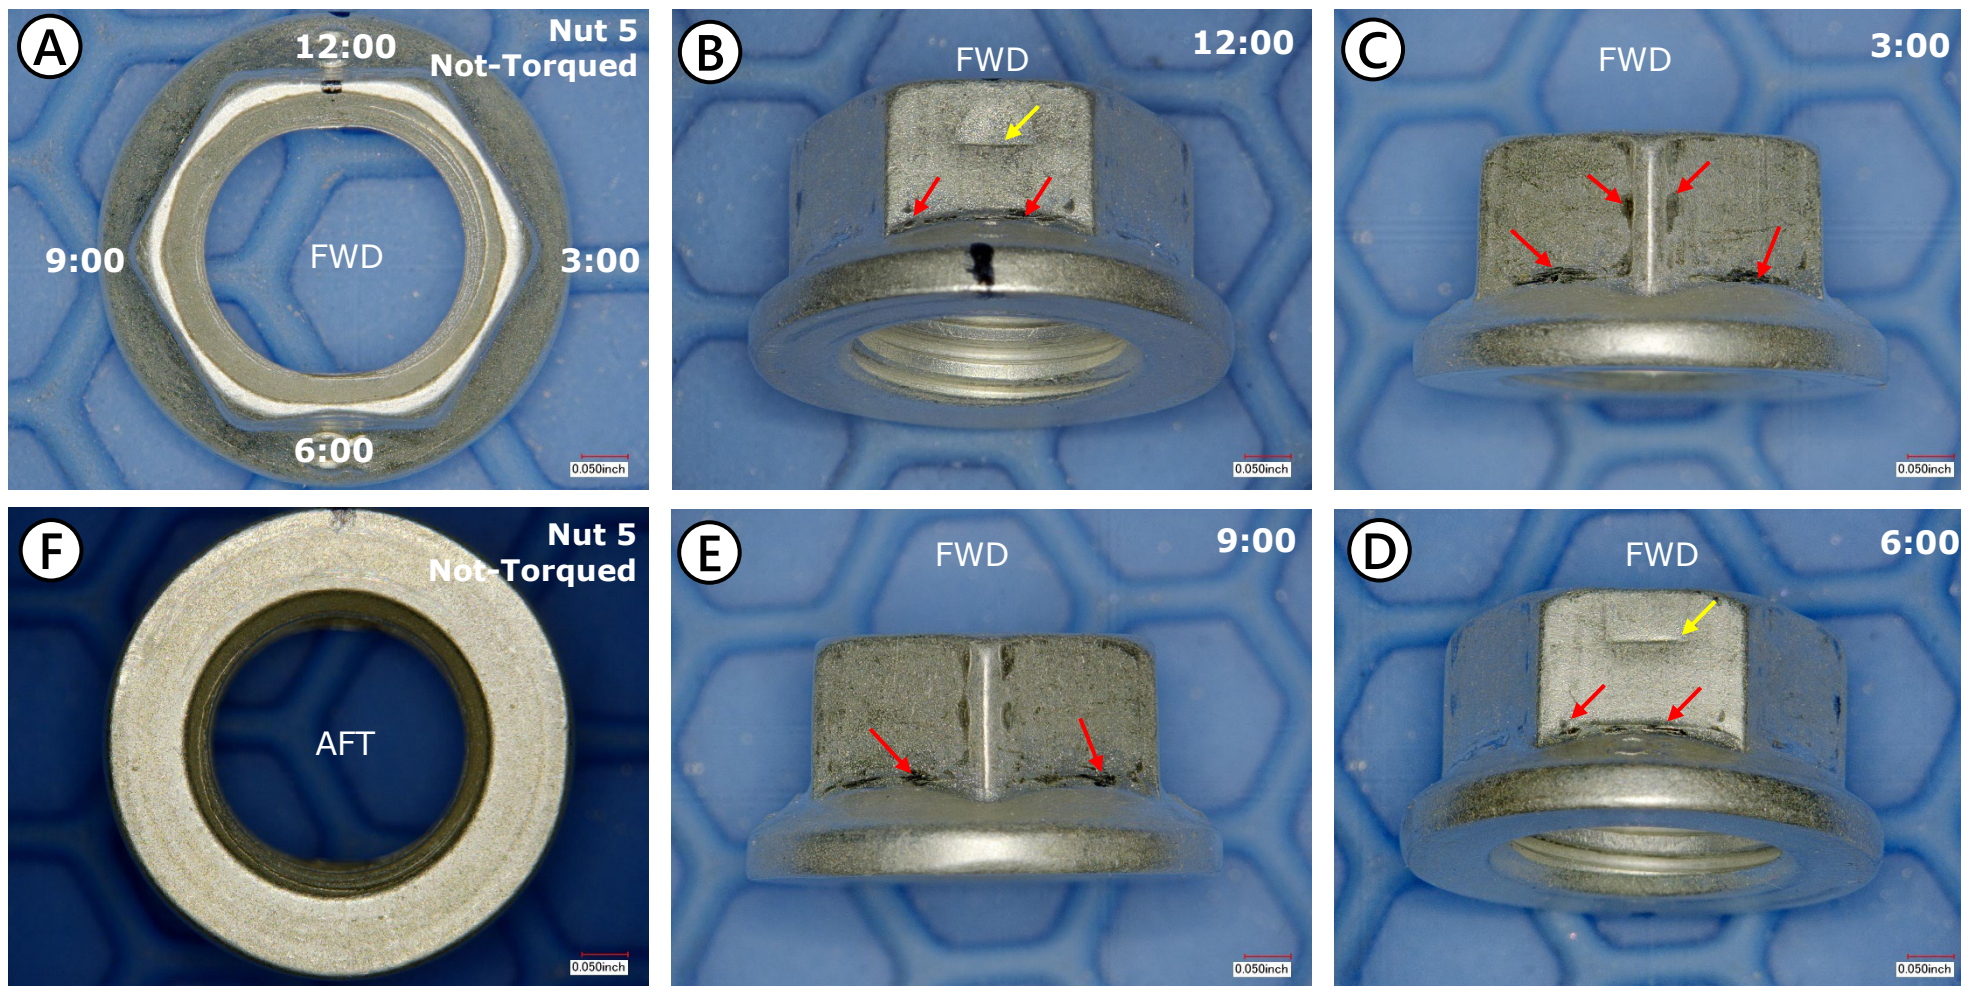
**Figure 31.**

Nut 5 was screwed into the assembly, but not torqued and then disassembled using a torque wrench. After disassembly, wear marks were observed on both sides of each nut face (Figure 31). It was noted that the wear marks were smaller to those marks observed on Nuts 1, 3, and 4. Wear was observed predominantly on the forward side of the threads. On the aft side of the threads, wear marks were observed on three threads that aligned with the locking tool marks at the 12:00 and 6:00 positions near the forward end of the

(A-F) Digital microscope images showing the condition of Nut 5 (P/N MS21043-5) after removal from the assembly, which was a new nut screwed with no torque without lubricant. The yellow arrows in (B) and (D) identify the locking tool marks. Wear marks were observed both sides of each of the nut faces (red arrows in (B-E)).

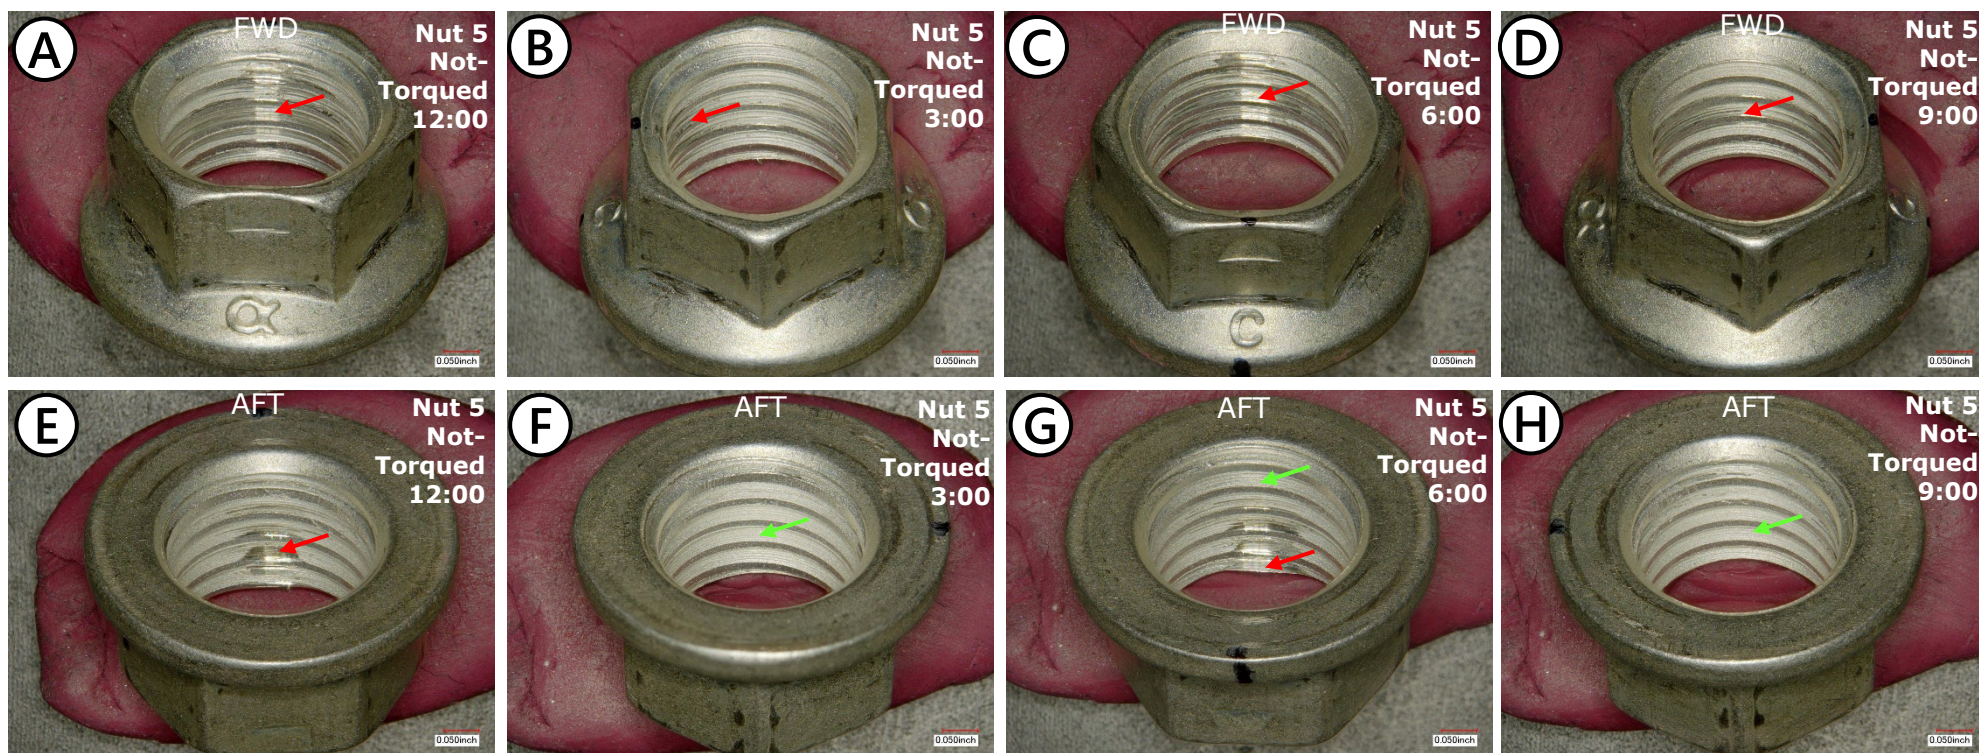
**Figure 32.**

nut (Figure 32). The remaining aft side of the threads exhibited little to no wear marks.

Digital microscope images showing the condition of the threads as viewed from the (A-D) forward and (E-H) aft sides of Nut 5. The red arrows identify wear on the threads that had penetrated through the silver plating. Note that the contact on the aft side of the thread was not uniform around the circumference (green arrows).

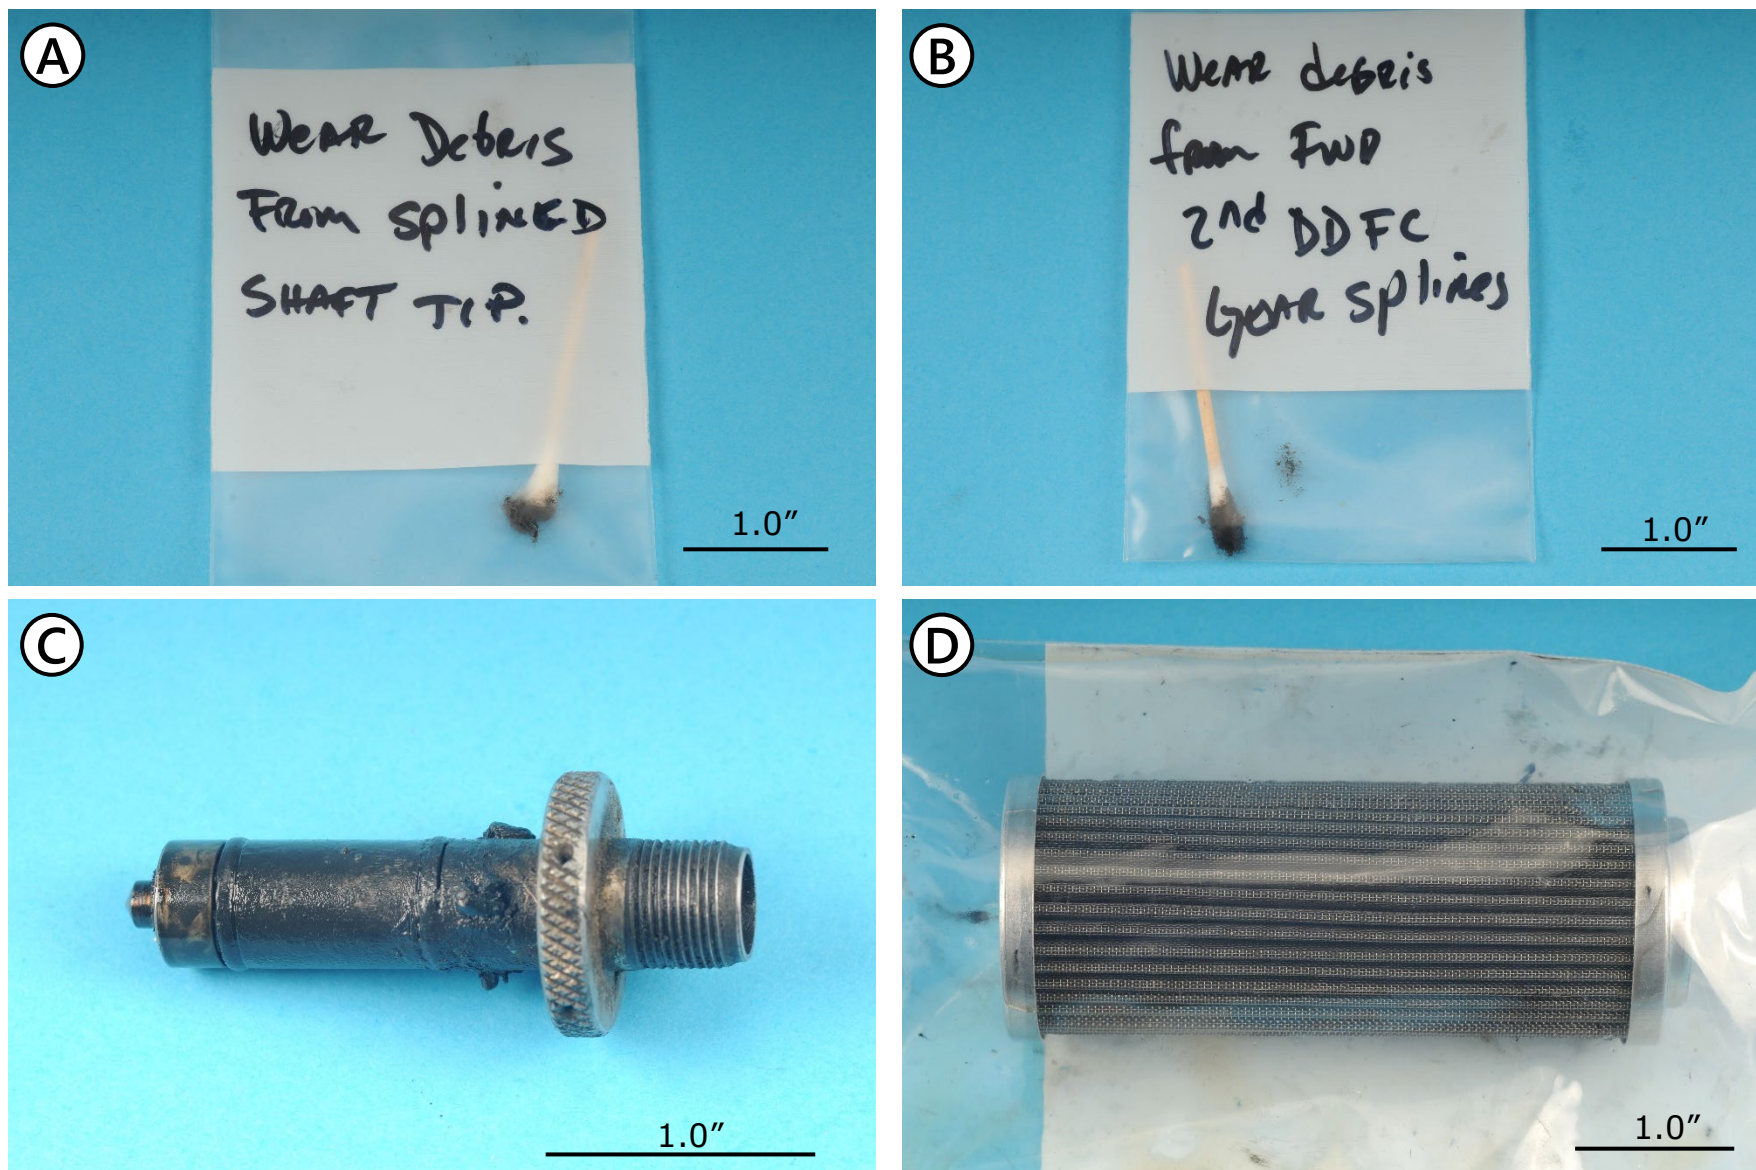
**Figure 36.**

Images of the submitted debris collected from the splined shaft tip and the 2<sup>nd</sup> idler forward gear splines are shown in Figures 36A-B, respectively. The as-received condition of the magnetic chip detector and the oil filter from TPE331 engine S/N P92122C are shown in Figures 36C-D, respectively. Representative debris particles were removed from each sample/component for SEM and energy dispersive X-ray (EDX) analysis.

Overall images showing the submitted debris captured from the (A) splined shaft tip and (B) forward 2<sup>nd</sup> direct drive fuel control (DDFC) gear splines from TPE331 engine S/N P92122C. Overall images showing the submitted (C) magnetic chip detector and (D) oil filter from TPE331 engine S/N P92122C. SEM images of representative debris removed from each sample/component are shown in Figures 37-41.
