Review and document all components of the torque sensor assembly. Analyze the debris of the submitted samples, oil filter, and magnetic chip detector.

| PART NAME: | Torque Sensor Assembly |
| MODEL/PROGRAM: | TPE331 |
| MODEL/PROGRAM S/N: | P92122C |

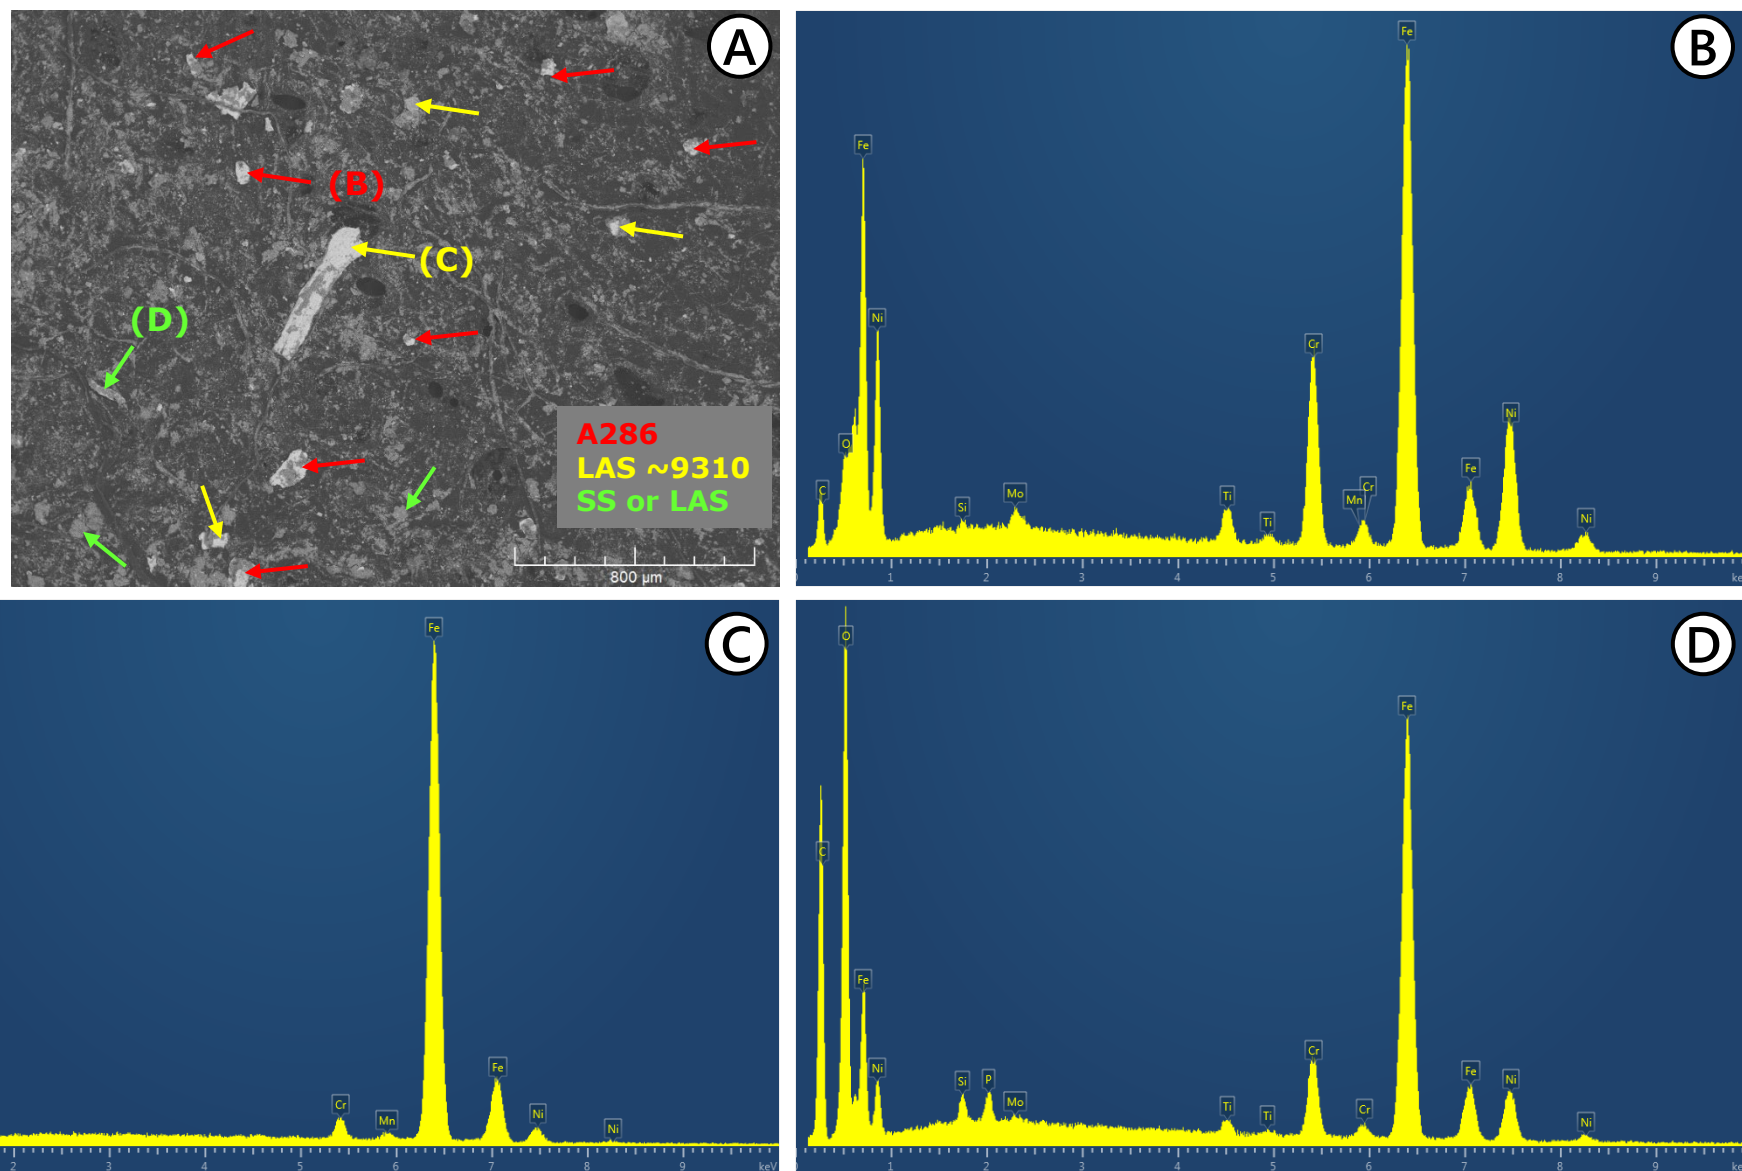
**Figure 37.**

(A) Backscattered electron (BSE) SEM image showing representative debris collected from the splined shaft tip (reference Figure 36A). (B-D) Energy dispersive X-ray (EDX) spectra produced from the areas identified by the red, yellow and green arrows in (A). The spectrum in (B) was indicative of a stainless steel similar to A286. The spectrum in (C) was indicative of a low alloy steel (LAS) similar to 9310. The spectrum in (D) was suggestive of an oxidized stainless steel or low alloy steel.

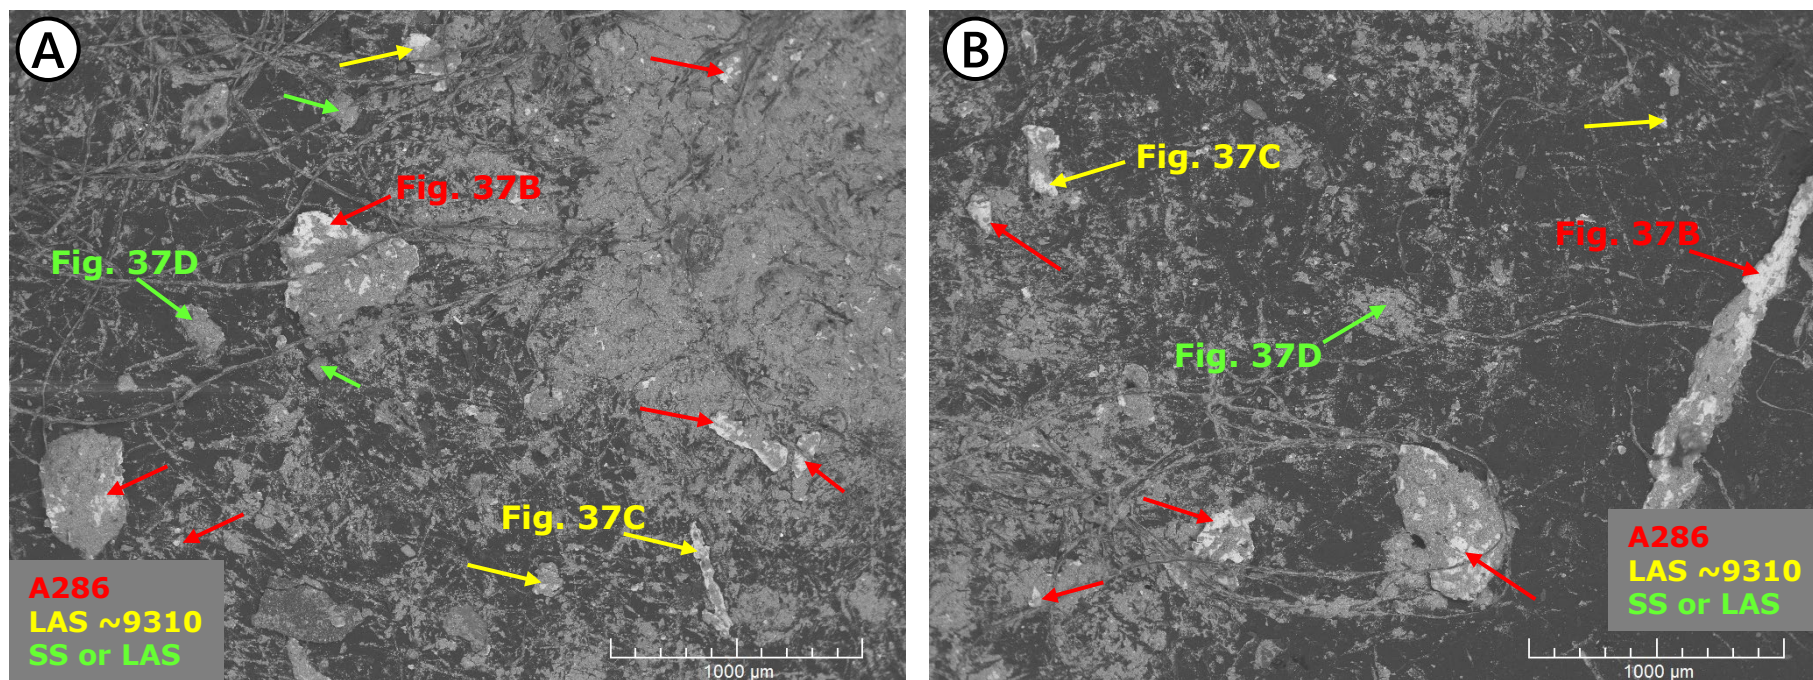
**Figure 38.**

(A-B) BSE SEM image showing representative debris collected from the forward 2<sup>nd</sup> DDFC gear splines (reference Figure 36B). The red arrows identify debris indicative of a stainless steel similar to A286. The yellow arrows identify particles indicative of a low alloy steel (LAS) similar to 9310. The green arrows identify particles suggestive of an oxidized stainless steel or low alloy steel. Reference Figure 37 for EDX spectra.

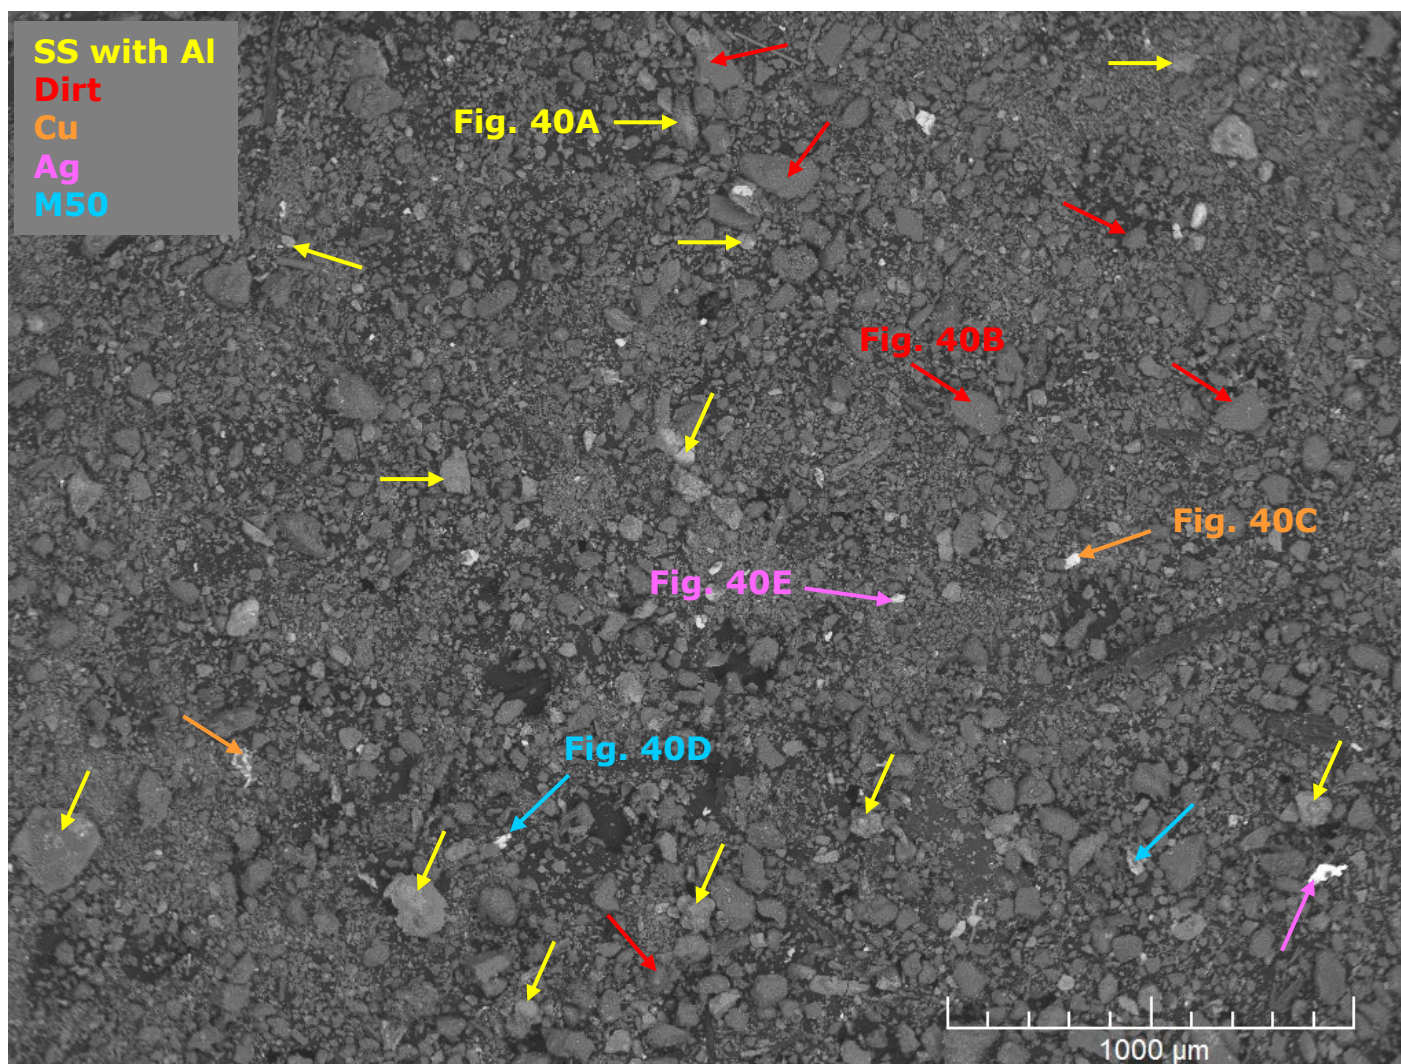
**Figure 39.**

- stainless steel with aluminum oxide,
- debris suggestive of dirt,
- copper (possible bearing cage material),
- silver (typical plating material),
- and M50 (typical bearing material).

BSE SEM image showing representative debris collected from the submitted magnetic chip detector (reference Figure 36C). The yellow arrows indicate particles suggestive of a stainless steel (SS) with aluminum oxide. The red and orange arrows indicate particles suggestive of dirt and copper, respectively. The pink and blue arrows indicate particles suggestive of silver and M50 materials, respectively. Reference Figure 40 for representative EDX spectra.

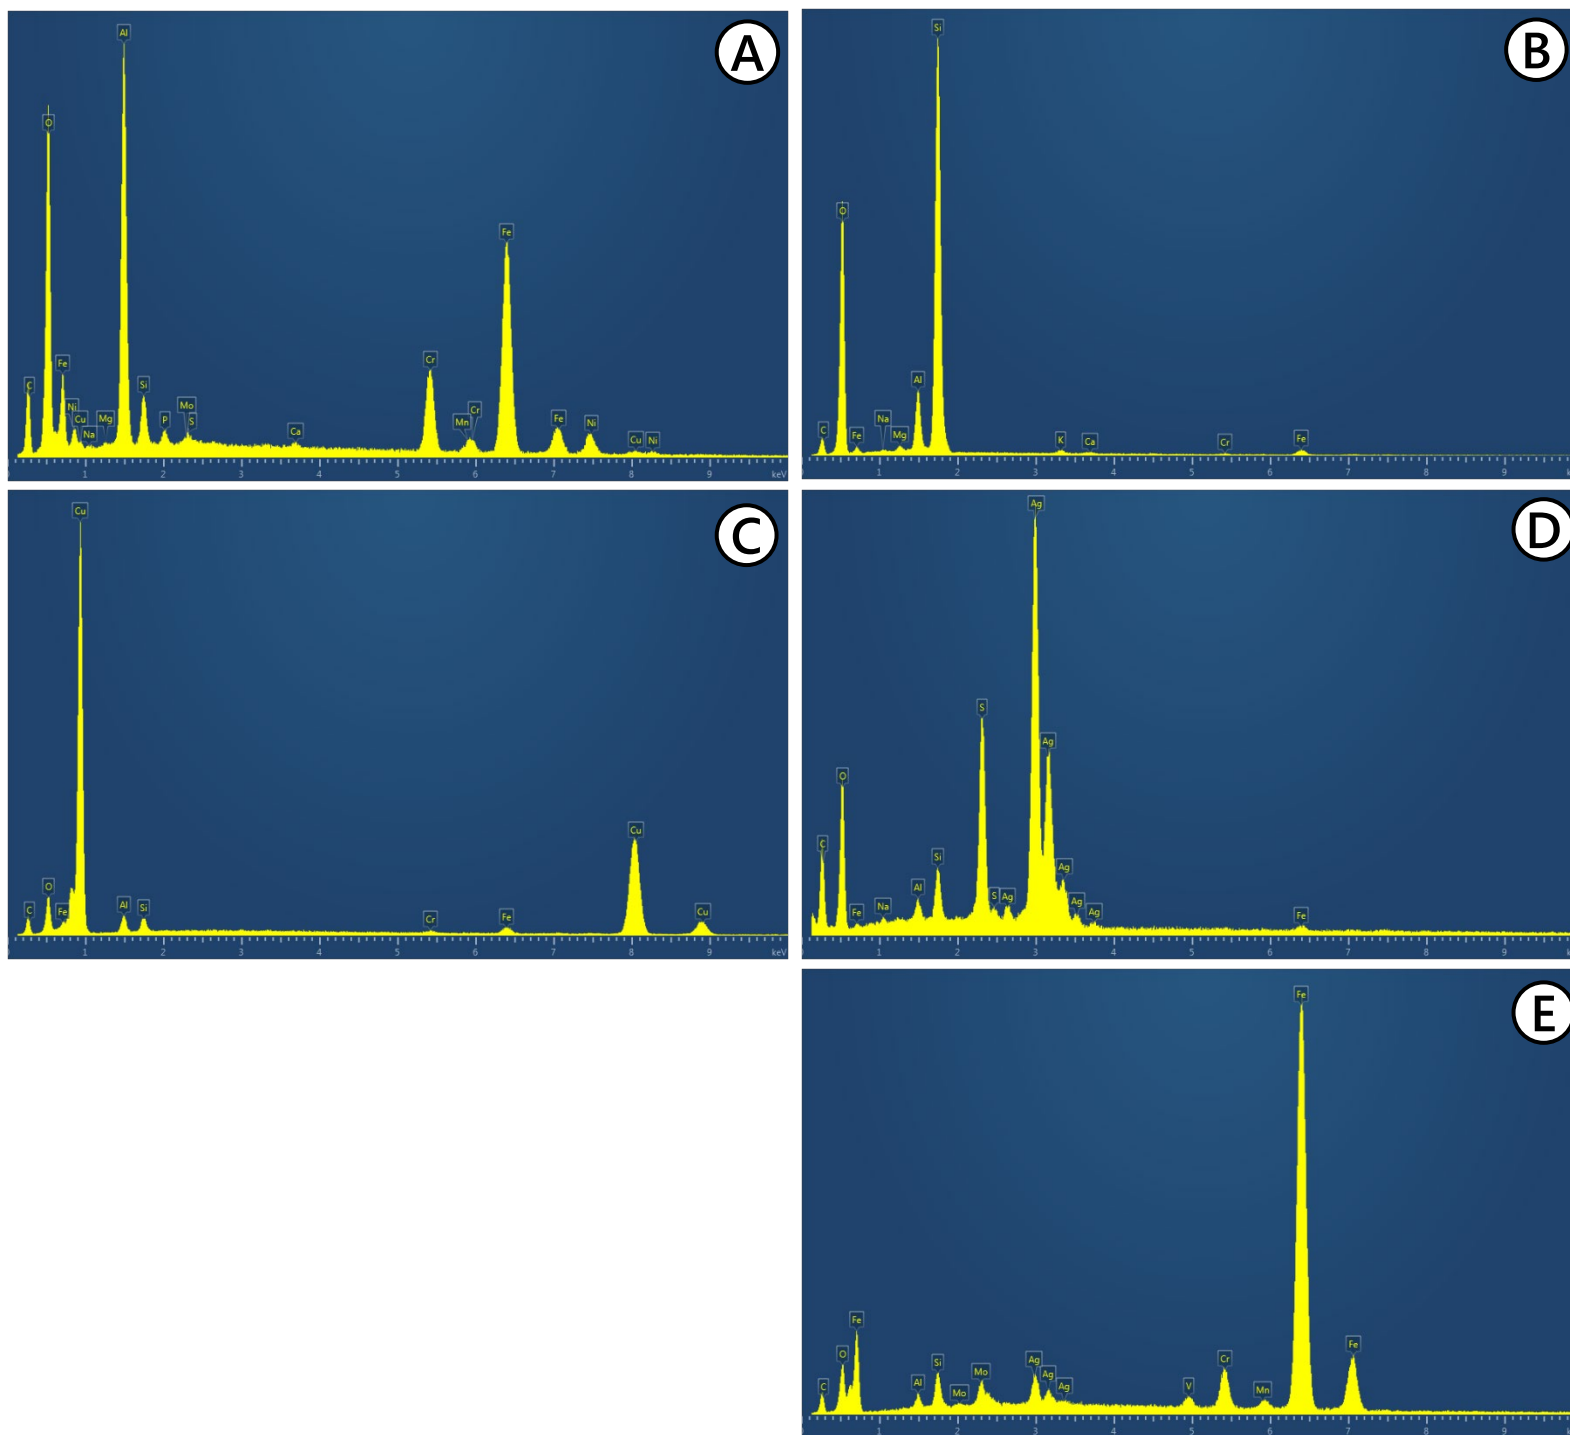
**Figure 40.** (A-E) Representative EDX spectra produced from analysis of the areas identified in Figure 39. The spectrum in (A) was indicative of aluminum oxide and a stainless steel. The spectrum in (B) was suggestive of dirt. The spectrum in (C) consisted primarily of copper. The spectrum in (D) consisted primarily of silver with sulfur. The spectrum in (E) was indicative of low alloy steel similar to M50 with silver.

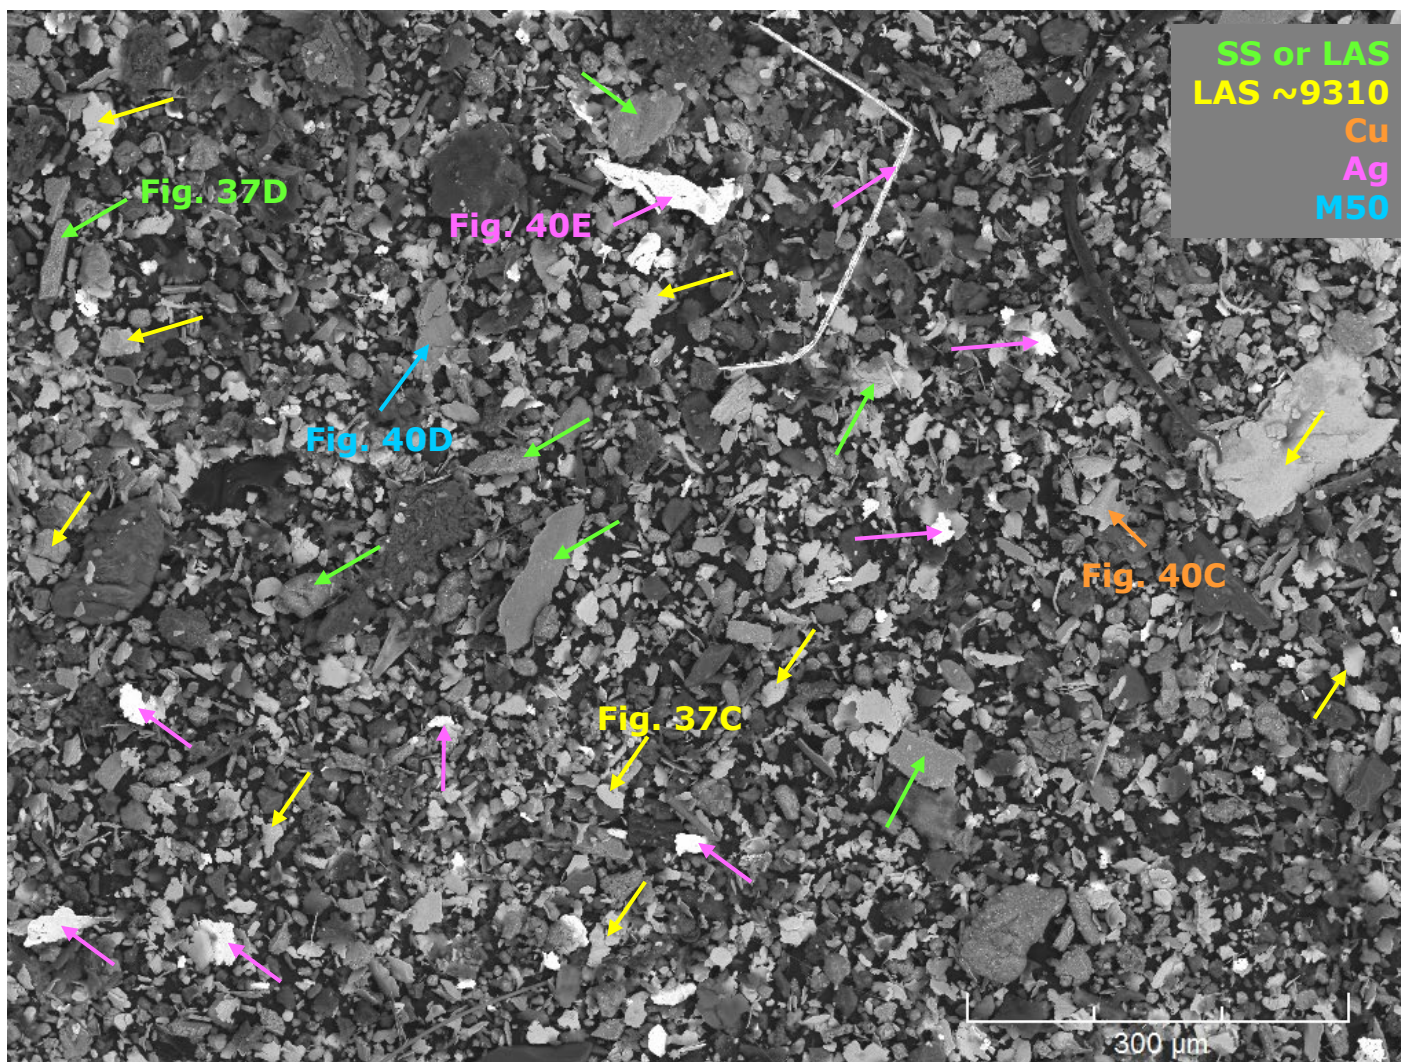
**Figure 41.**

was measured to be 36 mg. The following materials were observed from the debris collected from the oil filter (Figure 41):

- oxidized stainless or low alloy steel,
- a low alloy steel (LAS) similar to 9310 (the specified material for the spur gears),
- copper (possible bearing cage material),
- silver (typical plating material),
- and M50 (typical bearing material).

Most of the debris particles observed consisted of A286 and 9310 materials, which were consistent with the worn shaft and spur gear components.

BSE SEM image showing representative debris collected from the oil filter (reference Figure 36D). The green arrows indicate particles suggestive of a stainless steel (SS) or a low alloy steel (LAS). The yellow and orange arrows identify particles suggestive of low alloy steel similar to 9310 and copper, respectively. The pink and blue arrows indicate particles suggestive of silver and M50 materials, respectively. Reference Figures 37 and 40 for representative EDX spectra.
