**NATIONAL TRANSPORTATION SAFETY BOARD**  
**Office of Aviation Safety**  
**Washington, D.C. 20594**

**POWERPLANTS GROUPCHAIRMAN'S FACTUAL REPORT**

**NTSB No: CEN21LA287**

Aircraft: Grumman G-164B airplane, registration number N62375

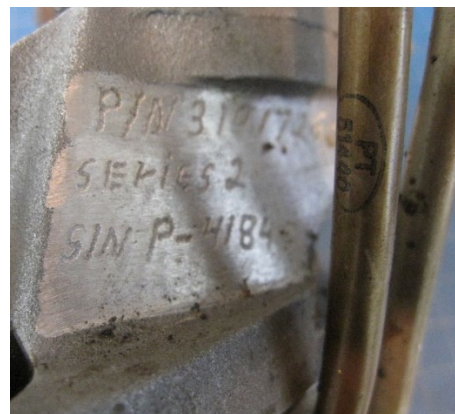
**PHOTO 3: TORQUE SENSOR ASSEMBLY ON ACCIDENT ENGINE**

The engine logbook indicated that torque sensor assembly part number (PN) 3101726-3, serial number (SN) P-4184C, series 2, was installed on the incident engine on February 11, 2015 (**PHOTO 2**); the data plate from the accident torque sensor confirms that this is the same torque sensor assembly as reference in the engine logbook (**PHOTO 3**).

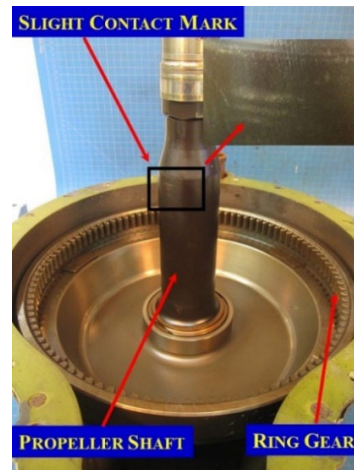
**PHOTO 14: PROPELLER SHAFT**

The gear reduction section was placed in a disassembly stand. The propeller front flange was intact and undamaged, the propeller locating pins were still present, and the output/nose cone assembly was intact and undamaged (**PHOTO 13**). The output/nose cone assembly was removed to expose the propeller shaft, the planetary gear, the sun gear front splines, the ring gear/hub, and the propeller shaft thrust bearing. The propeller shaft thrust ball bearing outer race is secured to the output/nose cone and the propeller shaft spun freely within the output/nose cone assembly; no further disassembly was performed to access the propeller shaft thrust bearing condition. The propeller shaft was intact, in good condition, and exhibited a very slight and small visual (no depth to the mark) rotational mark; the mark was localized and not circumferentially around the entire shaft (**PHOTO 14**). The ring gear/hub was intact, in good condition, and did not exhibit any distinguishing marks. The planetary gear set was intact, in good condition, all the gears spun freely, and did not exhibit any distinguishing marks.

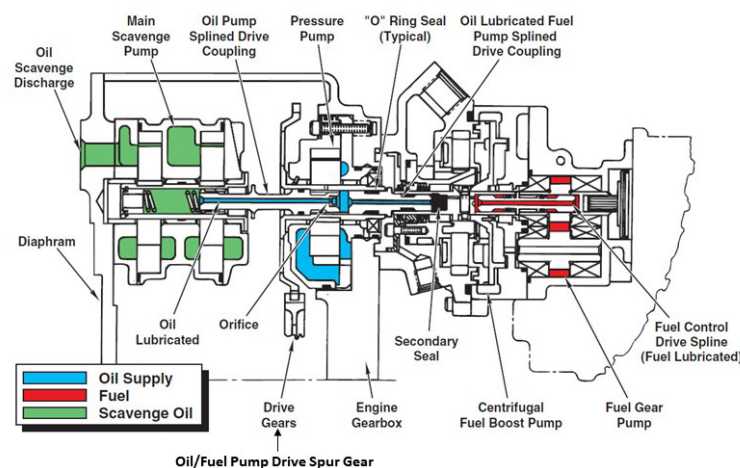
**FIGURE 4: EXPLODED VIEW OF ACCESSORY GEARBOX FUEL PUMP/FUEL CONTROL DRIVE GEAR**

Fuel flows from the aircraft system to the fuel pump assembly to the fuel control unit, where fuel is metered to the engine for all operating conditions. The engine-driven fuel pump assembly and fuel control unit are driven by a quill shaft coupling that is splined into the back of the oil pressure pump in the accessory gearbox (**FIGURE 4** and **PHOTO 15**). The oil pressure pump, fuel pump and fuel control are all driven by the gas generator through a gear train in the accessory gearbox. Should the quill shaft fail, or any of the gears that make up the gear train that drive the fuel pump and fuel control, the operational effect is an uncommanded engine shutdown or an engine overspeed depending on the operating condition.

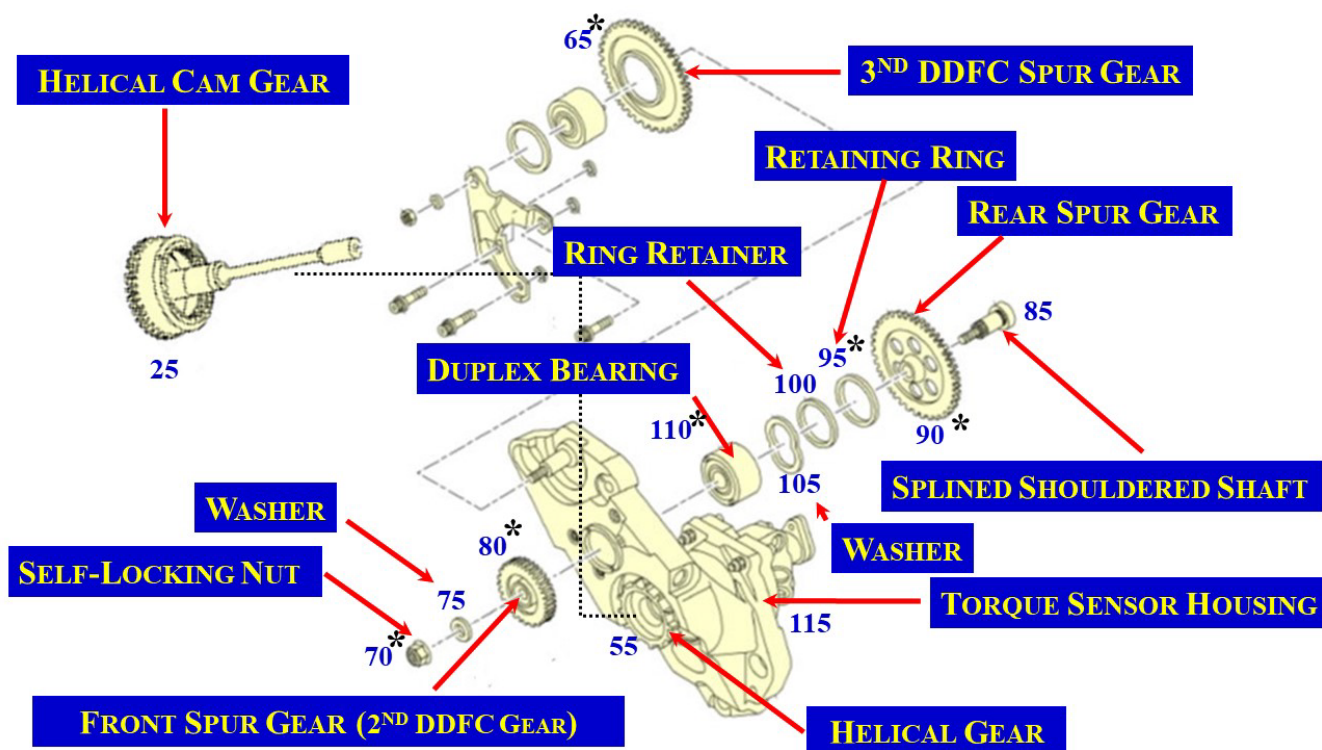
**FIGURE 5: TORQUE SENSOR ASSEMBLY EXPLODED VIEW**

- 1) front spur gear/2<sup>nd</sup> DDFC gear (PN 3103589-1) - item 80 in **PHOTOS 15-16** and **FIGURE 5**,
- 2) rear spur gear (PN 3103406-2) - item 90 in **PHOTO 16** and **FIGURE 5**,
- 3) 3<sup>rd</sup> DDFC gear (PN 3103590-2) - item 65 in **PHOTO 15** and **FIGURE 5**,
- 4) self-locking nut (PN MS21043-5) - item 70 in **PHOTOS 15-18** and **FIGURE 5**,
- 5) duplex bearing (PN 3103585-1) - item 110 (**FIGURE 5**)

The splined shouldered shaft (PN 3103405-3) - item 85 in **PHOTO 16** and **FIGURE 5** was not replaced and the torque sensor housing (PN 3103583-3) - item 115 (**PHOTO 18** and **FIGURE 5**) was provided in a serviceable condition.

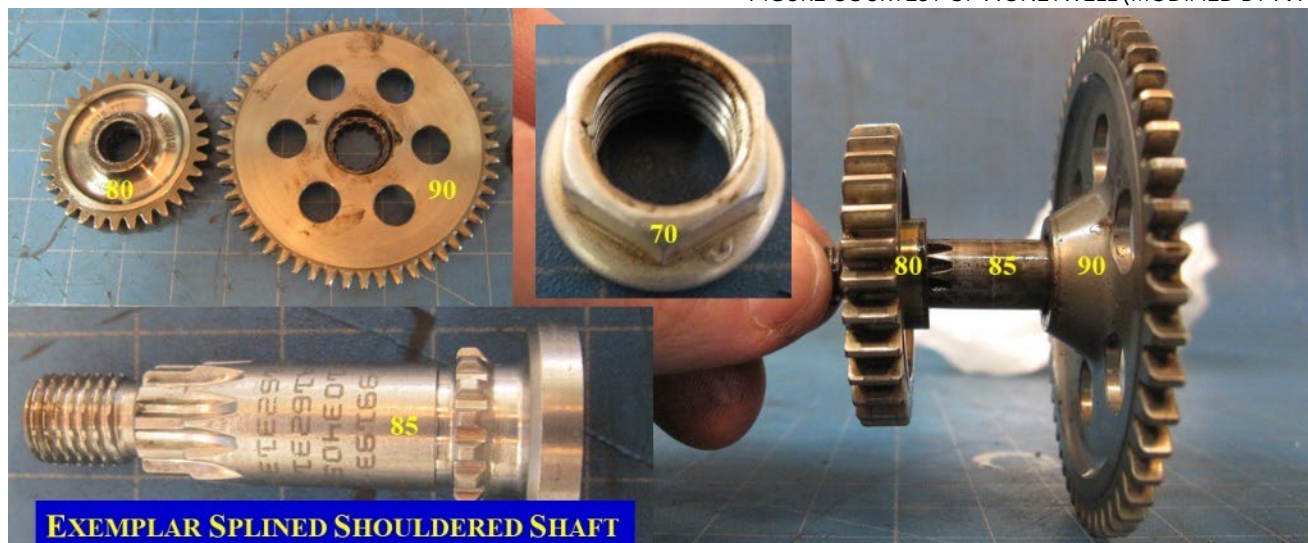
**PHOTO 16: 2<sup>ND</sup> DIRECT DRIVE FUEL CONTROL COMPONENTS**

The bottom portion of the accessory case was fractured and missing; the fracture location was coincident with where the torque sensor assembly was located (**PHOTO 15**)<sup>5</sup>. The 2<sup>nd</sup> direct drive fuel control (DDFC) is comprised of a front and rear spur gear supported by a duplex bearing and a splined shouldered shaft (PN 3103405-3) with a forward threaded end to accept an ovalized self-locking nut (**FIGURE 5** and **PHOTO 16**). The front 2<sup>nd</sup> DDFC spur gear was found loose and disengaged from the splined shouldered shaft and therefore disengaged from rear 2<sup>nd</sup> DDFC gear; they both should rotate together but when one was rotated the other did not. Both the front and rear 2<sup>nd</sup> DDFC spur gears were intact, and their gear teeth were in good condition; the self-locking nut that secures the front spur gear to the splined shouldered shaft was found loose with no torque (See **PHOTO 15**, yellow box, item 70). Comparing the self-locking nut from the event torque sensory assembly with that of an exemplar one revealed that the number of exposed threads on the splined shouldered shaft were not the same. On the event torque sensor assembly, no threads were exposed<sup>6</sup> indicating that the self-locking nut was at the very end of the splined shouldered shaft threads (**PHOTO 17**, left side) while on the exemplar torque sensor assembly, several exposed threads were observed (**PHOTO 17**, right side).

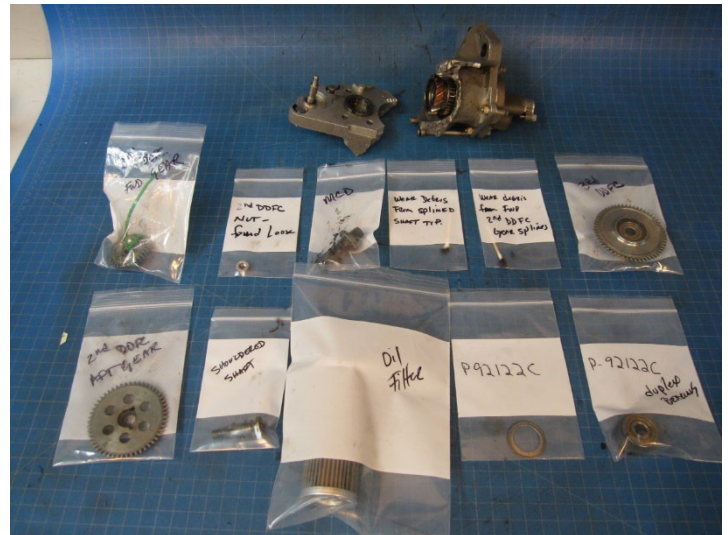
**PHOTO 24: PARTS SENT TO HONEYWELL METALLURGICAL LABORATORY FOR ADDITIONAL EVALUATION**

The following parts were sent to the Honeywell Metallurgical laboratory in Phoenix, Arizona for evaluation (**Photo 24 and Figure 6**):

- 1) The 2<sup>nd</sup> DDFC spur gears (PN 3103589-1 and 3103406-2)
- 2) Splined shouldered shaft (PN 3103405-3,
- 3) Duplex bearing (PN 3103585-1)
- 4) The 3<sup>rd</sup> DDFC spur gear (PN 3103590-2)
- 5) Torque sensor housing (PN 3103583-3)
- 6) Self-locking nut (PN MS21043-5)
- 7) Swabs of the debris from the 2<sup>nd</sup> DDFC, the MCD, and the oil filter

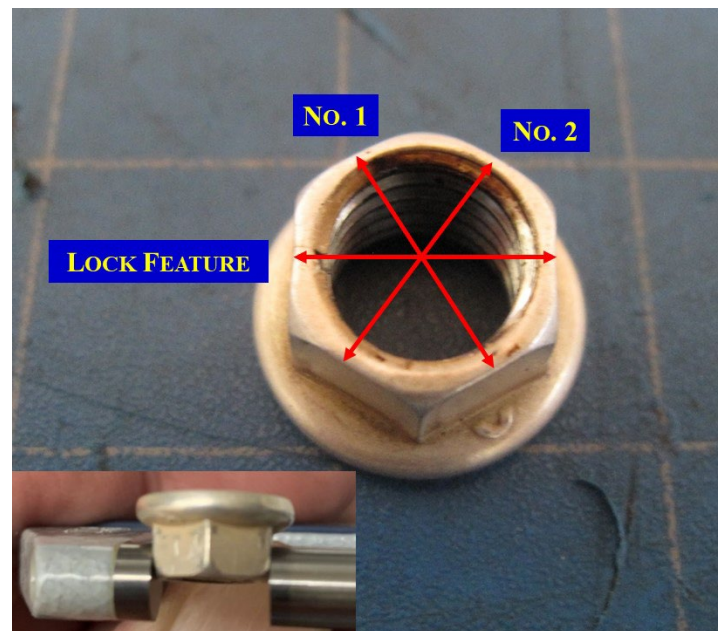
**PHOTO 29: NUT DIMENSIONAL LOCATIONS**

The five torque nuts used for the torque assembly wear and deformation assessment (Section 4.2, **TABLE 1**) were the same as for this test; also included were the event and two new self-locking nuts that were sourced from the Honeywell repair and overhaul (R&O) shop. A micrometer gage was used to measure across the distance across the wrenching nut flats (**PHOTO 29**) and calibrated torque wrench was used for the run-on (installation) torque. For the run-on torque, the nut was installed with a least 1 thread visible protruding through the so that the torque measurement would only be that of the self-locking nut and threads and not any additional torque build-up to overcome frictional forces between the self-locking
