# National Transportation Safety Board

CEN21LA329

## **POWERPLANT TEARDOWN EXAM**

Location: Amana, Iowa  
Date: July 19, 2021  
Time: 1410 central daylight time  
2110 UTC  
Airplane: Grumman G-164B, Registration N8422K

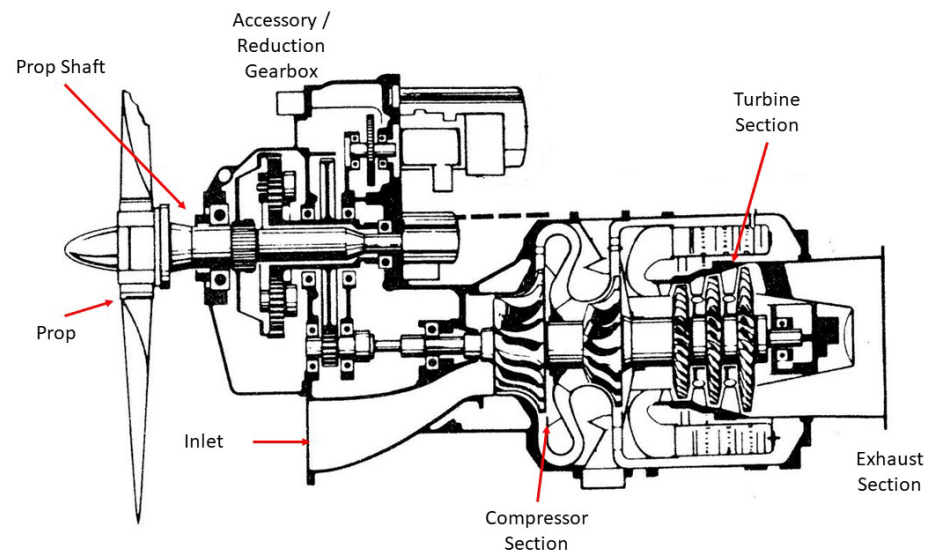
Figure 1: Generic TPE331 Engine Cros-Section; Figure Courtesy of Honeywell

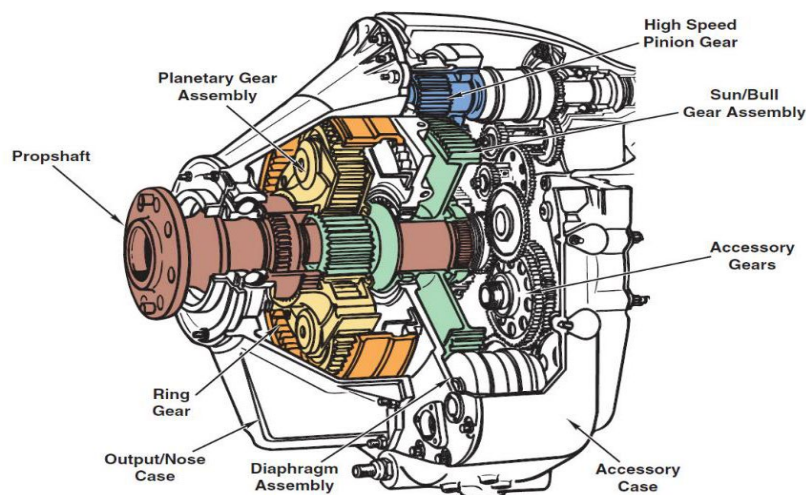
Figure 2: Accessory/Reduction Gearbox; FIGURE COURTESY OF HONEYWELL

attached to the propeller shaft with a splined hub. With the ring and propeller shaft rotating as one assembly this produces clockwise rotation. The gearbox ratio is 20.865 to 1, with a 2,000 RPM propeller speed at 100% engine speed (Figure 2).
