# National Transportation Safety Board

CEN21LA351

## **MATERIALS LABORATORY**

Factual Report 22-087

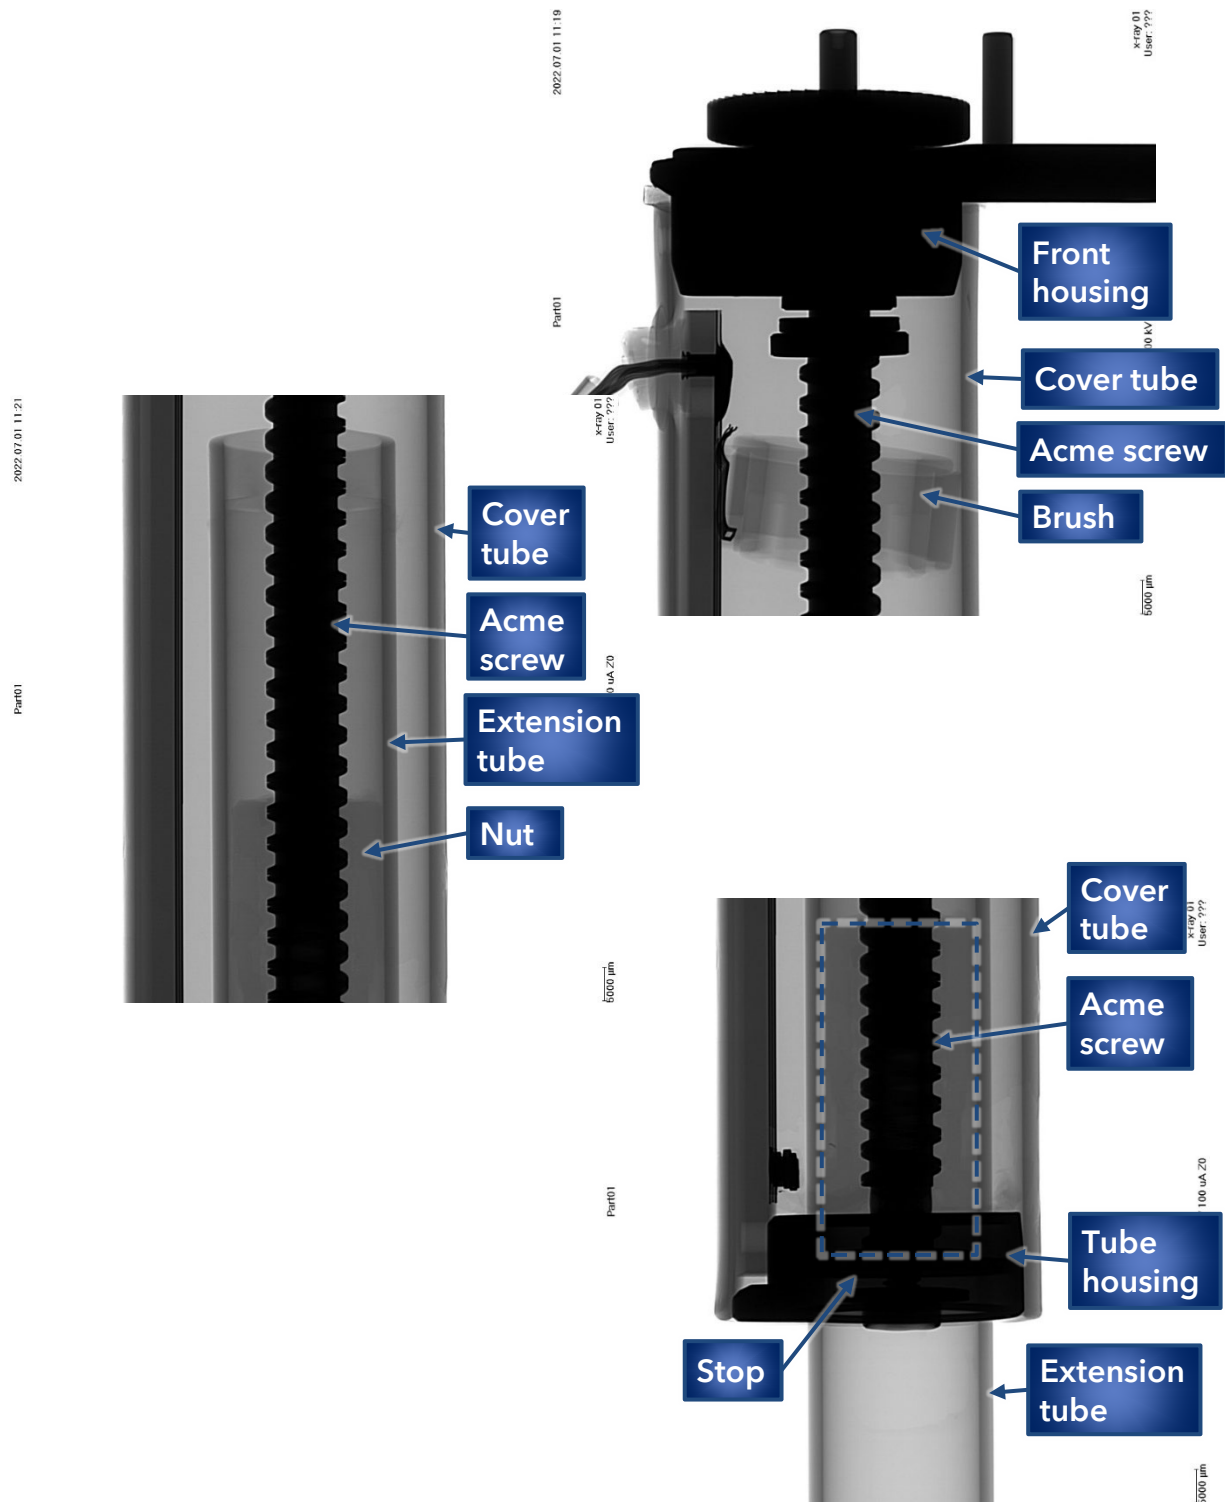
Before disassembly, the linear actuator was examined using x-ray radiography to assess the condition of the internal components. Radiographs at the upper end, middle, and lower end of the cover tube are shown in figure 3. At the upper end of the cover tube, a medium gray area consistent with the brush was observed near washers at the upper end of the acme screw. The brush was separated from the nut and was tilted slightly off axis consistent with a spring load from the contacts. The middle left image in figure 3 shows the upper end of the extension tube in the middle of the cover tube and a medium gray area consistent with the nut located within the extension tube. The nut is outlined with a dashed rectangle in the lower right image in figure 3 based on the nut dimensions and the extent of the medium gray area within the extension tube. The nut appeared to be against the lower mechanical stop.

**Figure 3.** Radiographs of the upper end, middle, and lower end of the actuator cover tube as received. A dashed line in the lower right image indicates the location of the nut against the stop within the extension tube.
