**NATIONAL TRANSPORTATIONS SAFETY BOARD**  
**Office of Aviation Safety**  
**Washington, DC 20594**

**SUMMARY OF EXAMINATION**

-- CEN22FA021 --

Location: Lena, Wisconsin  
Date: October 27, 2021  
Time: 1817 central daylight time  
Aircraft: Beech B36TC (s/n EA-402), N75RM

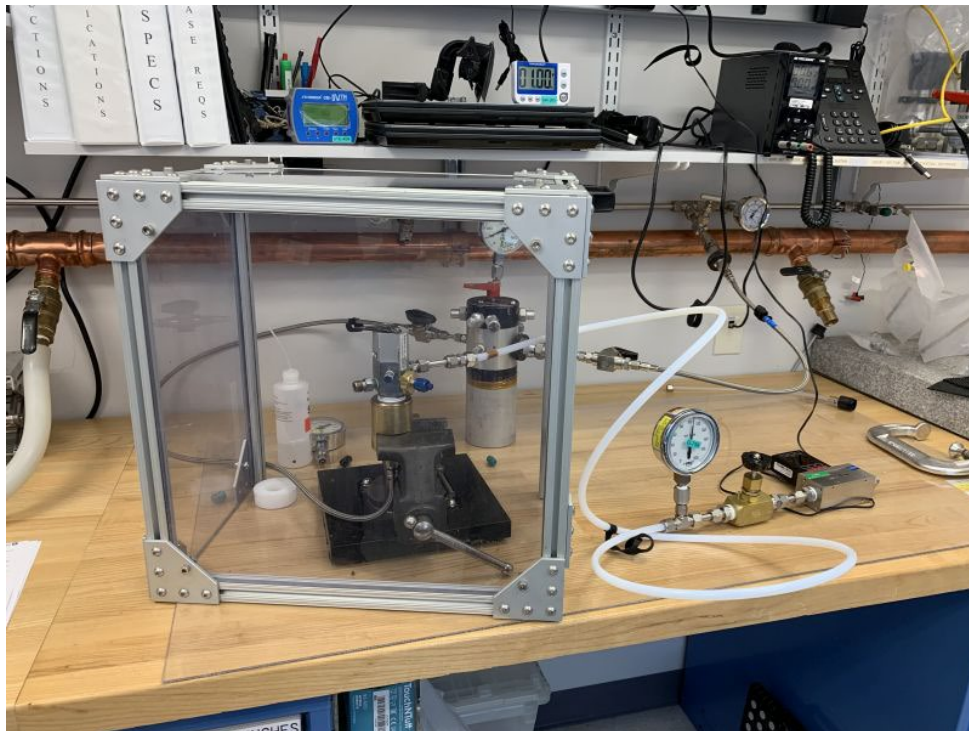
*Figure 4 – Cylinder Valve/Regulator Assy Test Set-up*

The low-pressure relief valve was removed and replaced with an exemplar valve for testing. The high-pressure port common to the high-pressure relief valve was capped for testing. The assembly was placed into the testing apparatus with supply pressure provided at the valve inlet as specified by the test procedure. Pressure and airflow were measured at the low-pressure outlet common to the altitude compensating regulator inlet port. The cylinder valve was positioned as observed during the on-scene examination. Testing revealed that the cylinder regulator outlet pressures were within the specified range at each data point.<sup>4</sup> The cylinder valve functioned properly with downstream pressure reduced to zero within 30 seconds of moving the valve to the OFF position as required.

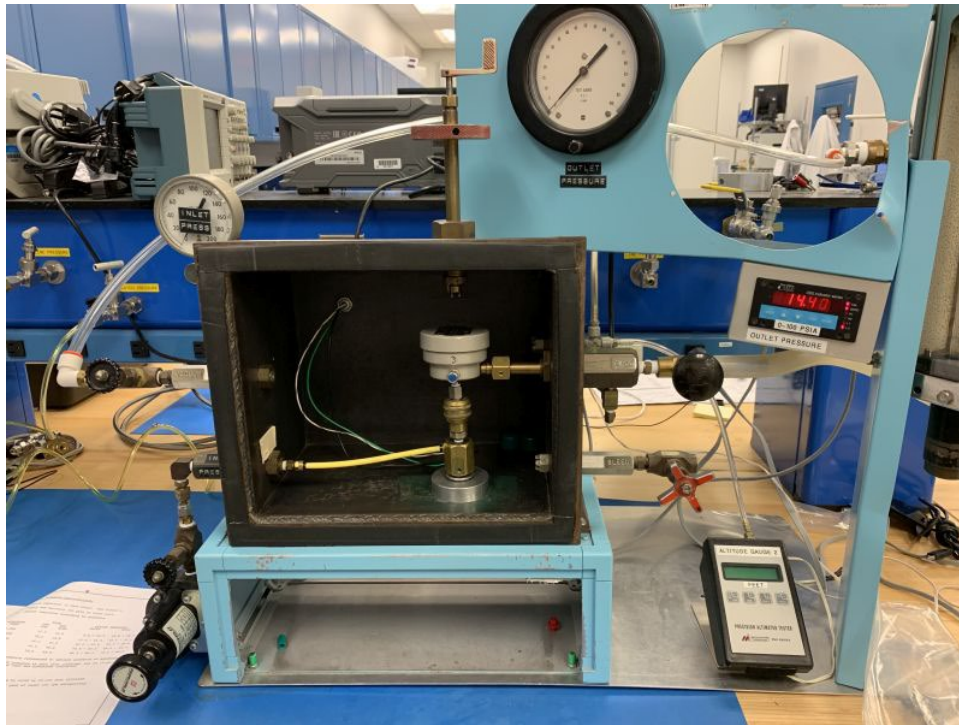
*Figure 8 – Altitude Compensating Regulator Assy Test Set-up*

The altitude compensating regulator housing appeared intact. However, the threaded inlet fitting and the low-pressure relief valve were damaged consistent with impact forces. Fitting threads exhibited PTFE tape consistent with current assembly procedures.
