# National Transportation Safety Board

CEN22FA053

## **HYDRAULIC SERVO EXAMINATION**

Specialist's Factual Report

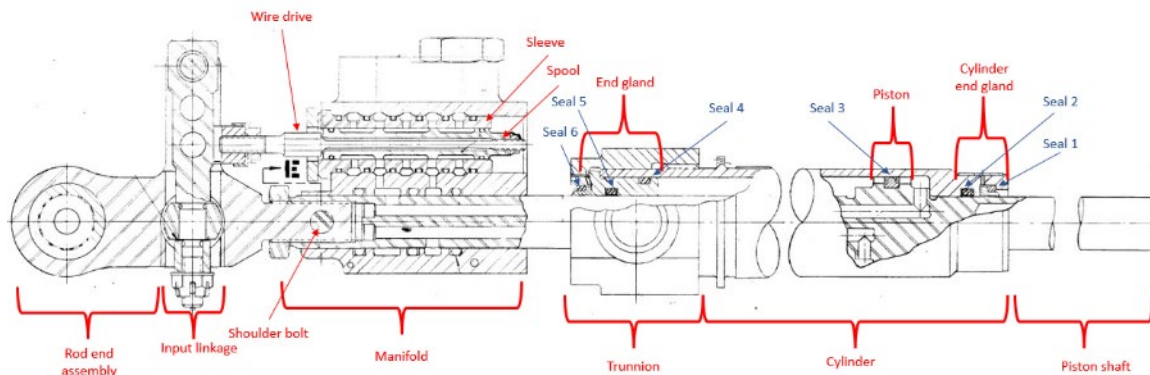
Figure 1. Hydraulic servo actuator diagram. (Source: Figure provided by Woodward and edited by NTSB).

Each of the gland seals (Figure 1) consist of two components. A blue Teflon exterior and a black polymer o-ring behind the Teflon.
