# National Transportation Safety Board

CEN22FA081

## **ONBOARD IMAGE RECORDER**

Location: Fulshear, TX  
Date: December 21, 2021  
Time: 09:26 central standard time (CST)  
15:26 coordinated universal time (UTC)  
Airplane: Cessna 208, N1116N  
Vehicle: Dudek Paragliders Solo 21 (A2), Unregistered

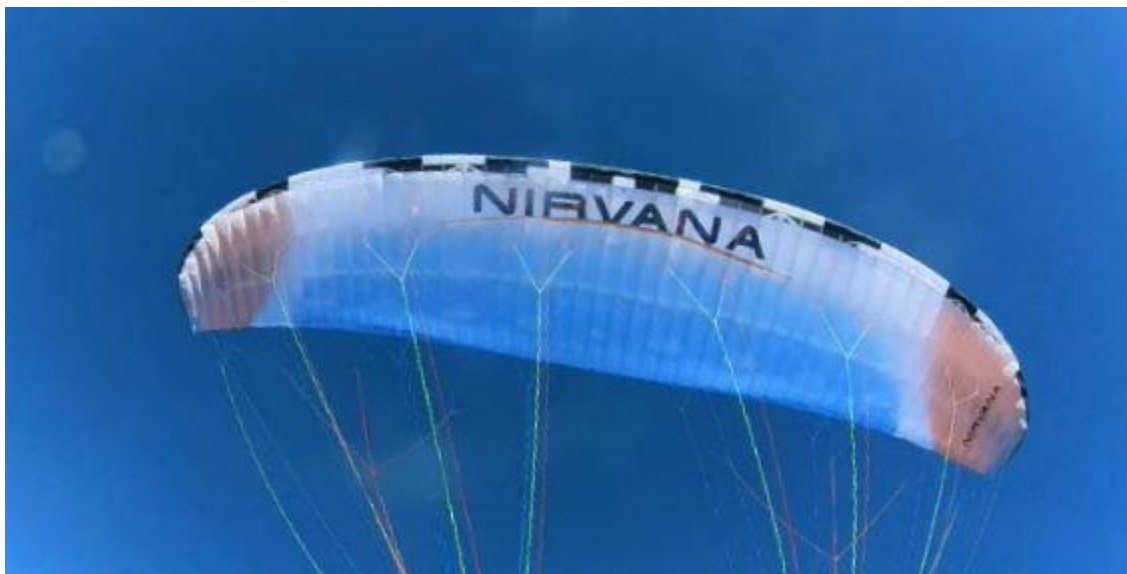
The paraglider wing had a light blue base color with a light blue trailing edge, pale red/orange wingtips and the leading edge quarter was white with a banded black color scheme<sup>9</sup>. The lines were neon orange and neon green. Figure 8 is partial screenshot that describes the colors of the paraglider wing against the sky. The PO appeared to be wearing a flight suit over clothing. The flight suit was a dark brown or olive color. The PO was wearing a white helmet with a headset. The type of headset was consistent with other commercially available devices that have passive noise attenuation features. The paraglider harness appeared to be mostly black with some blue elements, and the cage of the paramotor was of raw aluminum color.

**Figure 8.** The color of the paraglider wing against the sky.

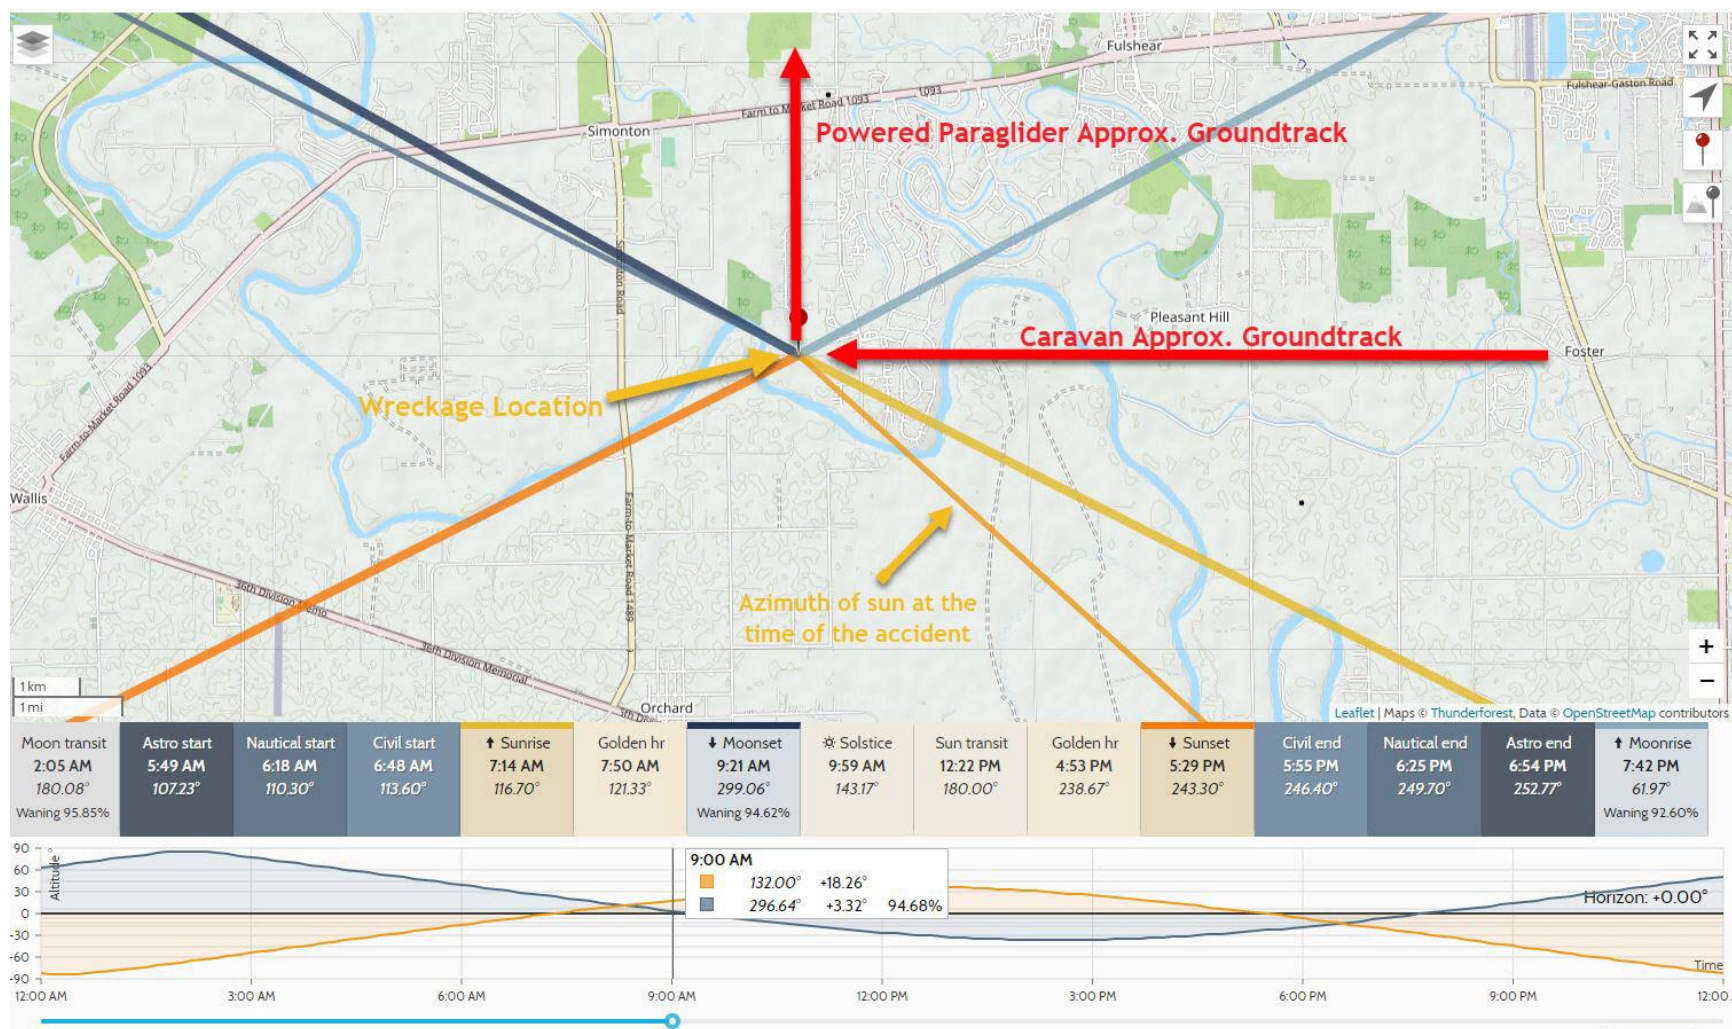
An ephemeris was used to calculate the position of the sun on the accident day around the reported time of the accident. A screenshot of the ephemeris with the given conditions are attached below as figure 9. The ephemeris indicated the sun was approximately out of the southeast (an azimuth of 132 degrees true, at an altitude of approximately 18 degrees) at the time of the accident. Given the position of the sun, and visible roads captured in the recovered footage, the PO was approximately on a northerly heading, north of the Brazos River, in the vicinity of Fulshear Farms Road, west of the Weston Lakes Village.

**Figure 9.** Ephemeris data for the time and position of the reported accident site.
