# National Transportation Safety Board

CEN22FA119

## **POWERPLANTS**

Group Chair's Factual Report

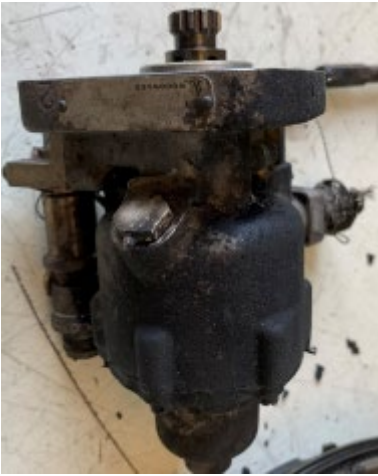
PHOTO 8: PROP OVERSPEED GOVERNOR

The propeller overspeed governor (Photo 8; Figure 2 Item 9), propeller governor (Photo 9; Figure 2 Item 7), and torque limiter (Photo 10) were removed for further analysis.

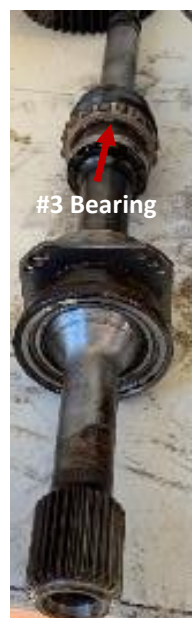
PHOTO 16: NO. 3 BEARING

The aft end of the PT shaft housing was asymmetrically crushed (Photo 15). The No. 3 and No. 4 bearings were clean, lightly oil-wetted, and rotated freely (Photo 16). The No. 4 bearing retention bolts were fractured.

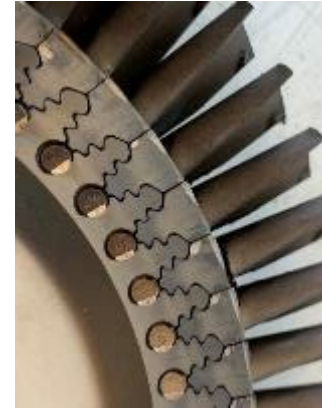
PHOTO 20: UPSTREAM (FRONT) FACE, COMPRESSOR

The compressor turbine was difficult to rotate by manually turning the blades. After removal of the AGB, tip rub was observed on all blades, with rubbing on the fir trees, disk bore, and balance weights. Rubbing was also noted on the downstream (AFT) (Photo 19) and upstream (Front) (Photo 20) blade platforms.

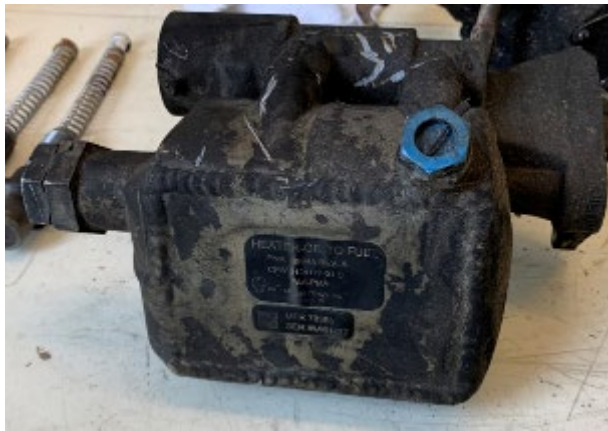
PHOTO 23: HEAT EXCHANGER

This heat exchanger was an airframe supplied component (Photo 35). The unit was covered with a black and oily deposit. The fuel outlet tube was present; the fuel inlet fitting was severed. The oil outlet and inlet ports were present and clean. One mounting support was fractured and missing. The lockwires were present and in the right locations. There were light fretting marks on the transfer valve outside diameter.

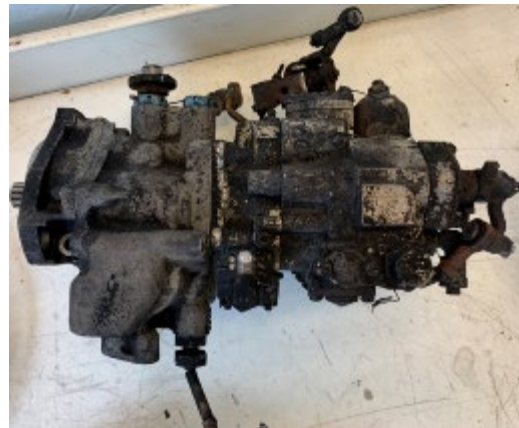
PHOTO 24: FUEL PUMP AND FUEL CONTROL UNIT

The fuel pump S/N 011287 matched the original pump shipped with the engine (Photo 36). The housing was covered with black deposits. The outlet fuel fitting was partially pulled out of the housing. The input shaft was rotated by hand in step movements. The fuel inlet port appeared clean. Lockwires were in the appropriate locations except for the fuel filter bowl, which was missing the lockwire. Prior to testing the fuel pump, the outlet fuel filter bowl was removed revealing a clean outlet fuel filter with no visible debris between the pleats. The fuel inlet screen was removed and was found clean as well.

The FCU housing was sooted (Photo 37, right). The metal components showed surface corrosion. The inlet fitting and throttle shaft were bent aft. The condition lever bracket was fractured. The minimum pressurizing valve housing was missing, along with the identification data plate. The manual override lever was bent aft and would not rotate full-travel by hand. The cut-off lever was bent inward. The acceleration adjustment cup was dented and perforated. The power trim was in the stowed position. The nylon coupling, where the fuel pump was removed, was in place and in good condition. The FCU drive shaft was rotated by hand with normal resistance. The acceleration adjustment lockwire, high-pressure relief valve lockwire, and high-pressure relief valve seal were damaged. Due to the impact damage, it was not possible to test the unit.

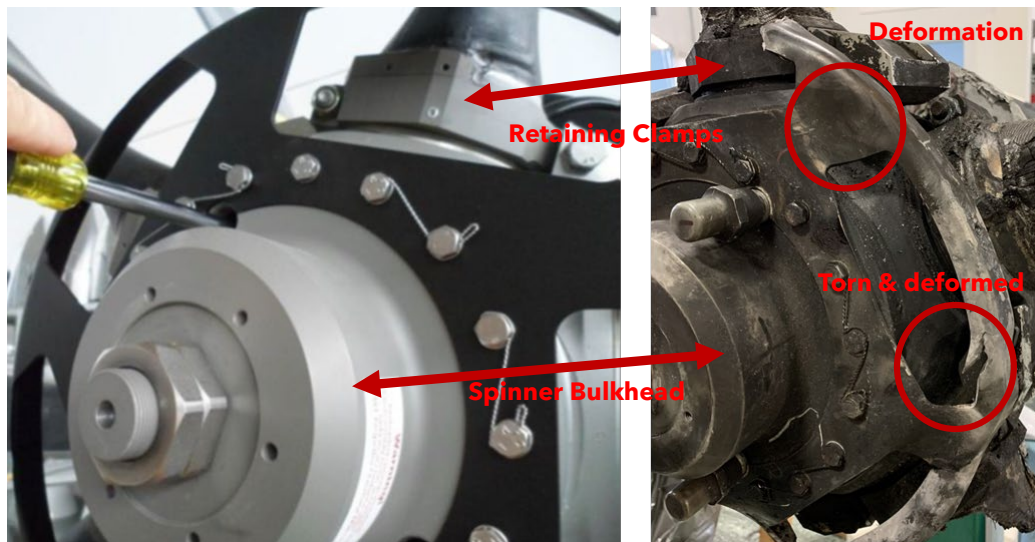
PHOTO 28: EXEMPLAR HUB (LEFT) AND ACCIDENT HUB (RIGHT)

The aluminum frame, part of the spinner bulkhead, around the propeller blades was melted and deformed, while the steel blade retaining clamps and blade counter-weights were heavily sooted (Photo 28). The spinner was not present; it was removed at P&WC West Virginia facility to facilitate separation of the propeller. All three beta rods were present but removed at P&WC to allow for separation and transport of the propeller. All required safety wire was in-place and intact on the hub retaining bolts.

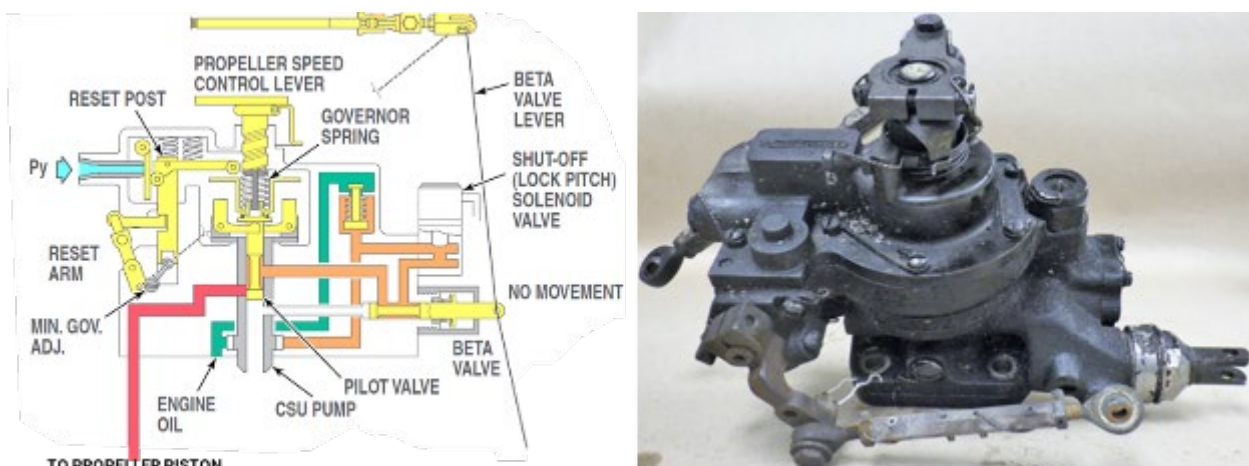
PHOTO 41: PROPELLER GOVERNOR DIAGRAMPT6 OPERATOR'S MANUAL (COURTESY OF P&WC) LEFT; SUBJECT PROPELLER GOVERNOR RIGHT

According to the original Honeywell build records, the propeller governor, also referred to as the Constant Speed Unit (CSU), was original to the initial engine delivery (Photo 41, right). Initial examination of the propeller governor at P&WC revealed the housing was sooted. There were granular deposits on the cover. The speed and reset levers were rotated through their full travel by hand and returned to

their respective maximum stop by spring tension. The beta valve moved with no restrictions. The input shaft rotated freely by hand. The eccentric adjustment screw slot was in-line with the indication mark on the retaining plate as it should be. The lockwires were at the right locations and in good condition.

The Py fitting was not properly seated on the housing (it had been loosened at P&WC West Virginia to facilitate removal), exposing a burnt O-ring. The O-ring was not installed correctly; it was installed between 2 cover bolts instead of going from one cover bolt to the pressure relief valve adjustment cap plug.

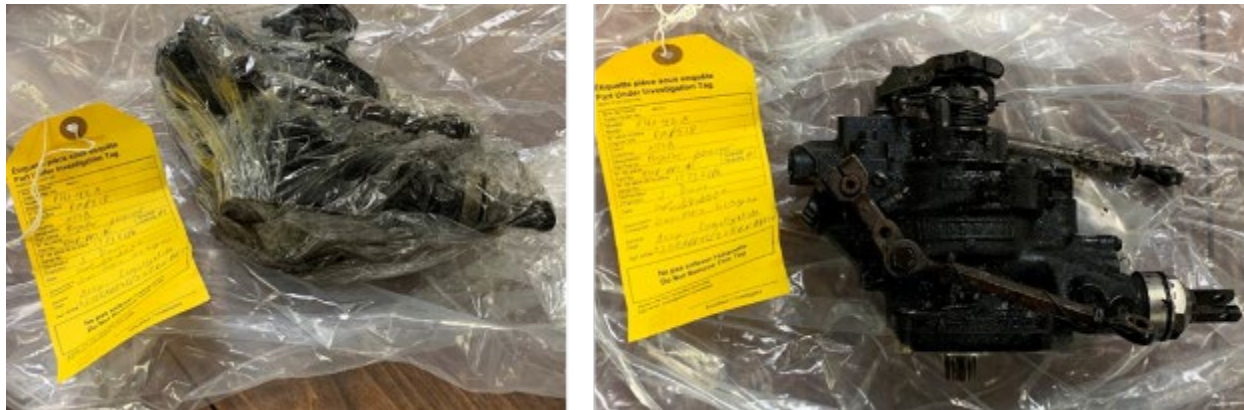
PHOTO 42: PROPELLER GOVERNOR (COURTESY OF WOODWARD)

After completion of the initial external examination at P&WC, the propeller governor was shipped to Woodward for additional testing and disassembly (Photo 42). It was confirmed as an older unit, originally shipped from Woodward on October 18, 2011, and it did not have the standard Woodward lockwire seals.

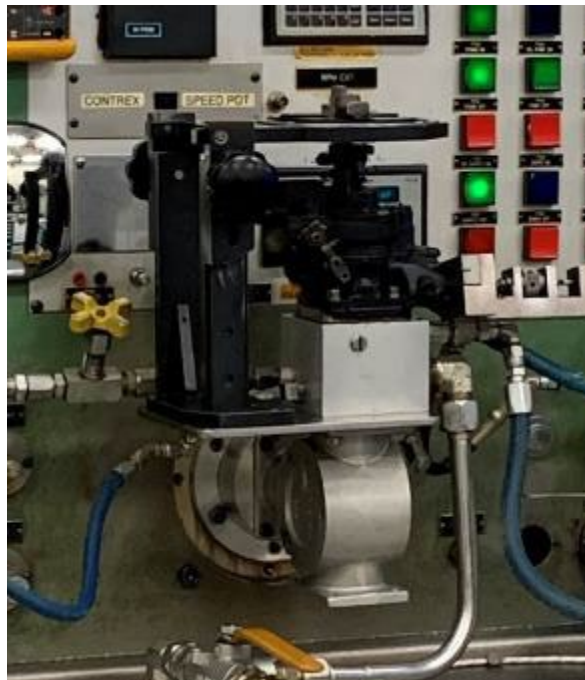
PHOTO 44: CSU ON THE WOODWARD TEST BENCH  
(COURTESY OF WOODWARD)

The CSU was installed on a test stand (Photo 44). On initial testing, the pump output flow and relief valve pressure were both below normal operating range. With a slaved, new relief valve (not for this CSU), both values increased.

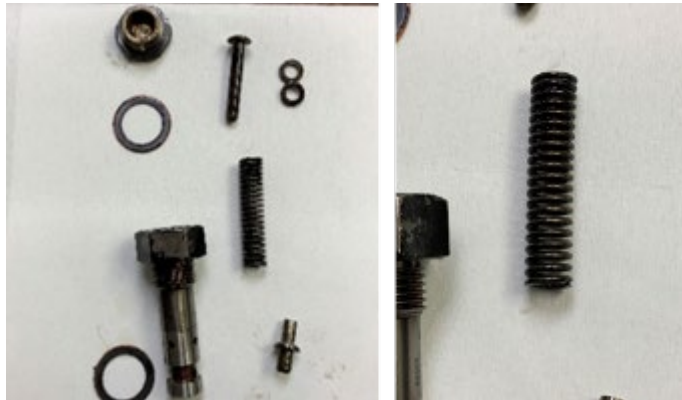
PHOTO 45: CSU RELIEF VALVE DISASSEMBLED (COURTESY OF WOODWARD)

The relief valve was disassembled to better define the low pressure seen on the test stand. The relief valve spring length was measured at 1.565 inches, which most closely corresponds to the installed, loaded length of 1.47-1.57 inches. The anticipated value was 1.74-1.78 inches, suggesting the valve was partially open. According to Woodward, this is a known issue when the relief valve springs are exposed to extreme heat, such as during a fire (Photo 45).

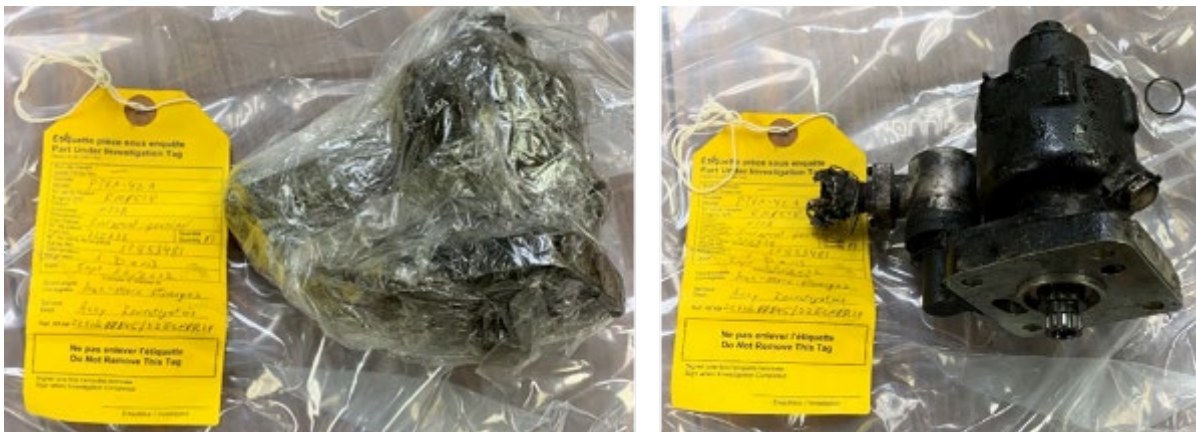
PHOTO 47: OVERSPEED GOVERNOR, OUT OF THE BOX (COURTESY OF WOODWARD)

After completion of the initial external examination and testing at P&WC, the propeller governor was shipped to Woodward for additional testing and disassembly. The overspeed governor was oily and sooted, with the ports uncovered (Photos 47 and 48). There were non-Woodward lockwire, seals, and attachment hardware including torque seals.

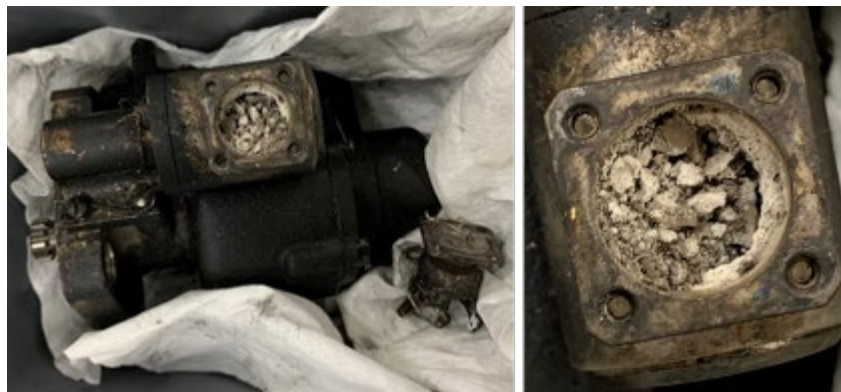
PHOTO 49: FEATHERING SOLENOID REMOVED FROM GOVERNOR (COURTESY OF WOODWARD).

With the electrical connection for the feathering solenoid removed, debris was seen inside the housing, likely the remains of the gasket, a room temperature vulcanized (RTV) silicone, inside the fitting (Photo 49).

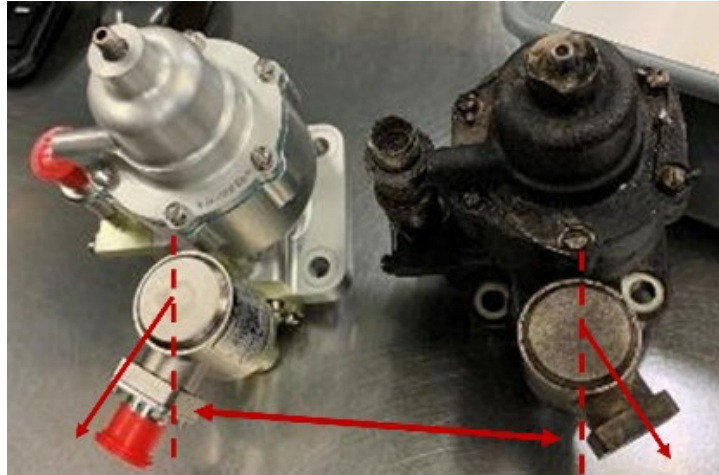
PHOTO 52: EXEMPLAR GOVERNOR WITH STANDARD FEATHERING SOLENOID (LEFT), WITH THE ACCIDENT UNIT (RIGHT) (COURTESY OF WOODWARD).

The feathering solenoid on the overspeed governor was approximately 60-degrees out of position and would not fit the test stand (Photos 50 and 51). The event feather solenoid was removed, and a feathering solenoid of the same part number was installed for testing (Photo 52).

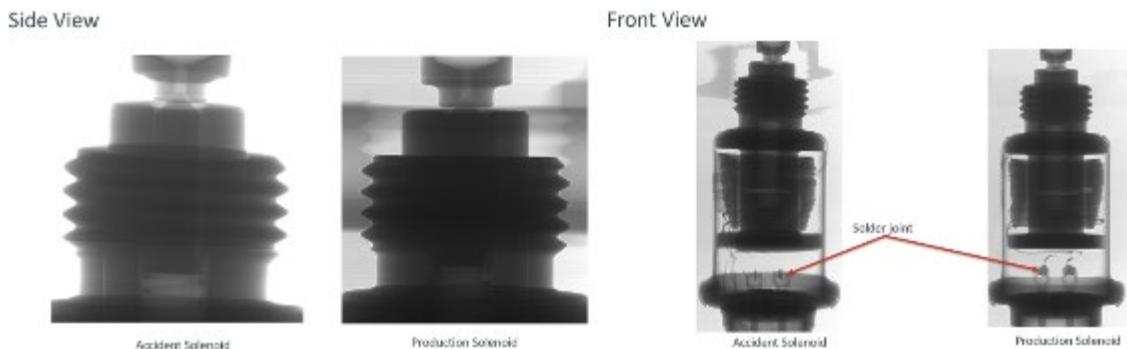
PHOTO 57: MISHAP SOLENOID NEXT TO A PRODUCTION SOLENOID (COURTESY OF WOODWARD)

The reset solenoid was x-rayed a second time to confirm the offset of the poppet. The x-ray also did not show internal solder; Woodward suggested that this was possibly due to melting in the post-impact fire (Photo 57).

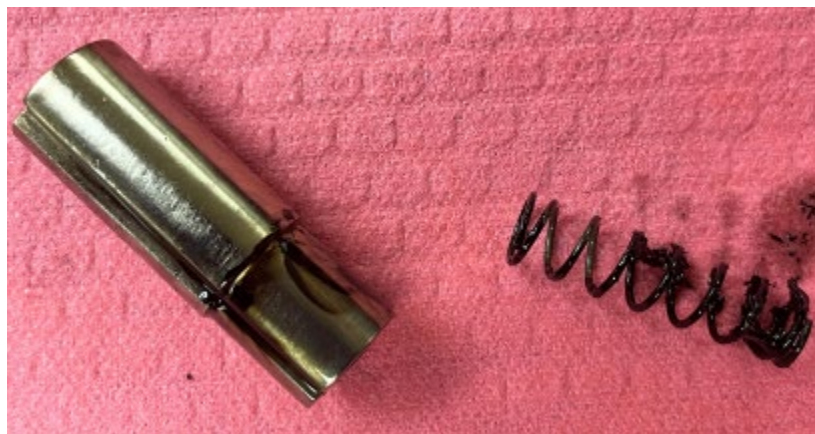
PHOTO 60: SLEEVE AND SPRING (COURTESY OF WOODWARD)

The spring length was measured to be 1.079 inches; the reference length is 1.090 inches (Photo 60). A resistance check was not possible due to the recessed pins. The magnet wire was in good shape, though the tape covering was missing, consistent with being exposed to the post-impact fire. With the feathering body separated, the spring and poppet seat were removed. The seat appeared in good condition other than heat damage.

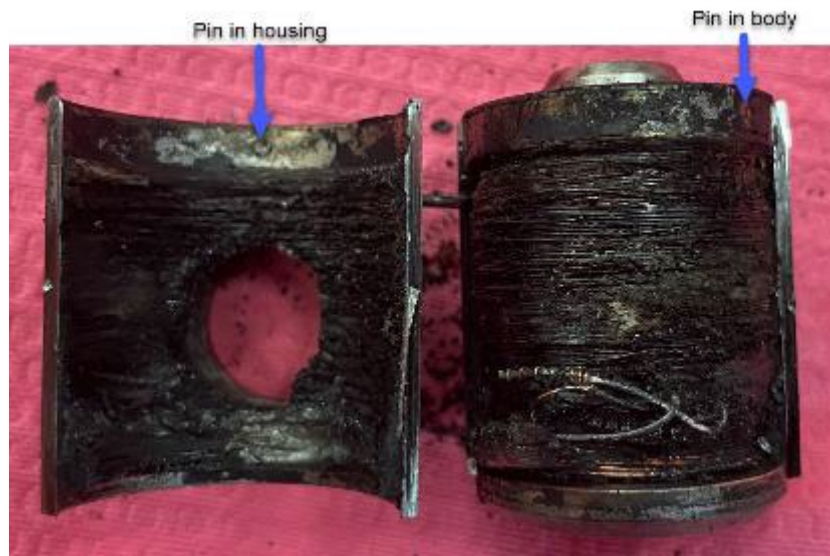
PHOTO 61: FEATHERING SOLENOID HOUSING & BODY (COURTESY OF WOODWARD)

The feather solenoid body was machined to split the housing from the body. Upon examination, the pin which engages the housing to the body of the solenoid was found sheared, consistent with the approximately 60-degree offset initially observed of the solenoid on the governor.

The reset solenoid was loose against the body when removed from the shipping bag (Photo 61). The sleeve was bent inside the housing to the extent it

could not be removed by hand, the poppet was exposed, and the plunger was sticking out of the threads. The sleeve should have been free to simply drop out, as it is not a press fit or adhered in any way.

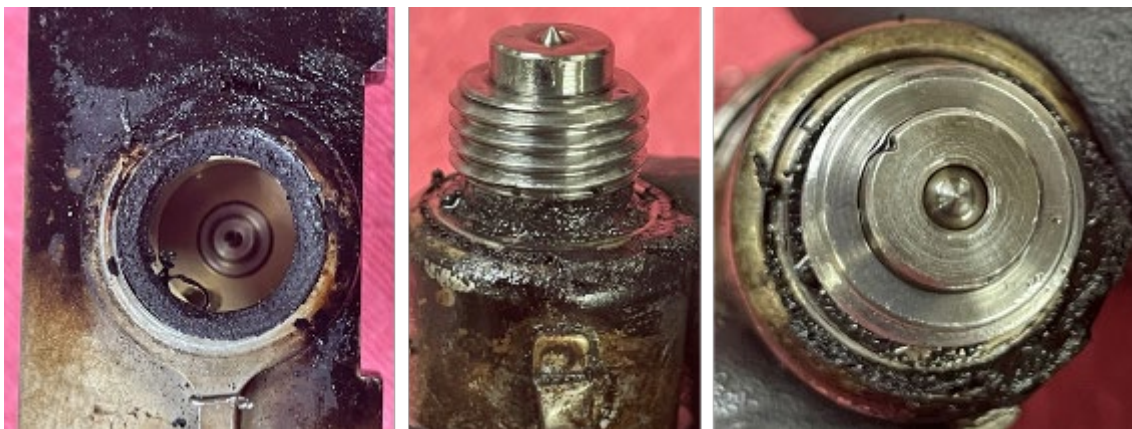
PHOTO 62: BURNT MATERIAL ON HOUSING, WITH THREADS & POPPET EXPOSED (COURTESY OF WOODWARD)

The electrical continuity check of the terminal pins registered 293,000 ohms, with the expected value being 100-150 ohms. Coil-to-casing continuity checks registered 0.2 Ohms and 17,220 Ohms respectively, suggesting a ground or short to the case housing.

Based upon the initial resistance checks, no further electrical testing was attempted. A mix of soft, sludge-like and some hardened, crumbly material was found in the seal - likely the 2 different sealant materials (stycast potting and RTV) (Photo 62).

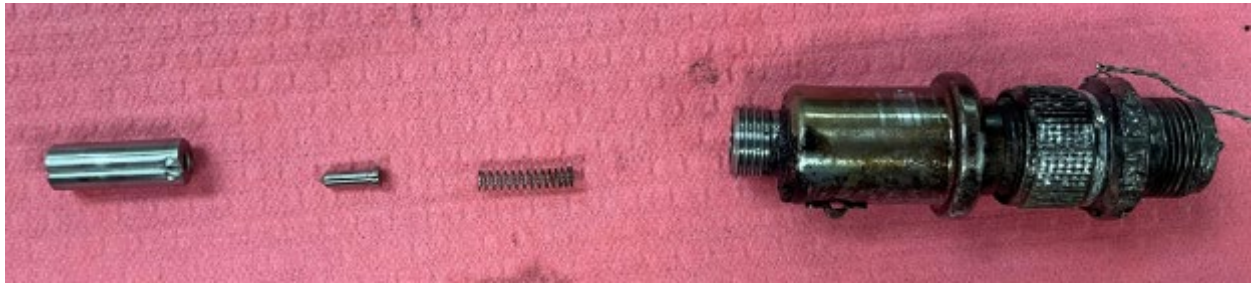
PHOTO 63: SLEEVE, POPPET, SPRING, AND SOLENOID (COURTESY OF WOODWARD)

Using a vise, the sleeve was separated from the body, and the plunger and spring dropped out (Photo 63). The spring's reference setting was 0.680 inches; the pre-length reference measurement was 0.6085 inches. The spring has two test points: with 0.25 pounds applied the length of the spring should be 0.560 +/-0.010 inches; and with 0.3 pounds applied the length of the spring should be 0.535 inches. The accident spring measured 0.494 inches in length when at 0.25 pounds was applied and 0.4677 inches in length when 0.3 pounds was applied.

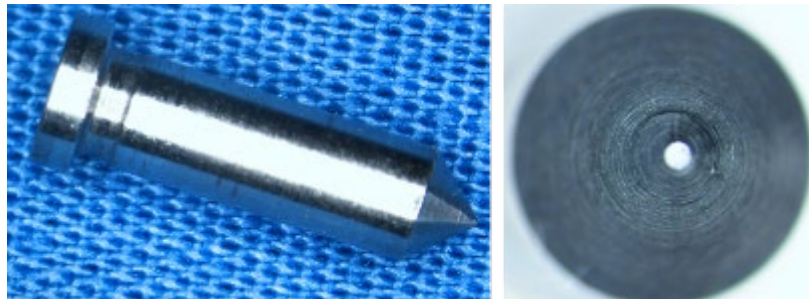
PHOTO 64: POPPET & HI-MAG VIEW OF INTERIOR (COURTESY BY WOODWARD)

Several high magnification photos of the poppet revealed impressions evenly spaced circumferentially, consistent with the poppet recessed evenly and to the correct depth at the time of accident (Photo 64).
