# National Transportation Safety Board

CEN22FA208

## **AIRPLANE PERFORMANCE STUDY**

Location: Broomfield, Colorado  
Date: May 22, 2022  
Time: 1149 MDT  
1749 GMT  
Airplane: Piper PA-32-260 Cherokee Six, N85CT

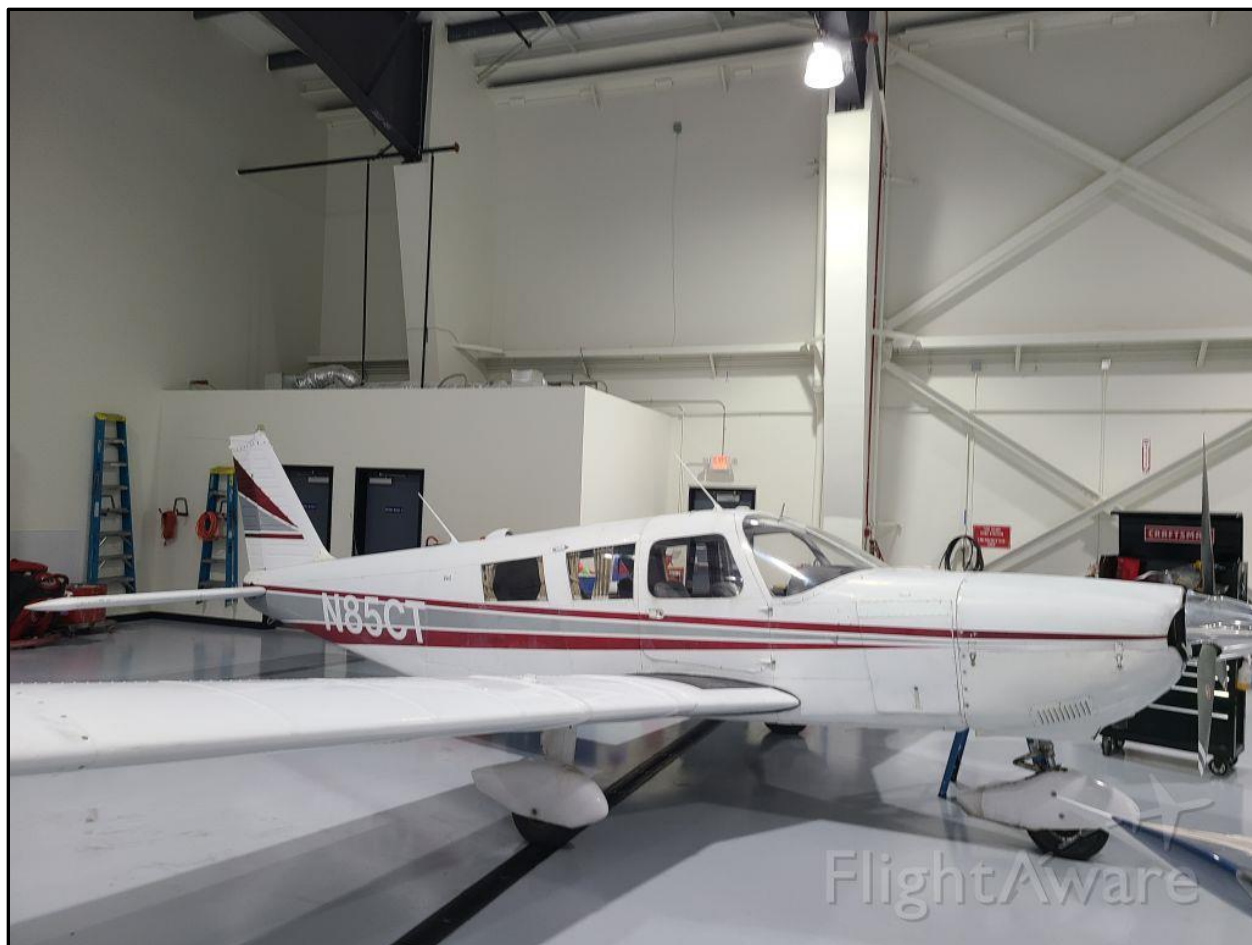
**Figure 3: Accident Airplane, N85CT, a Piper 32-260 Cherokee Six, N85CT**

A picture of the accident airplane, a Piper PA-32-260 Cherokee Six, N85CT, is shown in Figure 3. The airplane was manufactured by Piper Aircraft in 1966 and is registered to AEROBSESSION, LLC.

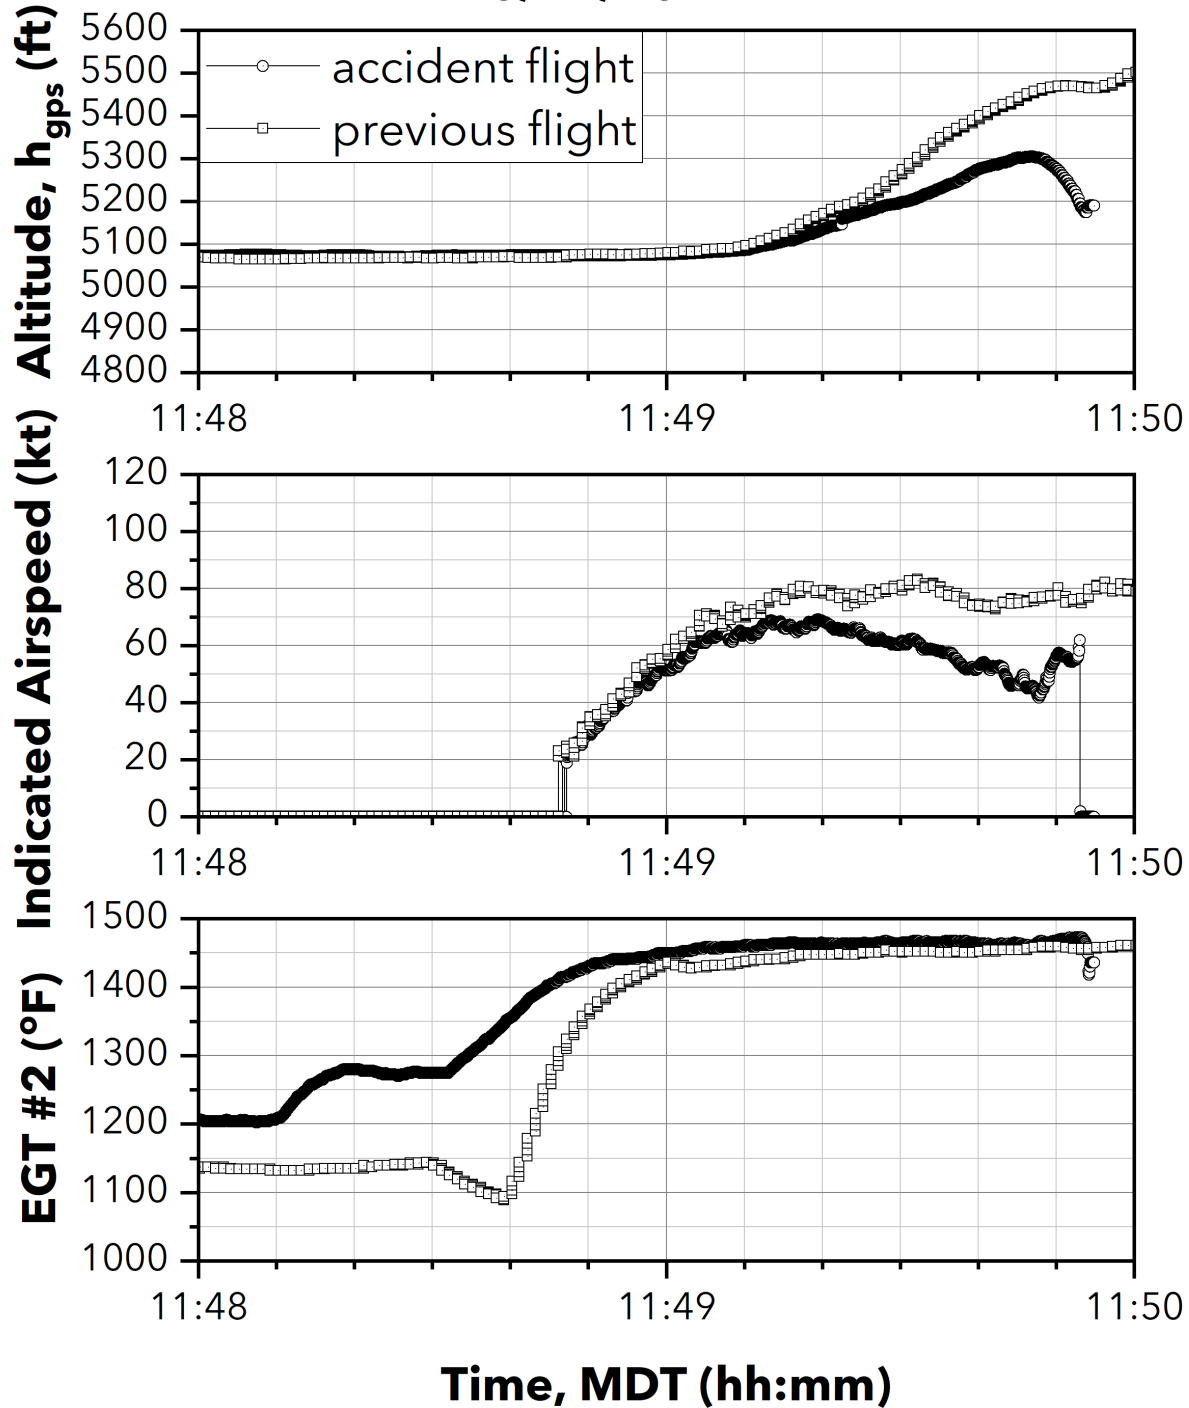
**Figure 8: EGT for Cylinder #2 for Accident and Previous Flight**

To better understand the reduced take-off performance during the accident flight, engine data recorded on the Dynon HDX1100 for the accident was compared with equivalent data from the flight three weeks earlier. Figures 7 through 15 compare exhaust gas temperatures (EGT), fuel flows, engine RPM, and manifold pressures for the two take-offs.
