# National Transportation Safety Board

CEN22FA216

## VEHICLE PERFORMANCE

Location: Cheyenne, Wyoming  
Date: May 30, 2022  
Time: 0748 MDT  
1348 GMT  
Airplane: Express 2000 RG, N44508

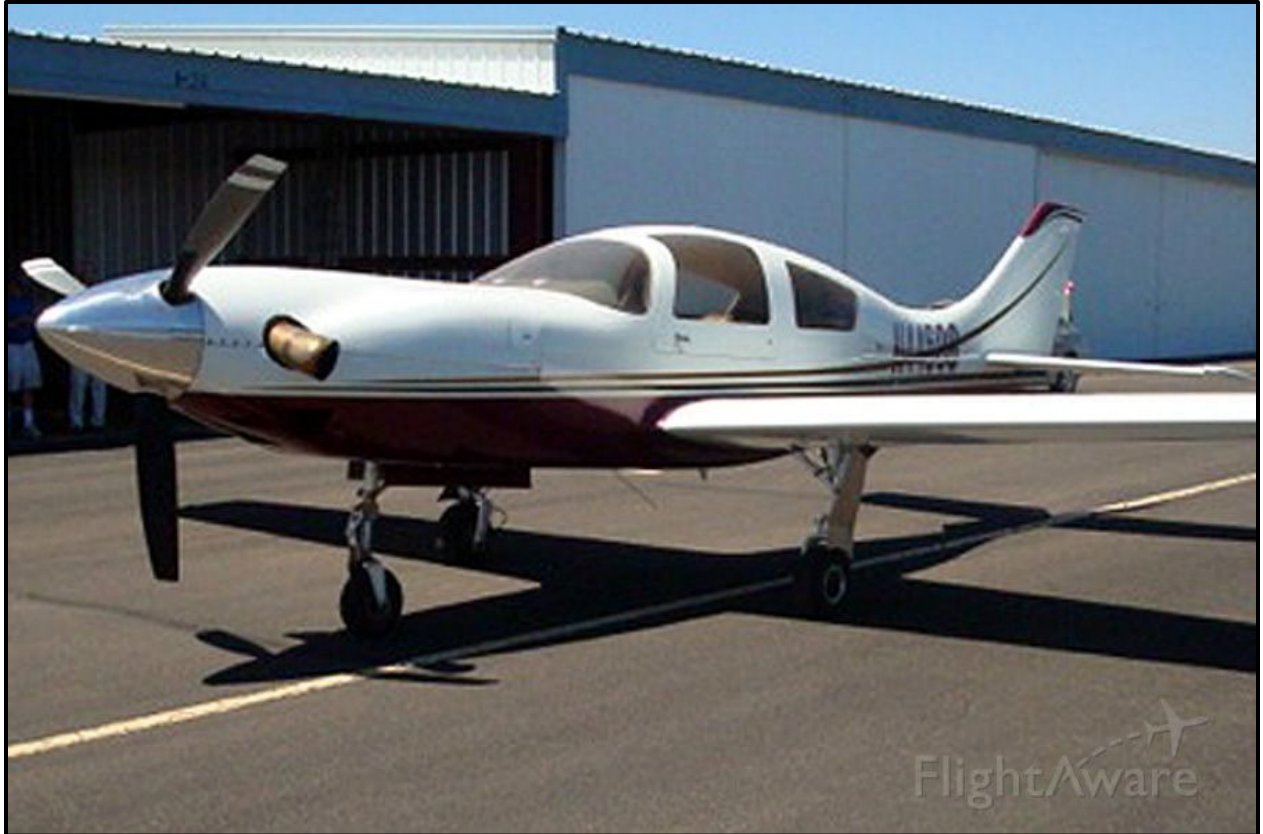
A picture of the accident airplane, an Express Aircraft Incorporated Express 2000 RG, is shown in Figure 2. The kit airplane was built by JG Burr in 2008 and is registered to Aeromania, LLC.

**Figure 2: Accident Airplane, N44508, a 2008 JG Burr Express 2000 RG**
