# National Transportation Safety Board

CEN22FA331

## **AIRWORTHINESS**

Location: North Fork, Idaho  
Date: July 21, 2022  
Time: 1644 mountain daylight time  
Helicopter: Columbia Helicopters CH-47D, registration N388RA

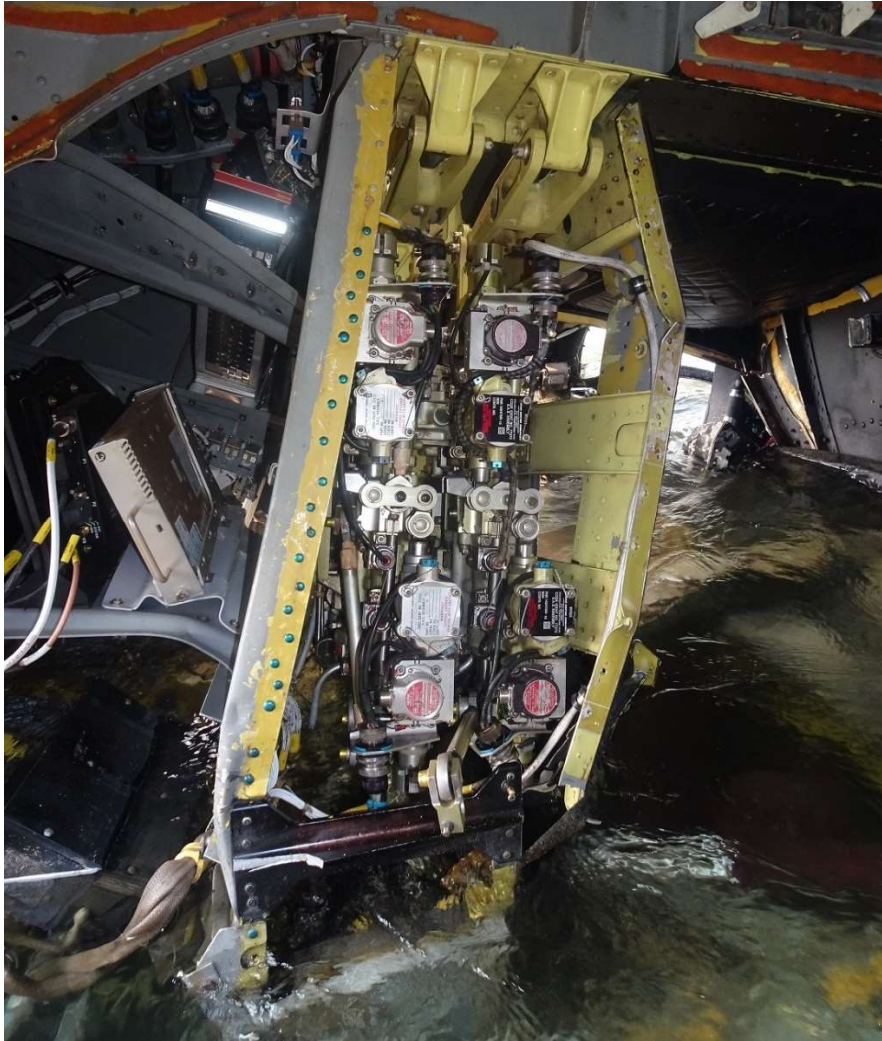
The pitch, roll, yaw, and thrust ILCAs remained installed in their normal positions within the flight control closet (**Figure 7**). The output rod for the pitch ILCA was separated, but the remaining output rods remained connected. All hydraulic lines remained connected to the ILCA manifold. The yaw No. 2 jam indicator had extended. The thrust No. 1 jam indicator had extended. All other ILCA jam indicators were not extended. The connecting rods and levers between the ILCA output to the first stage mixing unit were continuous and intact.

**Figure 7.** The pitch (right) and roll (left) ILCAs installed in the flight control closet. The yaw and thrust ILCAs are forward of the pitch and roll ILCAs.

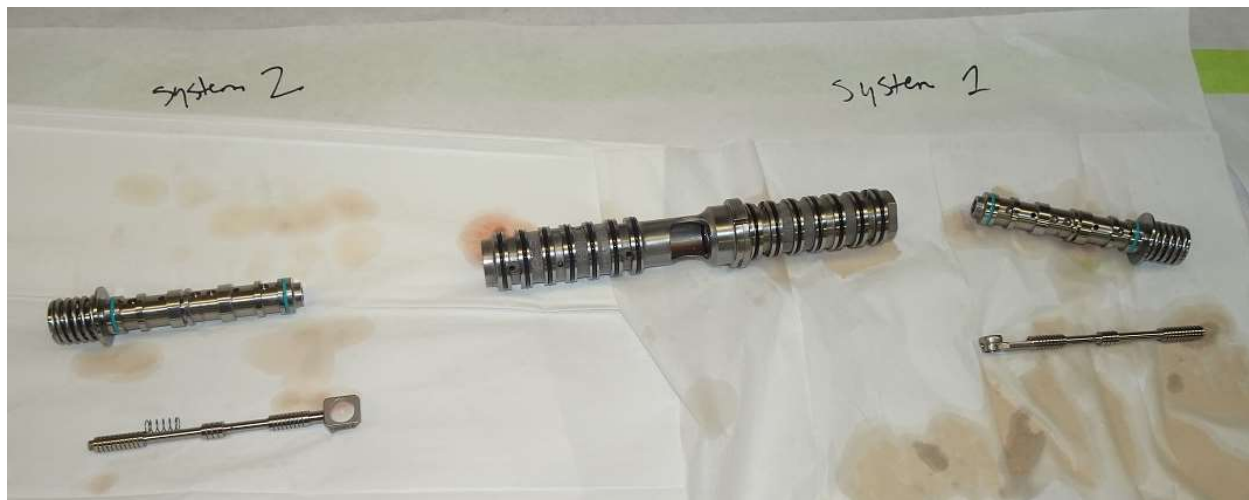
The Nos. 1 and 2 inner sleeves and spools were removed from the outer sleeve. The inner sleeves and their spools did not exhibit anomalous damage (**Figure 22**). White-colored material was observed within the inner diameter of the No. 1 side of the outer sleeve as well as the center housing (**Figure 23**). The white-colored material was collected for further evaluation.

The Nos. 1 and 2 inner sleeves were examined and exhibited no anomalous damage. The electrical discharge machined (EDM) slots on both Nos. 1 and 2 inner sleeves were examined and had no evidence of clogs or obstructions. The Nos. 1 and 2 spools showed no evidence of anomalous damage.

**Figure 22.** The spools and sleeves from the two systems of the yaw ILCA.
