# National Transportation Safety Board

CEN22FA405

## **MATERIALS LABORATORY**

Factual Report 22-069

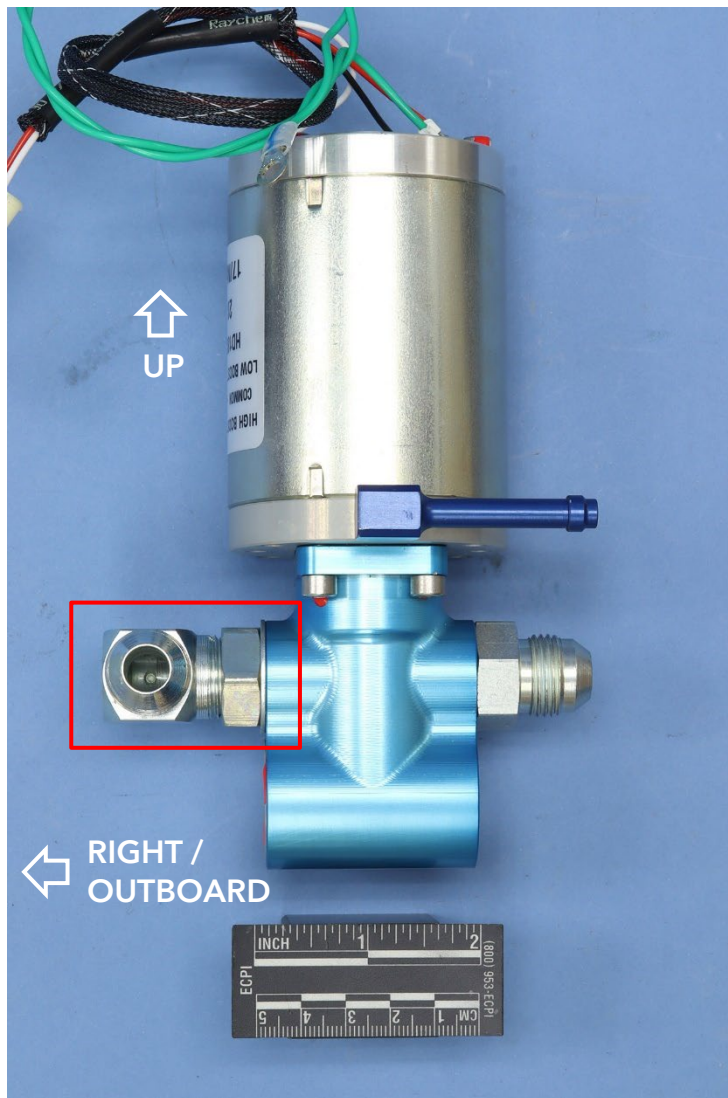
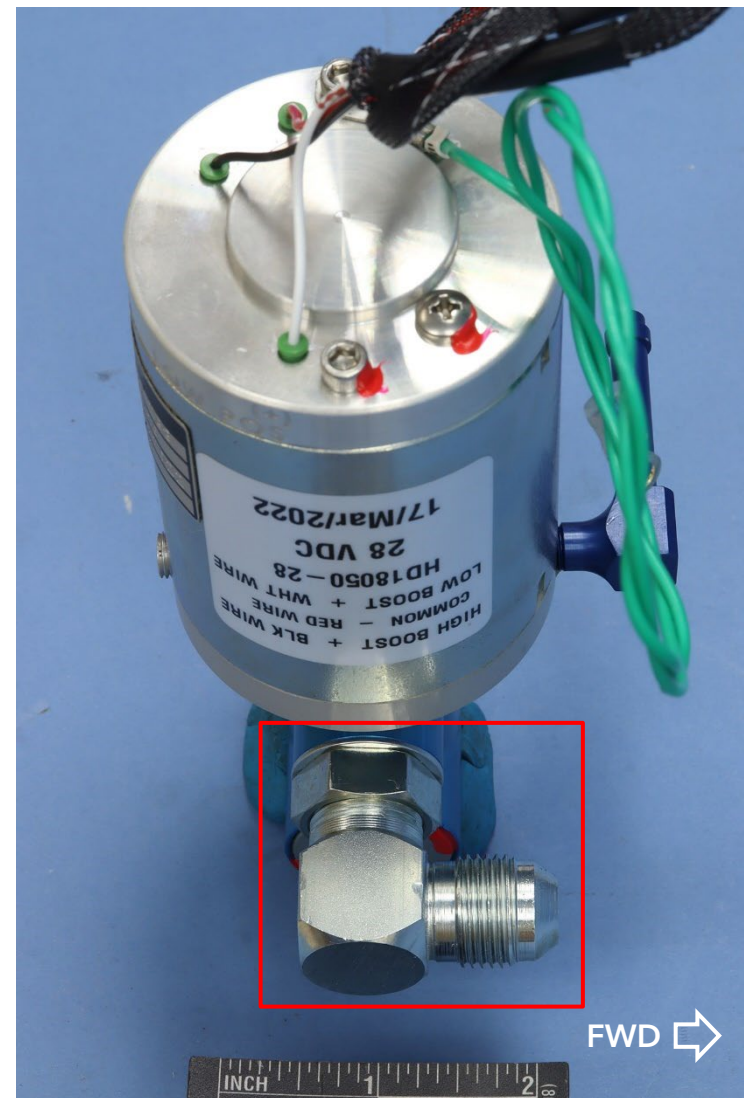
the aircraft and were viewed from the aft direction looking forward, with 12 o'clock located at top-dead-center (see figure 2 for the orientation of the installed pump). As indicated in figure 3b, a blue adhesive torque stripe had previously been applied to the tube, B-nut, and fuel line transition elbow along the 3:00 position. The torque stripe had fractured in two locations: one at the transition from the tube to the B-nut, and the other at the transition from the B-nut to the transition elbow. As indicated in figure 3b, the torque stripe at the later location was displaced in the circumferential direction, consistent with a rotation of the transition elbow relative to the B-nut. The displacement, measured on a calibrated image was approximately 0.075 inch. The rotation, viewed from the forward direction looking aft, was in the counterclockwise direction or from the 9:00 position toward the 12:00 position in the clock coordinate system of the brazed joint. When viewed at higher magnification, a small rotational offset of approximately 0.006 inch was also observed at the crack between the B-nut and tube, with the B-nut similarly rotating in the counterclockwise direction (viewed forward looking aft).

**Figure 2.** Two images showing different views of an exemplar fuel boost pump with red rectangles highlighting the 90° elbow fitting. The pump is installed on the right side of the aircraft. The left image shows the forward-facing side of the pump and the right image shows the right and top sides of the pump.
