## **NATIONAL TRANSPORTATION SAFETY BOARD**

### **Specialist's Factual Report**

## **HUMAN PERFORMANCE**

CEN22FA405

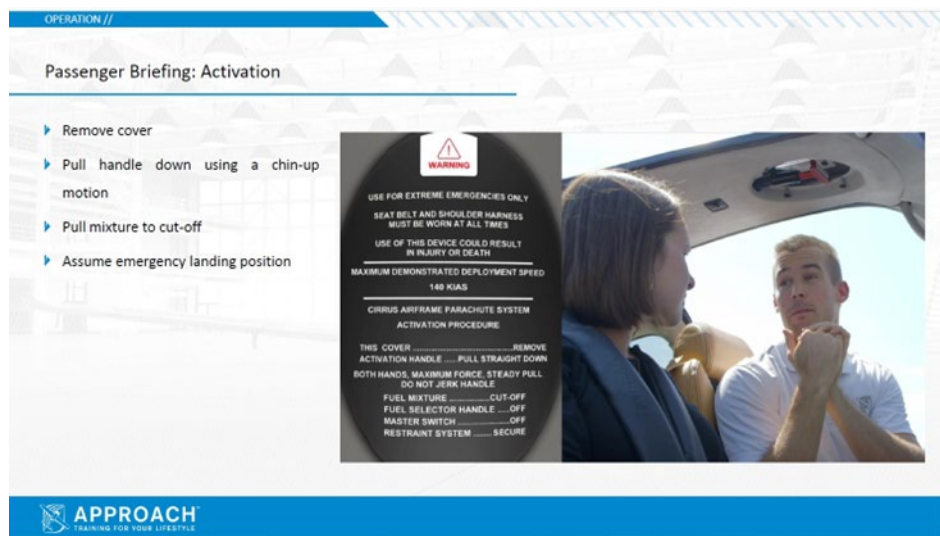
Figure 1: Excerpt from CAPS Briefing.

A Cirrus flight training development specialist provided the investigation team with the same Cirrus Airframe Parachute System (CAPS) training briefing that

customers receive (see figure 1). After the briefing, the investigative team participated in a simulator session using an SR20 simulator.<sup>1</sup> The goals were to document the simulator fidelity, flight deck array, emergency procedures, aural/visual alerts, and the RNAV (GPS) Runway 17R approach procedures into David Wayne Hooks Memorial Airport (DWH), Spring, Texas.

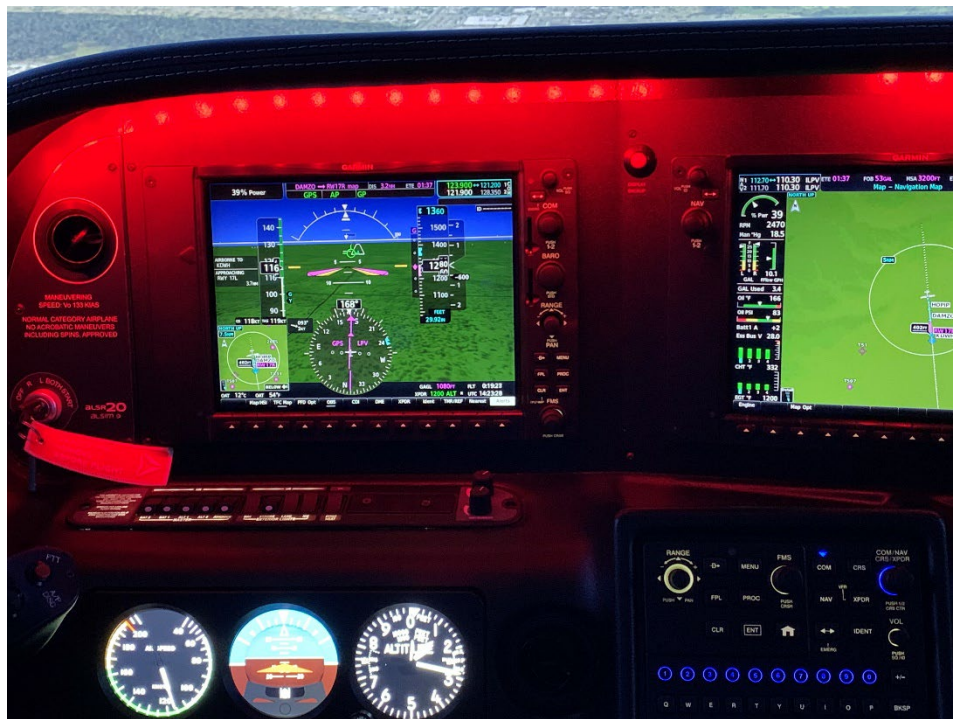
Figure 2: SR20 Simulator PFD and MFD

indication was a decrease in engine noise. There are no discreet aural warnings for a loss of fuel flow pertaining to the fuel mixture control lever being in the cutoff position. It must be noted that during the simulator run the IIC (seated in the left seat of the sim) inadvertently moved the fuel mixture control lever aft while cycling through throttle positions. The IIC's inadvertent movement of the mixture was due to his hand/finger placement on the throttle's T-handle, and the throttle had to be moved to the full idle position to inadvertently move the mixture control to the idle cutoff position. The Flight Training Development (FTD) Specialist serving as the simulator technician remarked that it was not something he had ever seen happen before. Additionally, the FTD specialist discussed and demonstrated alternative hand/finger positions that he typically uses to move the throttle that did not interfere with the mixture control.

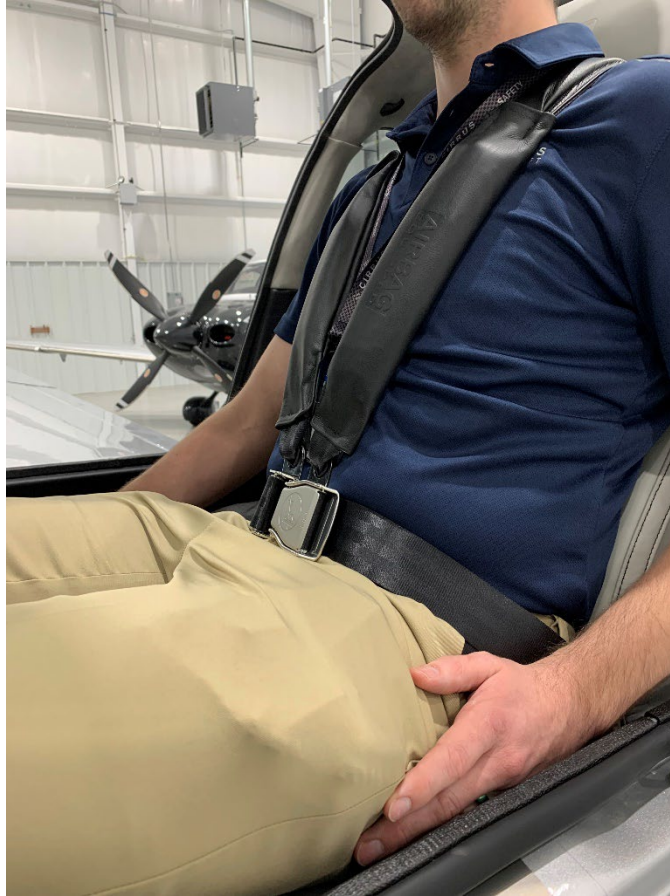
Figure 4: Photo documentation of 4-point seat restraint.

Additionally, the HP specialist photo documented use of the 4-point (front seats only) restraints using the FTD specialist as a reference (see Figure 4).
